WATER QUALITY MEMORANDUM

Utah Coal Regulatory Program

January 20, 2005

RE: 2004 Third Quarter Water Monitoring, Energy West Mining Company, Trail Mountain Mine, C/015/0009, Task ID # 2021

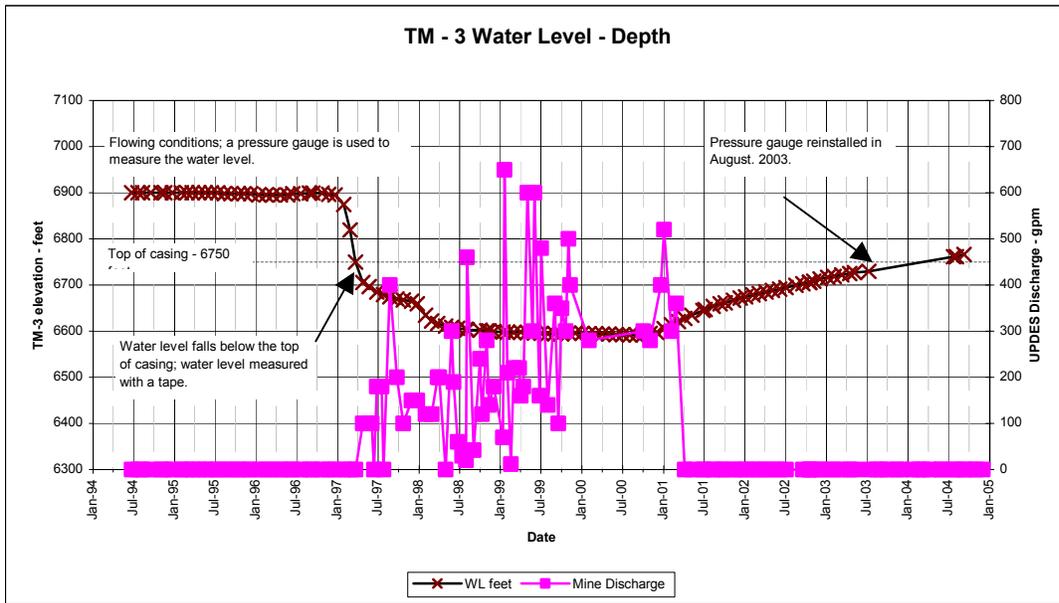
TM-3: depths reported for this piezometer for the third quarter were was outside the two standard deviation range because elevation was reported as depth; Dennis Oakley confirmed this and it has been corrected in the database. Water level in this piezometer has been recovering since Trail Mountain Mine operations ceased, and a well cap and pressure gauge were installed August 2003 because water was approaching the top of the casing: "no artesian pressure" was reported in April and "dry" for May and June, but values were reported for the 3rd quarter 2004 (see chart below).
