C/015/009 Incoming  
cc: Keenan

RE: Fossil Rock Resources, LLC Permit #C0150009, Waste Rock Site Ditch Evaluation and Request to Terminate NOV #21173

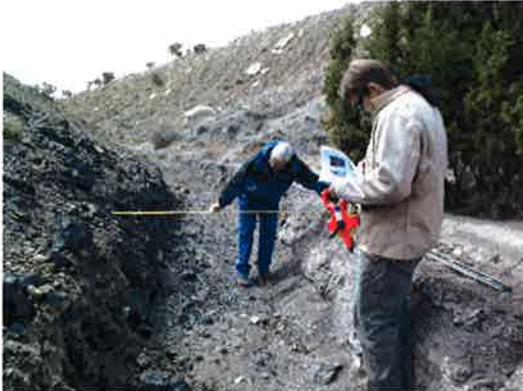
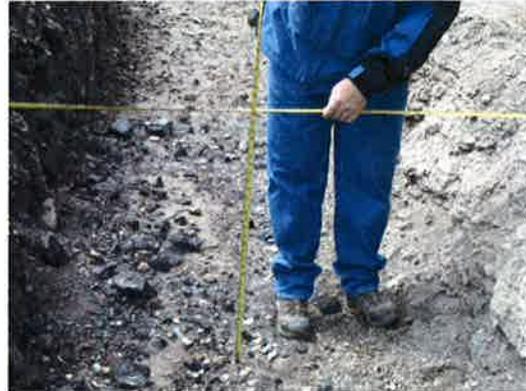
1. The NOV states that ditch DA was not maintained in the configuration as originally designed. The original design is a v-ditch with side slopes of 2.5:1. The ditch has been maintained as a box ditch. Both the original design and existing dimensions are shown on the attached drawing. One

of the tasks to be completed during the site visit was to verify the capacity of the existing ditch at least equaled the original design flow of 18.9 cubic feet per second. After inspection it was clear the existing ditch dimensions will function with a flow capacity of at least 23 cubic feet per second, a far greater capacity than originally designed (see calculations in Flow Capacity section). A box configuration will require more maintenance because of the steep side slope and the increased propensity for erosion of the side slopes during high flow events. However, at this site the nature of the native soils and fill material as well as access for equipment to perform ditch maintenance currently favor a geometry other than a "V"-shape. See the drawings in the Flow Capacity section for dimensions of Ditch DA at four locations that were deemed representative of the configuration of the existing ditch.

Photo 1: Ditch DA

Photo 2: Ditch DA

The upper segment of ditch DA has not been maintained to the dimensions originally specified in the permit dimensions. It has been shown that there is adequate discharge capacity within the ditch, to ensure the immediate watershed adequately drains into the sediment pond.

Instead of re-establishing the ditches and diversions to their original designs, FRR proposes to submit new ditch designs based on what will actually work in the field for this site based on the site configuration, access to ditches and sediment controls for maintenance work, and the stability characteristics of native and fill materials at the site. However, prior to FRR submitting new ditch designs, the company wants to present the Division with the information contained in this letter that demonstrates the ditches are constructed in such a manner as to convey runoff with appropriate flow capacities to the sediment pond as required by the permit and that there is no danger of creating off-site impacts if the ditches are allowed to remain in their current state until the new designs are submitted and approved. FRR requests the Division terminate the NOV based on the information contained within this letter.

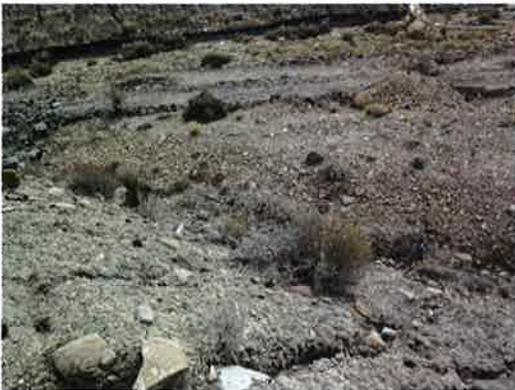
2. The NOV states that, "ditch DB is not-existent... and an access road has been constructed in its place." During our site visit we found the ditch is indeed in place though there is evidence of previous equipment access in the area and the access area had been roughened, see Photo 3. Two cross sections of ditch DB were measured where the ditch is the smallest. The actual flow capacities are

Photo 3: Equipment Access in Background

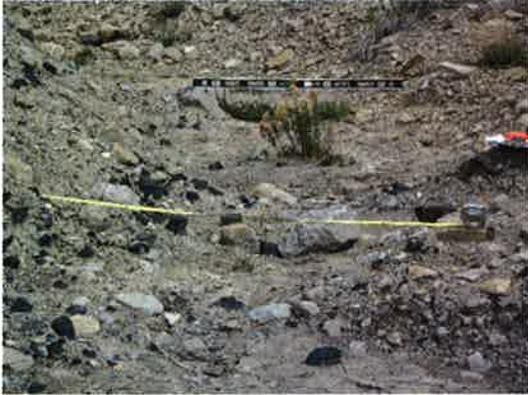
After a review of the permit documents, specifically Appendix C, the design flow for ditch DB was designed based on a watershed of 3.4 acres. FRR is not currently aware why the original design watershed was so large. The actual watershed is 1.1 acres in size. This is likely the reason why there is no evidence that ditch DB has undergone the permitted design flows. The two watershed boundaries are shown in the attached drawing. See Photos 4 and 5 for pictures of the two cross sections measured.

Photo 4: Ditch DB Cross Sections

Ditch DB has been maintained with dimensions close enough to the original design and should be considered compliant. Discharge capacities currently exist that exceed the design capacities.

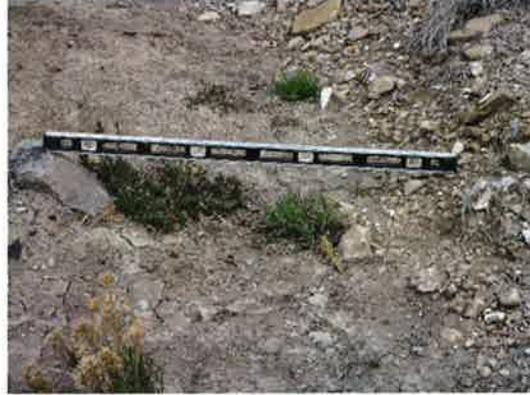
Photo 5: Ditch DB Cross Section E

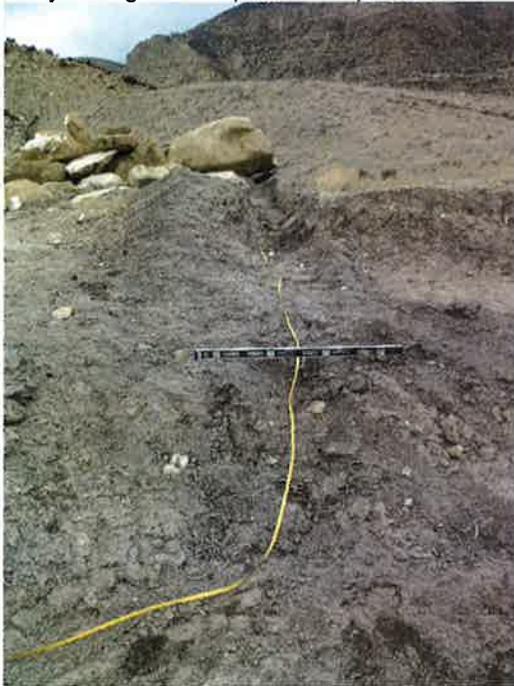
3. The NOV states, "ASCA, southern end of Subsoil Stock Pile... there is no clear runoff flow path on southern end... that directs water to the silt fence." During our site visit we found that there is a clearly defined flow path. Similar to ditch DB, the flow path is reduced in size because the size of its watershed source is very small. See Photos 6 and 7. A cloth tape was laid in the center of the flow path to more easily distinguish the path in the photos.

Photo 6: Upper Flow Path

The south end of the subsoil pile adequately drains to the sediment pond through the installed silt fencing.

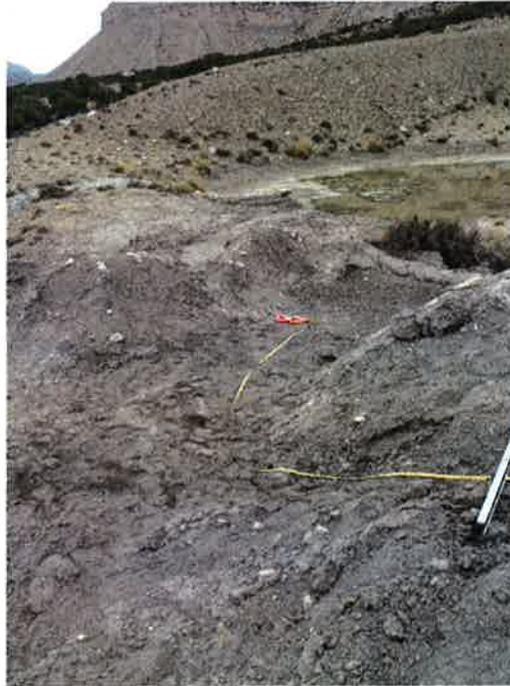
Photo 7: Lower Flow Path
