Re: 3rd Quarter Pond and Waste Rock Inspections, Fossil Rock Mine

Waste Rock Sediment Pond Quarterly Inspection Report

Fossil Rock Resources, LLC - Fossil Rock Mine  
Mine Site Sediment Pond Quarterly Inspection Report

**Quarterly Inspection Form - Refuse Disposal Areas**  
 (please provide to DOGM promptly after inspection is complete)

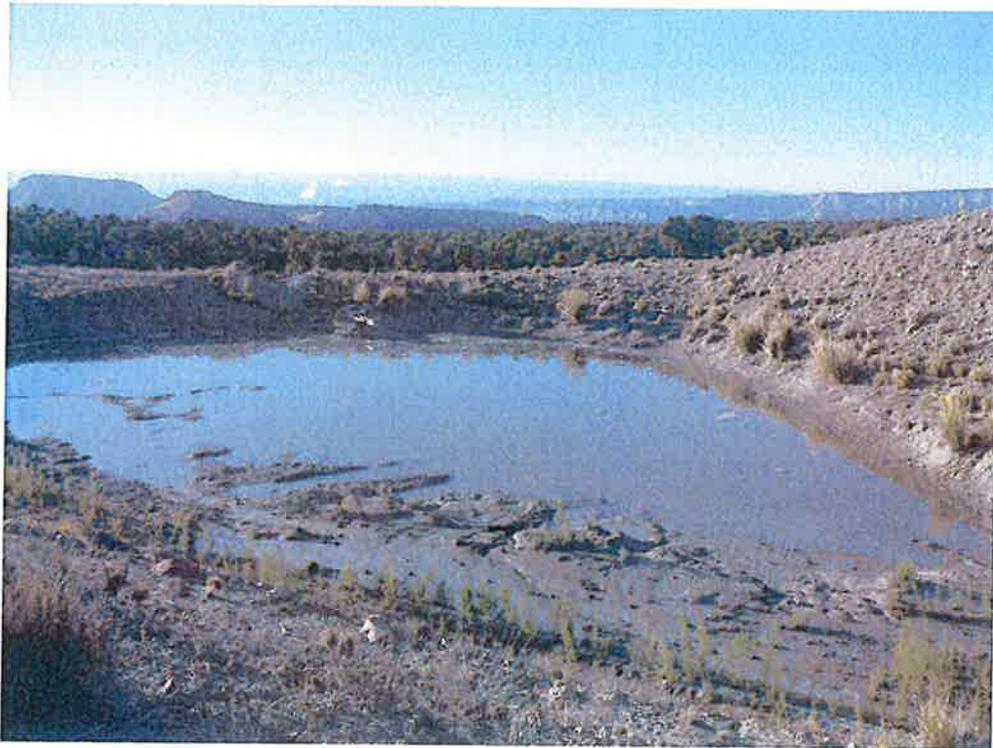
The pond collected approximately 8 inch of water from a storm on 9/12.

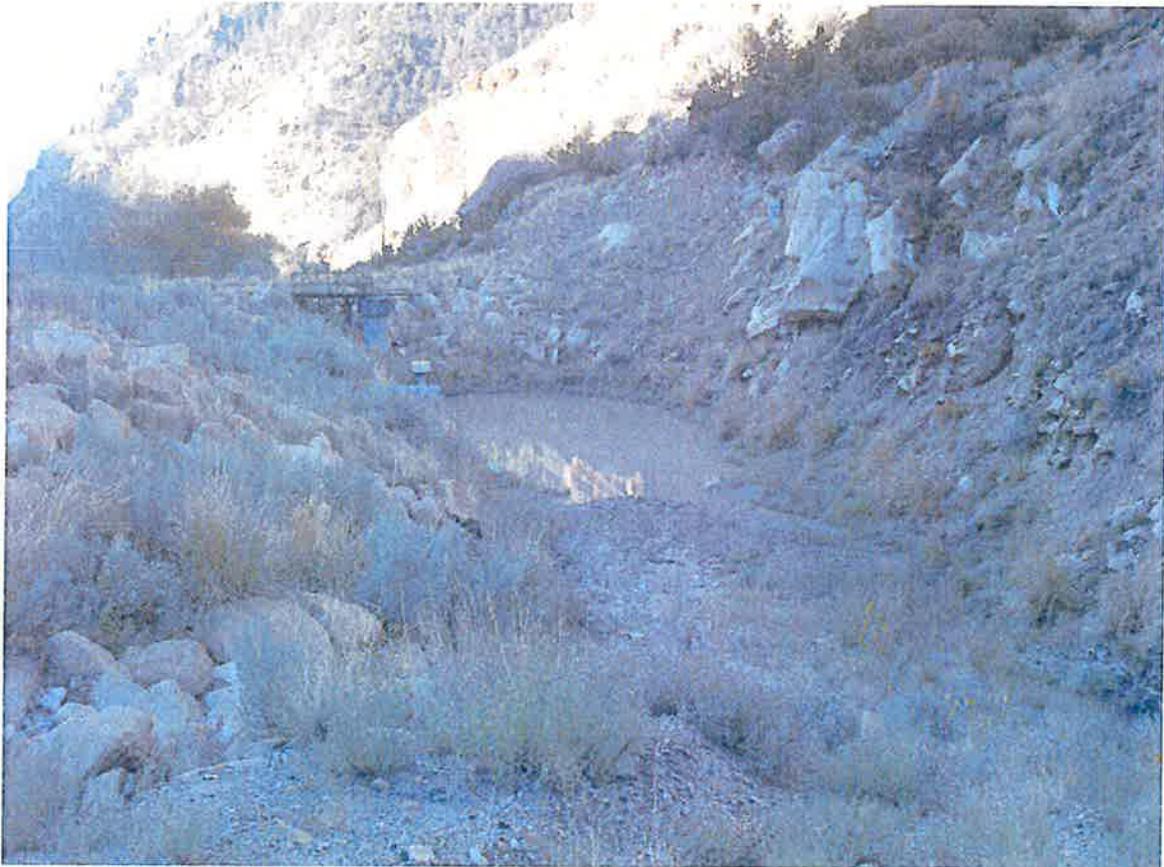
Storms on 9/3 and 9/12 put approximately 14 inches of water into the pond.  
Pond was not discharging during inspections.
