# Inspection Report

Permit Number:	C0150009
Inspection Type:	COMPLETE OVERSITE
Inspection Date:	Tuesday, March 08, 2016
Start Date/Time:	3/8/2016 9:00:00 AM
End Date/Time:	3/8/2016
Last Inspection:

Permittee: **FOSSIL ROCK RESOURCES, LLC**  
 Operator: **FOSSIL ROCK RESOURCES, LLC**  
 Site: **FOSSIL ROCK MINE**  
 Address: **225 North 5th Street, 9th Floor, CO 81501**  
 County: **EMERY**  
 Permit Type: **PERMANENT COAL PROGRAM**  
 Permit Status: **INACTIVE**

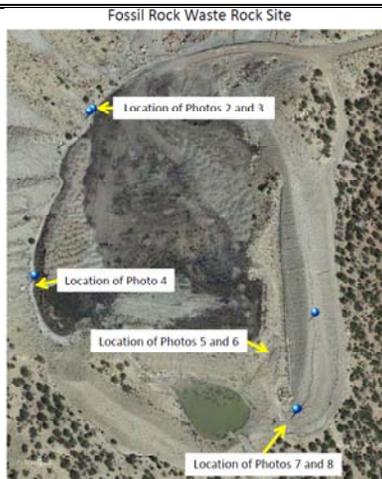
**FIGURE 1**

Location of photos taken at waste rock site.

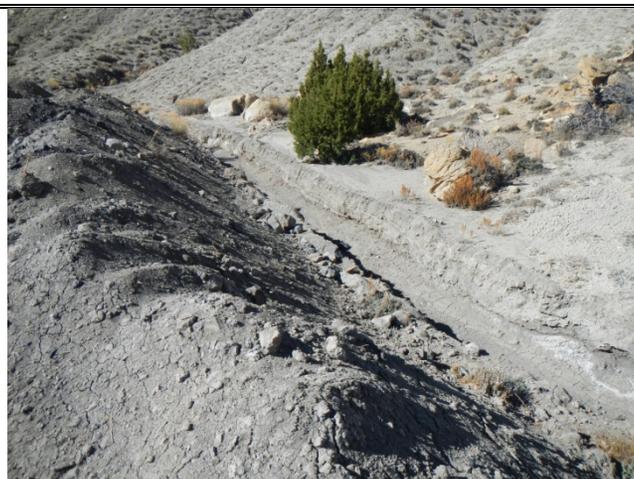
**PHOTO 2**

1. Ditch DA: Photos 2, 3, and 4 show the condition of Ditch DA. It is not maintained to function as a V-ditch with 2.5:1 side slopes as outlined in the MRP. In its current state the ditch is box cut with nearly vertical side slopes and a flat ~2 ft wide bottom. As stated in Volume 4, Appendix C, 'Drainage Control Design' for Ditch DA (see attached highlighted text from the MRP), "Ditch DA will be a V-ditch for the entire length until it approaches the pond where the slope increases from 2 to 18%". A cross-section of 'Ditch DA DETAIL 1' for this upper section is shown on Drawing 4-14 (CM-10877-WB), titled 'Interim Surface Refuse Drainage Plan'.

Ditch DA is a box-cut channel with nearly vertical sides and a flat bottom.  
Photo looks down channel.

NOV #21172 is issued requiring the Permittee to address three non-compliance issues with Diversions at the waste rock site. Drainage at the waste rock site does not match the designs or narrative in the MRP for Ditch DA, Ditch DB, and the ASCA at the southern end of the Subsoil Pile. Attachment A provides photos showing the condition of the ditches and the ASCA with Figure 1 identifying the photo locations at the waste rock site. The three non-compliance issues are as follows:

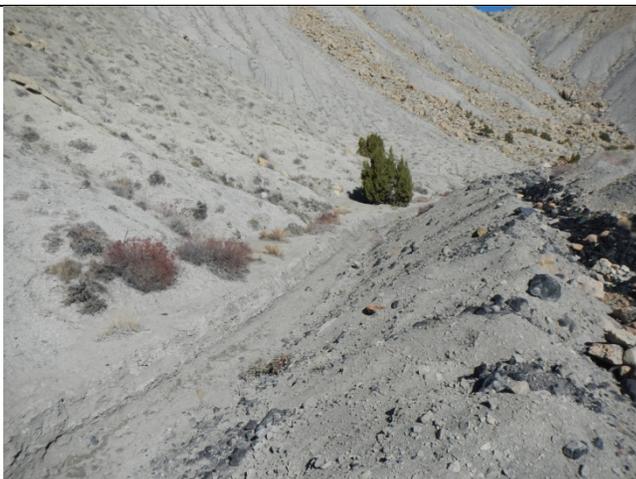
**PHOTO 3**

Ditch DA is a box-cut channel with nearly vertical sides and flat bottom.  
Photo looks up channel.

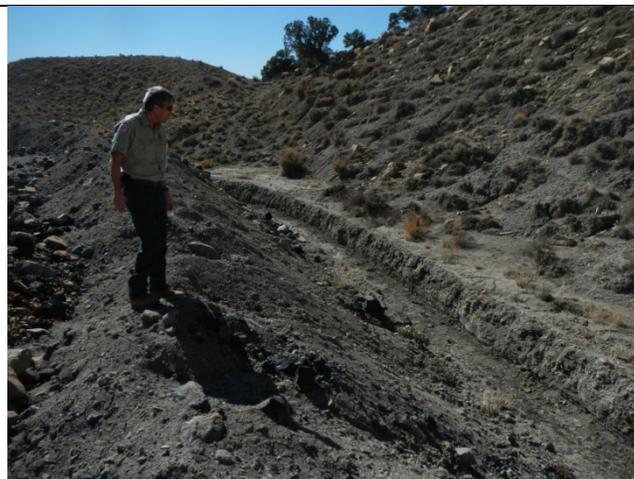
**PHOTO 4**

Ditch DA is a box-cut channel with nearly vertical sides and a flat bottom.

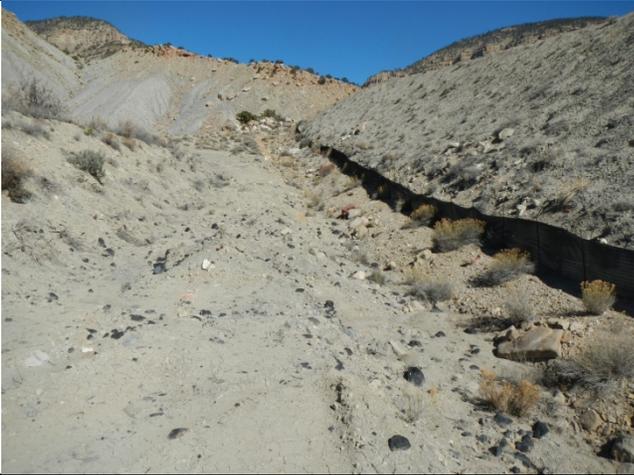
2. Ditch DB: Photos 5 and 6 show Ditch DB has not been maintained as designed in Volume 4, Appendix C, 'Drainage Control Design' stating, "Ditch DB will be a narrow trapezoidal ditch for its entire length". The ditch design calls for a, "2 foot bottom width, [and] 2:1 side slopes". Photo 6 shows Ditch DB is non-existent through this section and an access road has been constructed in its place. This disruption has prevented runoff from being properly routed to the sediment pond.

**PHOTO 5**  
Ditch DB looking up-channel.  
March 8, 2016

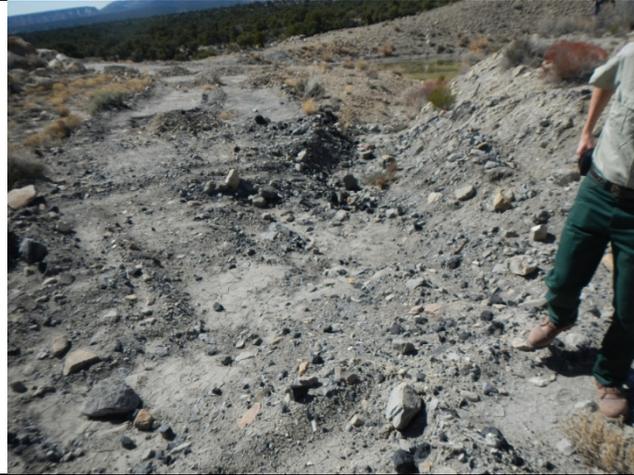
**PHOTO 6**  
Ditch DB looking down-channel. Disturbance has filled in this ditch so it is non-existent in this location.  
March 8, 2016

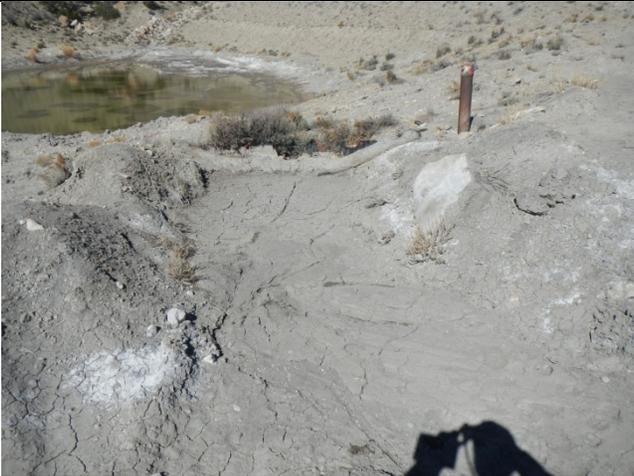
3. ASCA, southern end of Subsoil Stock Pile: Photo 8 shows there is no clear runoff flow path on the southern end of the Subsoil Stock Pile that directs water to the silt fence in Photo 7. The silt fence in Photo 7 needs to be properly maintained.

**PHOTO 7**  
Subsoil recapture silt fence in need of maintenance  
March 8, 2016

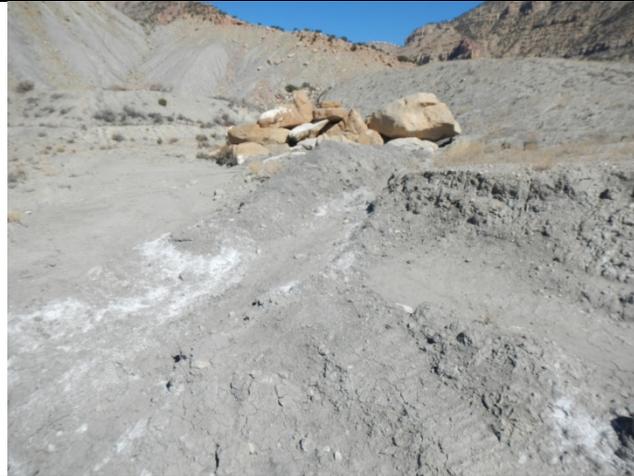
**PHOTO 8**  
Uncontrolled drainage off Subsoil Stock Pile. No clear drainage paths are established in this area to direct flow to the silt fence.  
March 8, 2016

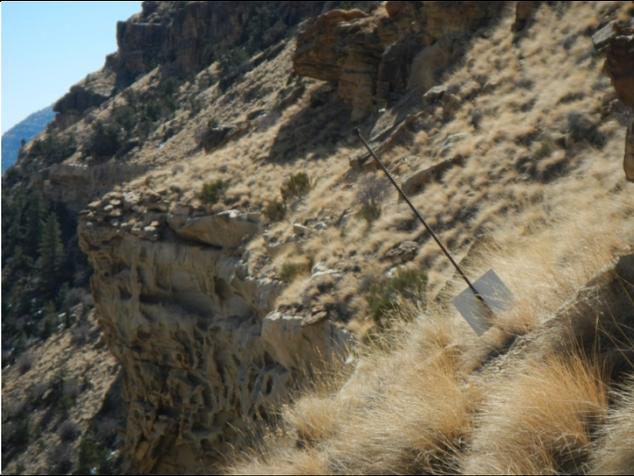
**PHOTO 9**

Perimeter markers along the North, South and West edges of the perimeter need maintenance. The signs were difficult to find and in many cases the sign had slid down on the post and had vegetation blocking it (Photo 9).

Perimeter sign is too low on the post. View is obstructed by vegetation.  
March 8, 2016

The Permittee agreed the perimeter marker signage was in need of repair and planned on getting them painted for better visibility.

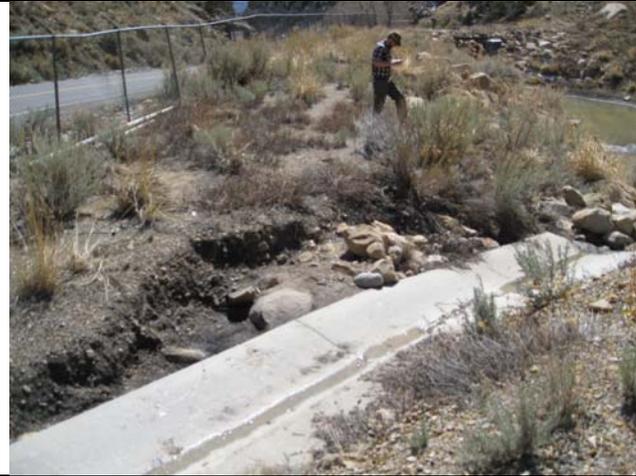
**PHOTO 10**

The inlet to sediment pond at the mine site needs maintenance (Photo 10). At the top of the hardened inlet, runoff is overtopping the diversion and scouring out the side bank. This area must be repaired.

Top of inlet at mine site pond needing maintenance.  
March 8, 2016
