Inspection Report

Permit Number:	C0150009
Inspection Type:	COMPLETE
Inspection Date:	Tuesday, June 14, 2016
Start Date/Time:	6/14/2016 9:00:00 AM
End Date/Time:	6/14/2016 1:00:00 PM
Last Inspection:	Tuesday, March 08, 2016

Permittee: **FOSSIL ROCK RESOURCES, LLC**
 Operator: **FOSSIL ROCK RESOURCES, LLC**
 Site: **FOSSIL ROCK MINE**
 Address: **225 North 5th Street, 9th Floor, CO 81501**
 County: **EMERY**
 Permit Type: **PERMANENT COAL PROGRAM**
 Permit Status: **INACTIVE**

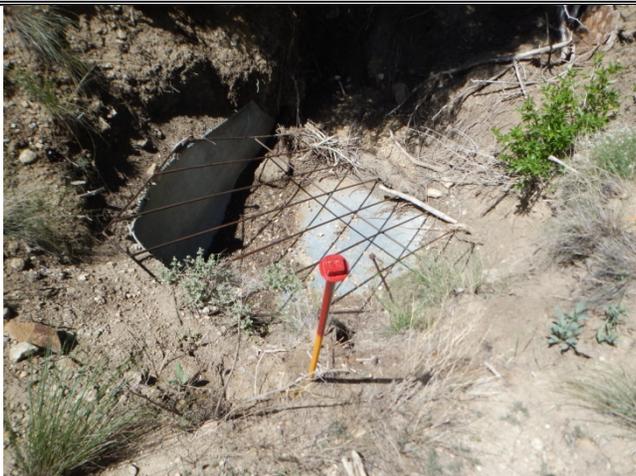
PHOTO 1

Perimeter markers at the main mine site and have recently been painted with bright coloring (Photo 1).

The perimeter markings have been painted so they are more visible.
June 14, 2016

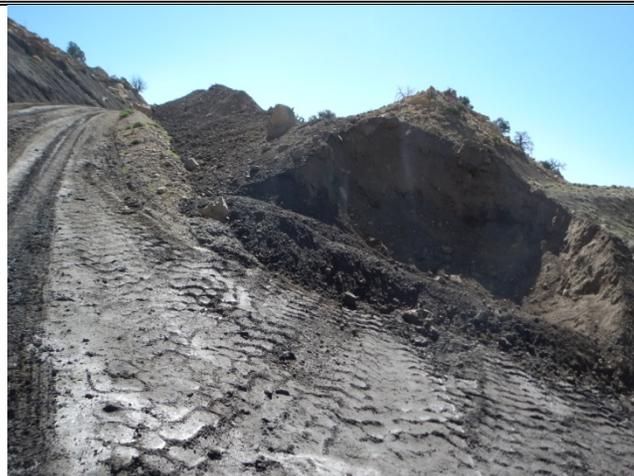
PHOTO 2

Subsoil was recovered from the top of the lift and moved to a temporary placement at the northern end of the subsoil stock pile (Photo 2). This subsoil pile will be moved another 100' to 200' south and placed on the top of the subsoil pile. Once it is in its final placement it will be bermed.

Temporary placement of recovered subsoil.
June 14, 2016

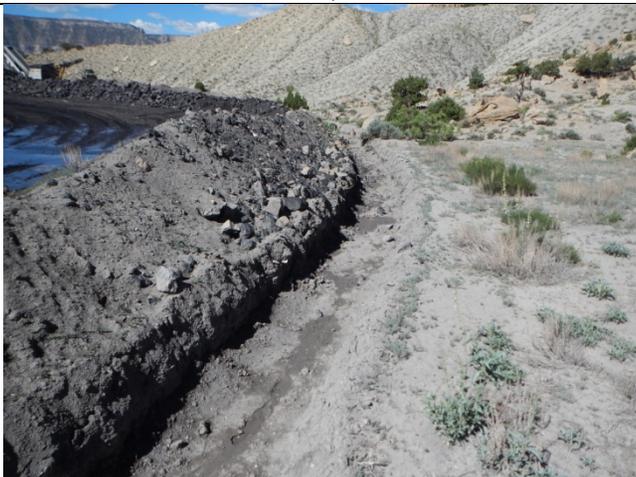
PHOTO 3

Ditch DA and DB along their lengths. No work has been performed on the diversions since the last inspection and issuance of NOV 21173 (Photos 3 - 6).

Ditch DA
June 14, 2016

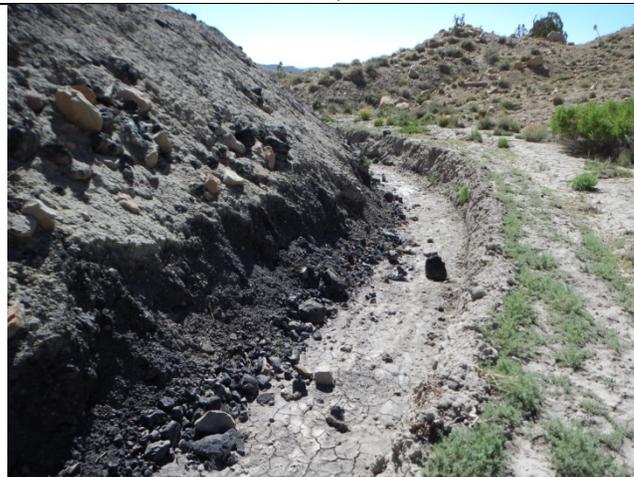
PHOTO 4

Ditch DA
June 14, 2016

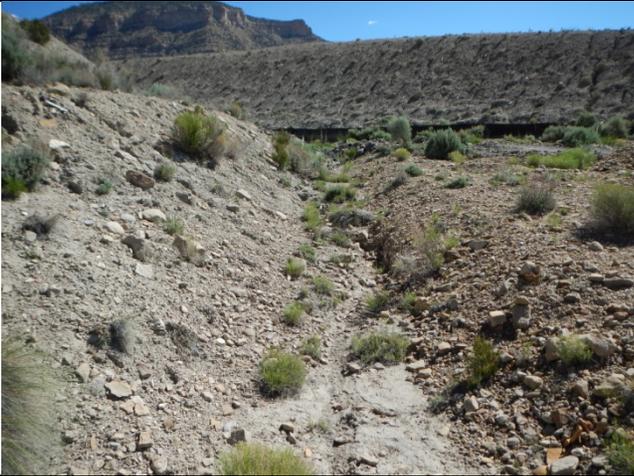
PHOTO 5
Ditch DB
June 14, 2016

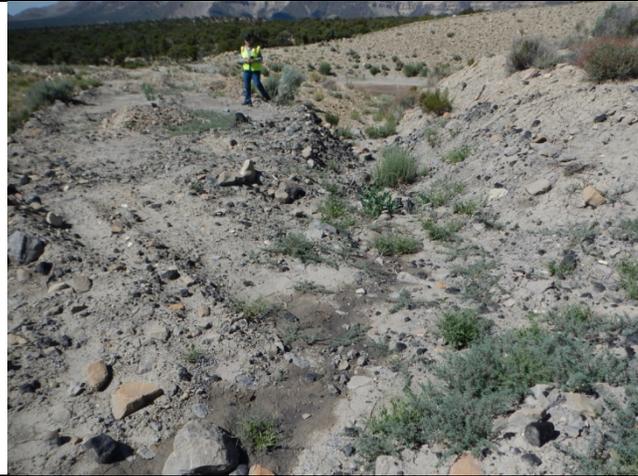
PHOTO 6
Ditch DB
June 14, 2016

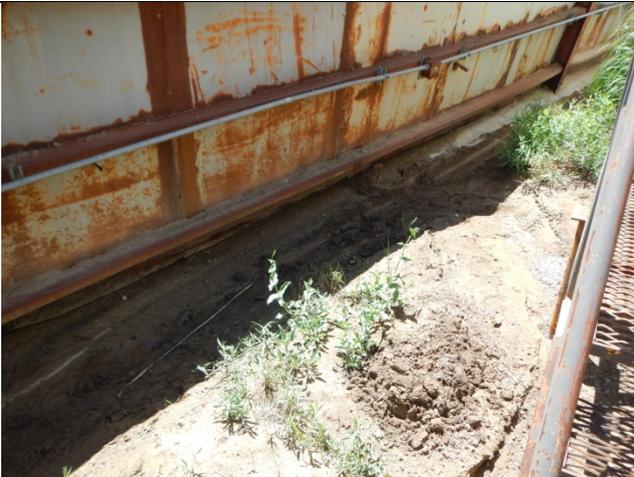
At the main mine two issues of the 'curb gutter' were inspected. The top end of the gutter has been cleaned out further since the last inspection (Photo 7). The lower end of the gutter, right before it spills into the pond, needs maintenance (Photo 8). This issue was pointed out in the last inspection as well. Vicky is aware of the issue and we discussed possible solutions to fix the erosion outside of the hardened concrete inlet.

PHOTO 7
Top of curb gutter ditch.
June 14, 2016

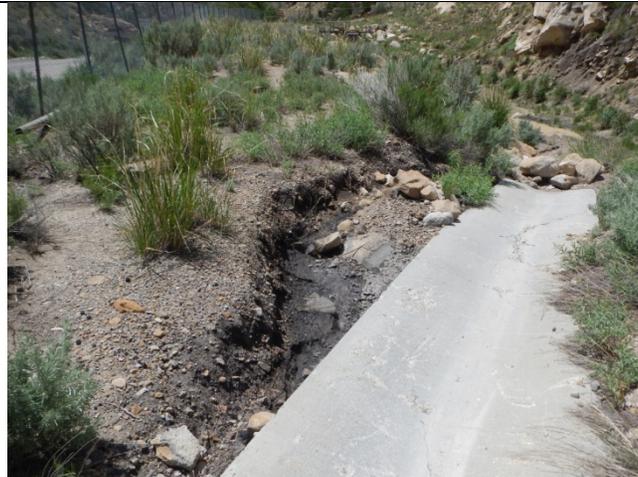
PHOTO 8
Bottom of curb gutter ditch needing maintenance.
June 14, 2016

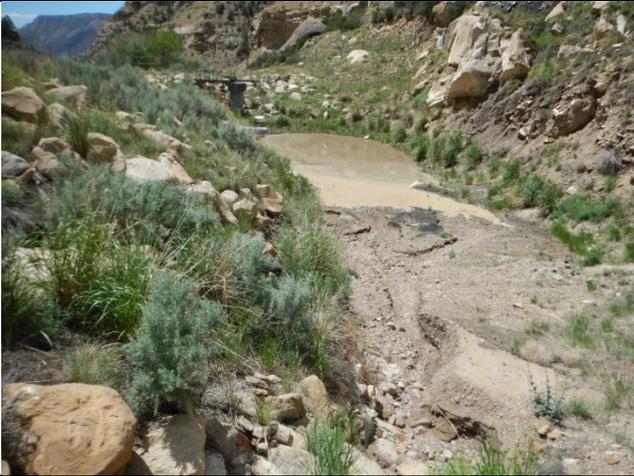
The sediment pond at the main mine site had one to two feet of standing water (Photo 9). The waste rock site pond was dry (Photo 15). The primary spillway for the pond at the waste rock site was clear of sediment and debris.

PHOTO 9
 Mine pond holding standing water.
 June 14, 2016

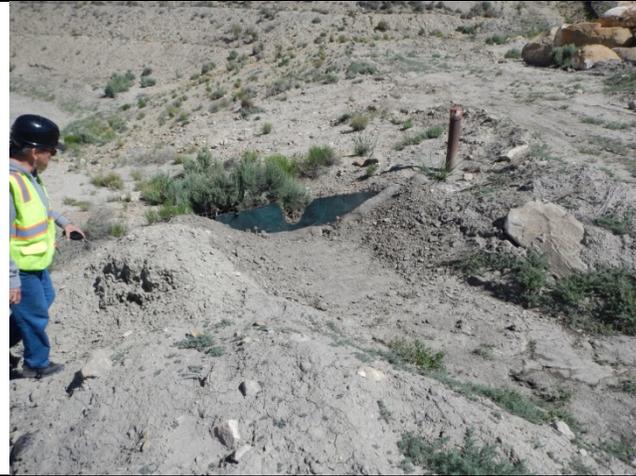
The sediment fence at the southern end of the subsoil stockpile has been replaced and is functioning correctly (Photo 10).

PHOTO 10
 ASCA silt fence has been replaced at southern end of subsoil pile.
 June 14, 2016

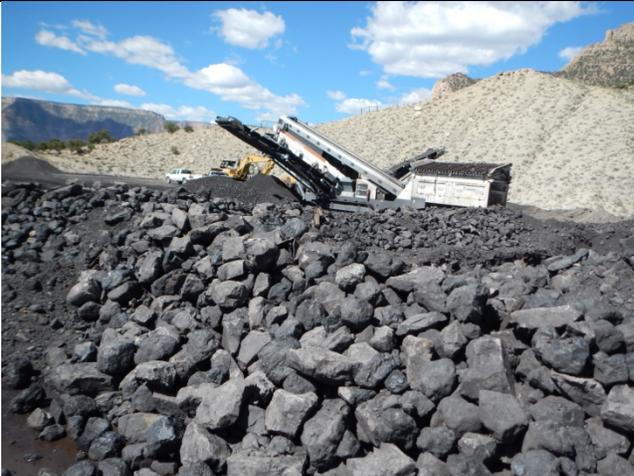
At the waste rock site the coal is being screened into three piles: 4" minus, fines, and waste rock (Photo 11). A roughly 4000 ton pile of 4" minus and a similar sized pile of fines was on the southeast corner of the lift (Photo 12). Mining has begun in the northwest corner of the site. The current plan is to bring the pile down in 10' lifts (Photo 13). The plan is dynamic and will adjust depending on the quality and availability of the coal.

PHOTO 11
 Coal screener at waste rock site.
 June 14, 2016

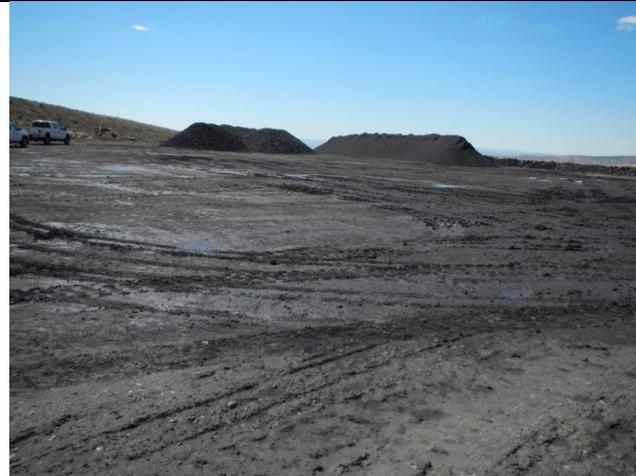
PHOTO 12
 Screened coal piles, 4" minus on left, fines on right
 June 14, 2016

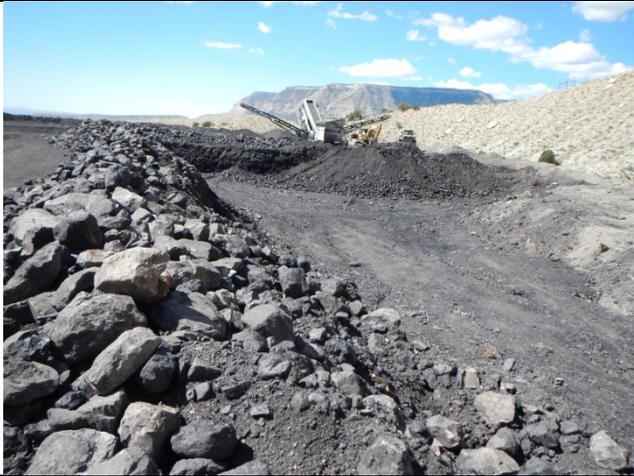
PHOTO 13
Beginning excavation of the first lift.
June 14, 2016

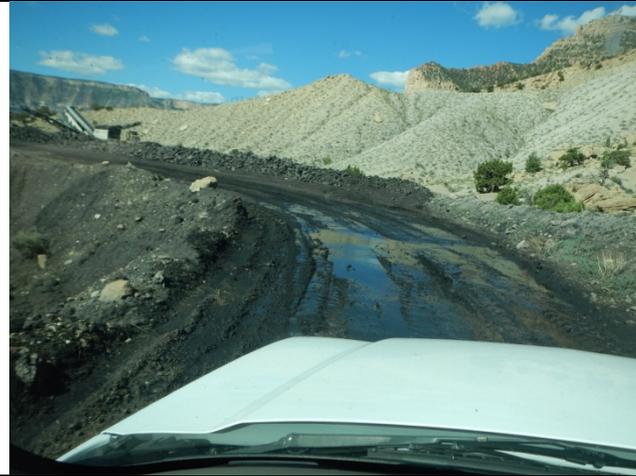
The road exiting the lift at the waste rock site is in need of maintenance. Water was ponding water on the surface of the road causing mud and debris to be tracked across the site as vehicles entered and exited the lift (Photo 14). The road will be regraded as reining lowers the lift elevation of the waste rock pile, so this issue will be fixed shortly.

PHOTO 14
Ponding on access road.
June 14, 2016

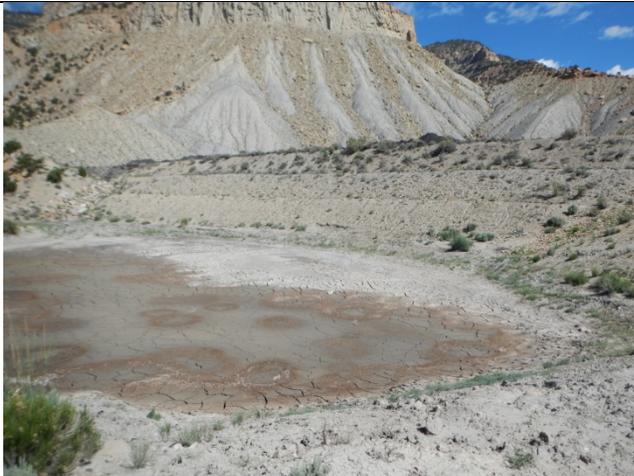
PHOTO 15
The waste rock pond is dry.
June 14, 2016
