Inspection Report

Permit Number:	C0150009
Inspection Type:	PARTIAL
Inspection Date:	Wednesday, July 20, 2016
Start Date/Time:	7/20/2016 11:00:00 AM
End Date/Time:	7/20/2016 2:00:00 PM
Last Inspection:	Tuesday, June 14, 2016

Permittee: **FOSSIL ROCK RESOURCES, LLC**
 Operator: **FOSSIL ROCK RESOURCES, LLC**
 Site: **FOSSIL ROCK MINE**
 Address: **225 North 5th Street, 9th Floor, CO 81501**
 County: **EMERY**
 Permit Type: **PERMANENT COAL PROGRAM**
 Permit Status: **ACTIVE**

ATTACHMENT A – Photos July 20, 2016 site visit

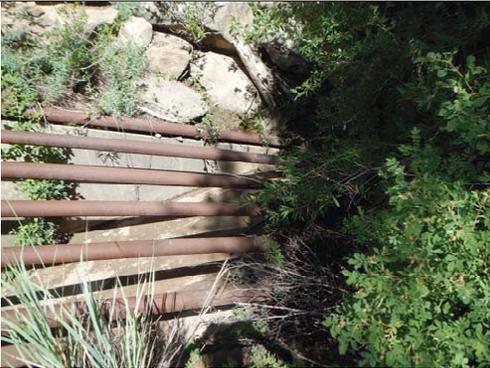
PHOTO 1

The inlet of mine site bypass culvert appeared to be clear of debris.
July 20, 2016

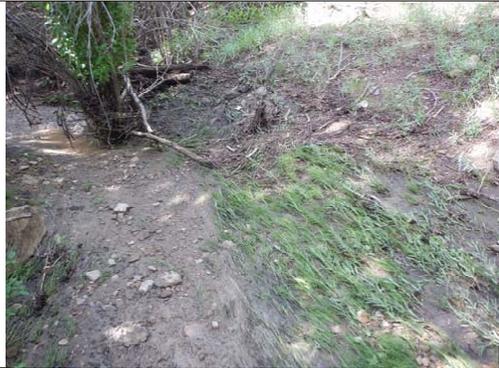
PHOTO 2

The wetted perimeter above the mine site is seen where the grass is lying down.
July 20, 2016

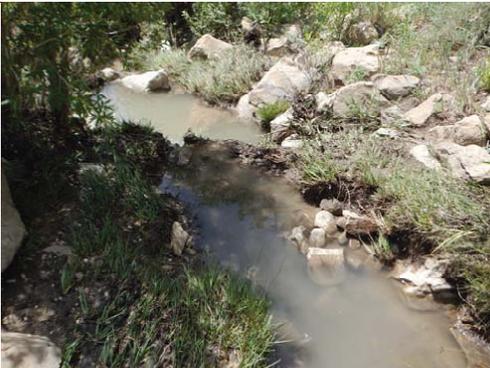
PHOTO 3

The wetted perimeter below the mine site is seen where the grass is lying down.
July 20, 2016

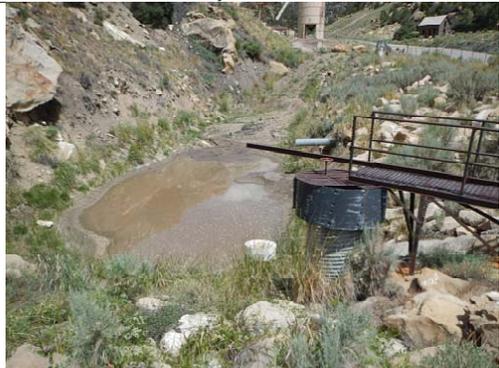
PHOTO 4

The bypass culverts at the main mine site were clear of obstructions (Photo 1). The main channel did not have water flowing above the mine site. Below the mine site, only mine water discharge from the Cottonwood mine was flowing out of the bypass culvert. It appeared a very large storm had passed over upper Cottonwood Canyon creek above the main mine site. Vegetation and organic material had been laid down and deposited within the undisturbed creek bed by runoff that was up to 10 feet wide and nearly 2 feet deep within the wetted perimeter (Photos 2 and 3). The mine site probably received rainfall from the event, however it was clear the main mine site had not received the same rainfall intensity as the upper canyon. This is because all the diversions were properly conveying runoff to the sediment pond and it was holding only a foot or two of standing water (Photo 4). The pond would have been holding much more water had the same event passed over the mine site.

The mine site pond impounding less than two feet of water.
July 20, 2016

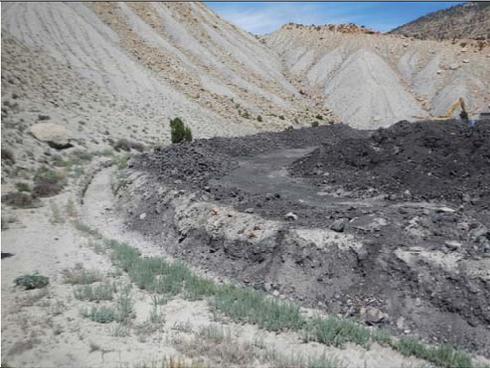
PHOTO 5

At the waste rock site I spoke to Lee about Diversion Ditch DA. The plan is to leave the ditch in place as the pile is excavated in 10' lifts. The floor of the excavated pit is sloped to drain runoff to the south and it will be tied back into Ditch DA when the pit floor is at the same elevation of the ditch (Photo 5). This will prevent the pit from impounding water and will route runoff from the surrounding hillslopes around the pit and work areas.

Ditch DA is seen on the left and the bottom of the pit is on the right. They reach the same elevation a little past the bottom left of the photo.
July 20, 2016

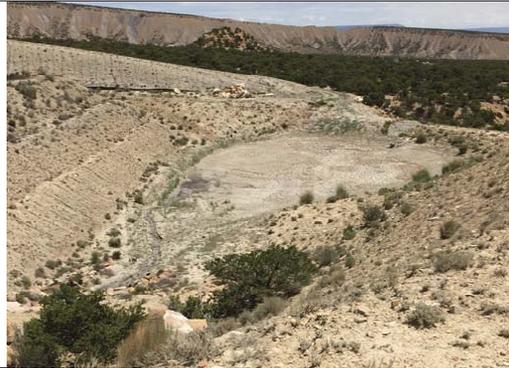
PHOTO 6

As stated previously, the pond at the mine site had only a foot or so of impounded water. The waste rock pond was dry (Photo 6).

The waste rock site pond is dry.
July 20, 2016

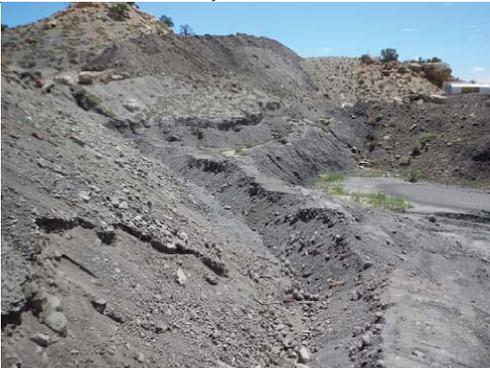
PHOTO 7

Subsoil is actively being recovered from the uppermost lift at the waste rock site. The subsoil is being relocated to the northern end of the subsoil stock pile. A berm has been installed around the newly placed subsoil (Photo 7).

The stockpiled subsoil is bermed.
July 20, 2016

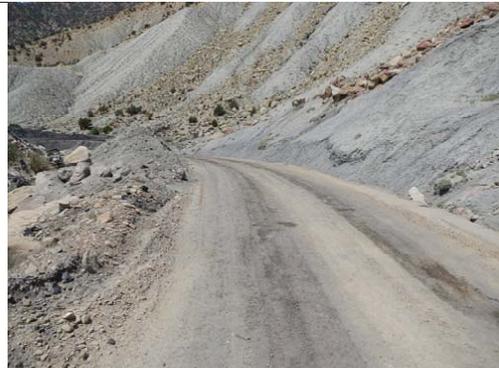
PHOTO 8

It appeared road base had been laid down on the waste rock site road (Photo 8).

Road base has been applied to the waste rock road.
July 20, 2016
