Inspection Report

Permit Number:	C0150009
Inspection Type:	PARTIAL
Inspection Date:	Wednesday, October 26, 2016
Start Date/Time:	10/26/2016
End Date/Time:	10/26/2016
Last Inspection:

Permitee: **FOSSIL ROCK RESOURCES, LLC**
 Operator: **FOSSIL ROCK RESOURCES, LLC**
 Site: **FOSSIL ROCK MINE**
 Address: **225 North 5th Street, 9th Floor, CO 81501**
 County: **EMERY**
 Permit Type: **PERMANENT COAL PROGRAM**
 Permit Status: **ACTIVE**

ATTACHMENT A – Photos October 26, 2016 site visit

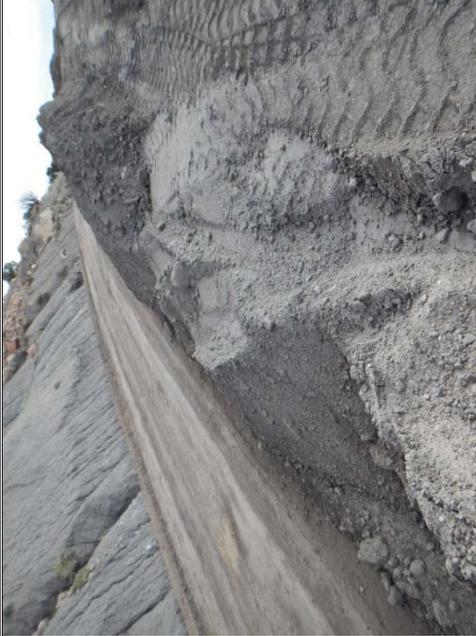
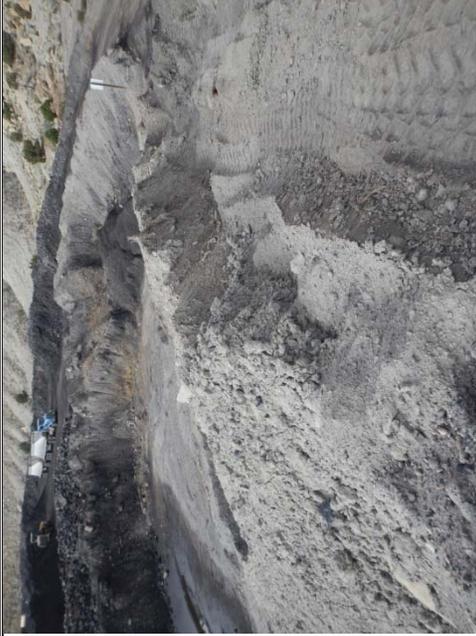
The subsoil pile along the east side of the site was inspected. The recently stockpiled subsoil has been adequately bermed (Photos 1, 2).

<p>PHOTO 1 Recently constructed berm around subsoil. October 26, 2016</p>	<p>PHOTO 2 Recently constructed berm around subsoil. October 26, 2016</p>

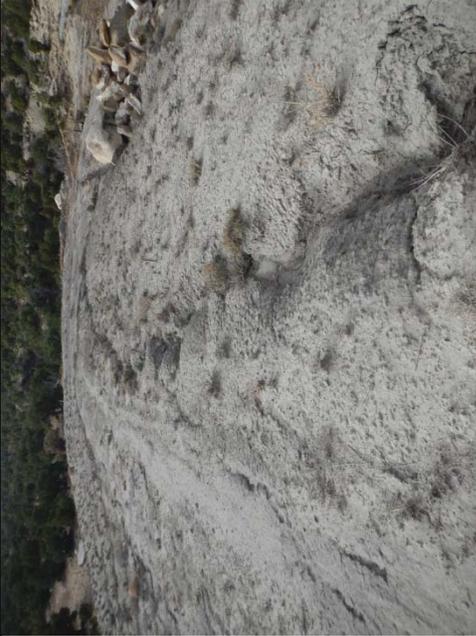
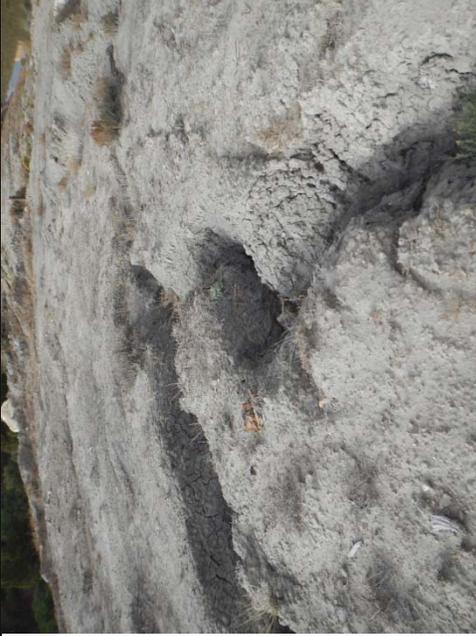
The southern end of the subsoil stock pile needs to be stabilized. A large gully has formed and is washing away subsoil needed for reclamation (Photos 3, 4, 5). The gully is still a manageable size making it easy to stabilize the area.

<p>PHOTO 3 Upper end of large gully on subsoil pile. October 26, 2016</p>	<p>PHOTO 4 Lower portion of gully on subsoil pile. October 26, 2016</p>

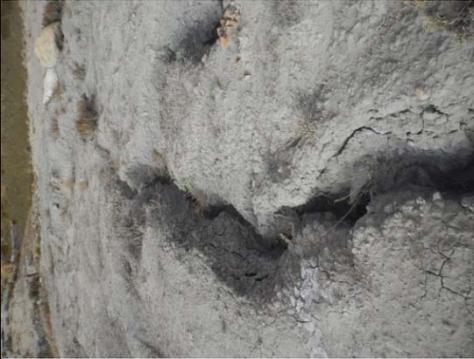
<p>PHOTO 5 Gully on southern end of subsoil pile. October 26, 2016</p>	<p>PHOTO 6 Diversion ditch DA. October 26, 2016</p>

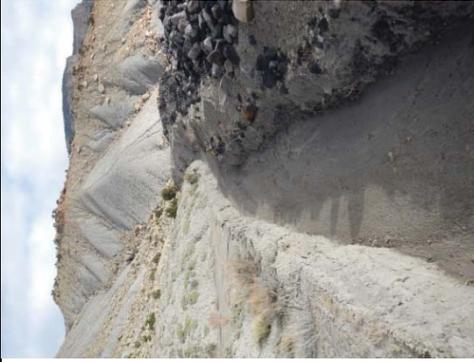
The mine site has experienced one or multiple large storm events over the last couple months. The length of diversion ditch DA was walked. The ditch appeared to be functioning as designed (Photos 6, 7).

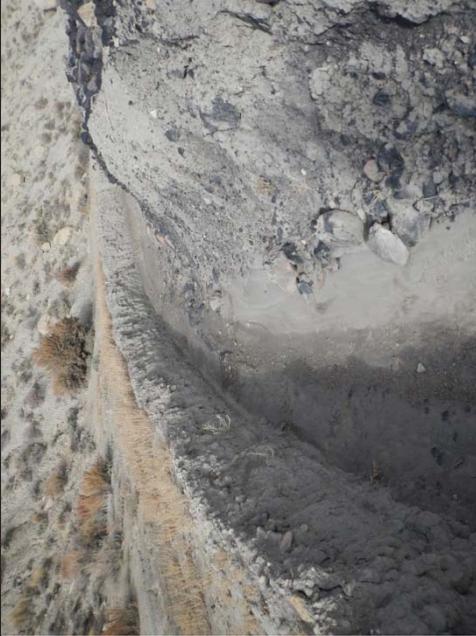
<p>PHOTO 7 Diversion ditch DA. October 26, 2016</p>	<p>PHOTO 8 High water mark of saturated sediment and debris higher in elevation than primary spillway. October 26, 2016</p>

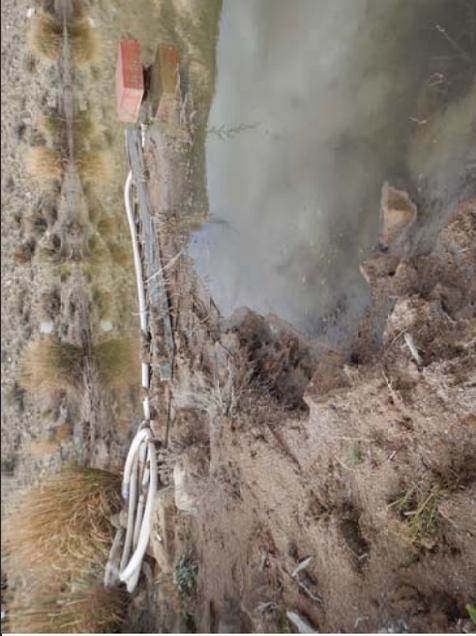
The sediment pond at the waste rock site recently discharged through the primary spillway. This conclusion was determined by examining the high water mark within the pond and the ground below the outlet of the primary spillway. The high water mark of debris and saturated sediment around the perimeter of the pond was observed to be higher in elevation than the opening of the spillway (Photos 8 - 10). This suggests runoff was reporting to the pond at a higher rate than the 8" primary spillway pipe could drain. Additionally, the concrete directly below the outlet of the spillway was still wet while all other areas of the concrete were dry (Photo 11). This suggests water had recently discharged out the spillway and into the channel below the pond.

I have followed up with Vicky Miller since the inspection and confirmed the discharged water was not sampled. A couple options were discussed in order to prevent another occurrence where pond discharge is not sampled. The best option is to add a valve on the end of the primary spillway, essentially turning the spillway into a decant pipe. This would increase the storage volume of the pond and allow for a controlled drawdown of the water level after rain events. As the pond is drawn down outflow can then be easily sampled at the valve.

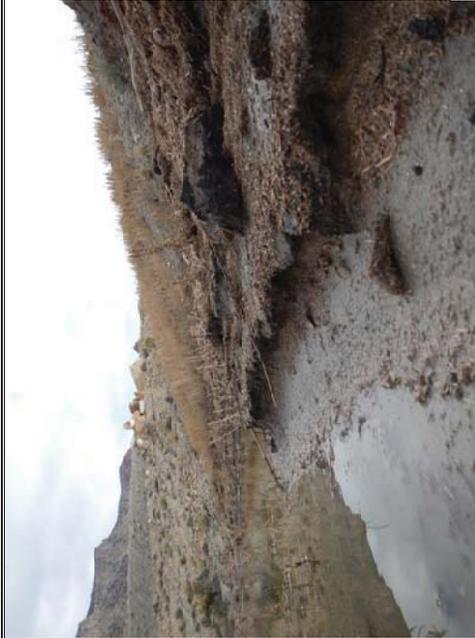
PHOTO 9
High water mark of saturated sediment and debris roughly a foot above current water level.
October 26, 2016

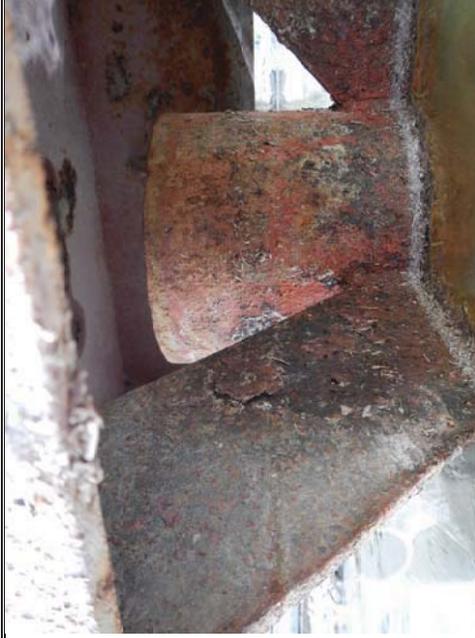
PHOTO 10
Spillway opening less than a foot above current water level.
October 26, 2016

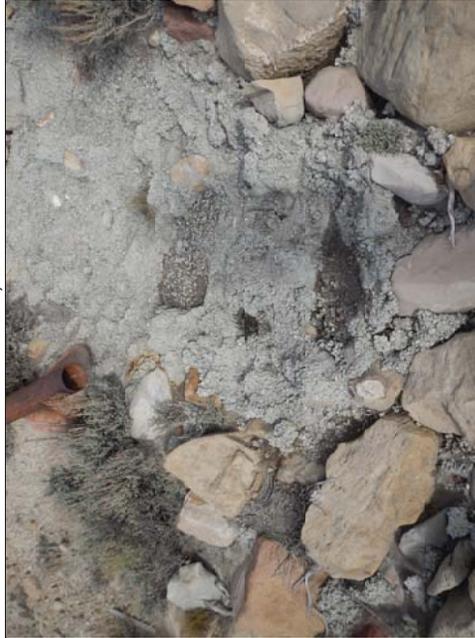
PHOTO 11
Concrete directly below outlet of spillway saturated from the recent discharge of the primary spillway.
October 26, 2016

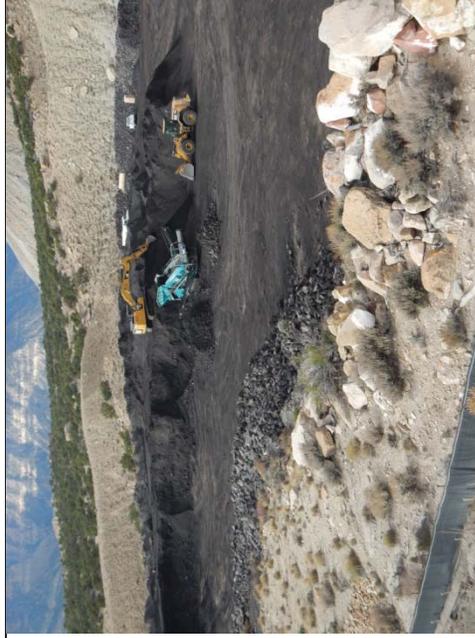
The remaining of the first lift is nearly complete (Photo 12). The large pile of fines has been hauled off and is no longer preventing operations from removing the final portion of the first lift.

PHOTO 12
The first lift has nearly been removed.
October 26, 2016
