**Inspection Report**

Permit Number:	<b>C0150009</b>
Inspection Type:	COMPLETE
Inspection Date:	Wednesday, December 21, 2016
Start Date/Time:	12/21/2016 12:45:00 PM
End Date/Time:	12/21/2016 2:00:00 PM
Last Inspection:

Permittee: **FOSSIL ROCK RESOURCES, LLC**  
 Operator: **FOSSIL ROCK RESOURCES, LLC**  
 Site: **FOSSIL ROCK MINE**  
 Address: **225 North 5th Street, 9th Floor, CO 81501**  
 County: **EMERY**  
 Permit Type: **PERMANENT COAL PROGRAM**  
 Permit Status: **ACTIVE**

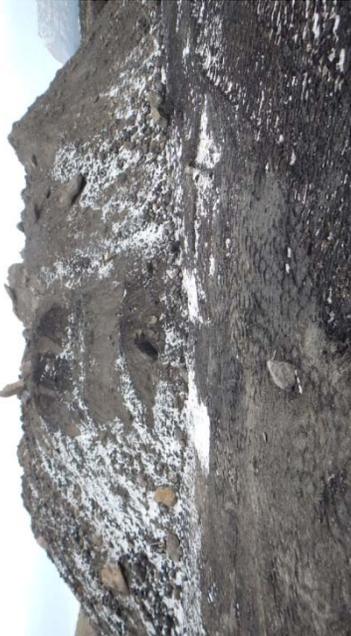
A pile what appeared to be topsoil and/or subsoil mixed with rocks and lump coal was placed at the southern extent of the top lift. It was unclear if this pile was salvaged from the west face of reclaimed top lift overlooking the sediment pond (Photos 1 - 3). If this is the salvaged topsoil and/or subsoil from the reclaimed face of the lift additional care must be taken to prevent the subsoil and topsoil from mixing with coal fines and lump coal. This pile must also be moved to a permitted location and stabilized.

<p><b>PHOTO 1</b> Salvaged topsoil from south face of top lift. December 21, 2016</p>

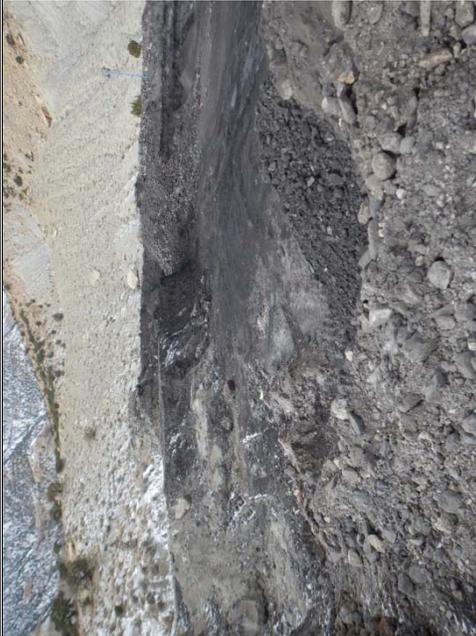
<p><b>PHOTO 2</b> Location the southern extent of pit disturbed western side of the reclaimed lift face. December 21, 2016</p>

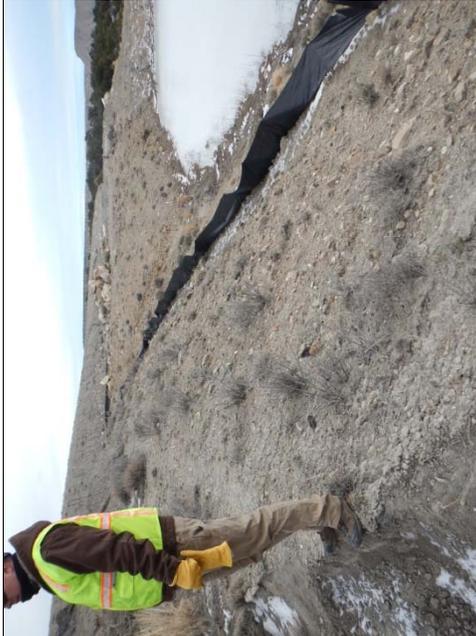
<p><b>PHOTO 3</b> East side of the top lifts reclaimed face. December 21, 2016</p>

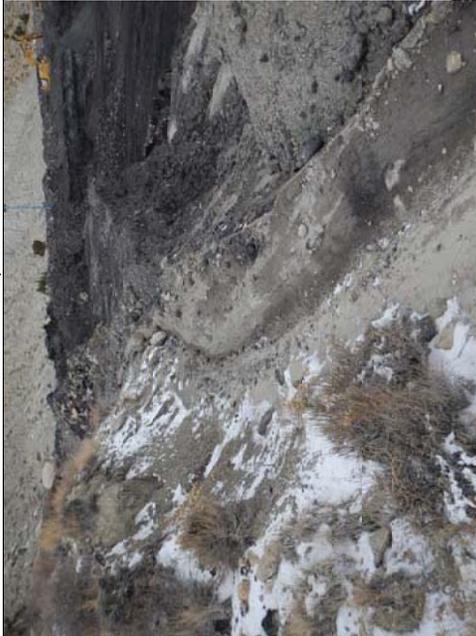
The southwestern pit has mined into the berm running along the east side of Ditch DA (Photos 4 – 5). The berm along this section appears to no longer be sized to handle runoff from a design storm. This issue was discussed and Mr. Bunnell agreed to fix it as soon as possible.

<p><b>PHOTO 4</b> Ditch DA missing berm running along the east side. December 21, 2016</p>

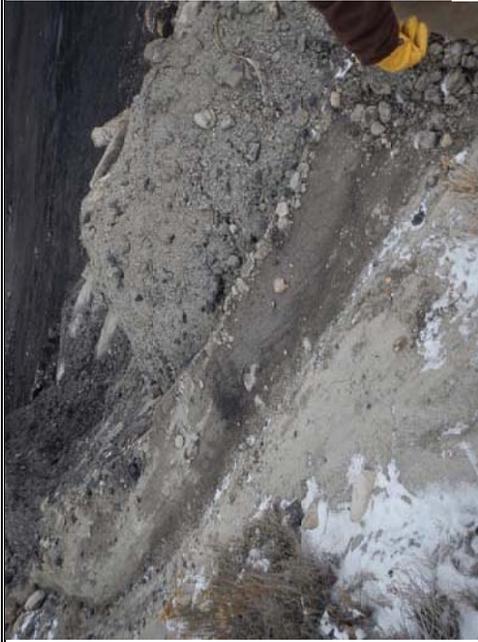
**PHOTO 5**  
Ditch DA missing berm running along the east side.  
December 21, 2016

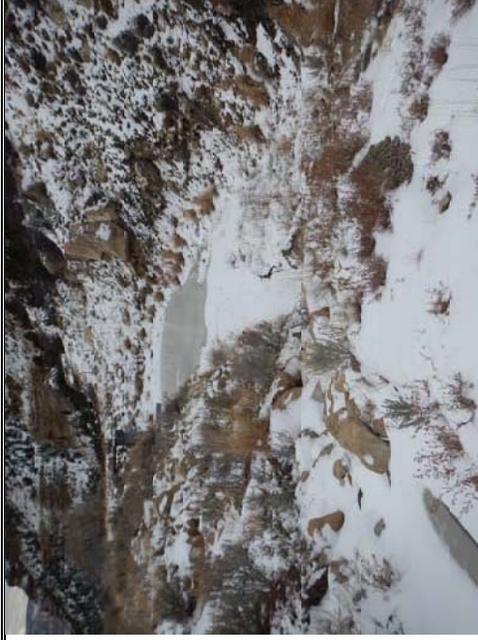
The sediment ponds contained a couple feet of frozen water (Photos 6 & 8).

**PHOTO 6**  
Mine site pond with about 2 feet of water.  
December 21, 2016

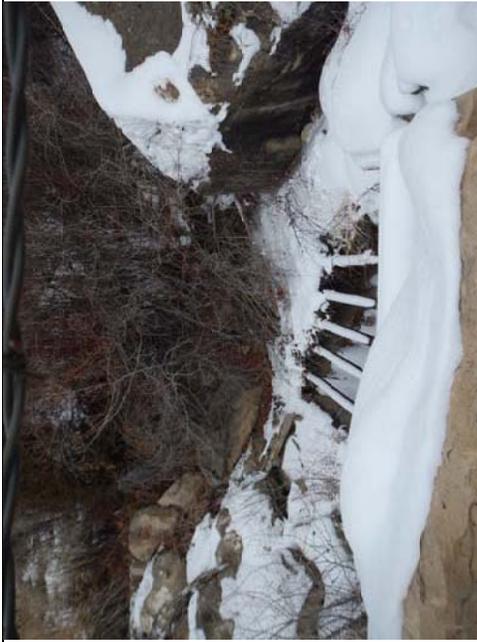
The inlet of the bypass culvert at the main mine site was clear of debris (Photo 7).

**PHOTO 7**  
Upper inlet of bypass culvert.  
December 21, 2016

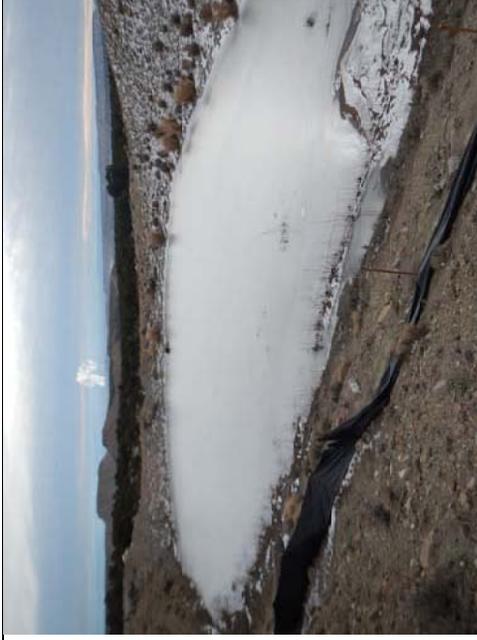
**PHOTO 8**  
Waste rock site sediment pond.  
December 21, 2016

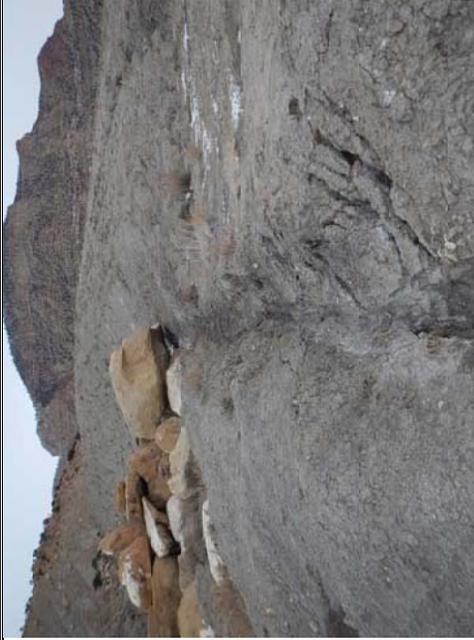
**PHOTO 9**

The waste rock site subsoil stock pile appears to need additional stabilization measures. There is a gully developing on the southern end of the pile running down its center (Photo 9).

Gully needing stabilization is seen in upper right of photo  
December 21, 2016
