Quarterly Inspection Form - Refuse Disposal Areas
(please provide to DOGM promptly after inspection is complete)

Permit Number :	<u>C/015/009</u>	Inspection Date :	<u>11/10/16</u>
Mine Name :	<u>Fossil Rock Mine</u>	Quarter / Year :	<u>4th / 2016</u>
Mine Operator (Permittee) :	<u>Fossil Rock Resources, LLC</u>	Inspector Name :	<u>Vicky Miller</u>
MSHA ID # :	<u>1211-UT-09-02052-04</u>	Inspector Signature :	
Facility Name / Location / Address :	<u>Fossil Rock Waste Rock Site</u>

Waste Rock Sediment Pond Quarterly Inspection Report

Fossil Rock Resources, LLC - Fossil Rock Mine
Mine Site Sediment Pond Quarterly Inspection Report

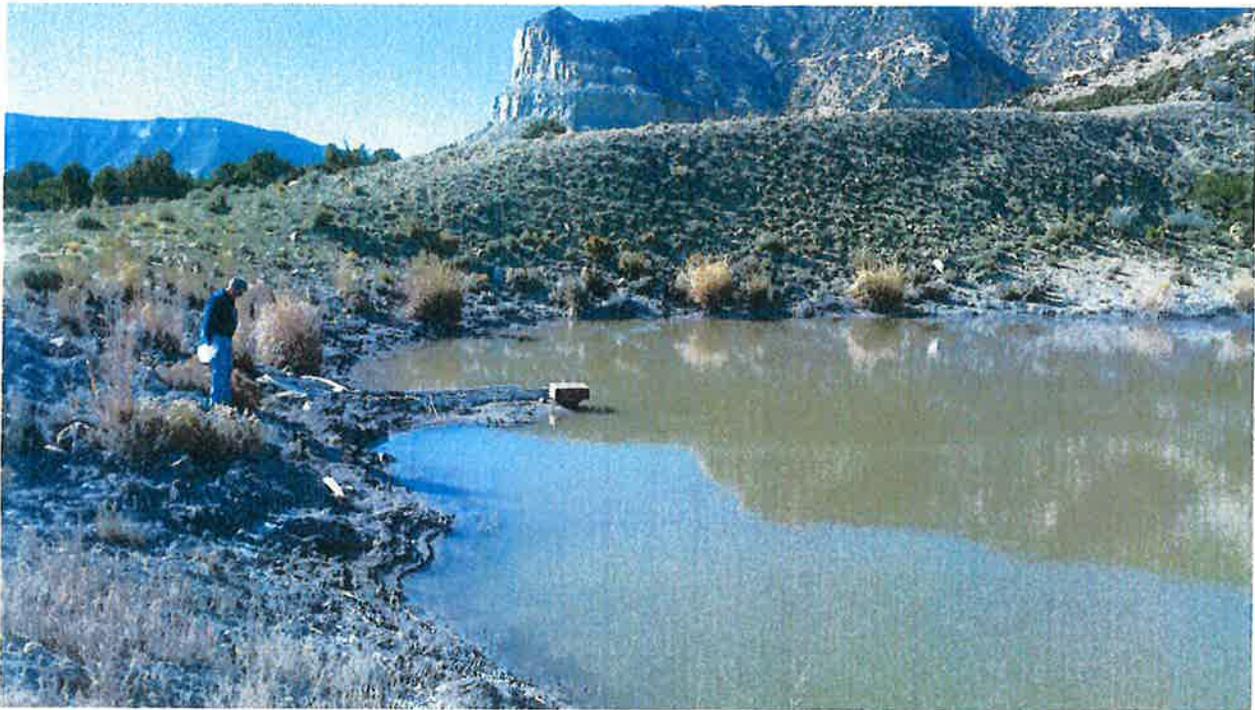
Pond has been dry the majority of the quarter, with evidence of flow into the pond recently at sometime prior to this inspection.

C. Diversion ditches were checked on 10/ 25 -26, 11/10, 11/15 and 12/9. Culverts and ditches were cleaned of sediment where needed.
