Re: 1st Quarter Pond and Waste Rock Inspections, Fossil Rock Mine

Quarterly Inspection Form - Refuse Disposal Areas

Fossil Rock Resources, LLC - Fossil Rock Mine
Mine Site Sediment Pond Quarterly Inspection Report

Fossil Rock Resources, LLC - Fossil Rock Mine
Waste Rock Sediment Pond Quarterly Inspection Report

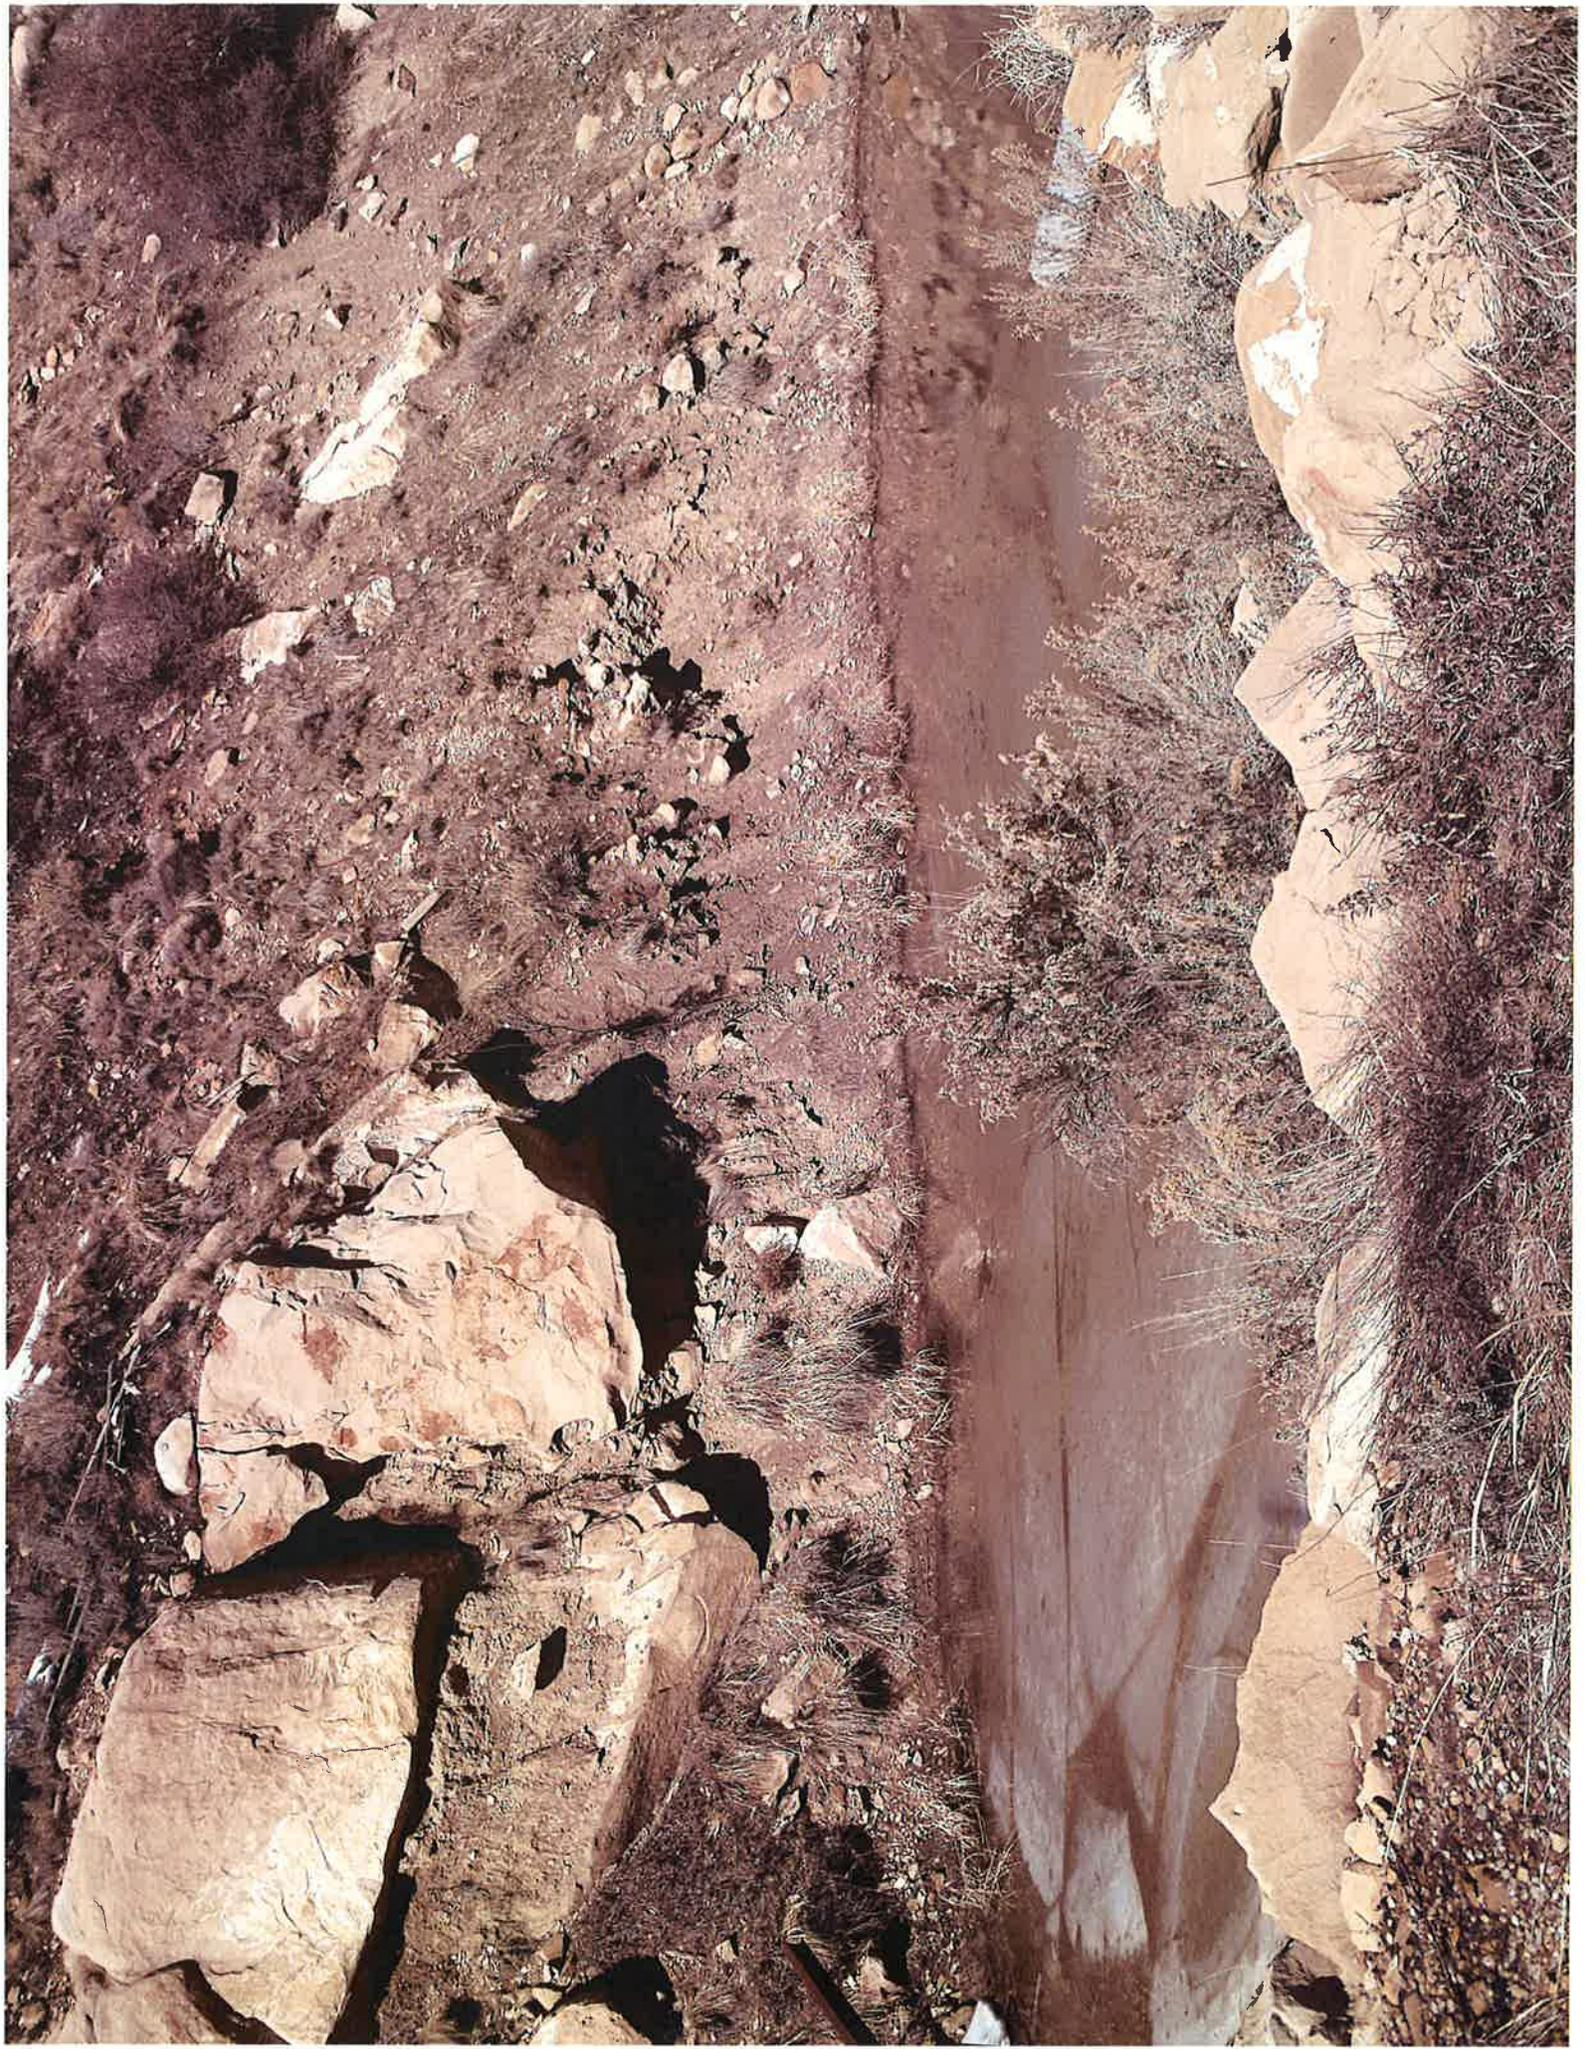
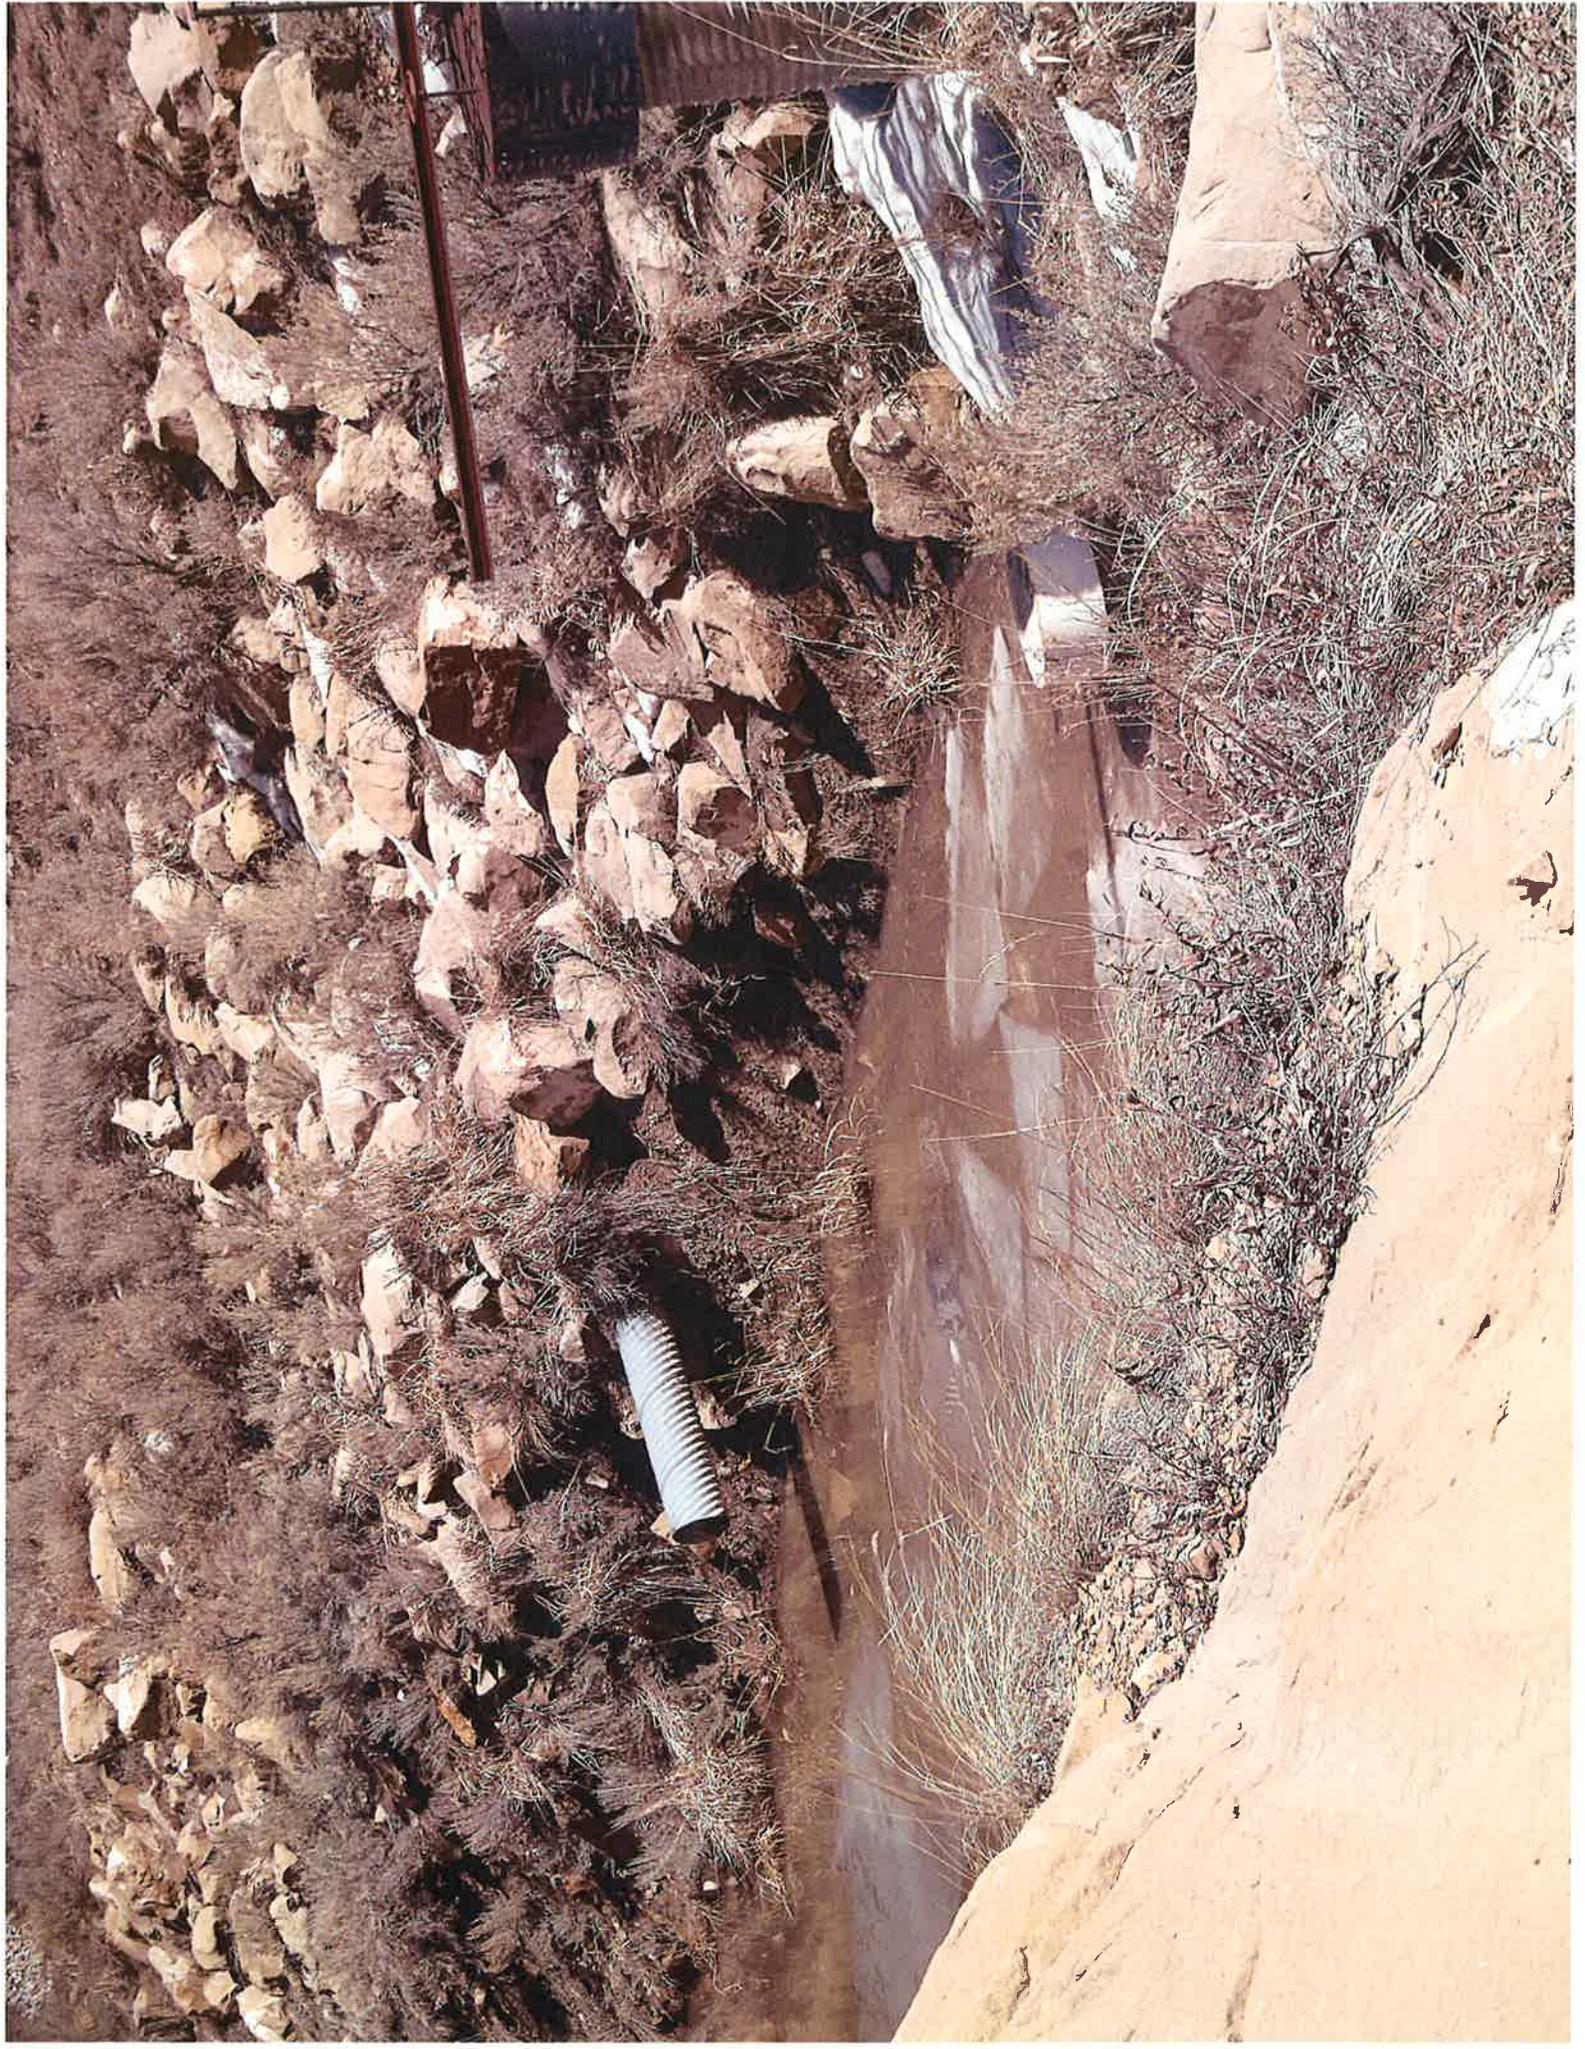
Pond contained water and some of the site ditches were flowing to the pond at time of inspection. The pond was discharging and a sample was taken. There was still snow on the ground over about 30% of the site and in some of the ditches and culvert inlets.

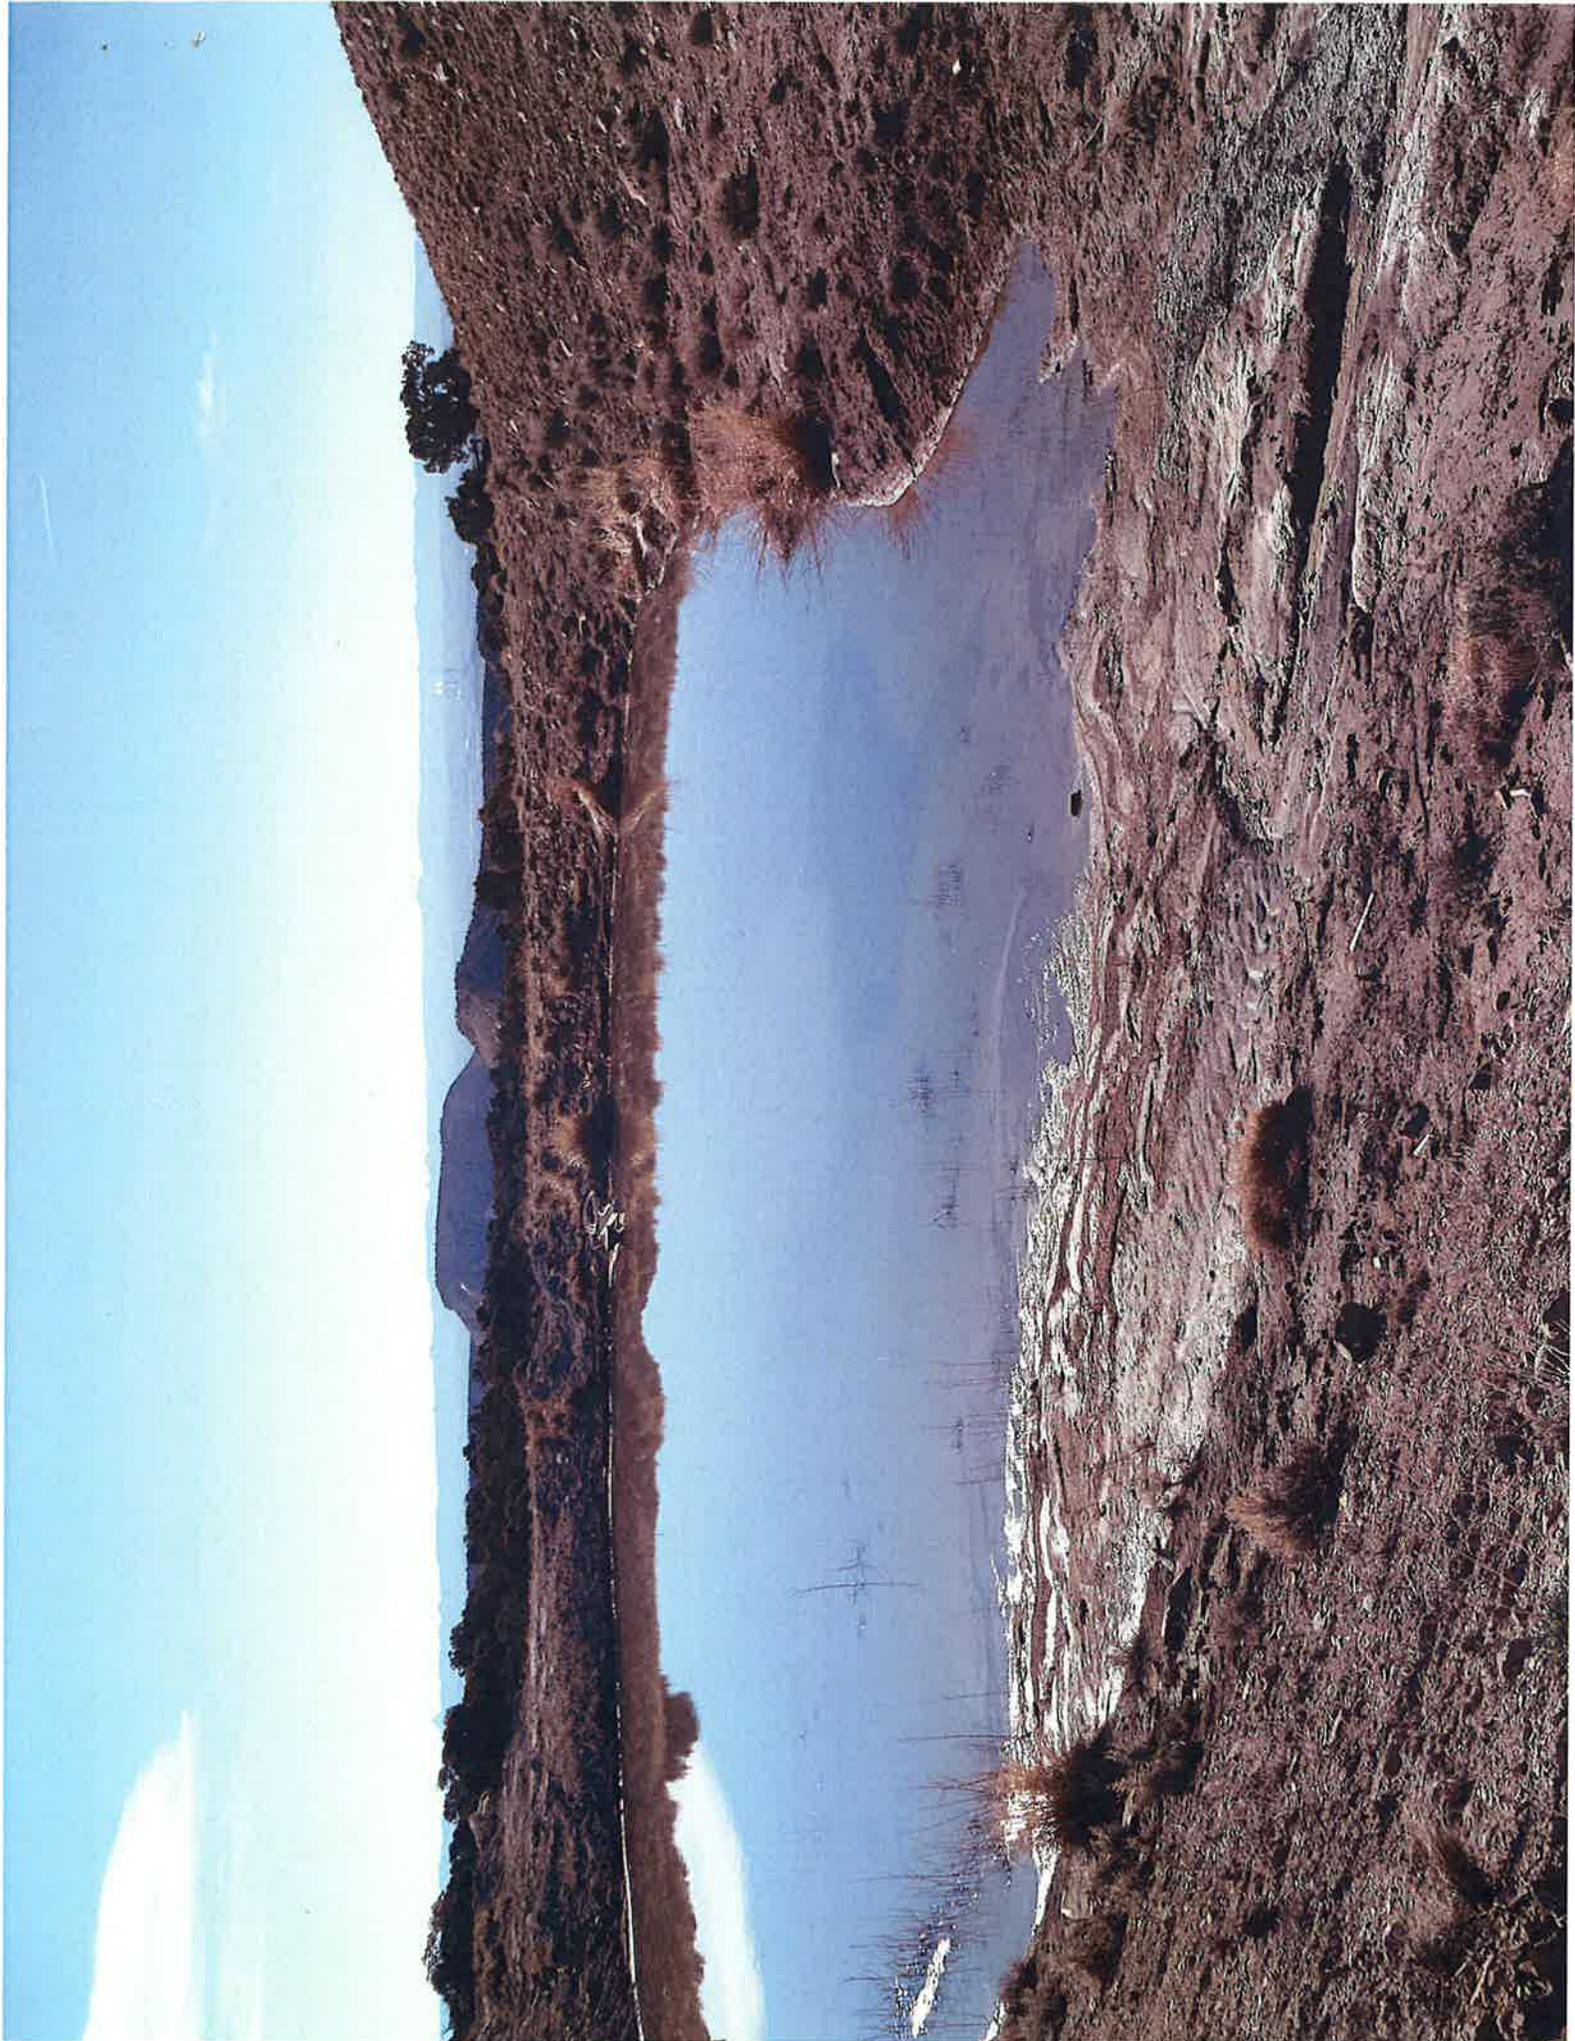
Pond has water in it, when the pond was checked on 3/9 and 3/15 it was not discharging.

- C. Diversion ditches were checked on, the relocated one on the waste rock site appears to be functioning as designed. Culverts and ditches were cleaned of sediment where needed earlier in the quarter, however they will receive additional work once spring runoff is complete .
6. Seepage (Specify Location, Color and Approx. Volume) Yes No
7. Any appearance of instability, structural weakness, or
other hazardous conditions Yes No
8. Other Comments - The pond was approximately 2/3 full at the time of the inspection.
