**Quarterly Inspection Form - Refuse Disposal Areas**  
 (please provide to DOGM promptly after inspection is complete)

Permit Number : C/015/009 Inspection Date : 12/19/2017  
 Mine Name : Fossil Rock Mine Quarter / Year : 4th / 2017  
 Mine Operator (Permittee) : Fossil Rock Resources, LLC Inspector Name : Bryant Bunnell  
 MSHA ID # : UT09-01211-14 Inspector Signature :

Fossil Rock Resources, LLC - Fossil Rock Mine  
Sediment Pond Quarterly Inspection Report

Fossil Rock Resources, LLC - Fossil Rock Waste Rock Site  
Sediment Pond Quarterly Inspection Report

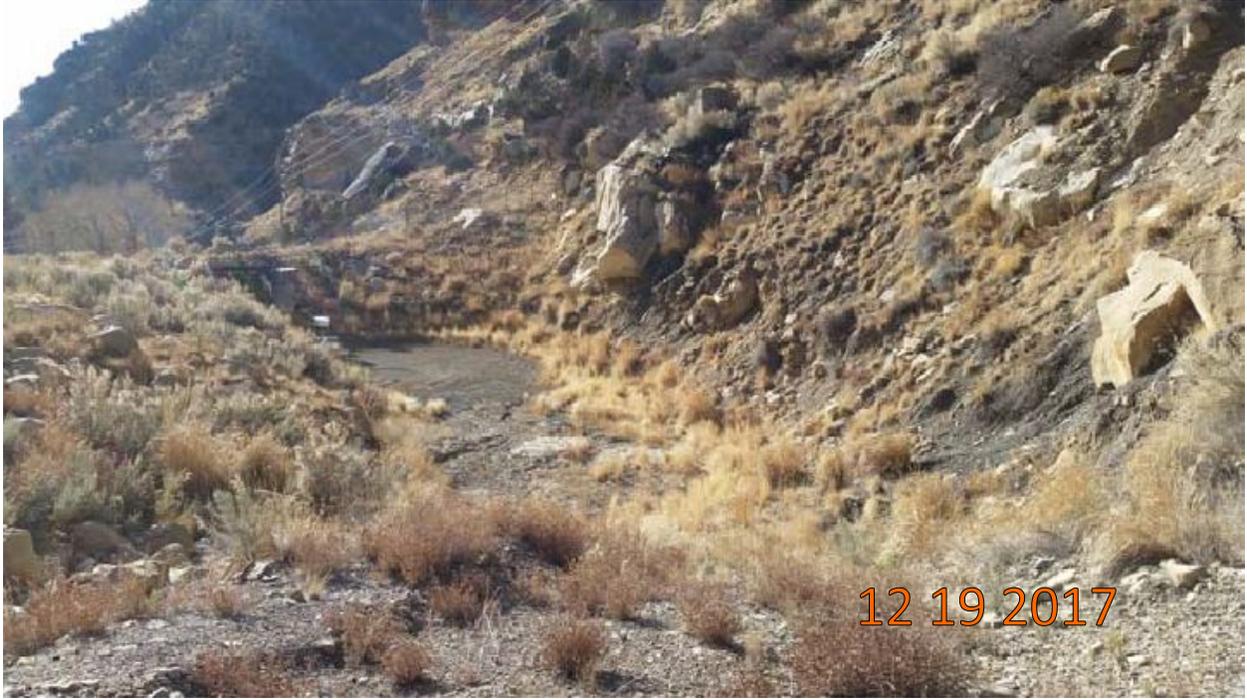
12 19 2017

Ditches were dry and clear. Pond had no water.  
\_\_\_\_\_

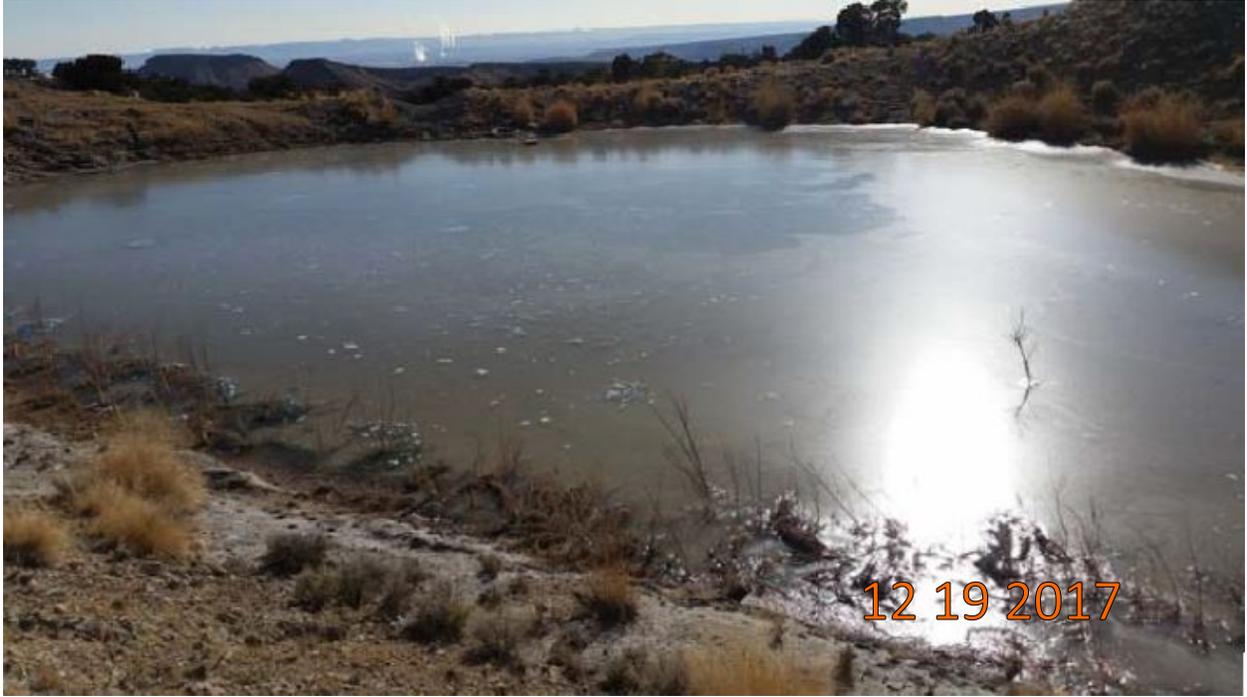
Ditches appeared clear and pond was ~1/2 full.
