Inspection Report

Permit Number:	C0150009
Inspection Type:	COMPLETE
Inspection Date:	Thursday, March 16, 2017
Start Date/Time:	3/16/2017 10:00:00 AM
End Date/Time:	3/16/2017 12:30:00 PM
Last Inspection:

Permittee: **FOSSIL ROCK RESOURCES, LLC**
 Operator: **FOSSIL ROCK RESOURCES, LLC**
 Site: **FOSSIL ROCK MINE**
 Address: **225 North 5th Street, 9th Floor, CO 81501**
 County: **EMERY**
 Permit Type: **PERMANENT COAL PROGRAM**
 Permit Status: **ACTIVE**

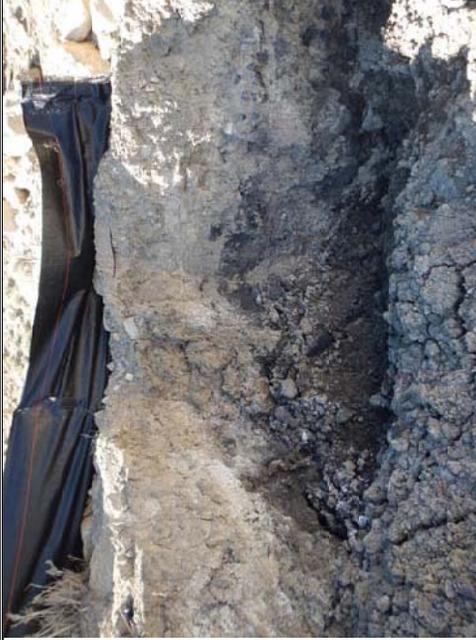
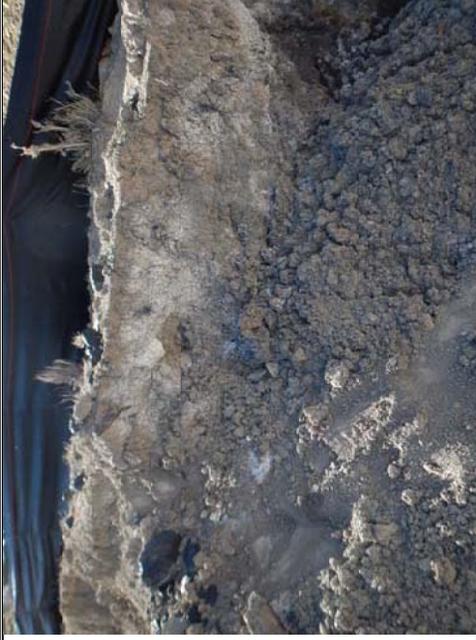
Topsoil recovery was discussed during the inspection. Topsoil placed on the southern face of the lifts must be recovered prior to re-mining the lift. There appears to be 1 to 1½ feet of topsoil placed on the reclaimed face of the lift (Photos 1 - 5). A pile of recovered topsoil was placed on the southeastern most corner of the lift (Photo 6).

<p>PHOTO 1 Topsoil placed on lift during lift construction. March 16, 2017</p>	<p>PHOTO 2 Topsoil placed on lift during lift construction. March 16, 2017</p>

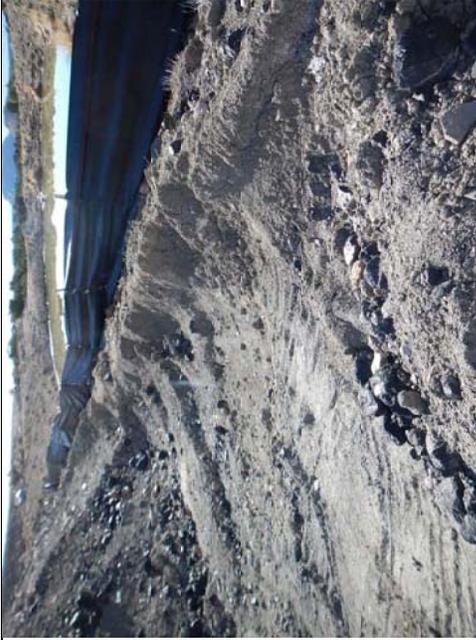
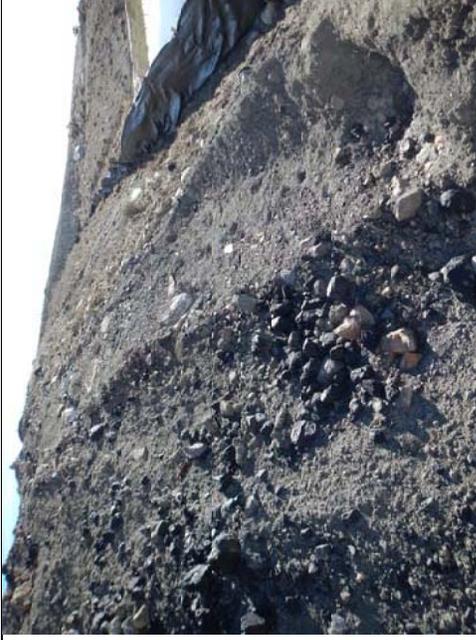
<p>PHOTO 3 Outslope face of reclaimed lift covered with topsoil. March 16, 2017</p>	<p>PHOTO 4 Outslope face of reclaimed lift covered with topsoil. March 16, 2017</p>

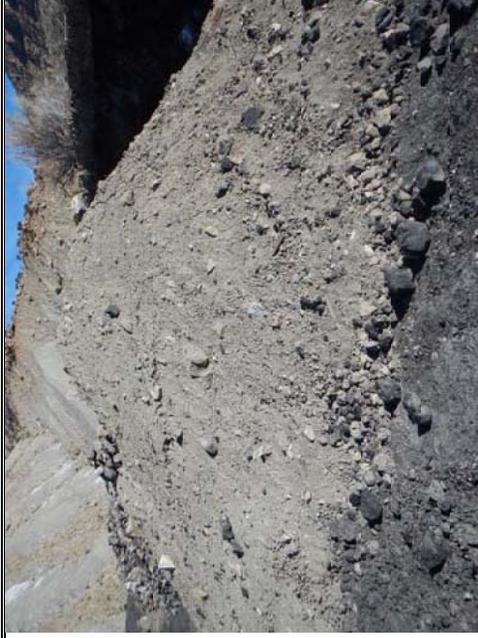
PHOTO 6

Topsoil pile southeast corner of lift.
March 16, 2017

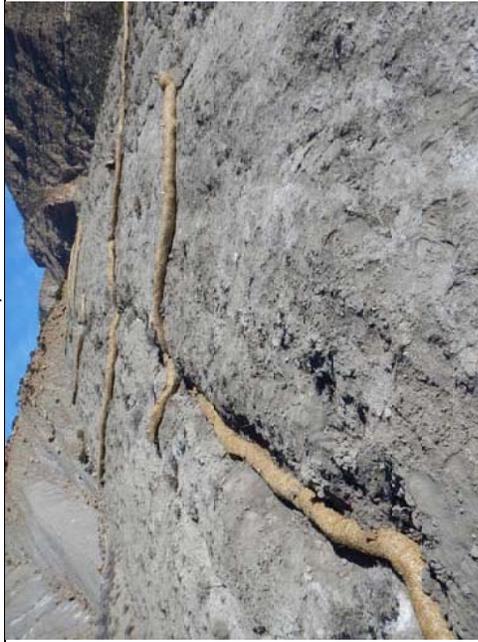
PHOTO 7

Measures to stabilize the subsoil pile had been implemented since the last inspection. Straw wattles are placed across the top of the subsoil pile and in the gullies (Photos 7, 8). This treatment will help reduce and prevent further erosion of the subsoil pile discussed in prior inspection reports.

Straw wattles placed on subsoil pile.
March 16, 2017

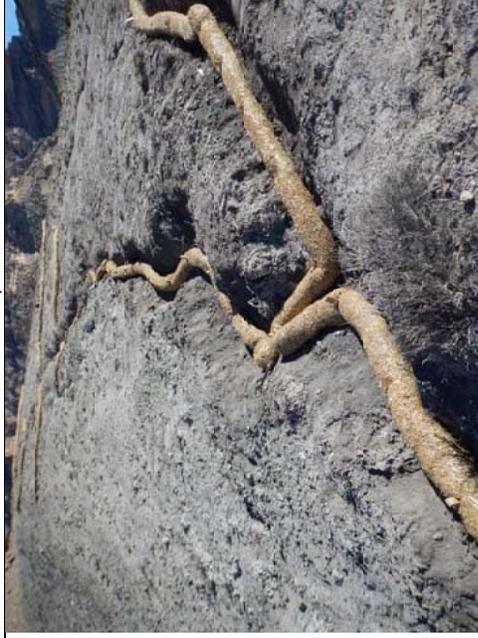
PHOTO 8

Straw wattles placed in gullies of subsoil pile.
March 16, 2017

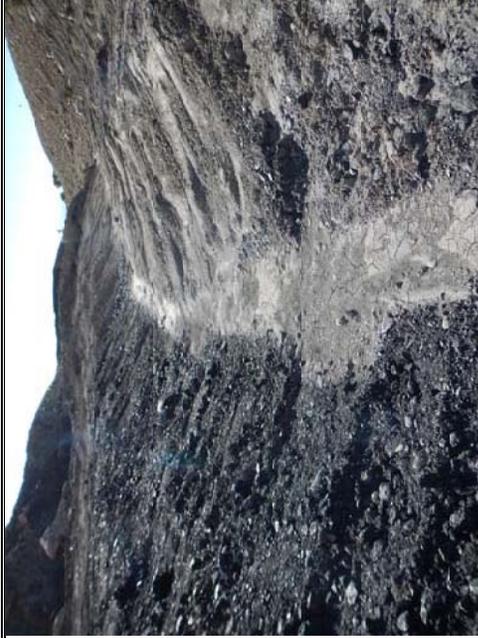
PHOTO 9

Diversions have been adjusted to accommodate the changing shape of the waste rock pile. Ditch DA has been lowered and reformed along its lower end to effectively drain the southwestern edge of the waste rock pile (Photos 9 - 12). The upper end of the ditch transitions to the new lower section through a steeper section of ditch. This transition ramp has been rip-rapped to prevent erosion or downcutting during runoff events (Photos 13, 14).

Lower reformed section of Ditch DA.
March 16, 2017

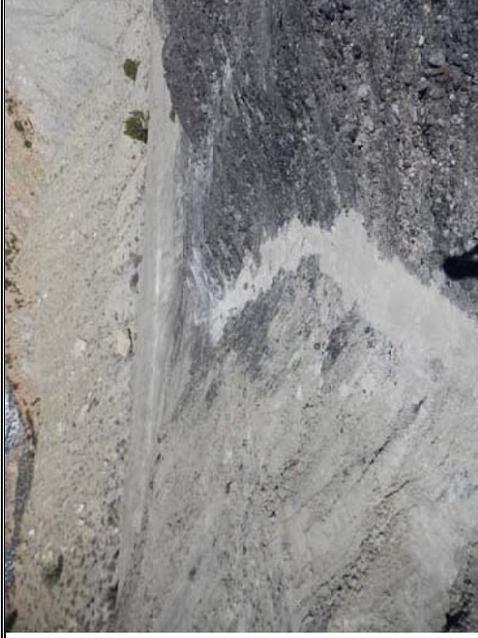
PHOTO 10

Lower reformed section of Ditch DA.
March 16, 2017

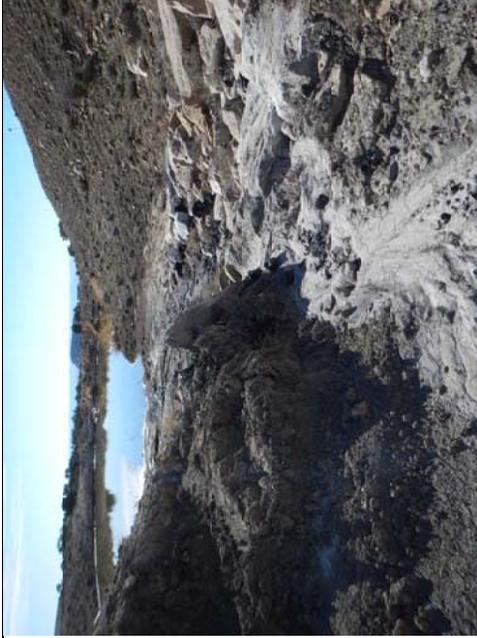
PHOTO 11

Lower end of Ditch DA tying into the rip-rapped drop to the waste rock pond.
March 16, 2017

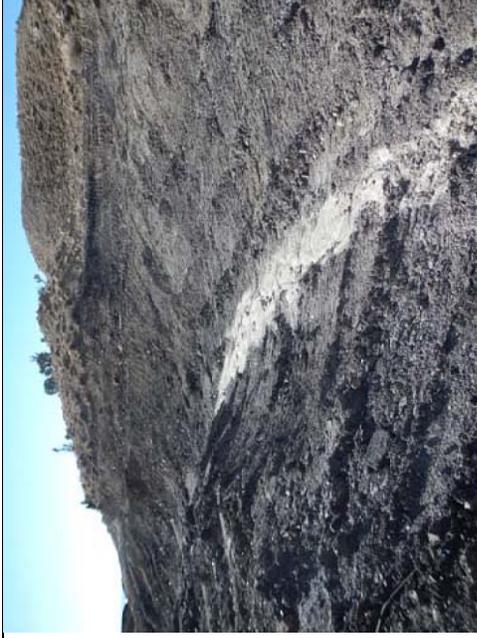
PHOTO 12

Lower reformed section of Ditch DA.
March 16, 2017

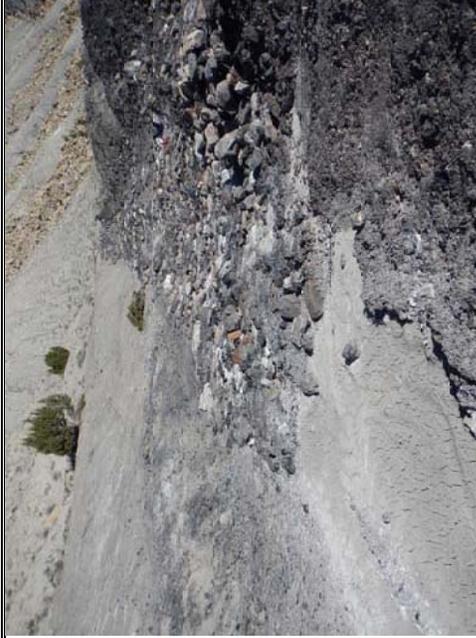
PHOTO 13
Rip-rapped transition ramp.
March 16, 2017

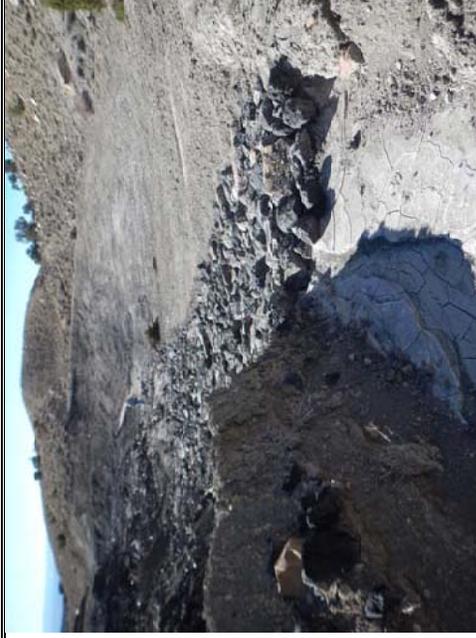
PHOTO 14
Rip-rapped transition ramp.
March 16, 2017

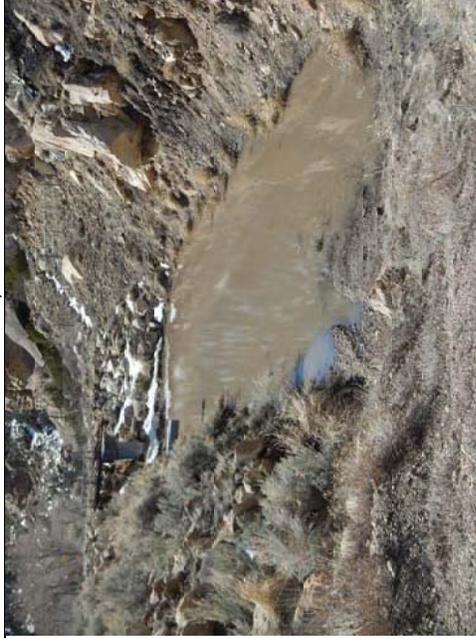
The mine site waste rock pond was discharging at the time of the inspection. The discharge was from snow melt runoff. Vicky Miller sampled the discharge for water quality during the inspection (Photos 15, 16).

PHOTO 15
Main mine site pond.
March 16, 2017

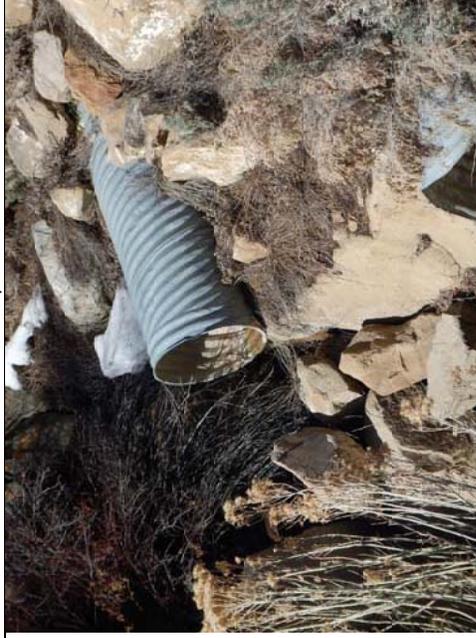
PHOTO 16
Main mine site pond outlet discharging.
March 16, 2017

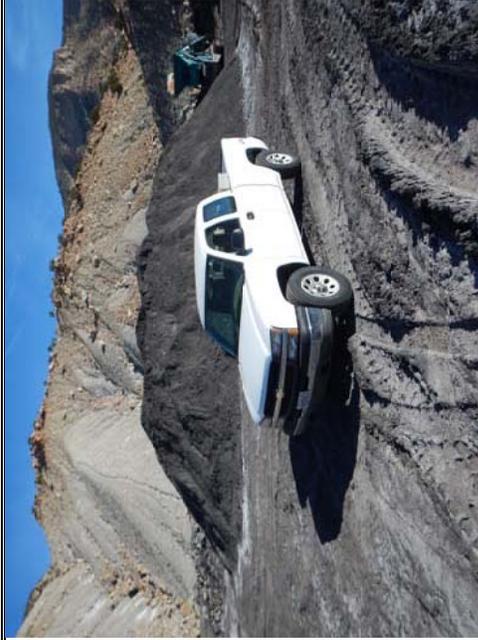
Large piles of sorted waste rock are piled across the lift (Photos 17 - 22).

PHOTO 17
Coal fines pile.
March 16, 2017

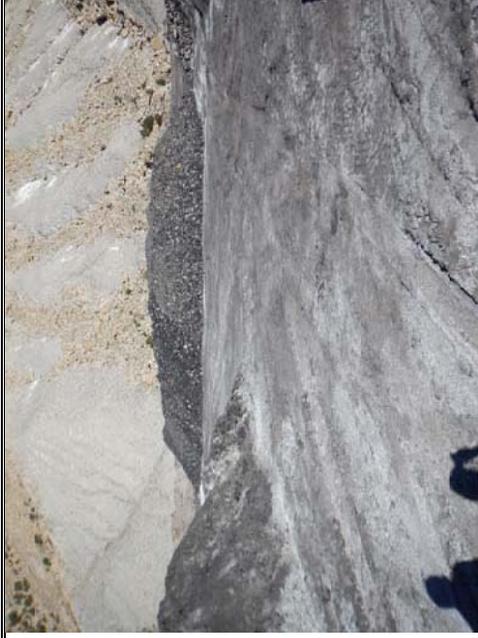
PHOTO 18
Lump coal pile.
March 16, 2017

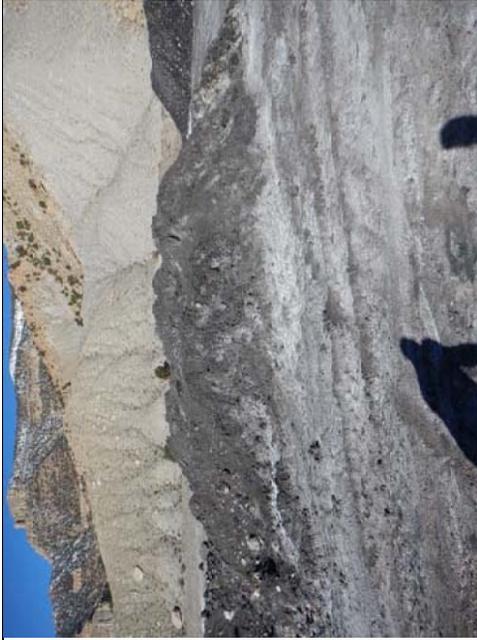
PHOTO 19
Coal fines pile.
March 16, 2017

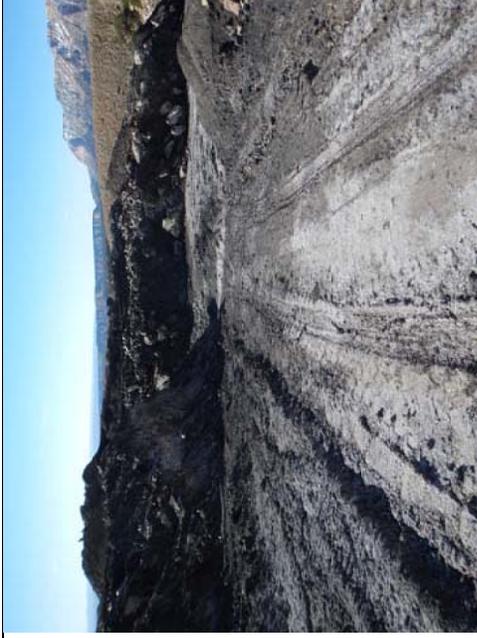
PHOTO 20
Waste rock piles.
March 16, 2017

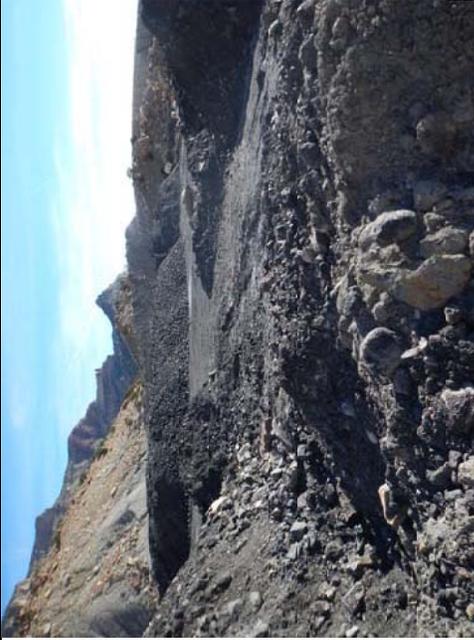
PHOTO 21

Coal and waste rock piles placed on top lift.
March 16, 2017

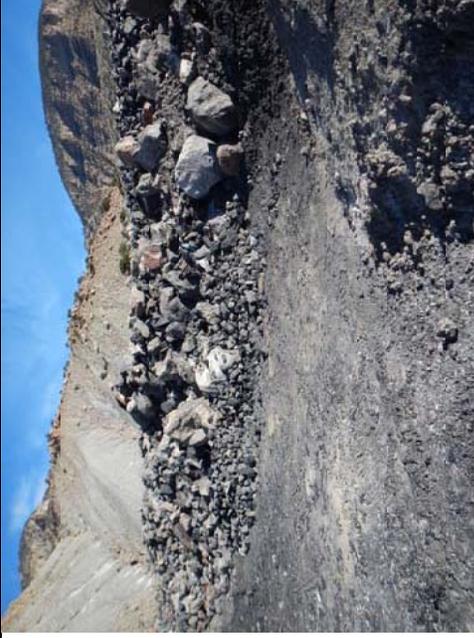
PHOTO 22

Waste rock placed on top lift.
March 16, 2017
