Subject: Findings of Fact, Conclusions, and Order for Violation #21173 Fossil Rock Resources, LLC, Fossil Rock Mine, C/015/0009

**FINDINGS of FACT,
CONCLUSIONS OF LAW
AND ORDER**

RE: Fossil Rock Resources, LLC Permit #C0150009, Waste Rock Site Ditch Evaluation and Request to Terminate NOV #21173

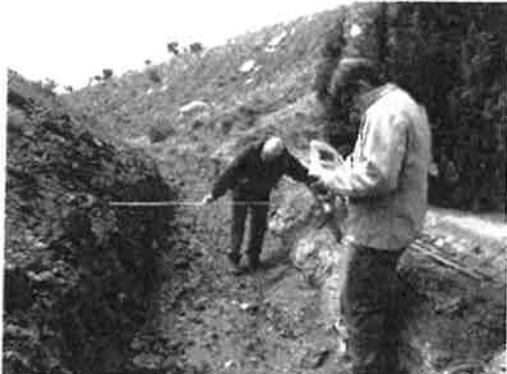
Photo 1: Ditch DA

1. The NOV states that ditch DA was not maintained in the configuration as originally designed. The original design is a v-ditch with side slopes of 2.5:1. The ditch has been maintained as a box ditch. Both the original design and existing dimensions are shown on the attached drawing. One

of the tasks to be completed during the site visit was to verify the capacity of the existing ditch at least equaled the original design flow of 18.9 cubic feet per second. After inspection it was clear the existing ditch dimensions will function with a flow capacity of at least 23 cubic feet per second, a far greater capacity than originally designed (see calculations in Flow Capacity section). A box configuration will require more maintenance because of the steep side slope and the increased propensity for erosion of the side slopes during high flow events. However, at this site the nature of the native soils and fill material as well as access for equipment to perform ditch maintenance currently favor a geometry other than a "V"-shape. See the drawings in the Flow Capacity section for dimensions of Ditch DA at four locations that were deemed representative of the configuration of the existing ditch.

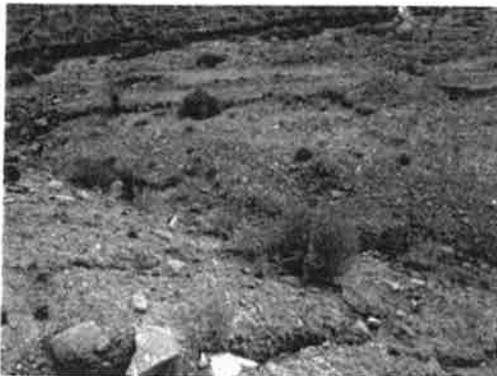
2. The NOV states that, "ditch DB is not-existent... and an access road has been constructed in its place." During our site visit we found the ditch is indeed in place though there is evidence of previous equipment access in the area and the access area had been roughened, see Photo 3. Two cross sections of ditch DB were measured where the ditch is the smallest. The actual flow capacities are

Photo 3: Equipment Access in Background

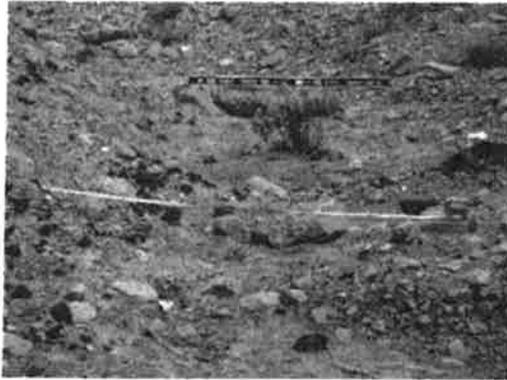
presented in the Flow Capacities section of this report. The original design flow is 2.52 cubic feet per second, with a flow depth of 4 inches. It should be noted that the entirety of ditch DB shows no evidence that the ditch has ever conveyed the 2.52 cubic-foot-per-second design flow.

After a review of the permit documents, specifically Appendix C, the design flow for ditch DB was designed based on a watershed of 3.4 acres. FRR is not currently aware why the original design watershed was so large. The actual watershed is 1.1 acres in size. This is likely the reason why there is no evidence that ditch DB has undergone the permitted design flows. The two watershed boundaries are shown in the attached drawing. See Photos 4 and 5 for pictures of the two cross sections measured.

Photo 4: Ditch DB Cross Sections

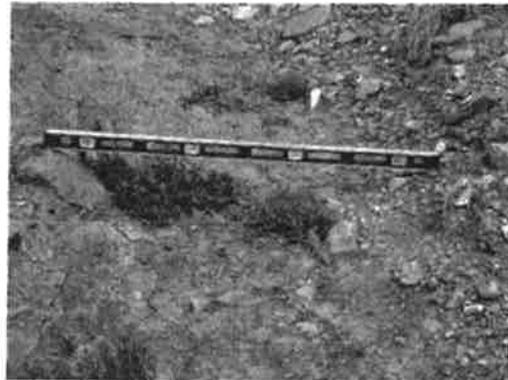
Photo 5: Ditch DB Cross Section E

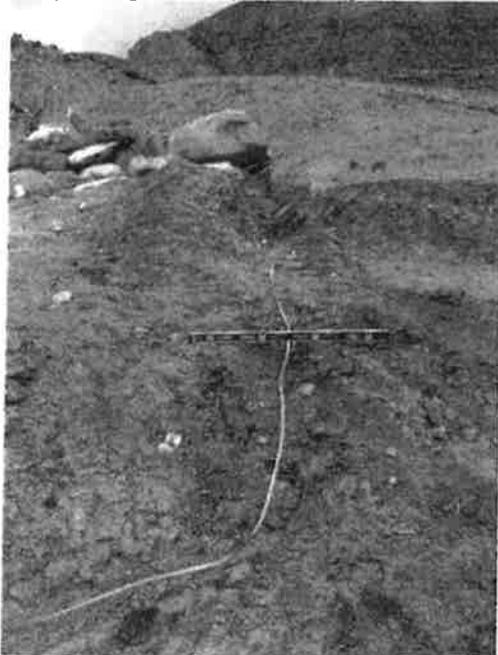
3. The NOV states, "ASCA, southern end of Subsoil Stock Pile... there is no clear runoff flow path on southern end... that directs water to the silt fence." During our site visit we found that there is a clearly defined flow path. Similar to ditch DB, the flow path is reduced in size because the size of its watershed source is very small. See Photos 6 and 7. A cloth tape was laid in the center of the flow path to more easily distinguish the path in the photos.

Photo 6: Upper Flow Path

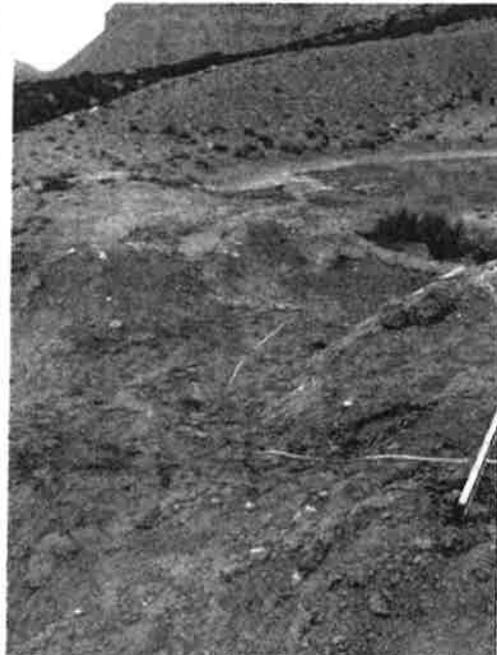
Photo 7: Lower Flow Path
