Quarterly Inspection Form - Refuse Disposal Areas

Permit Number : C/015/009 Inspection Date : 9/27/2018
Mine Name : Fossil Rock Mine Quarter / Year : 3rd/ 2018
Mine Operator (Permittee) : Fossil Rock Resources, LLC Inspector Name : Bryant Bunnell
MSHA ID # : UT09-01211-14 Inspector Signature :

**Fossil Rock Resources, LLC - Fossil Rock Mine
Sediment Pond Quarterly Inspection Report**

Fossil Rock Resources, LLC - Fossil Rock Waste Rock Site

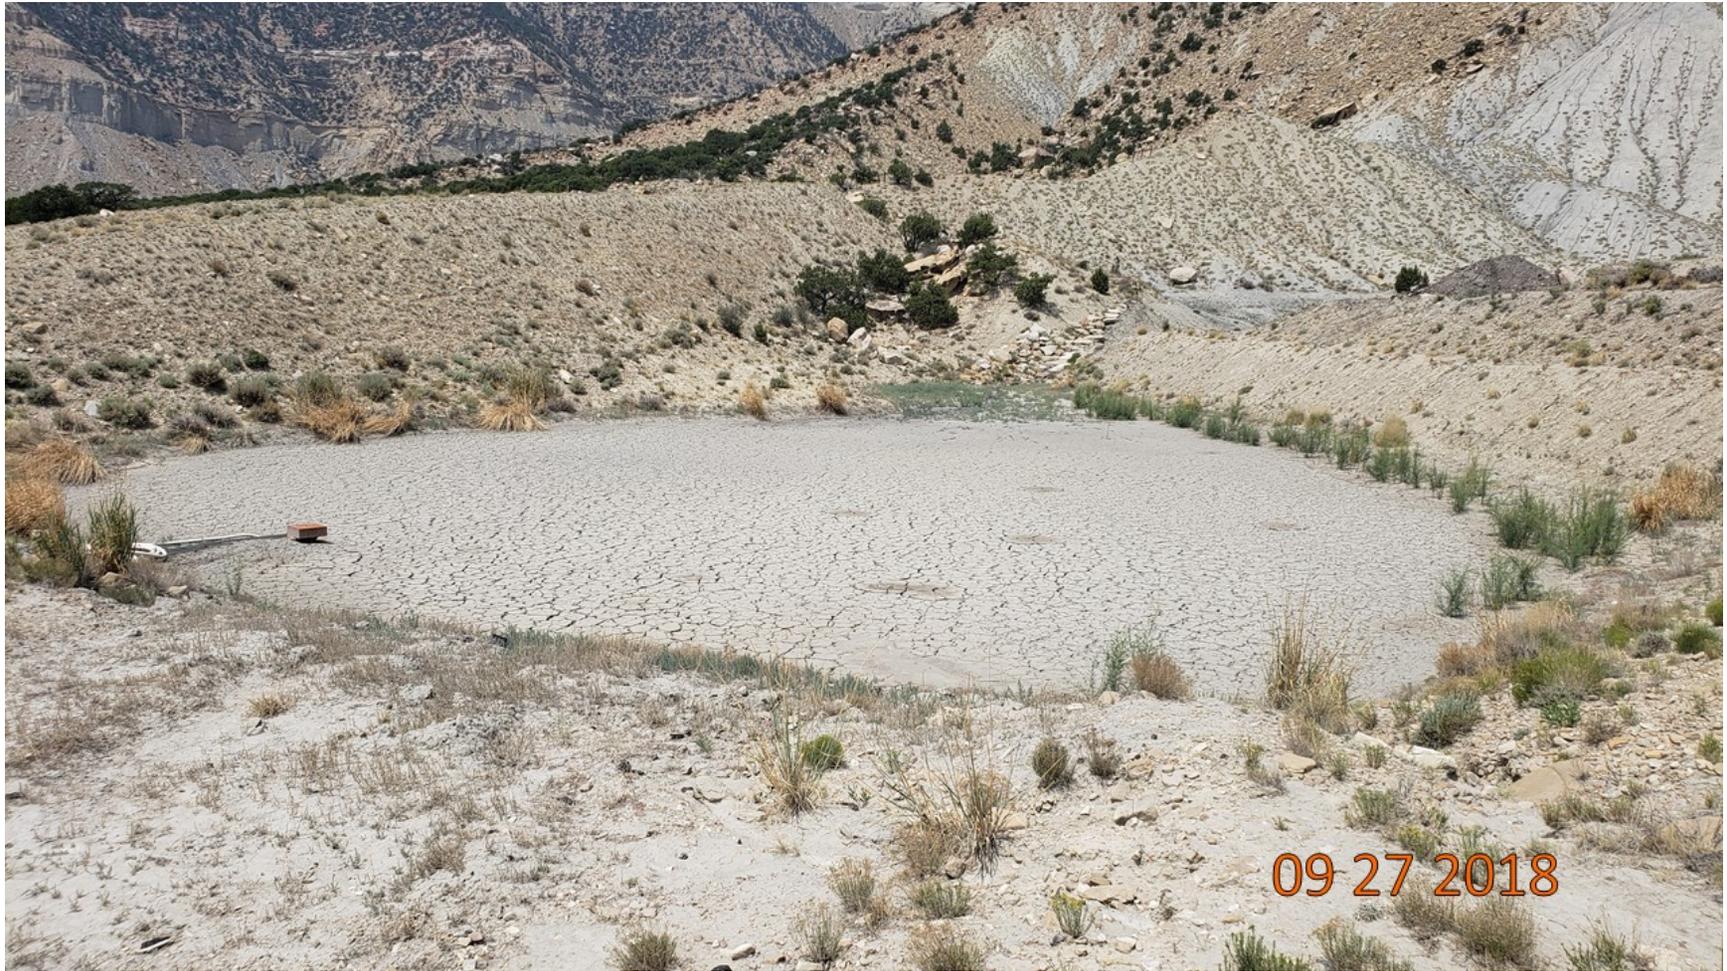
09 27 2018

Sediment Pond Quarterly Inspection Report

None Observed
