Inspection Report

| Inspection Date: | Wednesday, January 24, 2018 |

Permitee: **FOSSIL ROCK RESOURCES, LLC**
 Operator: **FOSSIL ROCK RESOURCES, LLC**
 Site: **FOSSIL ROCK MINE**
 Address: **225 North 5th Street, 9th Floor, CO 81501**
 County: **EMERY**
 Permit Type: **PERMANENT COAL PROGRAM**
 Permit Status: **ACTIVE**

This partial inspection of the main facilities site was completed on Wednesday, January 24th. The culverts, Cottonwood Mine water discharge point, and sediment pond were the subjects of inspection. Site was covered with about 1 - 2 inches of snow, accumulating mostly in areas that receive little sunlight.

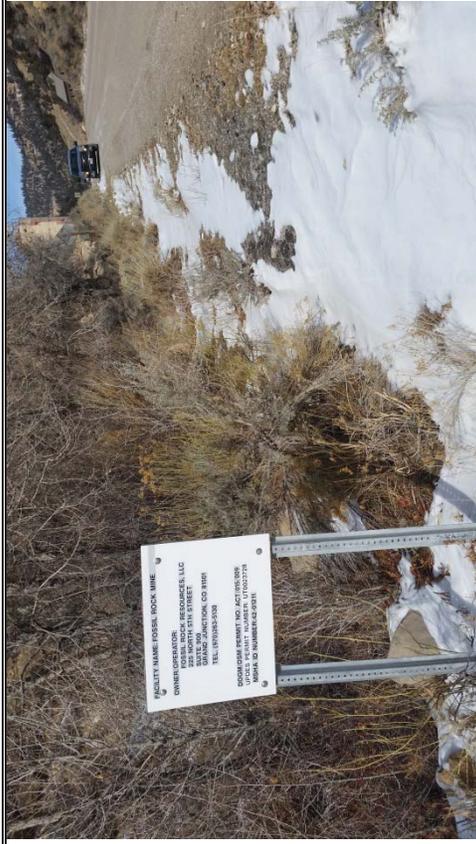
PHOTO 1 – POSTED PERMIT, MAIN SITE

Current and in good shape.
January 24, 2018

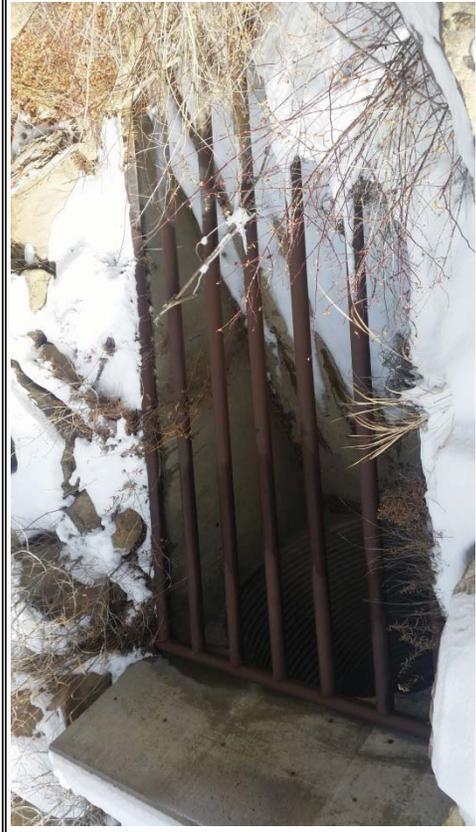
PHOTO 2 – INTAKE CULVERT, MAIN SITE

Culverts appeared to be functioning properly, inlets were free of debris. Cottonwood mine water discharge culvert was also clean and free of debris. Cottonwood Creek was not running at the time of this inspection.

This bypass culvert routes Cottonwood Creek under and through the main mine site. Culvert was clean and free of debris.
January 24, 2018

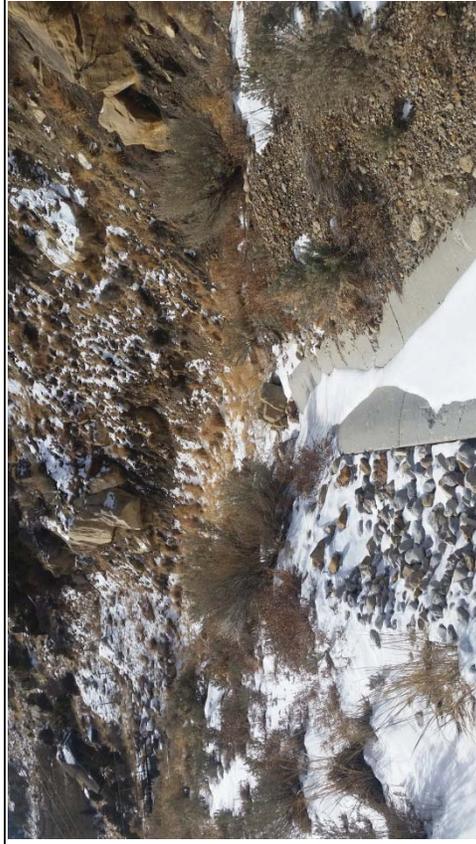
PHOTO 3 – CONCRETE CHANNEL, MAIN SITE

This channel drains all on site runoff into the primary sediment pond. Aside from the snow, the channel appeared to be free of debris.
January 24, 2018

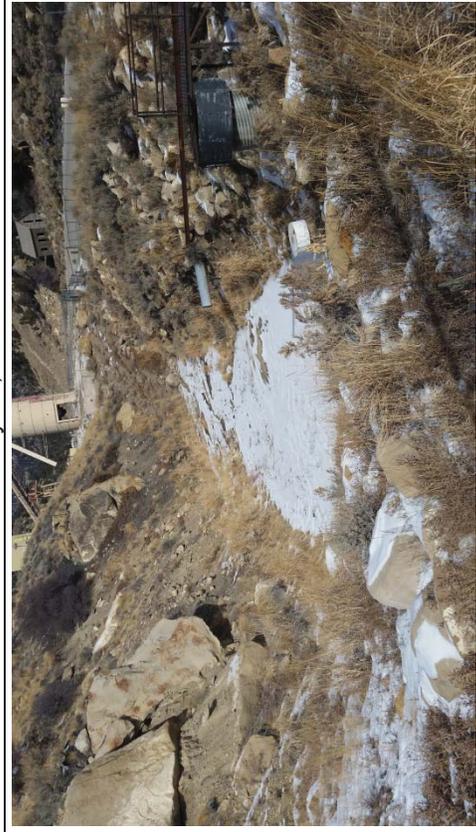
PHOTO 4 – PRIMARY SEDIMENT POND, MAIN SITE

Aside from a thin layer of ice and snow, sediment pond was dry.

Aside from a thin layer of ice and snow, the sediment pond was not impounding any water.
January 24, 2018
