Inspection Report

Permit Number:	C0150009
Inspection Type:	COMPLETE
Inspection Date:	Thursday, September 27, 2018
Start Date/Time:	9/27/2018 10:00:00 AM
End Date/Time:	9/27/2018 1:00:00 PM
Last Inspection:	Wednesday, August 29, 2018

Permittee: **FOSSIL ROCK RESOURCES, LLC**
 Operator: **FOSSIL ROCK RESOURCES, LLC**
 Site: **FOSSIL ROCK MINE**
 Address: **225 North 5th Street, 9th Floor, CO 81501**
 County: **EMERY**
 Permit Type: **PERMANENT COAL PROGRAM**
 Permit Status: **ACTIVE**

The purpose of this site visit was to conduct a complete inspection of the Fossil Rock Mine. The main mine site in Cottonwood Canyon was inspected, as well as the waste rock site located just below the reclaimed Cottonwood Mine. The Fossil Rock Mine stopped mining coal in 2001, and has been idle ever since. The permit area was physically inspected together with mine representative Bryant Bunnell.

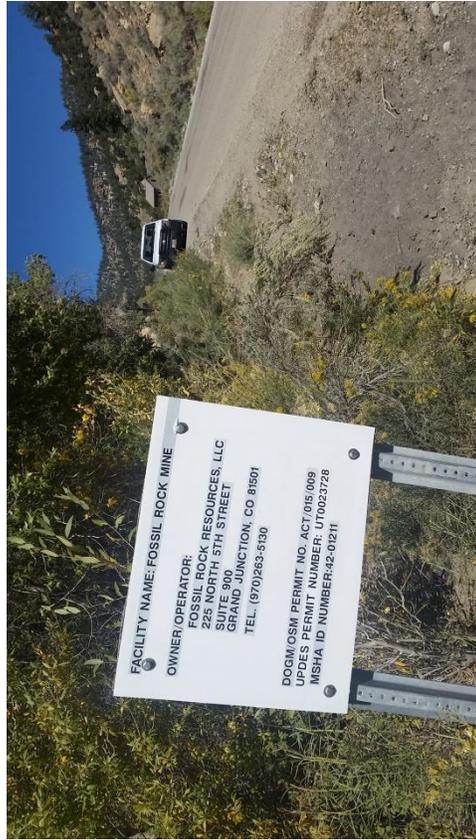
PHOTO 1 – POSTED PERMIT, MAIN SITE

Signs designating topsoil, subsoil, and disturbance limits are in place and in good condition. A sign indicating the name, permit number, and other contact information is posted in plain view at the main mine site as well as the waste rock site.

The south end of the permit area.

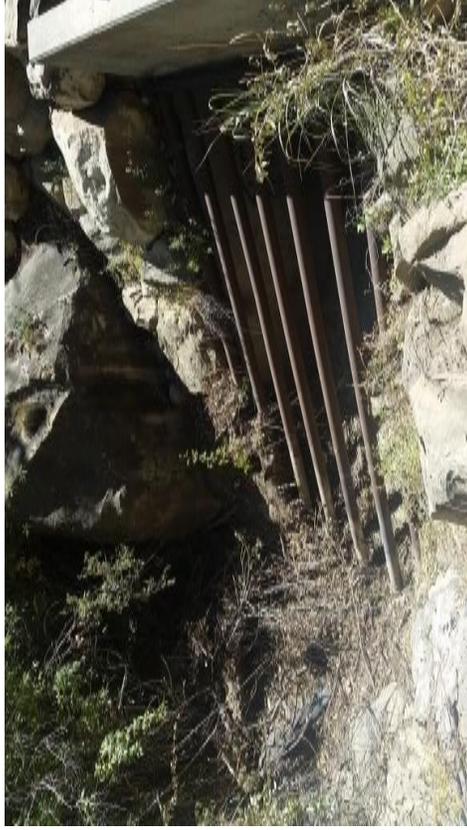
PHOTO 2 – INTAKE CULVERT, MAIN SITE

Diversions at both the main site as well as the waste rock site appear to be stable and functioning properly. The summer has been very dry, and consequently all the diversion ditches and sediment ponds have received very little moisture and very little sediment. Recently the vegetation was trimmed back at the intake of the 66" culvert running beneath the main mine site.

Looking due east. Encroaching vegetation on the left has been cut back.

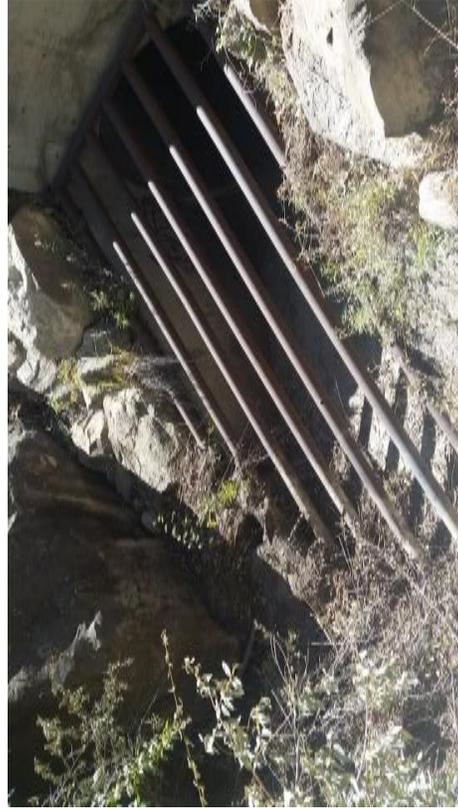
PHOTO 3 – INTAKE CULVERT, MAIN SITE

Looking southeast.

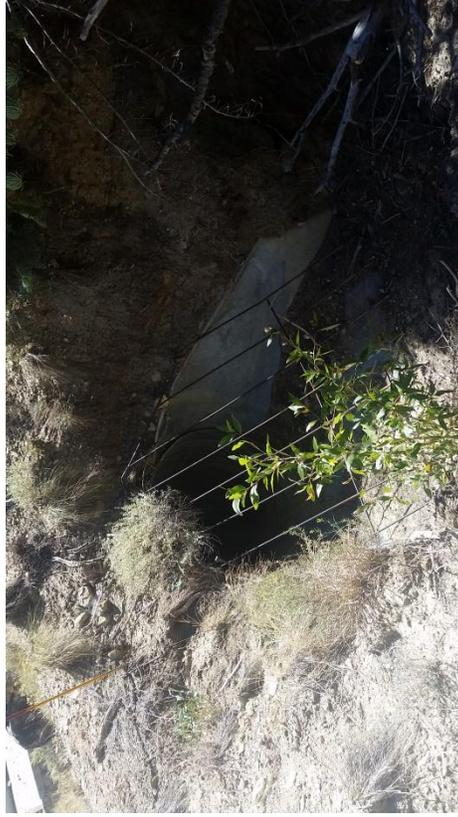
PHOTO 4 – DIVERSION, MAIN SITE

The inlet of the 48” CMP culvert that diverts runoff underneath the topsoil stockpile west of the buildings.

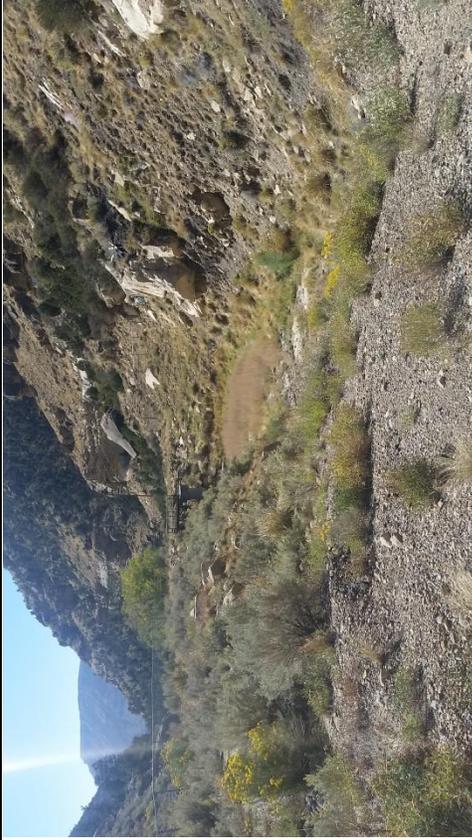
Sediment ponds at both the main mine site as well as the waste rock site are completely dry.

PHOTO 5 – SEDIMENT POND, MAIN SITE

Sediment pond is and has been almost completely dry for several months.

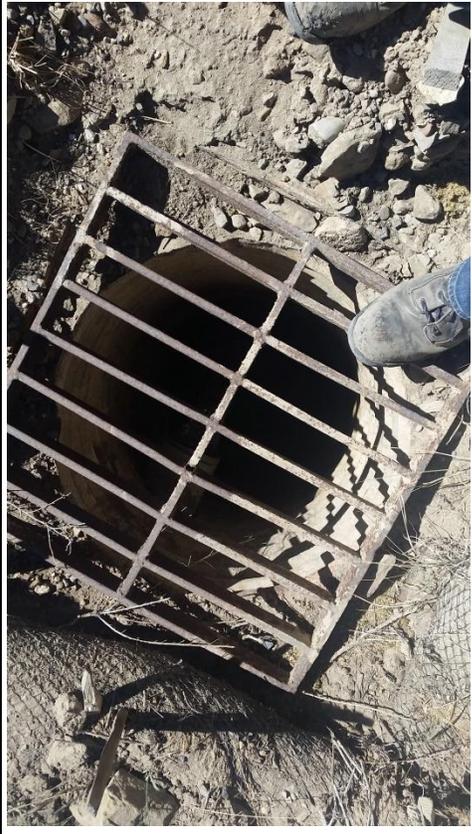
PHOTO 6 – 24” CMP DROP DRAIN

Drop drain which runs under the county road and hooks into buried 66” Cottonwood culvert. Culvert inlet was clear and free of debris.

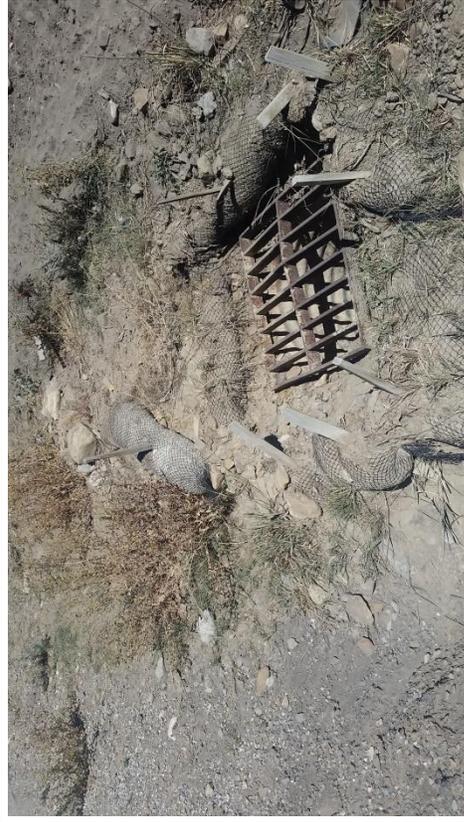
PHOTO 7 – 24” CMP DROP DRAIN

Drop drain which runs under the county road and hooks into buried 66” Cottonwood culvert. Culvert inlet was clear and free of debris.

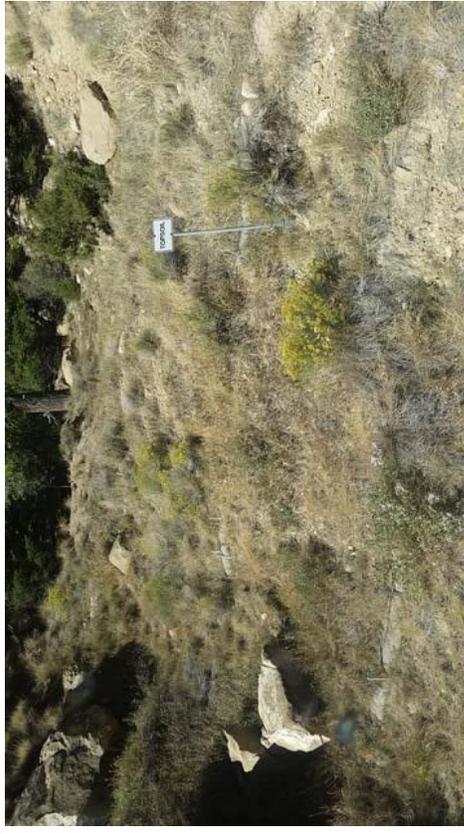
Topsoil piles #1, #2, and #3 at the waste rock site were inspected and found in stable condition. There is a thick layer of native vegetation over piles #2 and #3, and a sparse layer over #1. The topsoil pile at the main mine site was also found to be stable and vegetated, although the Excelsior logs have been overrun with silt and are currently almost buried entirely. No noxious weeds were present at either location.

PHOTO 8 – TOPSOIL STOCKPILE, MAIN SITE

Excelsior logs peeking through thickly vegetated native grasses and forbes.

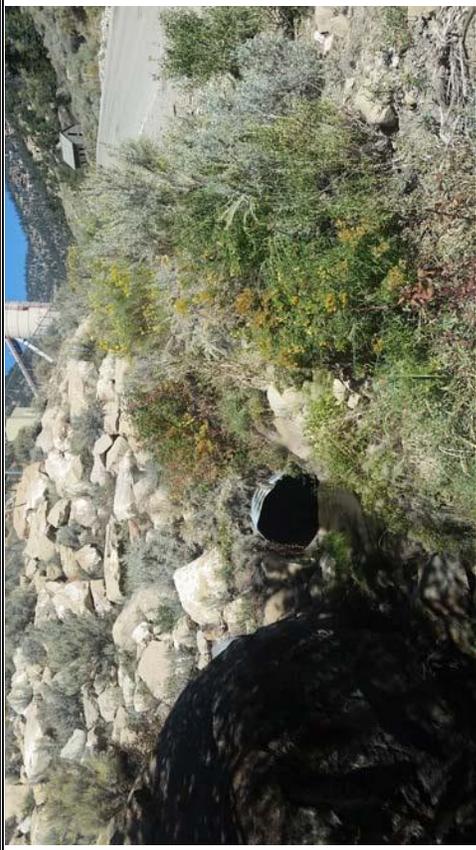
PHOTO 9 – 66” CULVERT OUTLET, MAIN SITE
 The water flowing from the culvert is Cottonwood mine water discharge. The flow dries up a mile down canyon from this point.

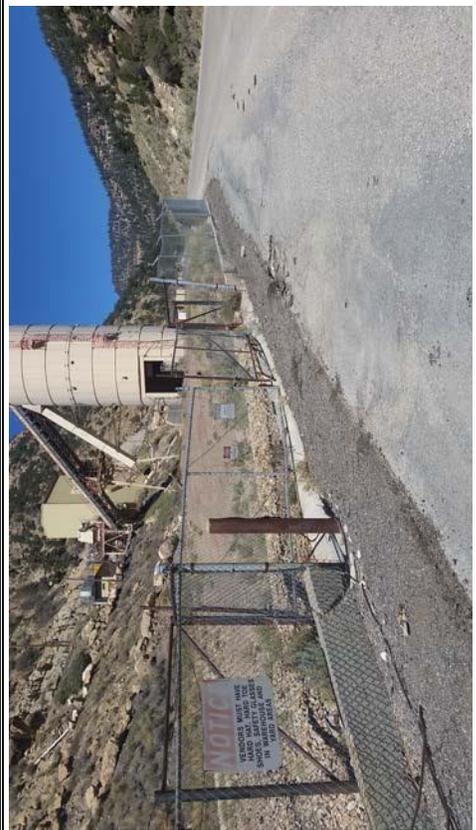
PHOTO 10 – FENCING AND SIGNS
 View looking northwest across main mine site from Emery County road.

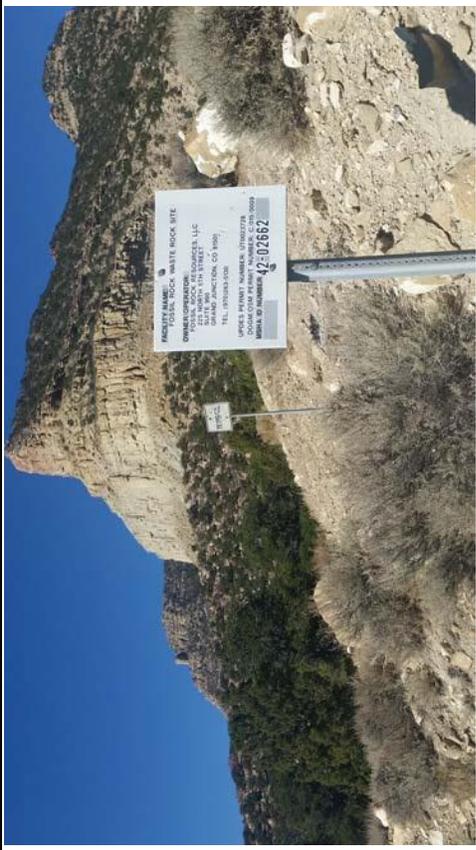
PHOTO 11 – PERMIT SIGN, WASTE ROCK SITE
 Topsoil pile #3 just behind this sign.

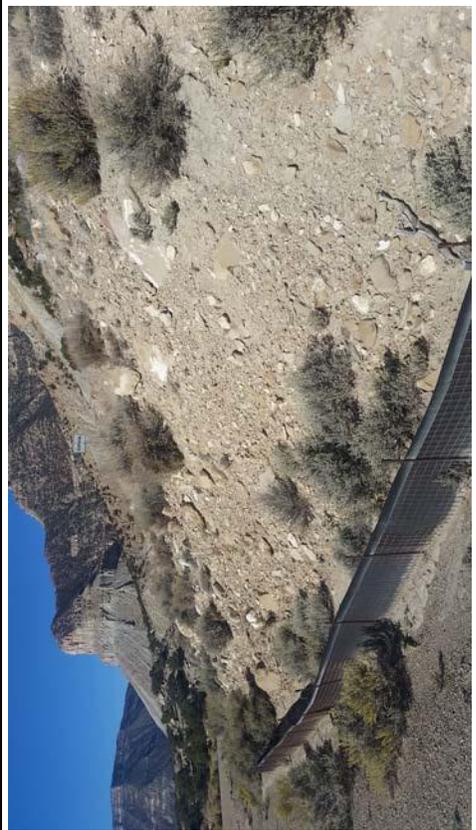
PHOTO 12 – TOPSOIL PILE #2, WASTE ROCK SITE
 Silt fence appears sturdy.

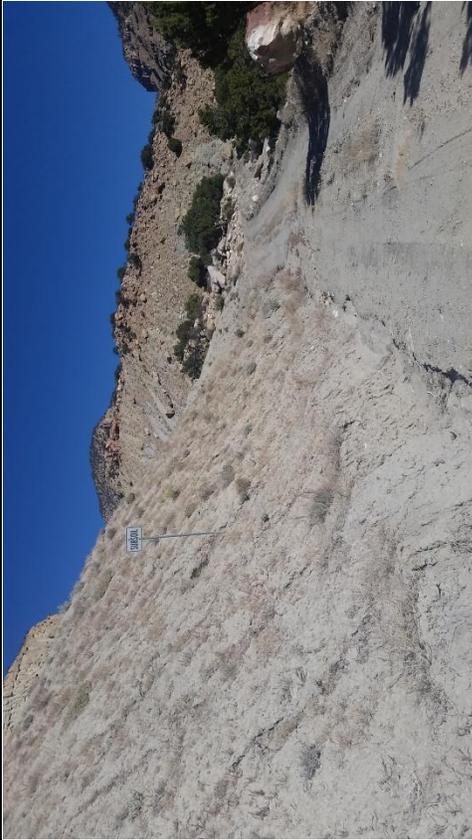
PHOTO 13 – SUBSOIL STOCKPILE, WASTE ROCK SITE
Sparsely vegetated east slopes.

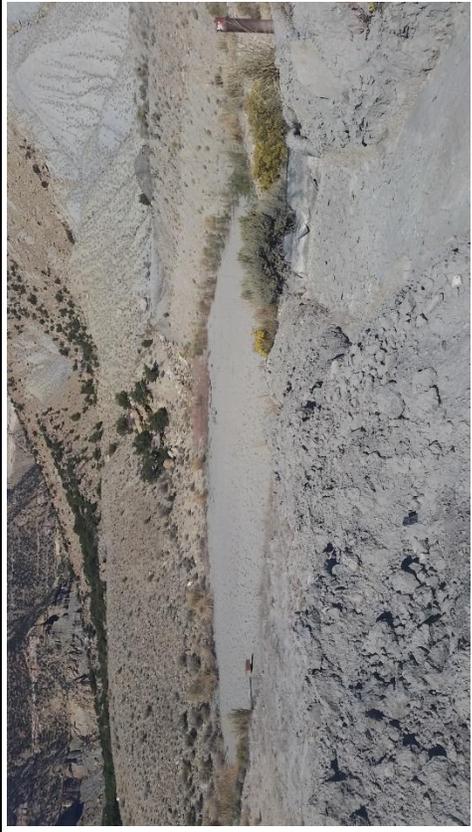
PHOTO 14 – SEDIMENT POND, WASTE ROCK SITE
This pond hasn't seen moisture in a while.

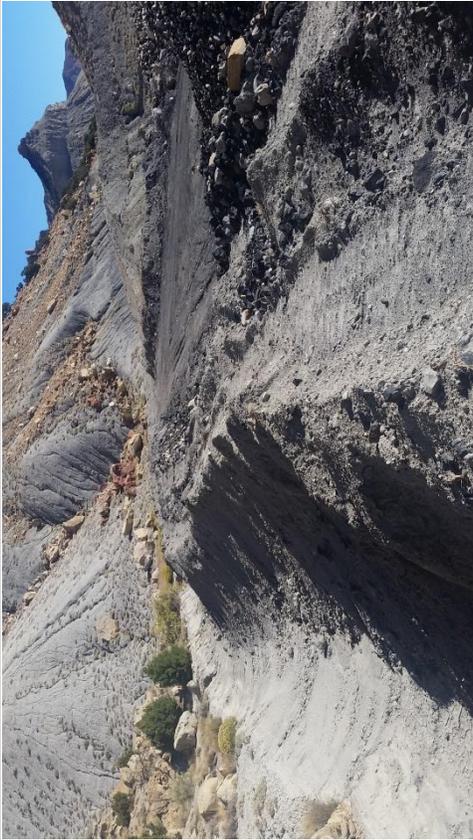
PHOTO 15 – DIVERSION DITCH, WASTE ROCK SITE
This runs along the north side of the disturbed area.

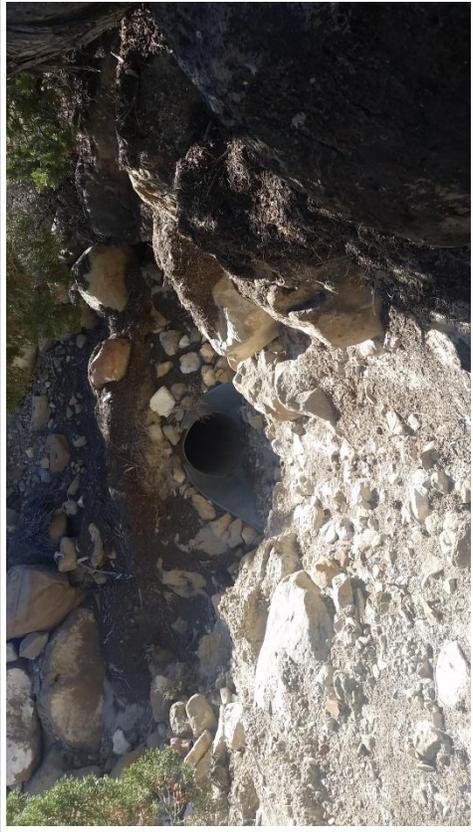
PHOTO 16 – 24" CULVERT, WASTE ROCK SITE
This culvert runs beneath the access road northeast of Topsoil Pile #2. Culvert was clean and free of debris.
