Inspection Report

Permit Number:	C0150009
Inspection Type:	COMPLETE
Inspection Date:	Thursday, December 13, 2018
Start Date/Time:	12/13/2018 11:30:00 AM
End Date/Time:	12/13/2018 1:30:00 PM
Last Inspection:	Tuesday, November 27, 2018

Site: **FOSSIL ROCK MINE**

ATTACHMENT A – December 13, 2018 Complete inspection

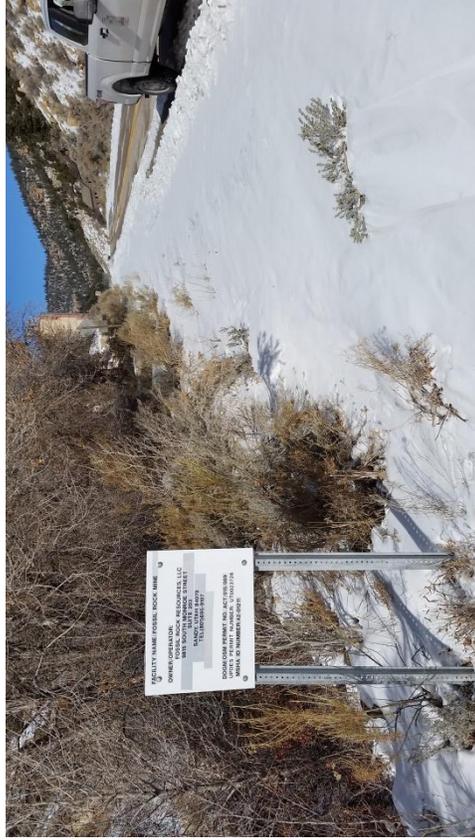
PHOTO 1 – POSTED PERMIT, MAIN SITE

The south end of the permit area.

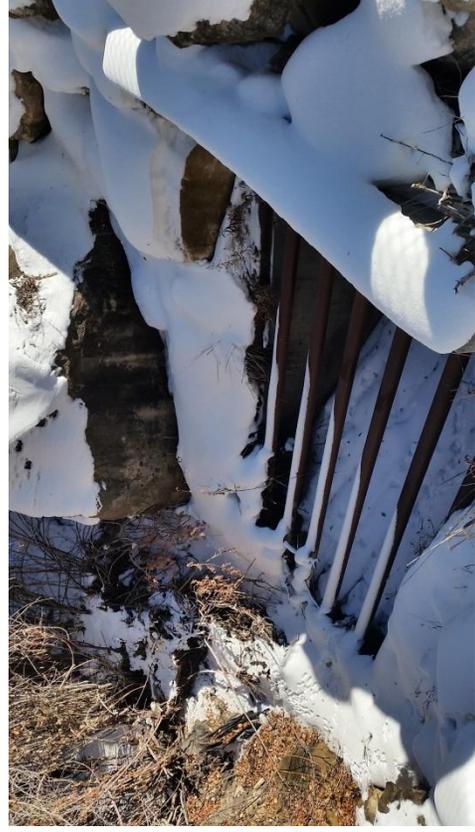
PHOTO 2 – INTAKE CULVERT, MAIN SITE

Diversions at the waste rock site appeared to be in stable condition, and diversions around the subsoil stockpile had seen maintenance work in recent weeks. The diversions at the main site were covered in snow but the intake culverts were all clear of debris.

Looking due east. Culvert intake appears clear.

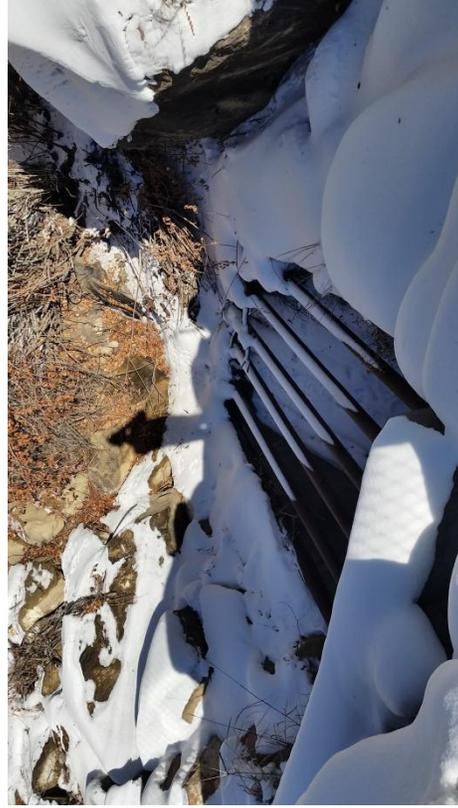
PHOTO 3 – INTAKE CULVERT, MAIN SITE

Looking north.

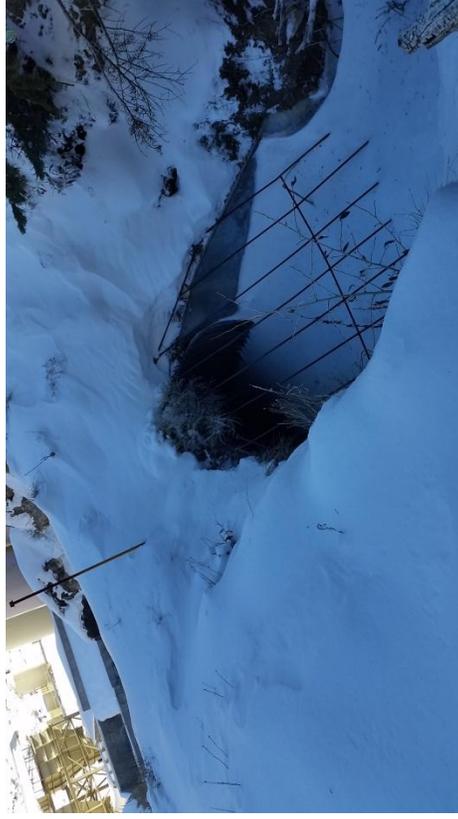
PHOTO 4 – DIVERSION, MAIN SITE

The inlet of the 48" CMP culvert that diverts runoff underneath the topsoil stockpile west of the buildings.

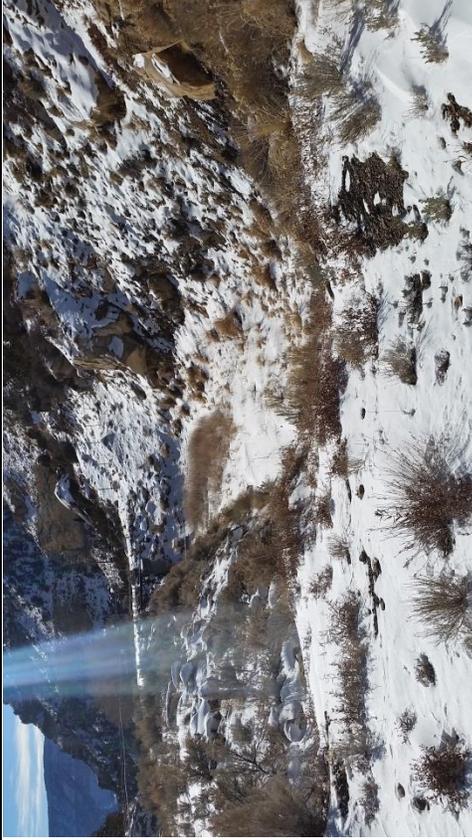
PHOTO 5 – SEDIMENT POND, MAIN SITE

The sediment pond at the main site is covered in snow, and the sediment pond at the waste rock site is at approximately 1/3 capacity and frozen.

There was no moisture in this pond prior to the snow that now blankets the site.

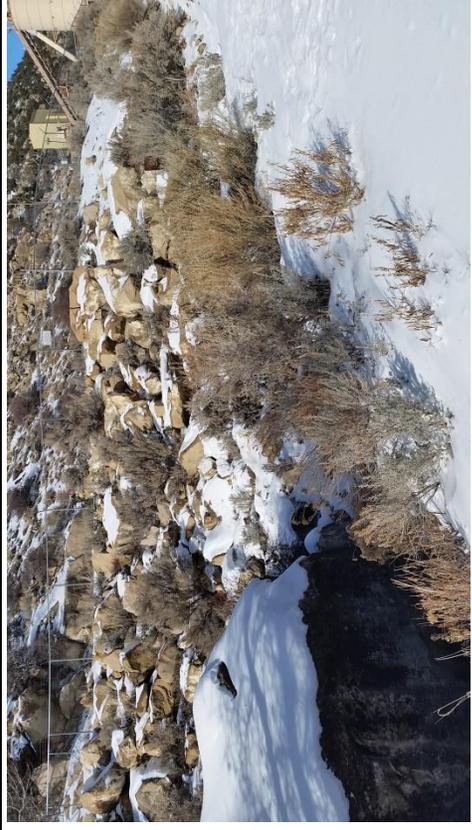
PHOTO 6 – FENCING AND SIGNS

The fencing and posted signage is in good repair along the County road.

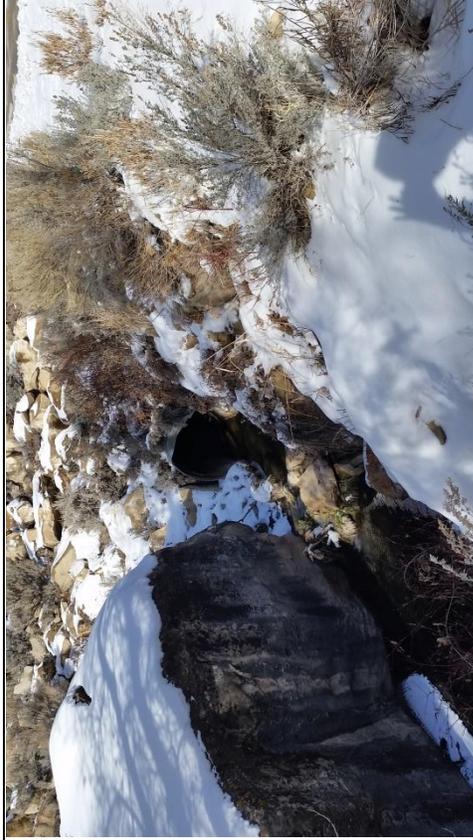
PHOTO 7 – 66” CULVERT OUTLET, MAIN SITE

The water flowing from the culvert is Cottonwood mine water discharge. The flow dries up a mile down canyon from this point.

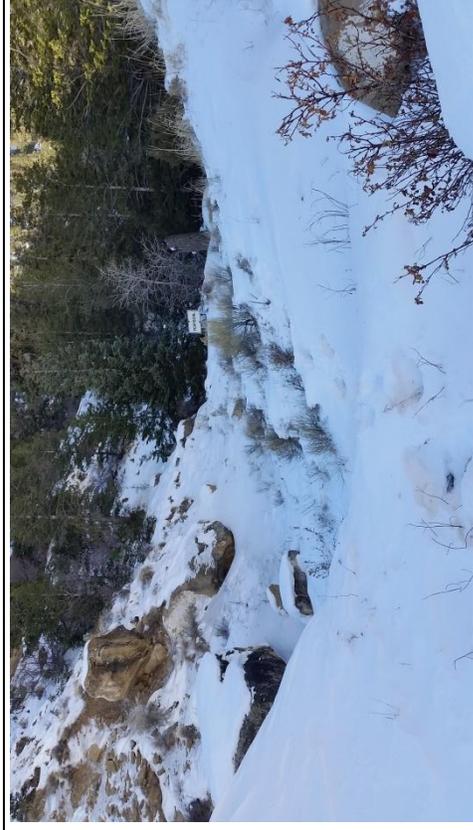
PHOTO 8 – TOPSOIL STOCKPILE, MAIN SITE

Not much of the topsoil stockpile is visible through the 6 – 7 inches of freshly fallen snow.

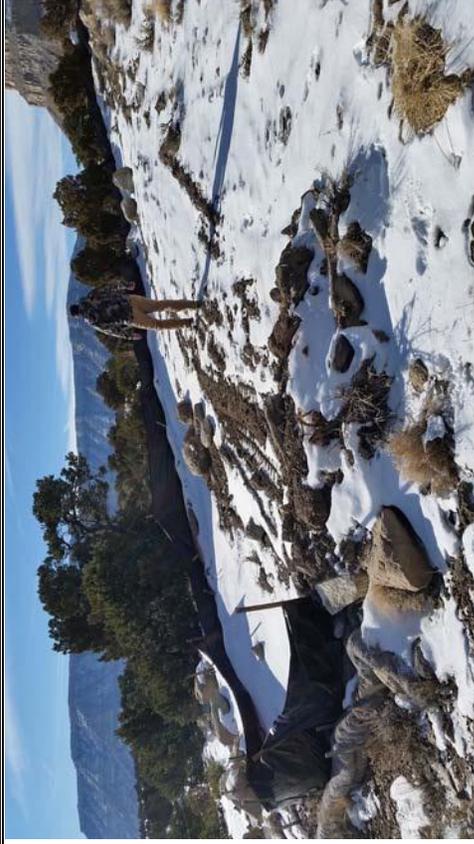
All topsoil piles at the main site as well as the waste rock site appeared to be in stable condition. The silt fences on the south side of Topsoil pile #1 at the waste rock site had undergone some maintenance work recently to repair sections that were slumping or torn. The topsoil pile at the main site was covered with about 6-8 inches of fresh snow.

PHOTO 9 – SILT FENCE, WASTE ROCK SITE
The newly installed silt fence at the base of Topsoil pile #1. The old silt fence was tattered and sagging in places.

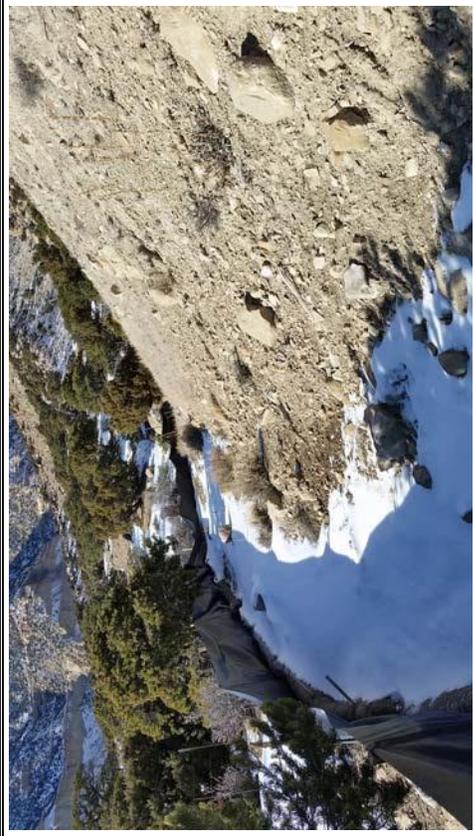
PHOTO 10 – SILT FENCE, WASTE ROCK SITE
Newly installed silt fence at the base of Topsoil pile #1.

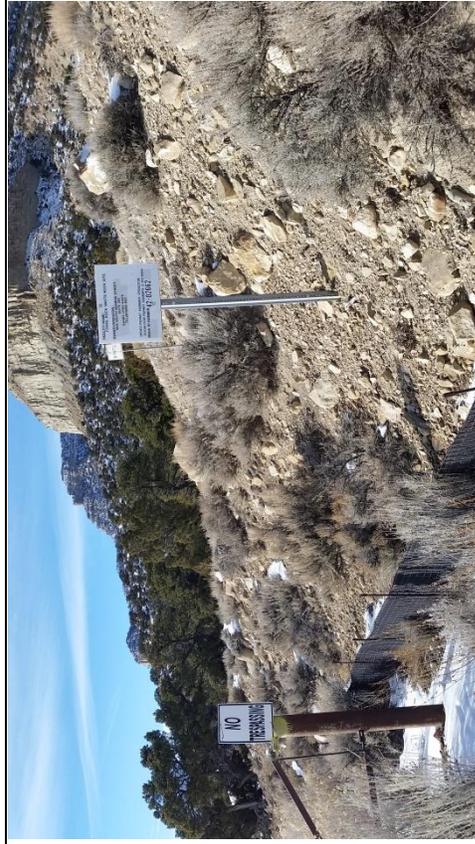
PHOTO 11 – PERMIT SIGN, WASTE ROCK SITE
Topsoil pile #3 just behind this sign.

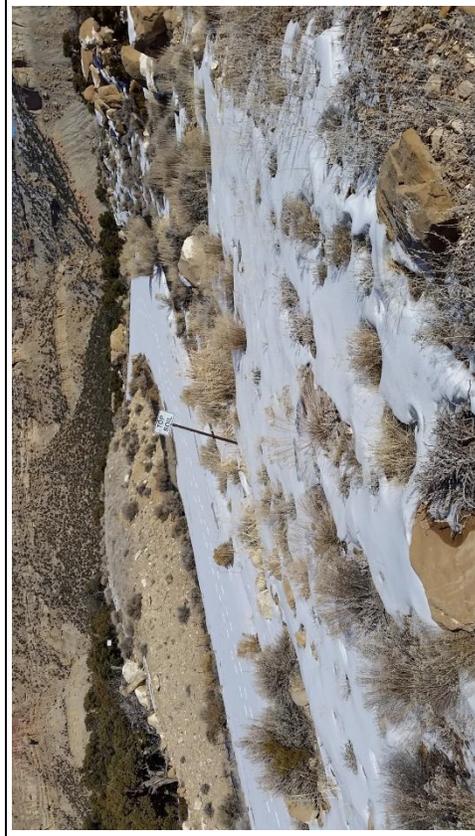
PHOTO 12 – TOPSOIL PILE #2, WASTE ROCK SITE
Topsoil pile #2 is bisected by the access road.

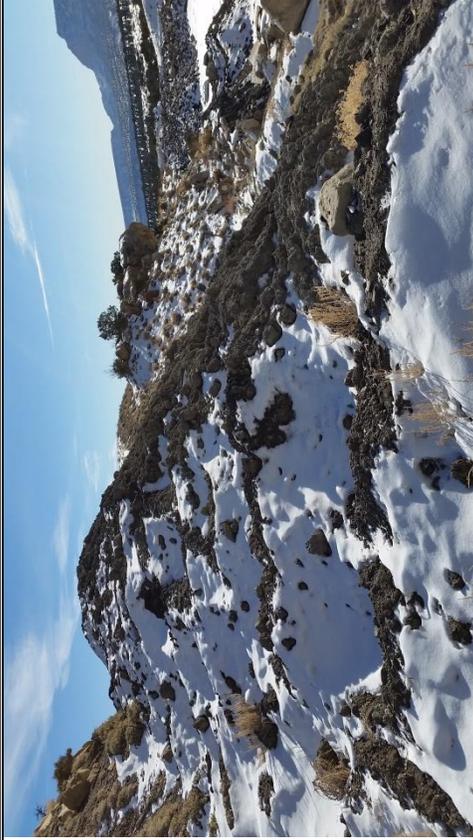
Recently a small swath of the subsoil stockpile was pocked to discourage runoff and promote vegetative cover.

PHOTO 13 – SUBSOIL STOCKPILE, WASTE ROCK SITE
This is the newly pocketed section on the north end.

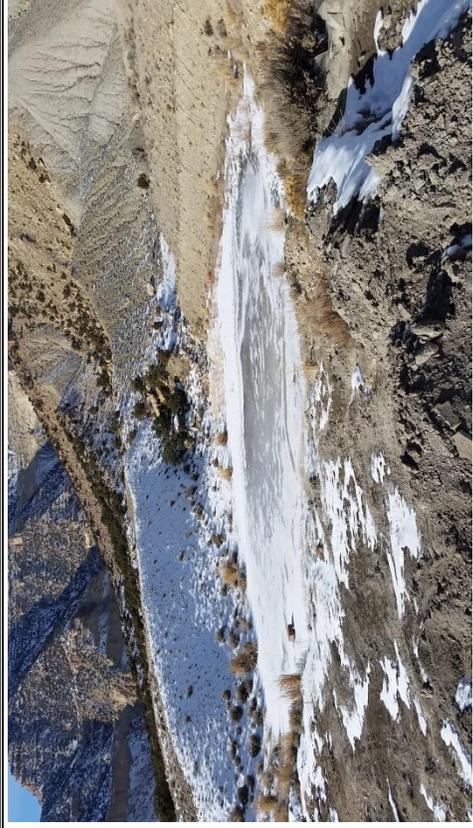
PHOTO 14 – SEDIMENT POND, WASTE ROCK SITE
Approximately 1/3 capacity and frozen over.

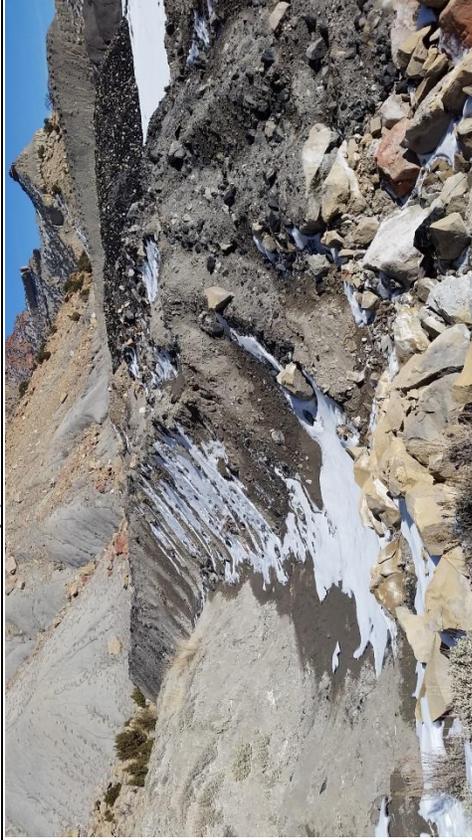
PHOTO 15 – DIVERSION DITCH, WASTE ROCK SITE
This runs along the north side of the disturbed area.

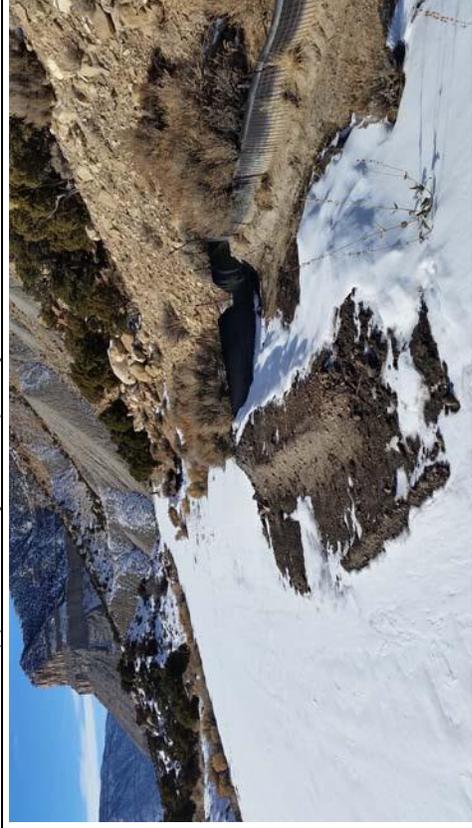
PHOTO 16 – DIVERSION DITCH, WASTE ROCK SITE
This diversion runs parallel to the access road, and check dams like this are installed at periodic intervals.
