Inspection Report

Permit Number:	C0150009
Inspection Type:	COMPLETE
Inspection Date:	Wednesday, March 27, 2019
Start Date/Time:	3/27/2019 10:30:00 AM
End Date/Time:	3/27/2019 2:00:00 PM
Last Inspection:	Thursday, December 13, 2018

Permitee: **FOSSIL ROCK RESOURCES, LLC**
 Operator: **FOSSIL ROCK RESOURCES, LLC**
 Site: **FOSSIL ROCK MINE**
 Address: ,
 County: **EMERY**
 Permit Type: **PERMANENT COAL PROGRAM**
 Permit Status: **INACTIVE**

ATTACHMENT A – March 27, 2019 Complete inspection

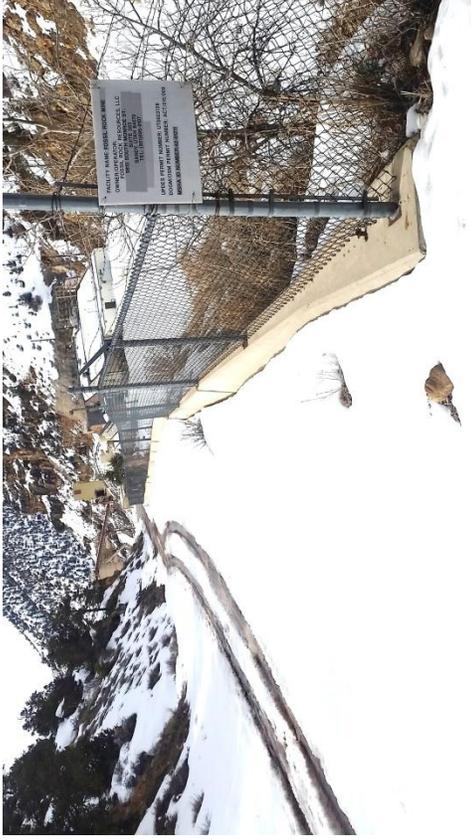
Signs designating topsoil, subsoil, and disturbance limits are in place and in good condition. A sign indicating the name, permit number, and other contact information is posted in plain view at the main mine site as well as the waste rock site.

PHOTO 1 – POSTED PERMIT, MAIN SITE
Posted on the fence along the North end of the Permit area. Snow plows didn't quite reach this far.

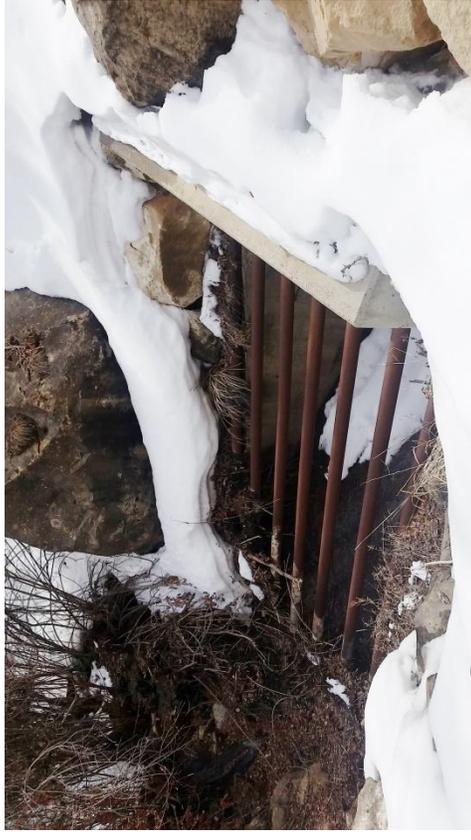
Diversions at the waste rock site appeared to be in stable condition, although some of the wider diversions on the west side were beginning to fill with silt. The diversions at the main site were covered in snow but the intake culverts were all clear of debris.

PHOTO 2 – INTAKE CULVERT, MAIN SITE
Looking due east. Culvert intake appears clear.

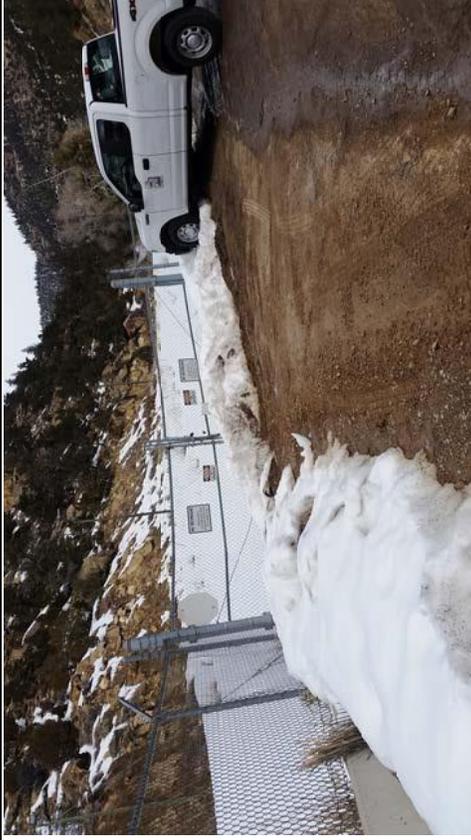
The Division met with Bryant Bunnell on Wednesday, March 27 for this complete inspection of the Fossil Rock Mine. The main site was almost entirely covered by up to 2 feet of snow, while the waste rock site was almost completely dry. The main site could not be accessed by vehicles because snow drifts had been pushed in front of the main gates.

PHOTO 3 – MAIN GATE, MAIN SITE
Snow plows piled up snow drifts in front of the entrance gate.

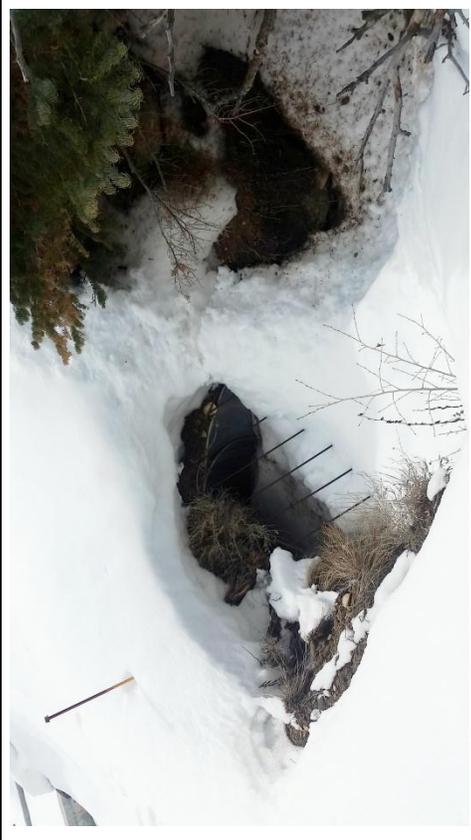
PHOTO 4 – DIVERSION, MAIN SITE
The inlet of the 48" CMP culvert that diverts runoff underneath the topsoil stockpile west of the buildings.

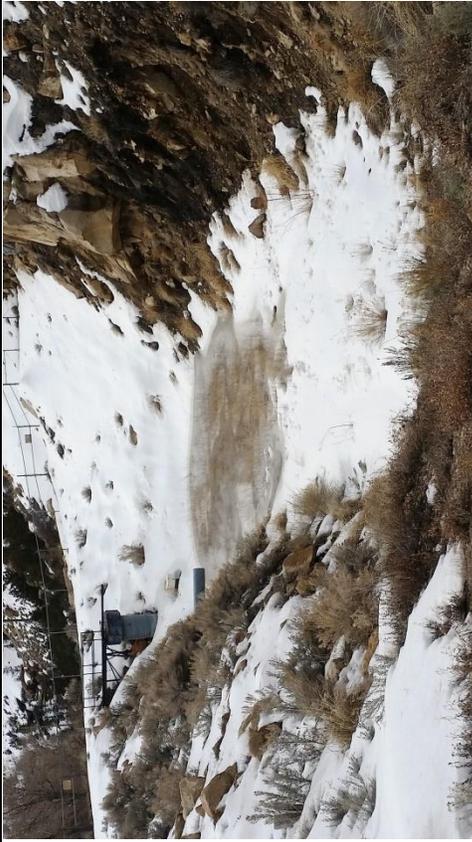
The sediment pond at the main site is covered with a thick layer of snow, but the sediment pond at the waste rock site appears to be 1/3 full and ice free.

PHOTO 5 – SEDIMENT POND, MAIN SITE
Snowy and icy conditions persist.

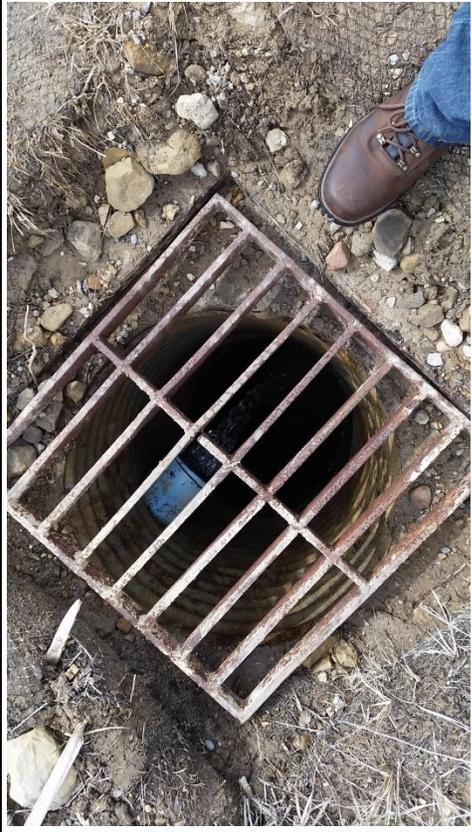
PHOTO 6 – COTTONWOOD MINE DRAINAGE
This 66" drop culvert captures the Cottonwood Mine water drainage in route to Cottonwood Creek.

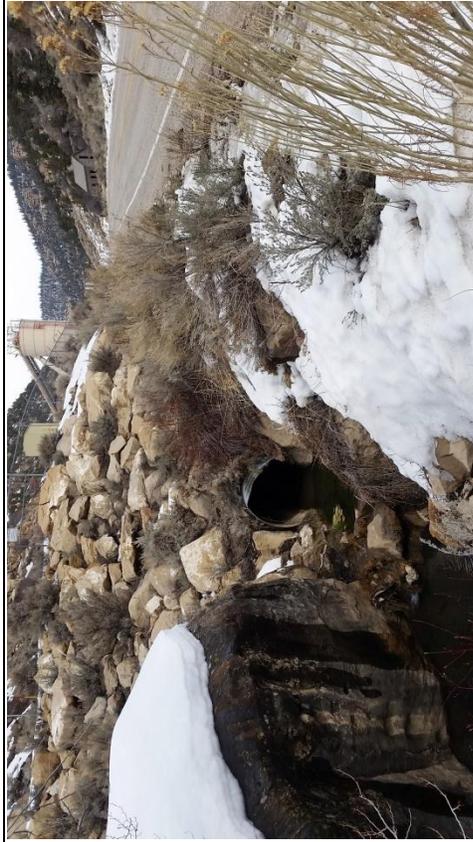
PHOTO 7 – 66" CULVERT OUTLET, MAIN SITE
The water flowing from the culvert is Cottonwood mine water discharge. The flow dries up a mile down canyon from this point.

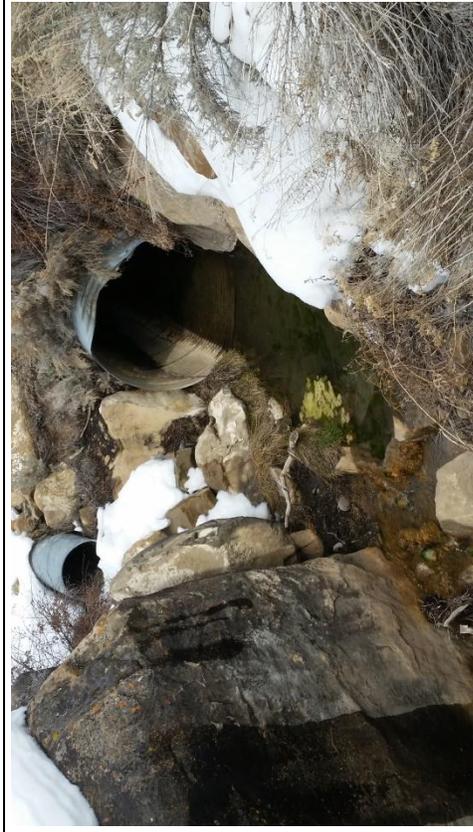
PHOTO 8 – 66" CULVERT OUTLET, MAIN SITE
Close up photo shows algae is thriving in the water despite the cold temperatures.

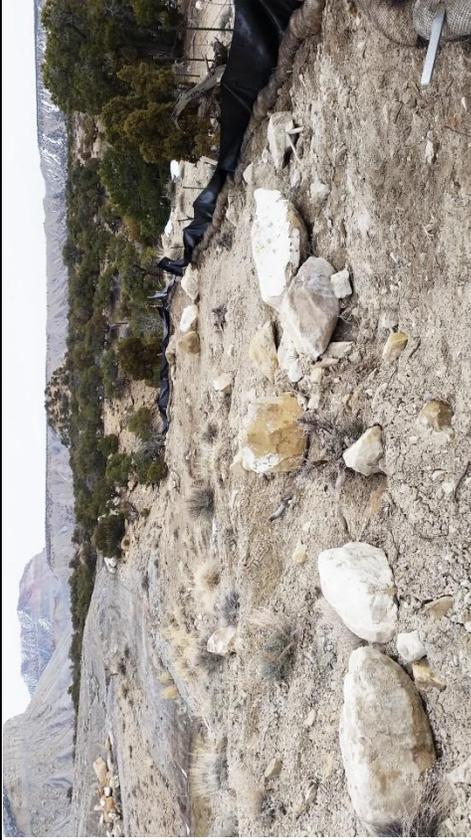
PHOTO 9 – SILT FENCE, WASTE ROCK SITE

Recently installed silt fences on the south of Topsoil Pile #1 at the waste rock site appear to be in good condition.

Looking North - The newly installed silt fence at the base of Topsoil pile #1. The sediment pond is on the left.

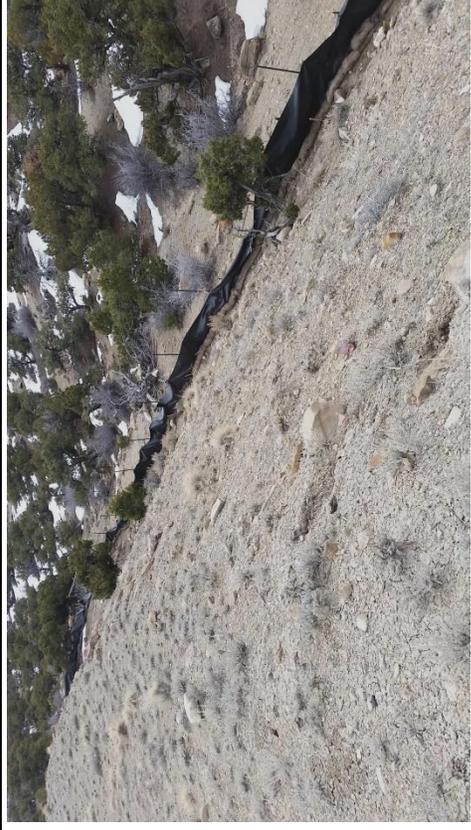
PHOTO 10 – SILT FENCE, WASTE ROCK SITE

Newly installed silt fence at the base of Topsoil pile #1.

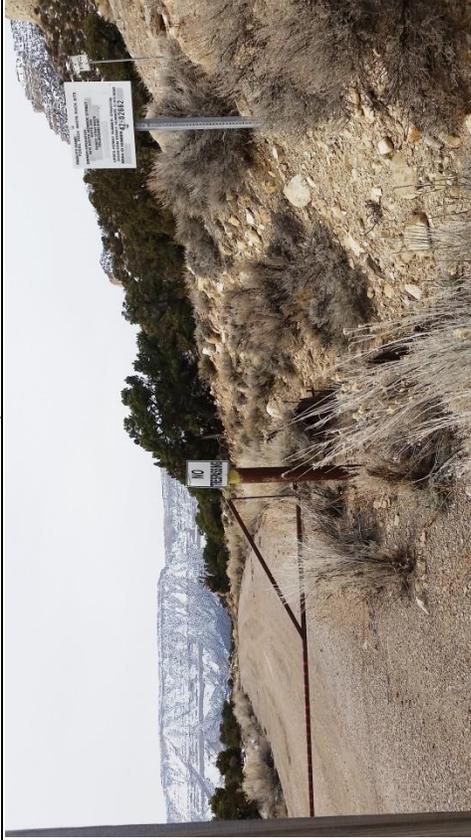
PHOTO 11 – PERMIT SIGN, WASTE ROCK SITE

Topsoil pile #3 just behind this sign.

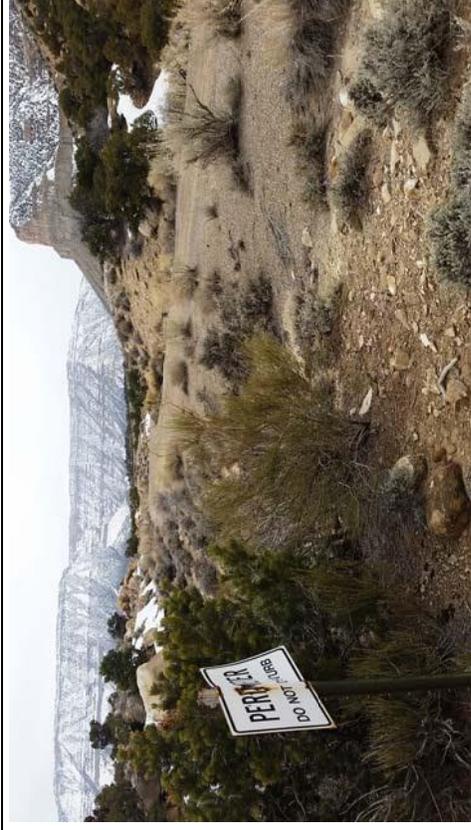
PHOTO 12 – PERIMETER SIGN, WASTE ROCK SITE

Installed parallel to the primary road, looking South.

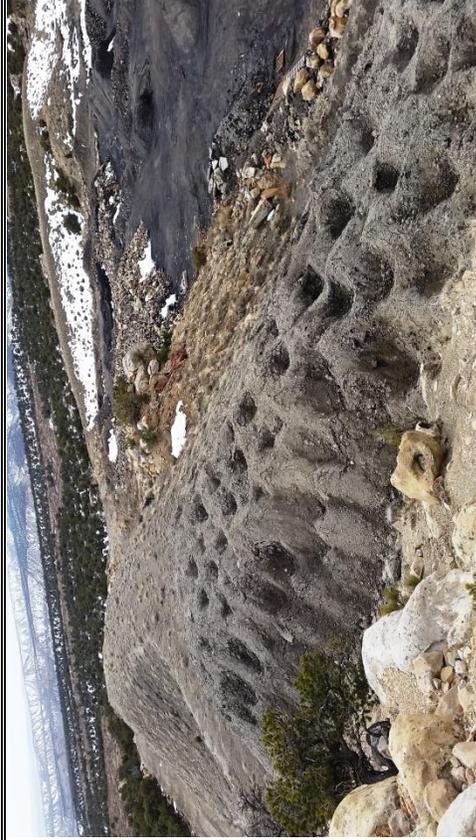
PHOTO 13 – SUBSOIL STOCKPILE, WASTE ROCK SITE
This is the newly pocked section on the north end.

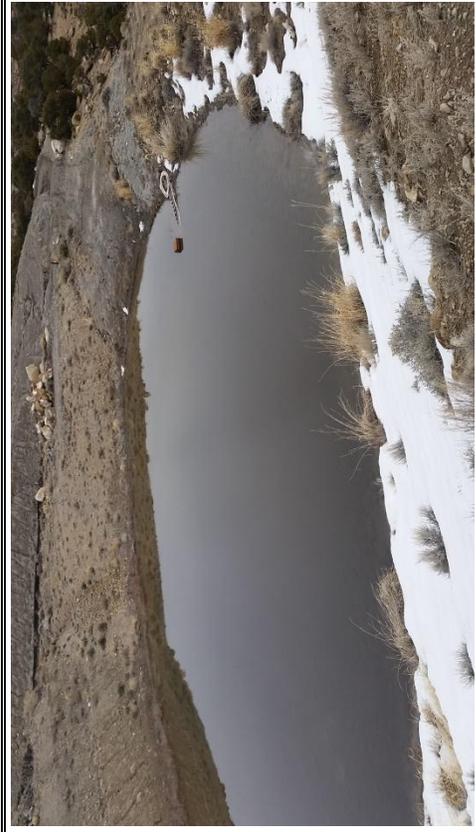
PHOTO 14 – SEDIMENT POND, WASTE ROCK SITE
Approximately 1/3 capacity, no ice.

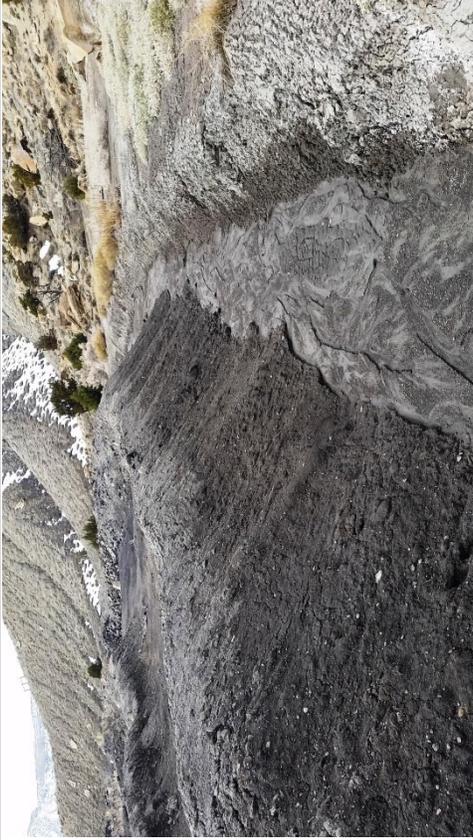
PHOTO 15 – DIVERSION DITCH, WASTE ROCK SITE
This runs along the north side of the disturbed area. This particular ditch collects a lot of silt.

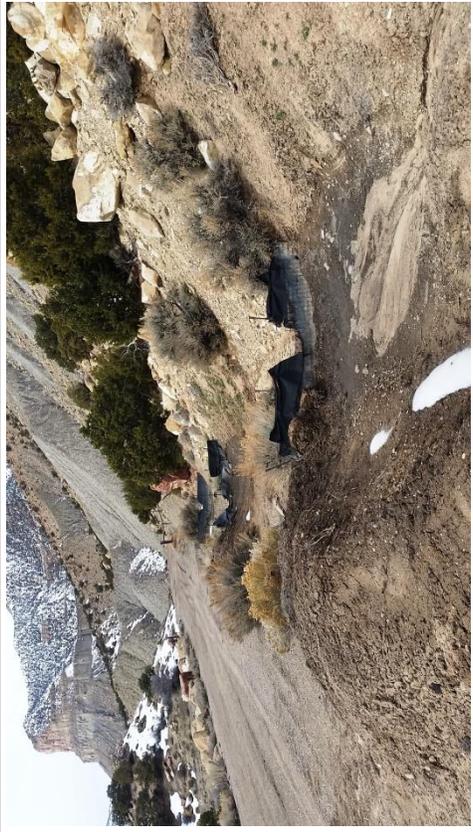
PHOTO 16 – DIVERSION DITCH, WASTE ROCK SITE
This diversion runs parallel to the primary road, and check dams like this are installed at periodic intervals.
