# Inspection Report

Permit Number:	<b>C0150009</b>
Inspection Type:	COMPLETE
Inspection Date:	Wednesday, March 4, 2020
Start Date/Time:	3/4/2020 12:30:00 PM
End Date/Time:	3/4/2020 3:00:00 PM
Last Inspection:	Wednesday, December 11, 2019

Permitee: **FOSSIL ROCK RESOURCES, LLC**

Site: **FOSSIL ROCK MINE**

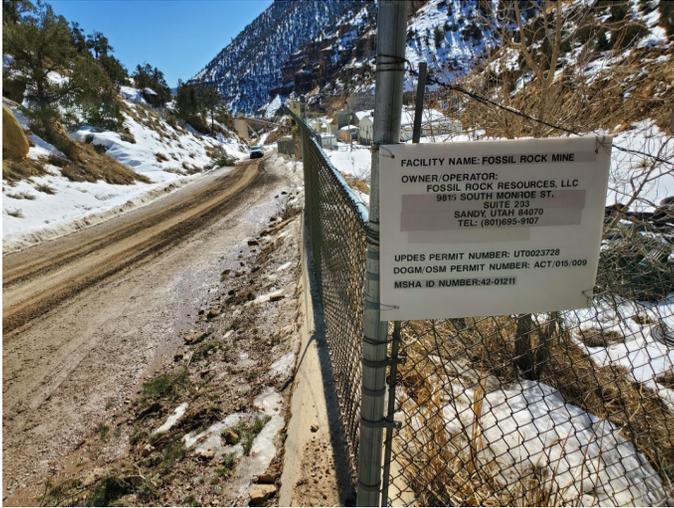
**PHOTO 1 – POSTED PERMIT, MAIN SITE**  
Posted along the County road on the north of the Permit area.

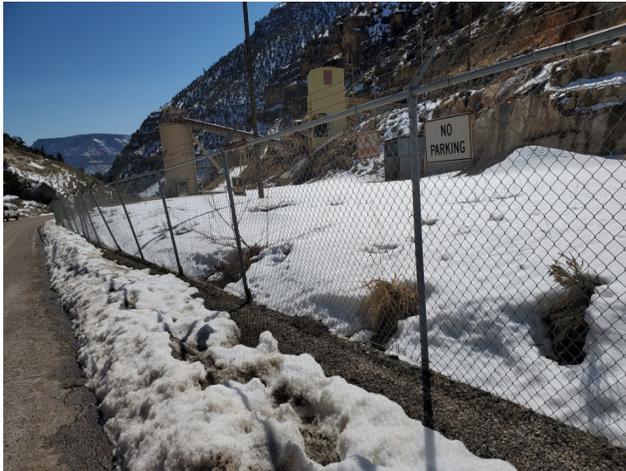
**PHOTO 3 – CHAIN LINK FENCE, MAIN MINE SITE**  
The snowy conditions persist, especially in the shady sections.

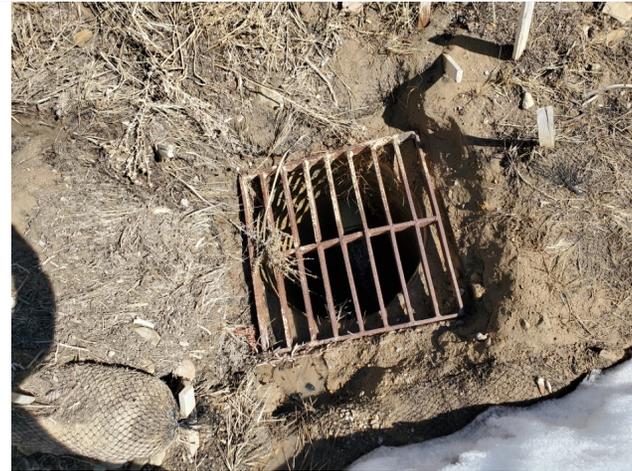
**PHOTO 4 – COTTONWOOD MINE DRAINAGE**  
This 24” drop culvert captures the Cottonwood Mine water drainage in route to Cottonwood Creek.

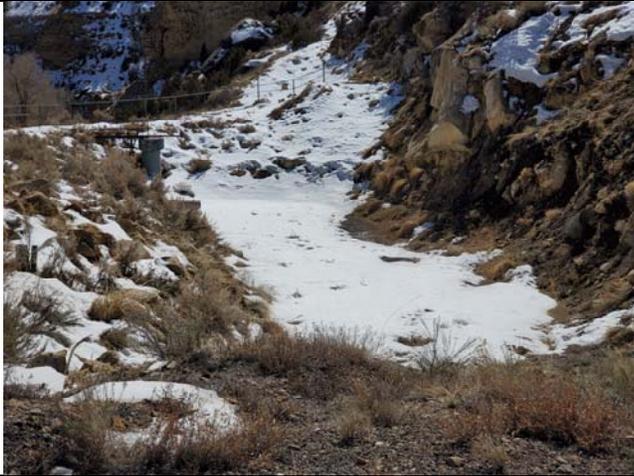
The main site sediment pond was still covered in snow. The waste rock site sediment pond was about 25% full of ice water. The sediment from the waste rock site sediment pond was cleaned out last Fall and the sediment placed beside the waste rock piles west of the pond.

**PHOTO 5 – SEDIMENT POND, MAIN SITE**  
Winter snows haven't quite melted yet. No standing water.

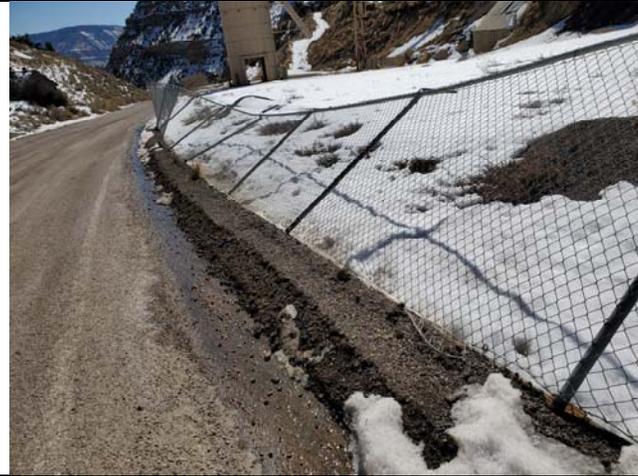
Signs designating topsoil, subsoil, and disturbance limits are in place and in good condition. A sign indicating the name, permit number, and other contact information is posted in plain view at the main mine site as well as the waste rock site. A small, 50-foot section of chain link fence surrounding the main site had fallen over recently. It appears that the metal fence posts had rusted off at the base and then succumbed to the wind. Permittee has plans to repair and rehab this section soon.

**PHOTO 6 – PERIMETER FENCE, MAIN SITE**  
This section of chain link fence had fallen over due to several fence posts rusting off at the base.

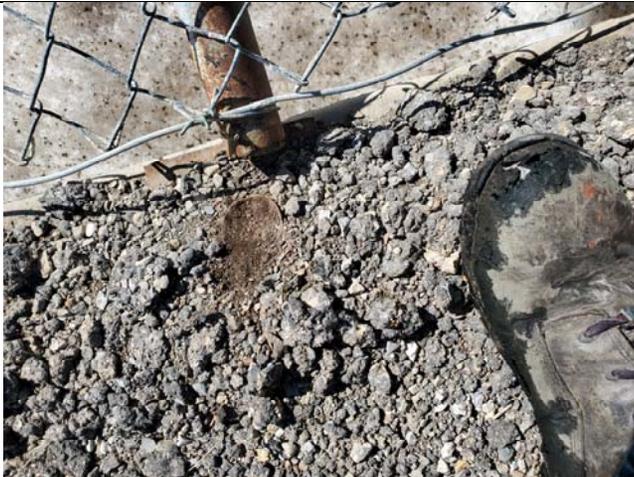
**PHOTO 7 – PERIMETER FENCE, MAIN SITE**  
Note the post has completely rusted/snapped off at the base.

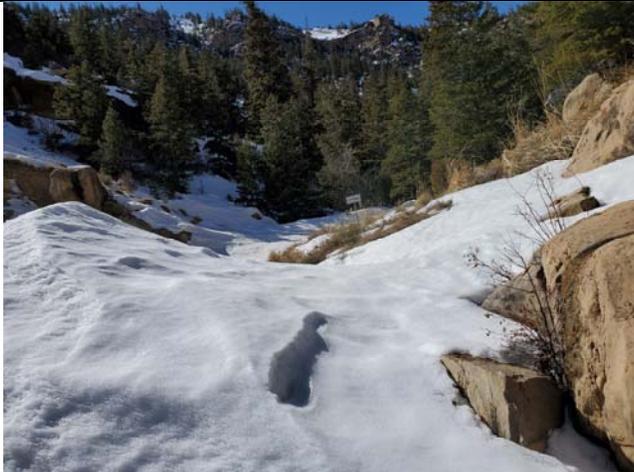
**PHOTO 9 – TOPSOIL STOCKPILE, MAIN SITE**  
The snow is about 2 feet deep here.

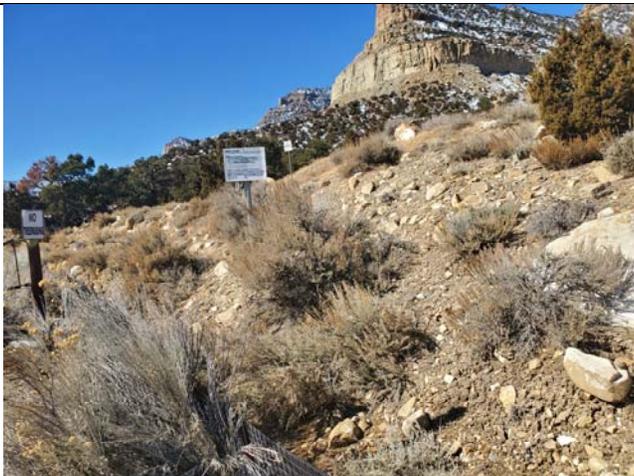
**PHOTO 11 – PERMIT SIGN, WASTE ROCK SITE**  
Topsoil pile #3 just behind this sign.

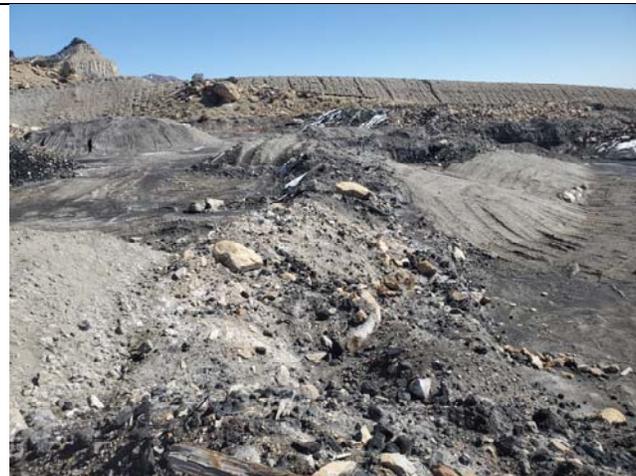
**PHOTO 12 – WASTE ROCK PILES, WASTE ROCK SITE**  
The blonde piles are sediments that were dug out of the sediment pond during last year's cleanout.

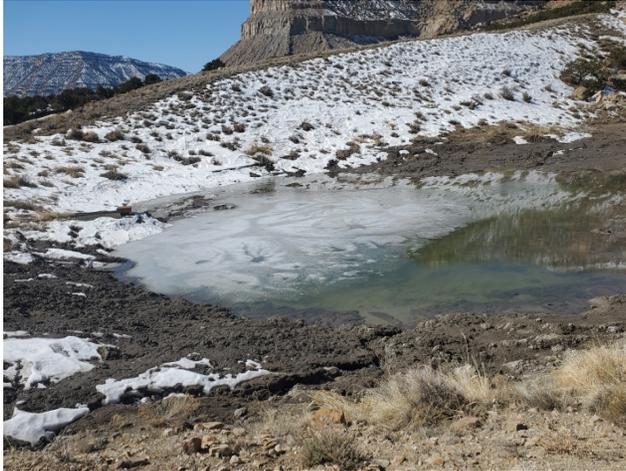
**PHOTO 5 – SEDIMENT POND, WASTE ROCK SITE**  
Looking south, decant structure left of center.

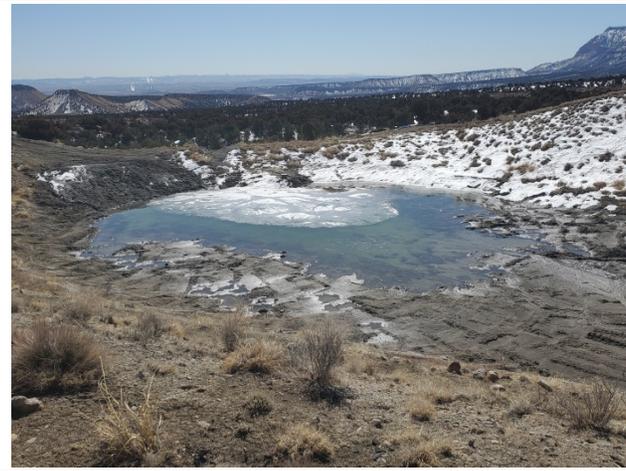
**PHOTO 6 – SEDIMENT POND, WASTE ROCK SITE**  
Looking southeast. Pond is about 25% full.

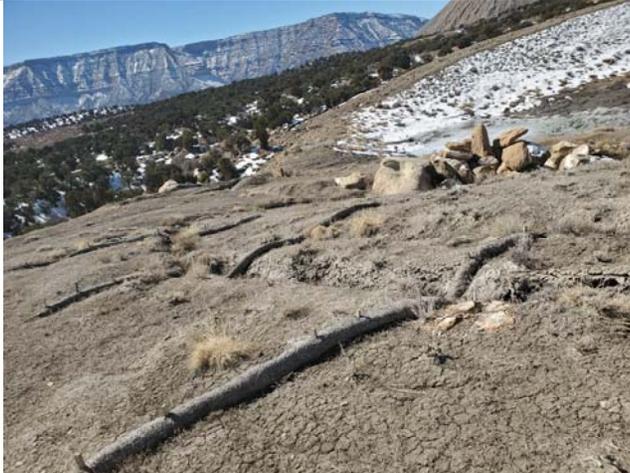
**PHOTO 7 – SUBSOIL STOCKPILE, WASTE ROCK SITE**  
Looking southeast from the top of the subsoil stockpile.

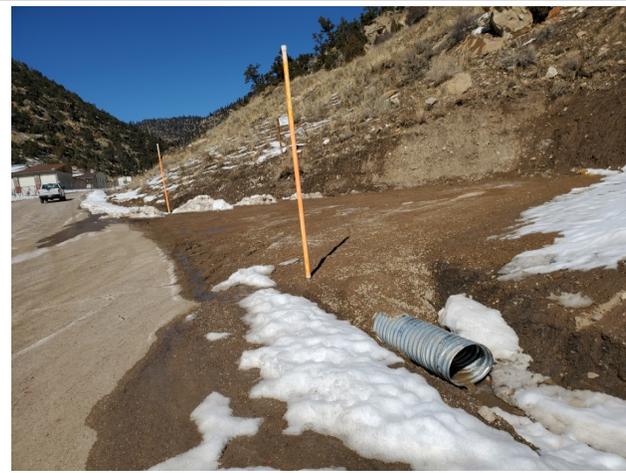
**PHOTO 8 – SNOWPLOW TURNAROUND, MAIN MINE SITE**  
These two fluorescent orange poles along the county road mark where county owned space has been reserved for snow plows.
