Consolidation Coal Company  
Emery Mine  
P. O. Box 527  
Emery, Utah 84522  
(801) 286-2301

Re: Emery Deep Mine  
ACT /015/015  
Emery County Utah

DOGM Monthly Inspection - July 1983

CONSOLIDATION COAL COMPANY  
Emery Mine /  
Temporary Stockpile Area  
1" = 100'  
(approximate)

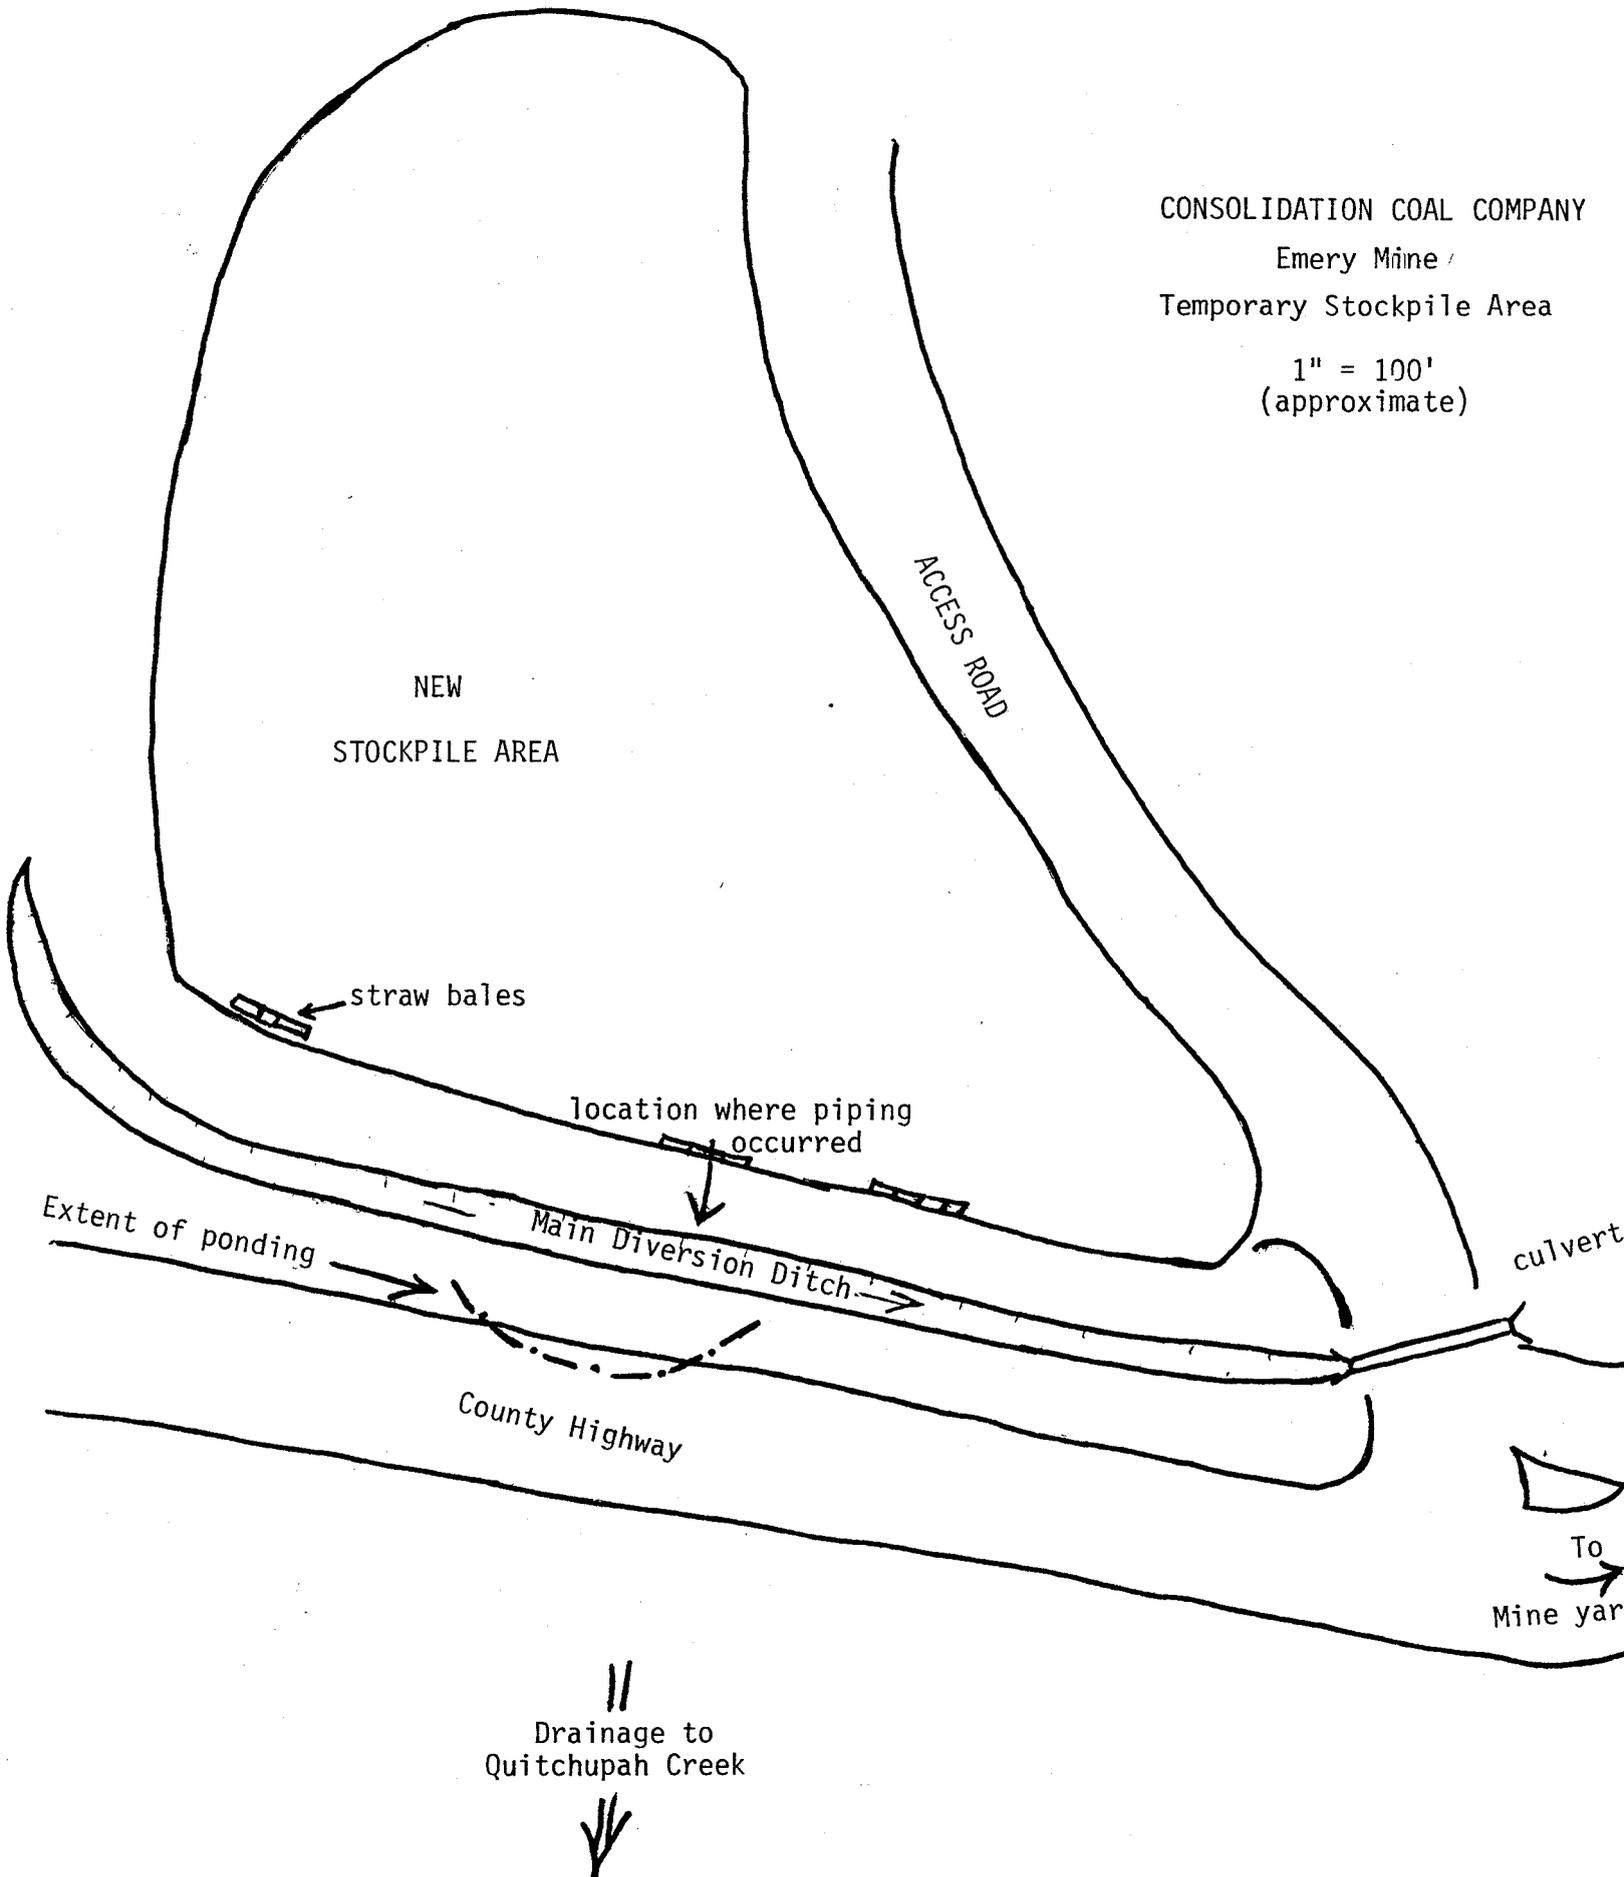
The second precipitation event interrupted the inspection of the stockpile area with rain of sufficient intensity as to limit visibility and restrict travel. The drainage diversion around the stockpile area was inspected immediately after this event. Erosion had occurred along the fill slopes partially undercutting some of the strawbales that had been emplaced the preceding day.

This fill material had washed into and partially blocked the diversion ditch. Piping occurred permitting some of the runoff from the stockpile area to flow outside of the control area. The amount of flow escaping appeared to be minimal and was completely contained by the highway. No runoff from this event had flowed across the highway and into the Quitcupah drainage.

Due to the wet conditions equipment could not access the area where piping had occurred and repair work had to be completed by hand-shoveling. Sediment was removed from the diversion ditch and additional bales were placed on the fill slope to check further erosion. All repairs were completed by 10:00 AM of the following morning (July 21, 1983).

After the fill area had sufficiently dried and equipment access was possible, a secondary diversion ditch was constructed to prevent further erosion on the downslope fill area and reduce flow along the main diversion ditch.
