Document Information Form

Mine Number: C/015/015

Inspector's Statement

RE: ACT/015/015
CONSOL-Emery Mine

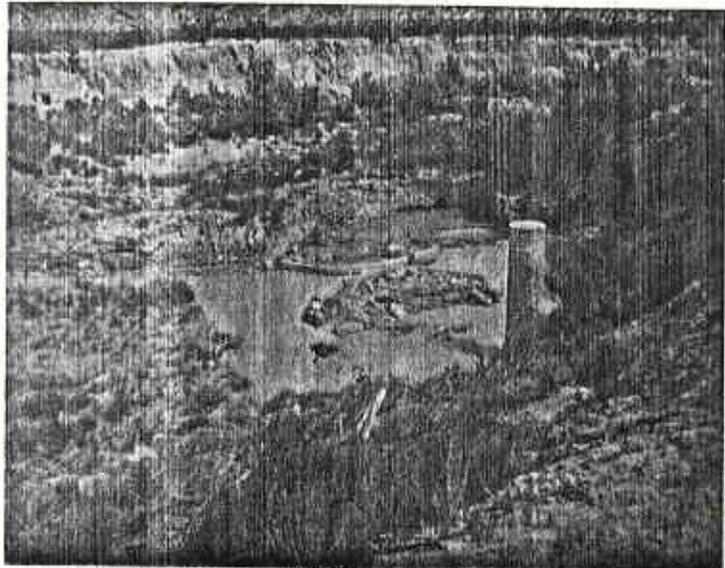
NOV 83-4-11-2, 2062

THE EVENT HAS OCCURRED SEVERE EROSION HAS OCCURRED ERODING THE STREAM BANKS AND CHANGING THE STREAM CHANNEL SO THAT IT CAN BYPASS THE TWO FOOT PERMANENT FLUME.

SEVERAL HUNDRED CUBIC YARDS OF MATERIAL HAVE BEEN ERODED AWAY CONTRIBUTING ADDITIONAL SUSPENDED SOLIDS TO QUITEQUIAN CK. DAMAGE DOES EXTEND OFF THE PERMIT AREA.

EMERY DEED MINE 6/29/83 FLOWING SITE BELOW

CONFLUENCE OF CHRISTIANSEN WASH & BUTCHMAN CREEK

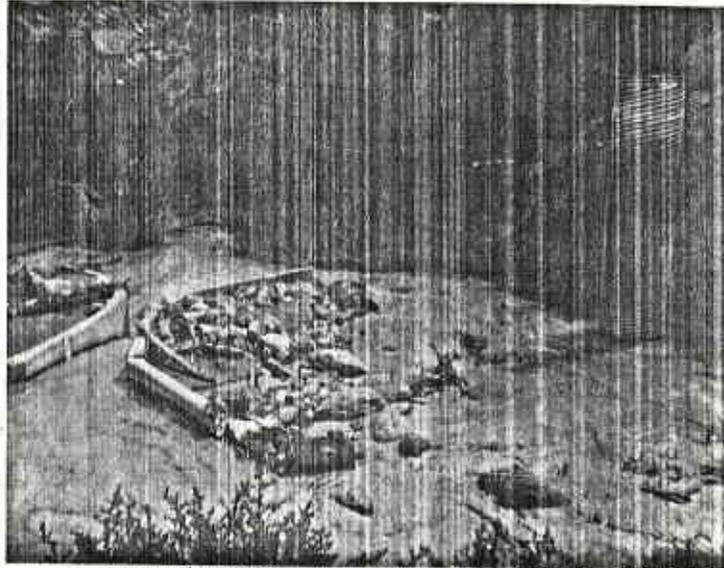
NOV 83-4-11-2, 2062

EMERY DEED MINE 6/29/83 FLOWING SITE BELOW

CHRISTIANSEN WASH - BUTCHMAN CR. CONFLUENCE. LARGE STANDING ROCK, SCULPTING BANK STATED ABOUT APPROXIMATELY 10 FEET DEEP
