**PRE-SUBSIDENCE SURVEY
PRIOR TO FULL EXTRACTION AT THE
ZERO NORTH, 4th EAST MAINS, AND 6th WEST PANELS**

CONSOLIDATION COAL COMPANY
Emery Mine
Emery County, Utah

October 2007

EARTHFAX ENGINEERING, INC.
Engineers/Scientists
Midvale, Utah
www.earthfax.com

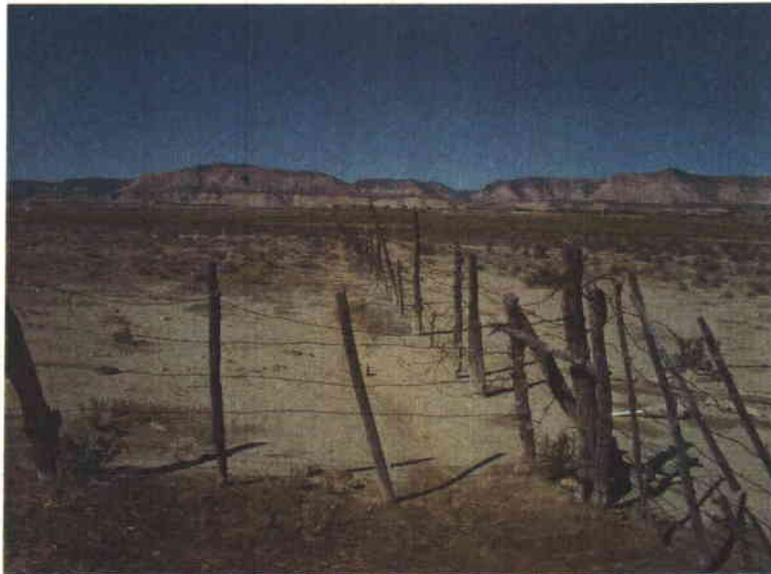
Corners of Sections 22, 23, 26, and 27. Looking west at the ground surface above the Zero North Panel. USGS bench marker is visible where fences intersect. Note that the fence is constructed of unfinished timbers and is in fair condition.

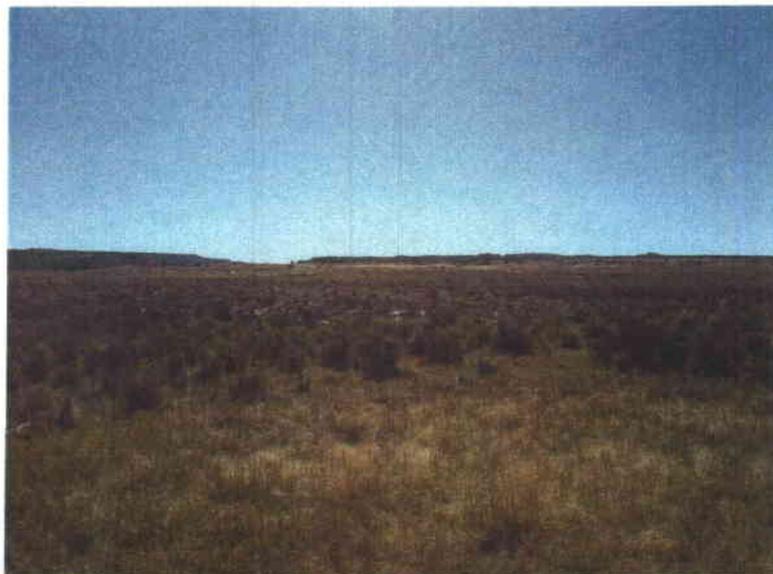
View looking south near the center of the Zero North Panel. The ground surface is relatively flat, and is not currently used for crop production.

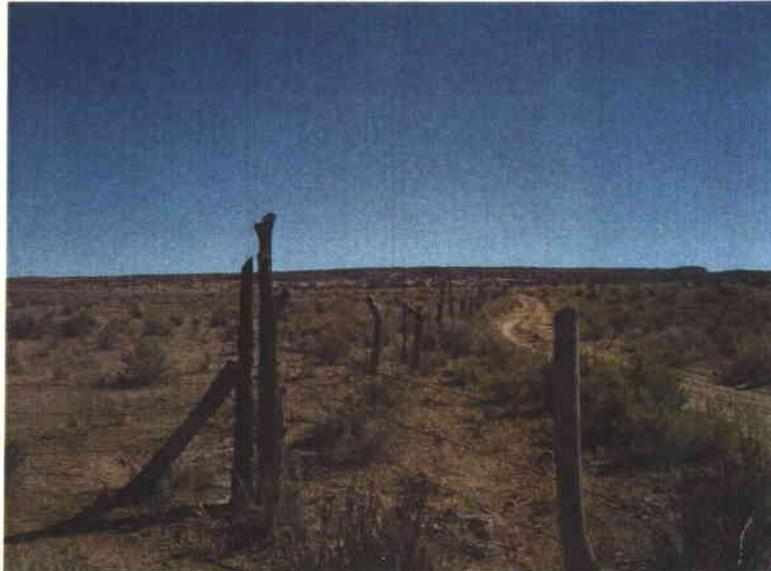
Feature 85. Dirt Road and Fences. This feature is essentially unchanged from how it is described in the Valley Engineering (1980) report, which states the following: “The road is a two-track, single lane, dirt road. The road surface consists of the natural sand and clay that is in the area, and has been compacted by vehicles that travel the road. The fences in the area are barbed wire with either natural rough cut wood posts or steel posts.” The fences are in fair to good condition.

Feature 85. Dirt Road and Fences. Looking east. Fence is constructed from rough cut timbers and is in good condition. The road is an unsurfaced two track road and is in good condition.

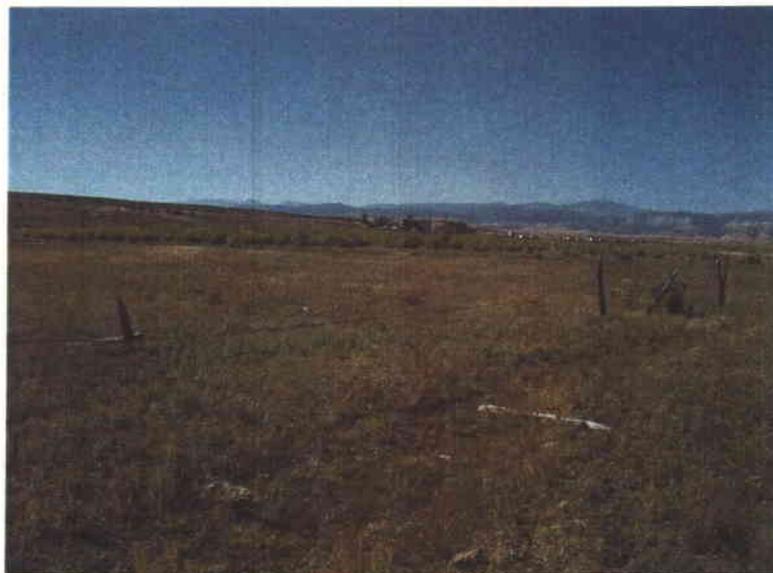
Feature 86. Barbed Wire Fence. This feature has been updated from the Valley Engineering (1980) report. The fence, which is constructed with rough cut timber posts, is in dilapidated condition. Several of the posts are missing, and many of the barbed wire strands are loose and partially buried under the ground surface.

Feature 86. Barbed Wire Fence. Looking west at the fence that extends to the north from the point labeled Feature 86 on Appendix V-5 Figure 1. The fence is missing several of its rough cut timber posts, and is in poor condition.

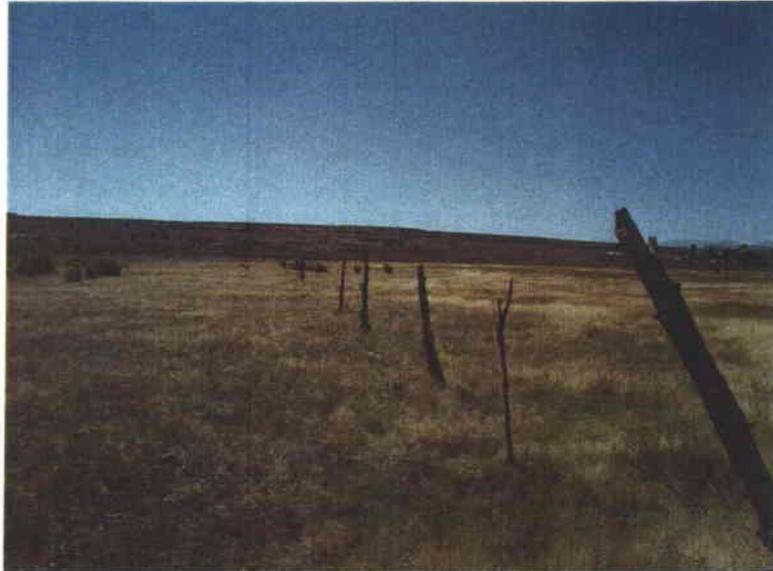
Feature 86. Barbed Wire Fence. Looking south along the fence that extends to the north from the point labeled Feature 86 on Appendix V-5 Figure 1.

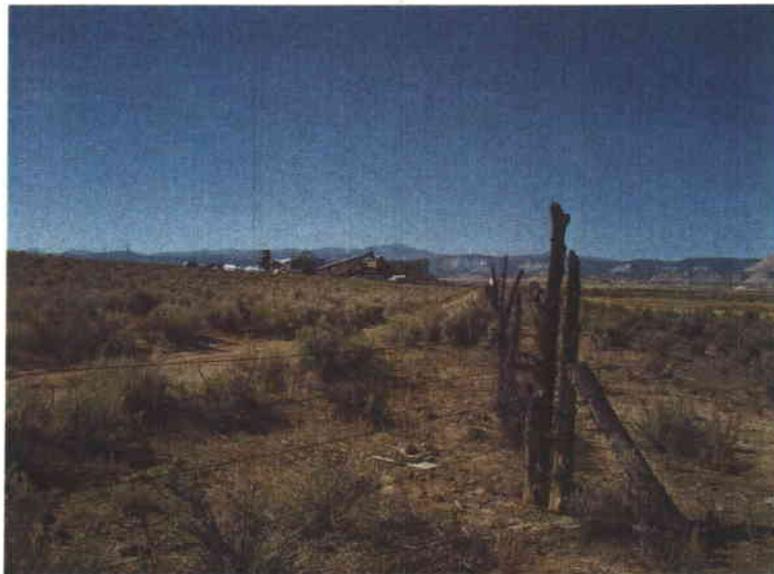
Feature 87. Small Creek and Fence. The description of this feature has been updated from the Valley Engineering (1980) report. The fence is constructed of rough cut timber posts and barbed wire and is in good condition. The “small creek” was incorrectly identified in the 1980 survey. The survey area is relatively flat, dry, and contains no established stream channels. The 1980 survey shows several irrigation ditches overlying the Zero North Panel which drain toward this “stream channel,” which was actually an irrigation outflow ditch. During the 2007 survey, it was evident that many of the irrigation ditches had been allowed to fill in, including the “stream channel” identified in the 1980 survey.

Features 86, 87. Barbed Wire Fence, Small Creek and Fence. Looking southwest. Fence is constructed from rough cut timbers and is in good condition. The small creek identified in the 1980 survey was not present in 2007.

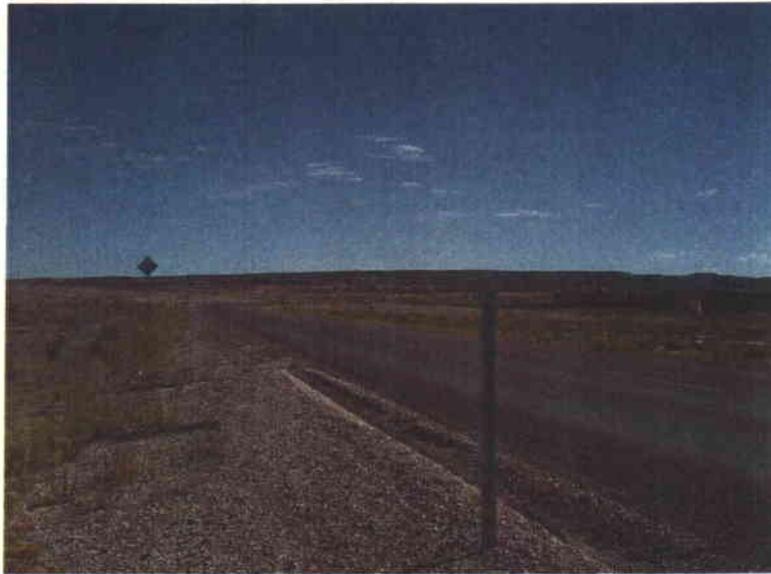
Paved Access Road to 4th East Portal. Looking southeast along road. The 4th East Portal is visible in the distance.

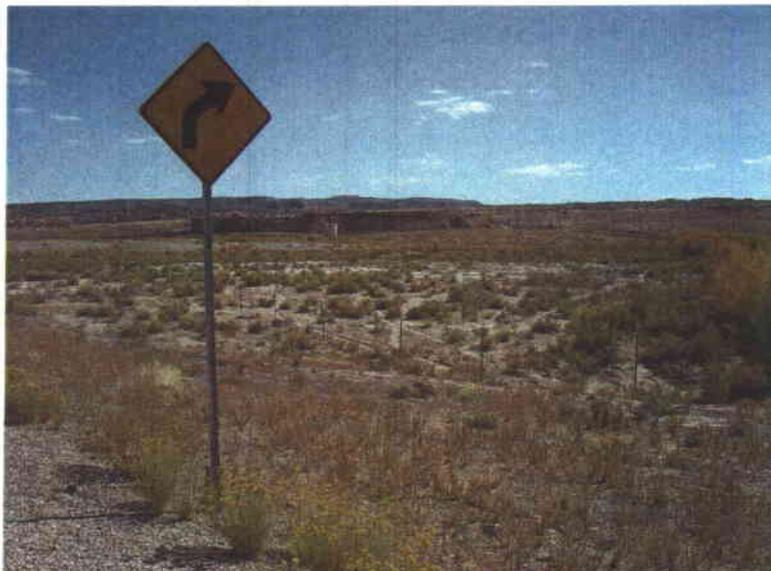
4th East Mains South of Paved Access Road. Looking South. Note Christiansen Wash on far right of photo. The land surface is undeveloped.

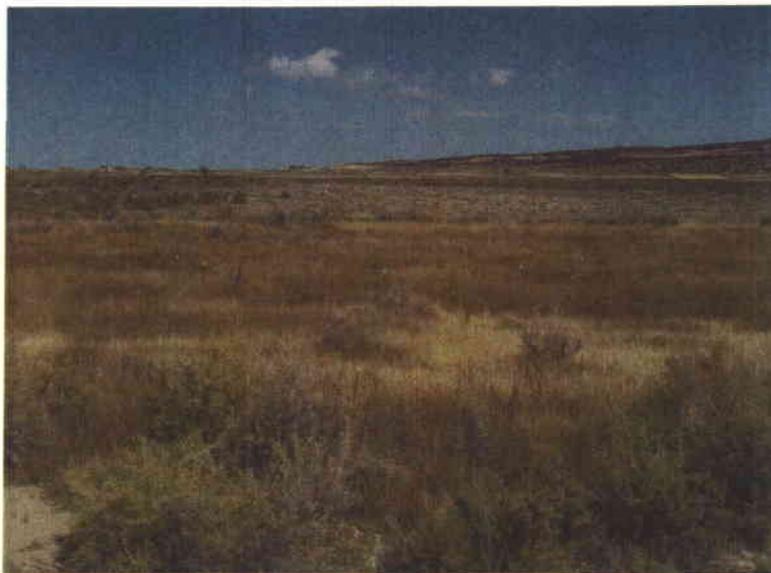
Feature 88. Small Fenced Area. The description of this feature has been updated from the Valley Engineering (1980) report. It has fallen into disrepair since it was surveyed in 1980. The fenced area measures approximately 25 feet by 25 feet. Many of the fence posts are no longer straight, and the barbed wire sags. The area in the vicinity of the fence is overgrown with vegetation.

Feature 88. Small Fenced Area. Looking east.

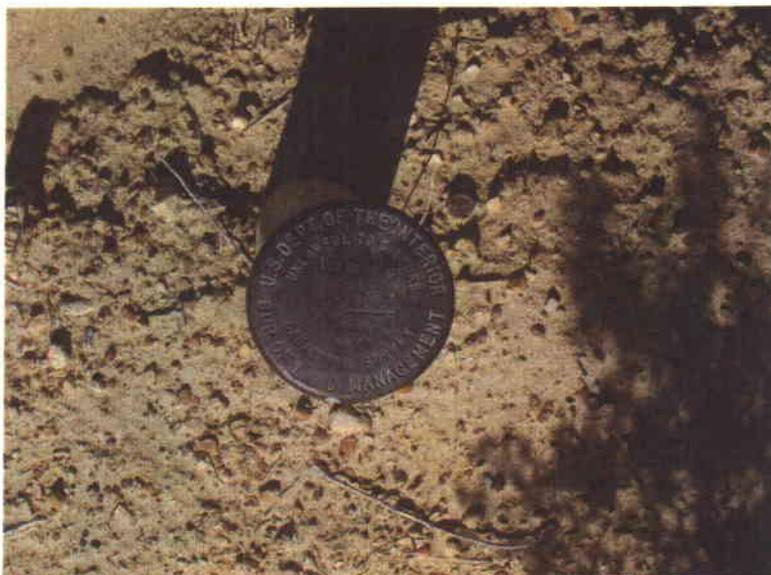
Feature 89. Quarter Section Marker. This feature remains the same as described in the Valley Engineering (1980) report, which states the following: “This quarter section corner marker is in Range 6 East Township 22 South. It divides sections 22 and 27. The marker is a metal cap on a short steel pipe.”

Feature 89. Quarter Section Corner Marker.

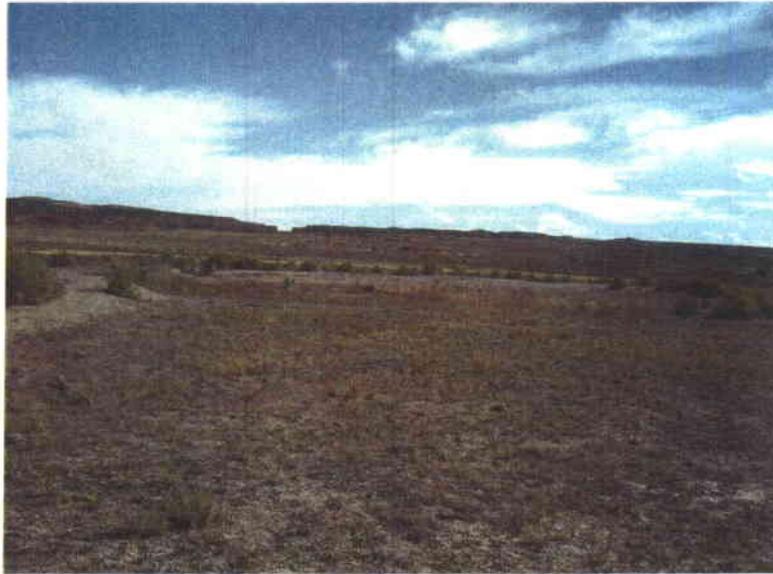
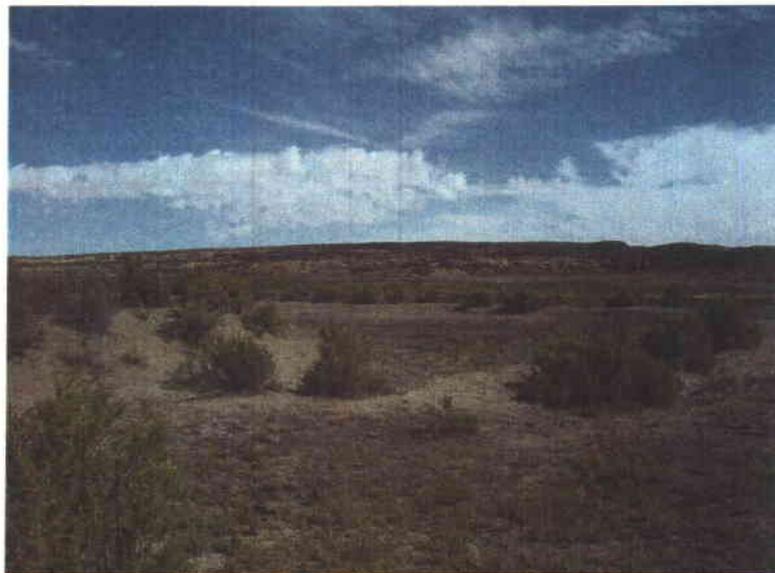
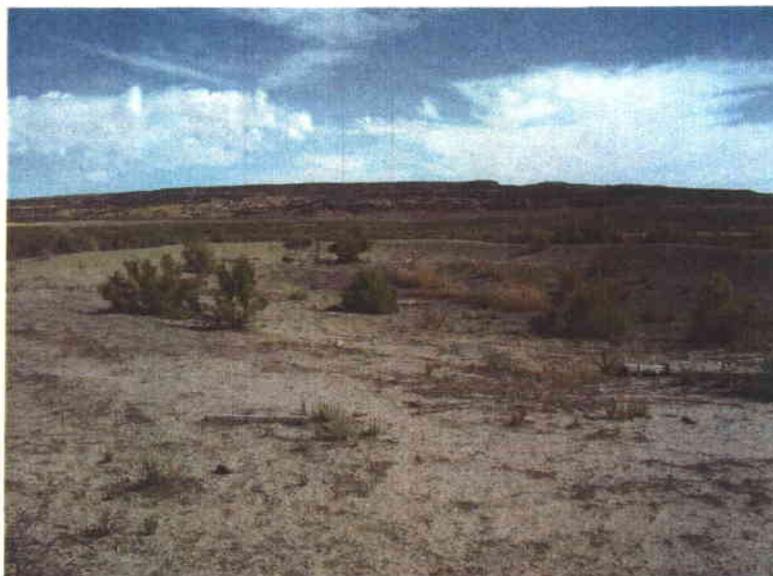
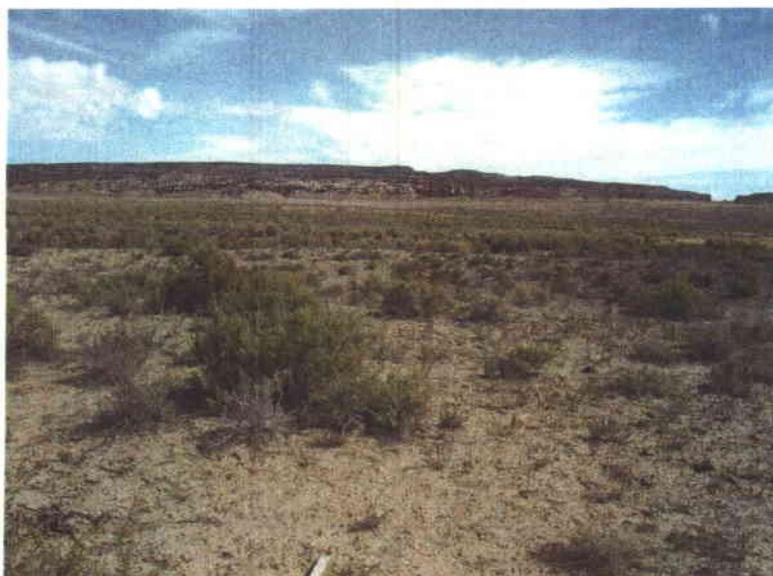
Feature 90. Ponds. The description of this feature has been updated from the Valley Engineering (1980) report. The ponds were empty during the October 2007 survey, but four earth berms were present that appeared capable of impounding water. The berms are approximately 3 feet tall. Three of the berms are clustered together in a north to south alignment, and one berm is located a few hundred feet to the northeast. A dry irrigation ditch located west of the three clustered ponds appears to serve as a water source. A dilapidated wooden corral and small shed is located just north of the three clustered ponds.

Feature 90. Ponds. Looking southeast at southern pond.

Feature 90. Ponds. Looking southeast at central pond.

Feature 90. Ponds. Looking southeast at northern pond.

Feature 90. Ponds. Looking southeast at northeastern pond.

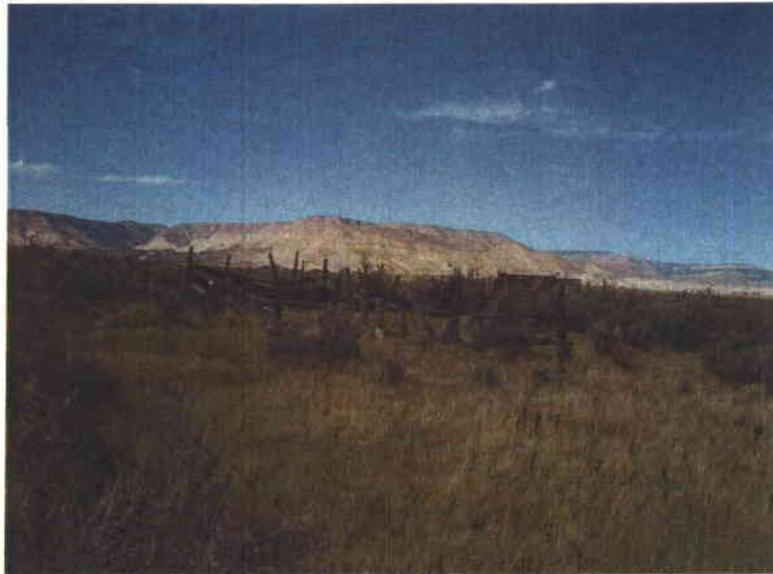
Feature 90. Ponds. Looking north at a nearby dilapidated corral and small Shed.

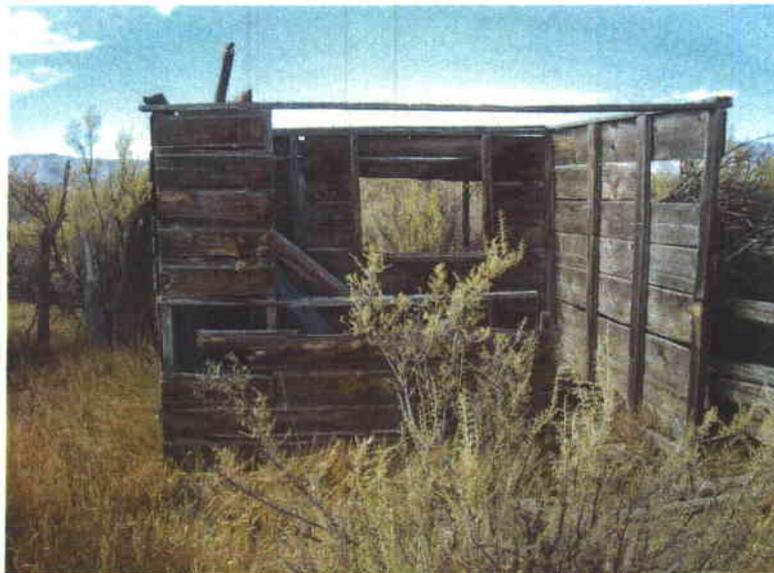
Feature 90. Ponds. Looking west at a nearby small Shed.

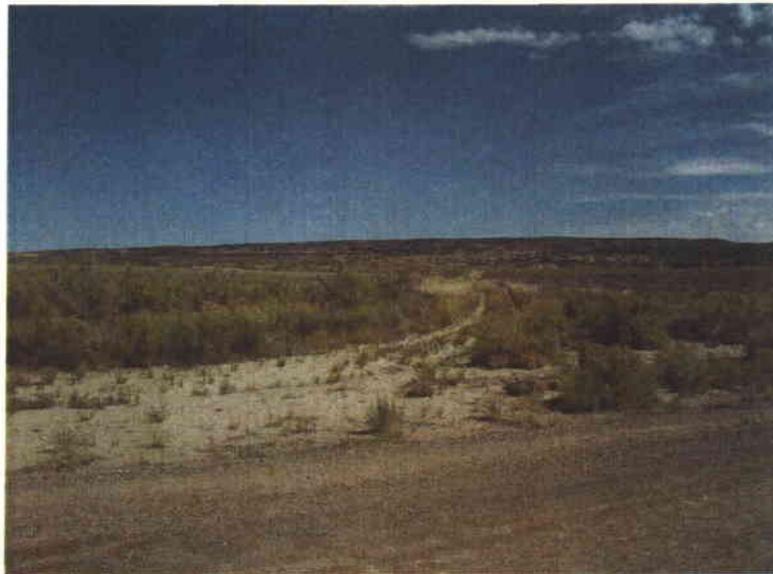
Feature 92. Fence and Dirt Road. The description of this feature has been updated from the Valley Engineering (1980) report. This feature is in fair to poor condition. The road is rutted and overgrown with vegetation, especially where irrigation runoff discharges from the center of the field located to the north. The fence, which is constructed from rough cut timber and barbed wire, is also overgrown by grasses. Many of the fence posts are no longer plumb, and many of the barbed wire strands sag.

Feature 92. Fence and Dirt Road. Looking east. Note that road and fence are overgrown and in fair to poor condition.

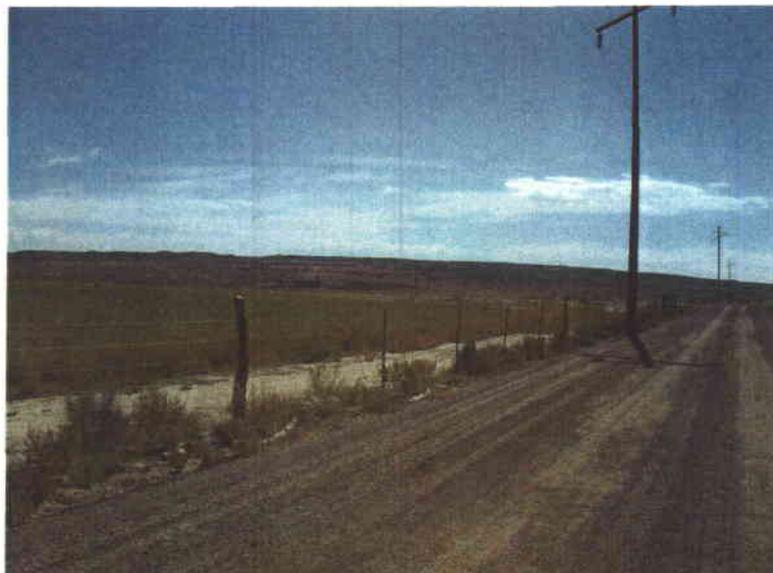
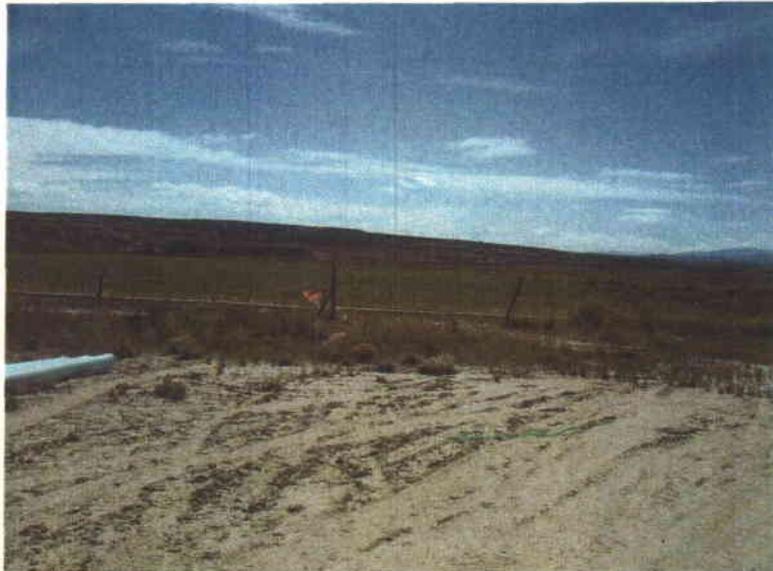
Feature 93. Irrigation Ditches and Farmland. The description of this feature has been updated from the Valley Engineering (1980) report. The portion of this feature that overlies the

6th West Panel (it does not exist above the 4th East Mains) contains two irrigated fields with a total of 9.1 acres of cultivated land. The northwestern field drains to the south/southeast and receives irrigation water from a ditch running along its eastern edge. The southeastern field drains to the south and receives irrigation water from a ditch that enters the field from the north.

Feature 93. Irrigation Ditches and Farmland. Looking south at the northern field.

Feature 93. Irrigation Ditches and Farmland. Looking south at the southern field.

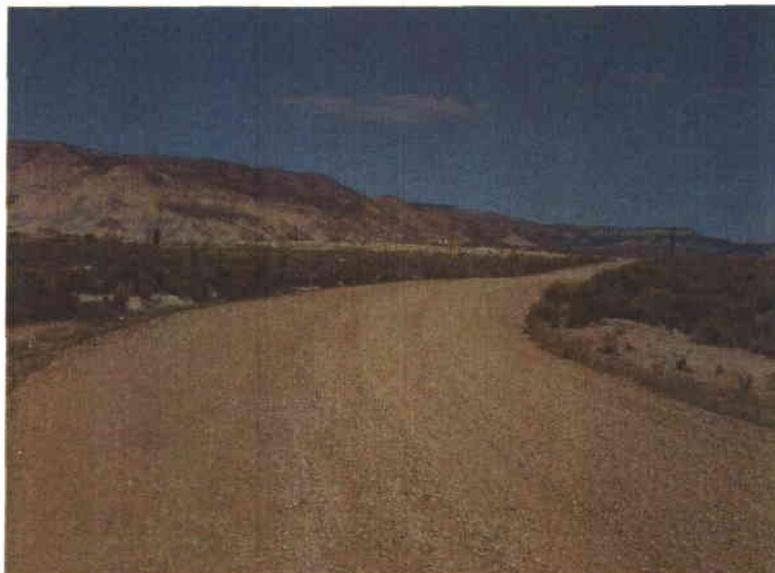
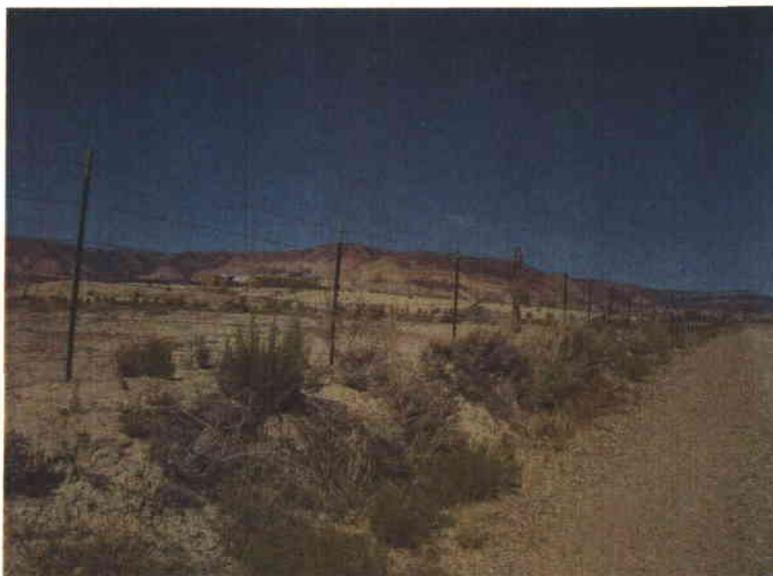
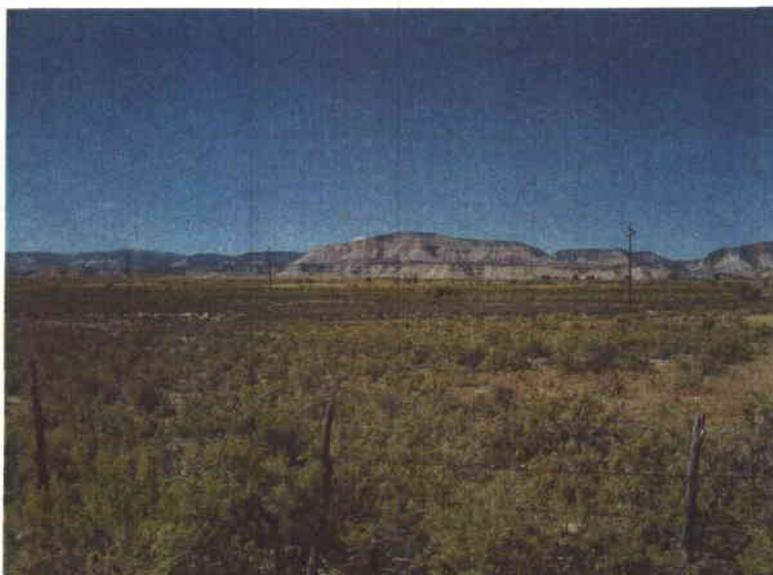
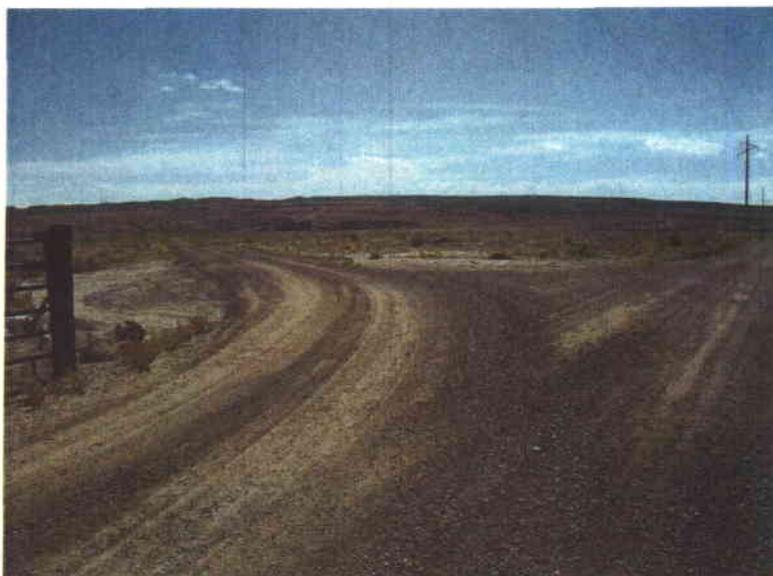
Feature 97. Dirt Road, Utility Power Line, and Fence. The description of this feature has been updated from the Valley Engineering (1980) report. The dirt road is approximately 24 feet wide with a surface constructed from imported, compacted gravel. The road is in very good condition. The utility power line hangs from 30 to 40 foot tall wooden poles, and is in very good condition. The poles appear relatively plumb. The barbed wire fence is located on the west side of the road and has posts constructed from rough cut timbers and metal tee-stakes. The fence is in good to excellent condition.

Feature 97. Dirt Road, Utility Power Line, and Fence. Looking north from a point just north of where the dirt road crosses Christiansen Wash.

Feature 97. Dirt Road, Utility Power Line, and Fence. Looking north. Note that Feature 103 is visible in the distance.

Feature 97. Dirt Road, Utility Power Line, and Fence. Looking west at fence and power line.

Feature 97. Dirt Road, Utility Power Line, and Fence. Looking south from road junction in Panel 6W. The 4th East Portal is visible in the distance.

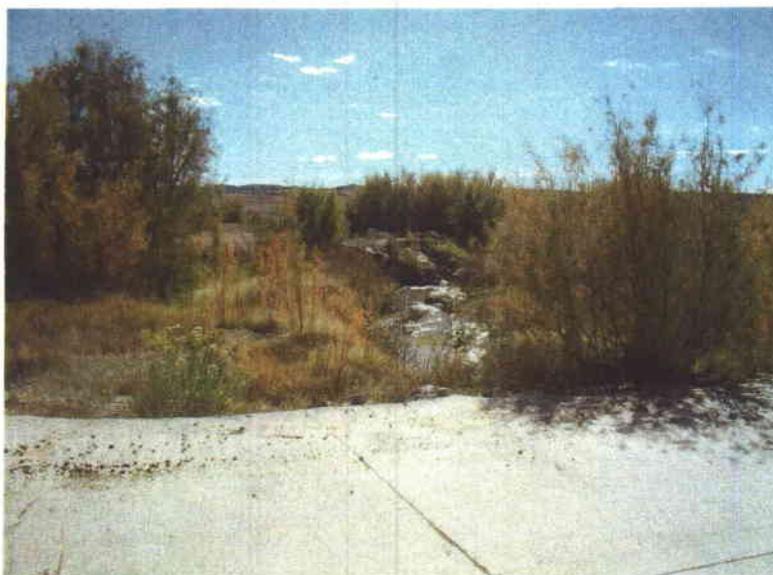
Feature 98. Small Creek. The description of this feature has been updated from the Valley Engineering (1980) report. The creek is called Christiansen Wash. During the October 2007 survey, flow in the creekbed was approximately 3 feet wide. The creek flows to the southwest and discharges into Quitchupah Creek. The creek flows under the paved access road for the 4th East Portal via a 60-inch diameter coated corrugated steel pipe that is in very good condition.

Feature 98. Small Creek. Looking south from where the creek intersects the graded gravel road. Note the embankment for the paved access road for the 4th East Portal along the horizon. This small creek is called Christiansen Wash. During the October 2007 survey, the stream was flowing about 3 feet across.

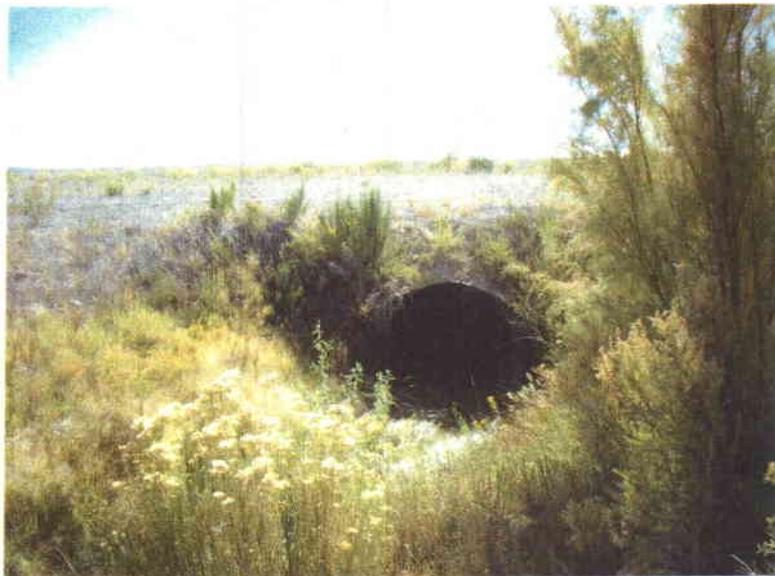
Feature 98. Small Creek. Looking south at the 60-inch diameter coated corrugated metal pipe that conveys Christiansen Wash under the paved access road for the 4th East Portal.

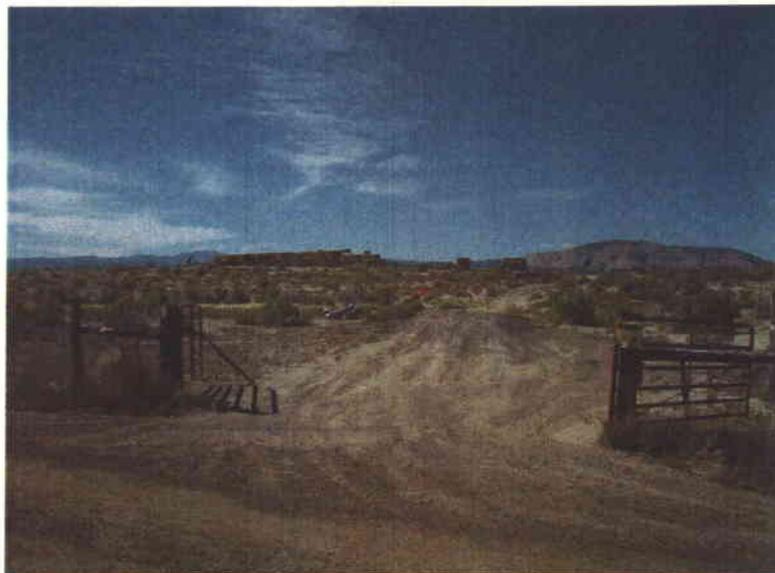
Feature 103. Farm Land, Corrals, Ponds, and Fences. The description of this feature has been updated from the Valley Engineering (1980) report. Most of this feature lies just outside the boundaries of the 4th East Mains and 6th West Panel. However, a fenced and gated hay storage area is located just to the northwest of the 6th West Panel. The fence and gate are in good

condition. An unimproved dirt road (good condition) leads from the gravel road up to the hay storage area.

Feature 103. Farm Land, Corrals, Ponds, and Fences. Looking west at a hay storage area.

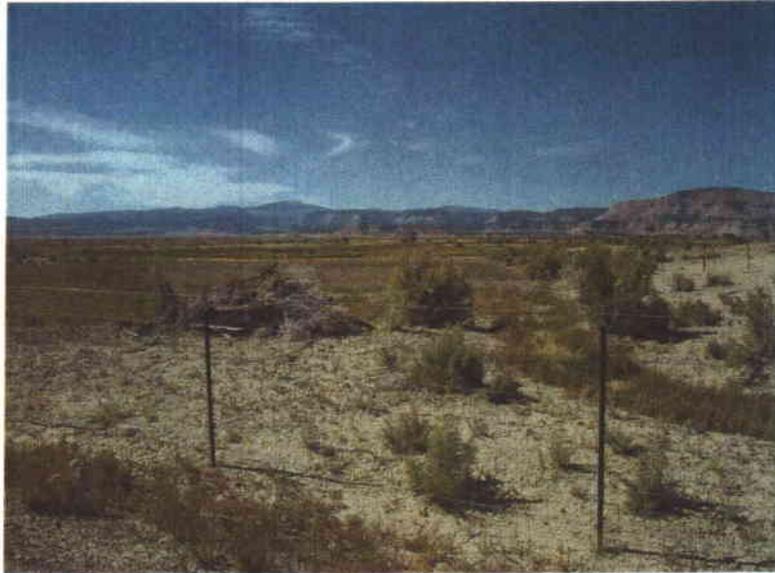
Feature 122. Irrigation Ditch. This feature was mapped but not enumerated in the Valley Engineering (1980) report. It consists of an irrigation ditch that conveys water from north to south along the west side of the road described in Feature 97, and then along the northwest edge of an irrigated field adjacent to the road. The ditch is approximately six inches deep and is in fair to good condition.

Feature 122. Irrigation Ditch. Looking southwest where the ditch curves from running along the gravel road toward the irrigated field located west of the road. Vegetation is growing in the ditch, which is located on the right side of the photo.

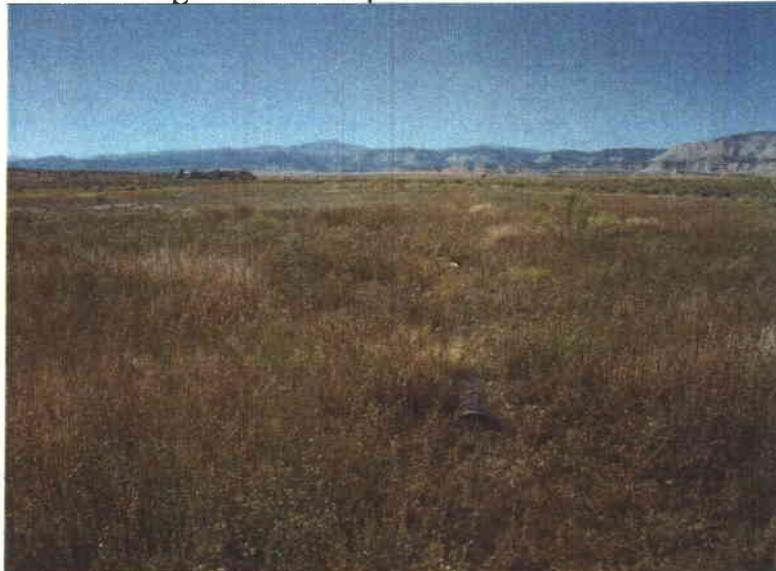
Feature 123. Remnant Irrigation Ditch Segment. This feature was mapped but not enumerated in the Valley Engineering (1980) report. It consists of a segment of an irrigation ditch that has been allowed to fall into disrepair. The ditch contains a section of irrigation piping, and both the ditch and the piping have mostly filled in with sediment. Both the inflow and outflow to and from this ditch segment are completely filled in.

Feature 123. Remnant Irrigation Ditch Segment. Looking southwest from the northeast portion of Zero North Panel. Note the partially buried piping in the foreground. It is in dilapidated condition.
