From: "McClain, Ian" <IanMcClain@consolenergy.com>
To: "ogmcoal@utah.gov" <ogmcoal@utah.gov>
CC: "SteveChristensen@utah.gov" <SteveChristensen@utah.gov>, "karlhouskee...
Date: 5/1/2009 9:10 AM
Subject: Emery Subsidence report
Attachments: Emery Subsidence 03-2009.pdf

Consolidation Coal Emery Mine Subsidence Report for March 2009

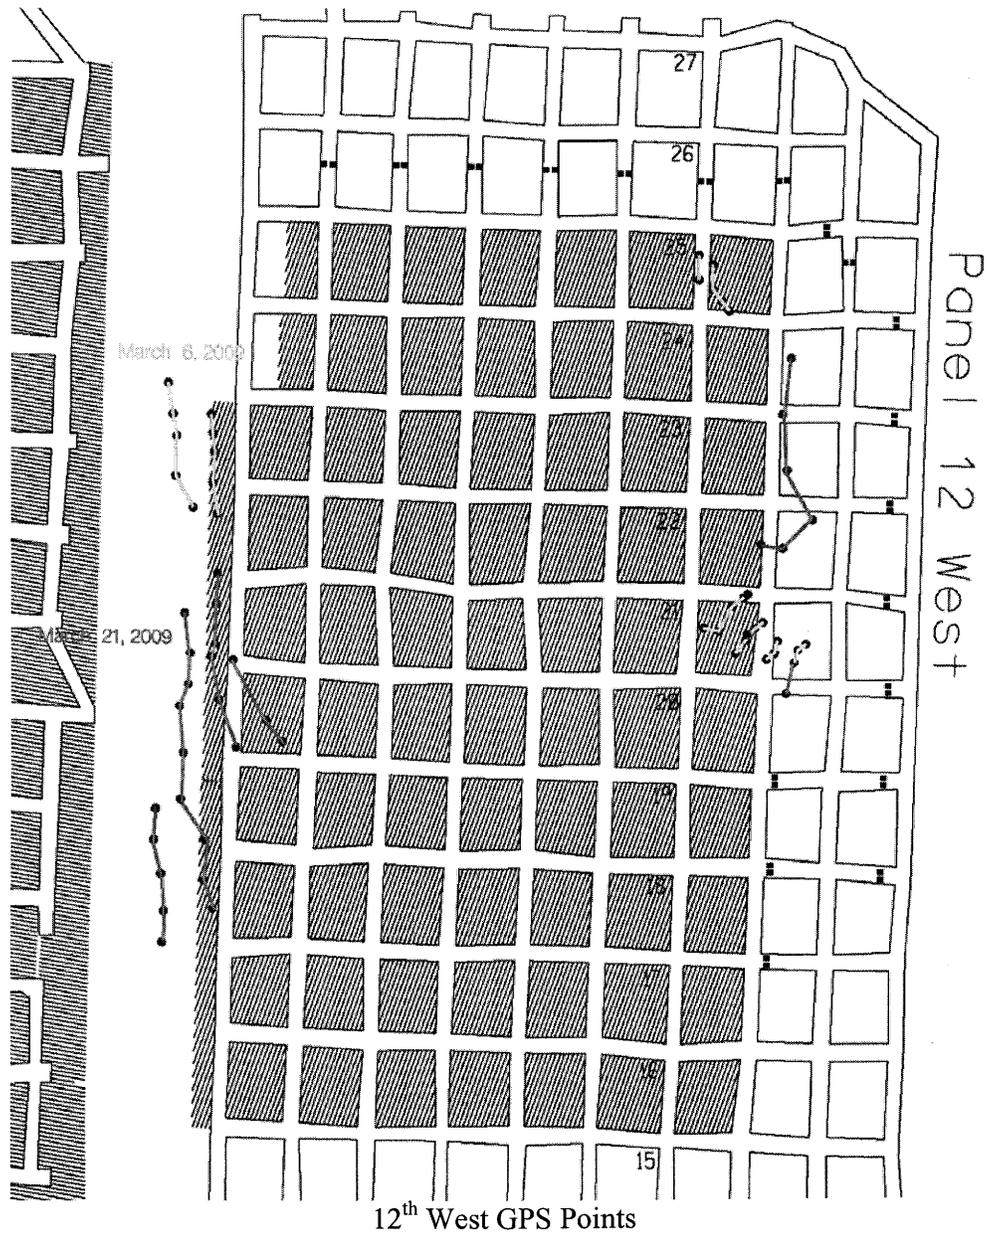
12th West – Walked 12th West GPS points on mine map (see red below). As before, the right side cracks are still harder to see. JJ

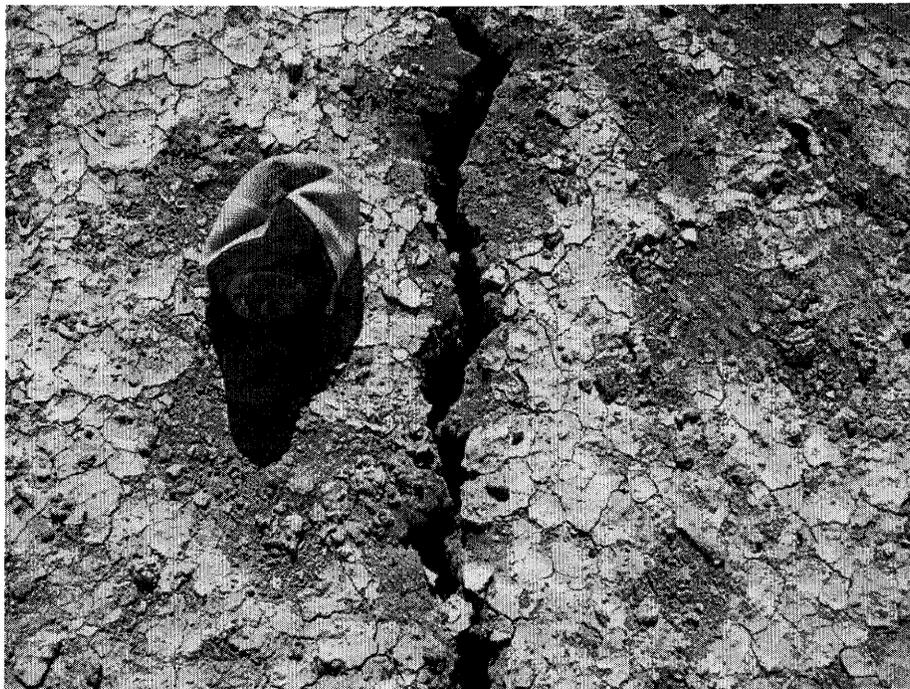
Cracks along left side of 12th West Panel

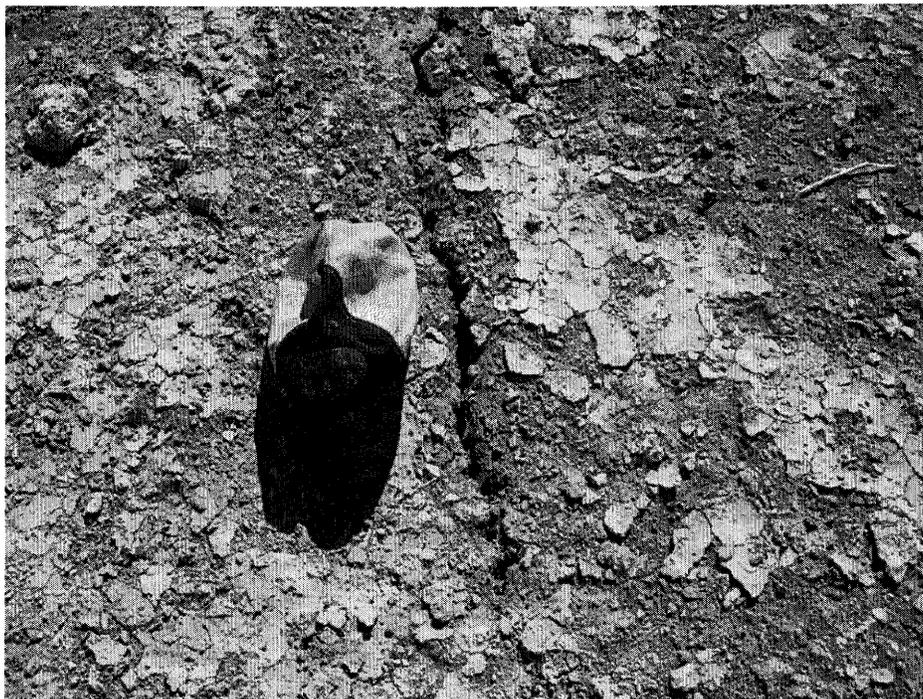
Cracks along right side of 12th West Panel

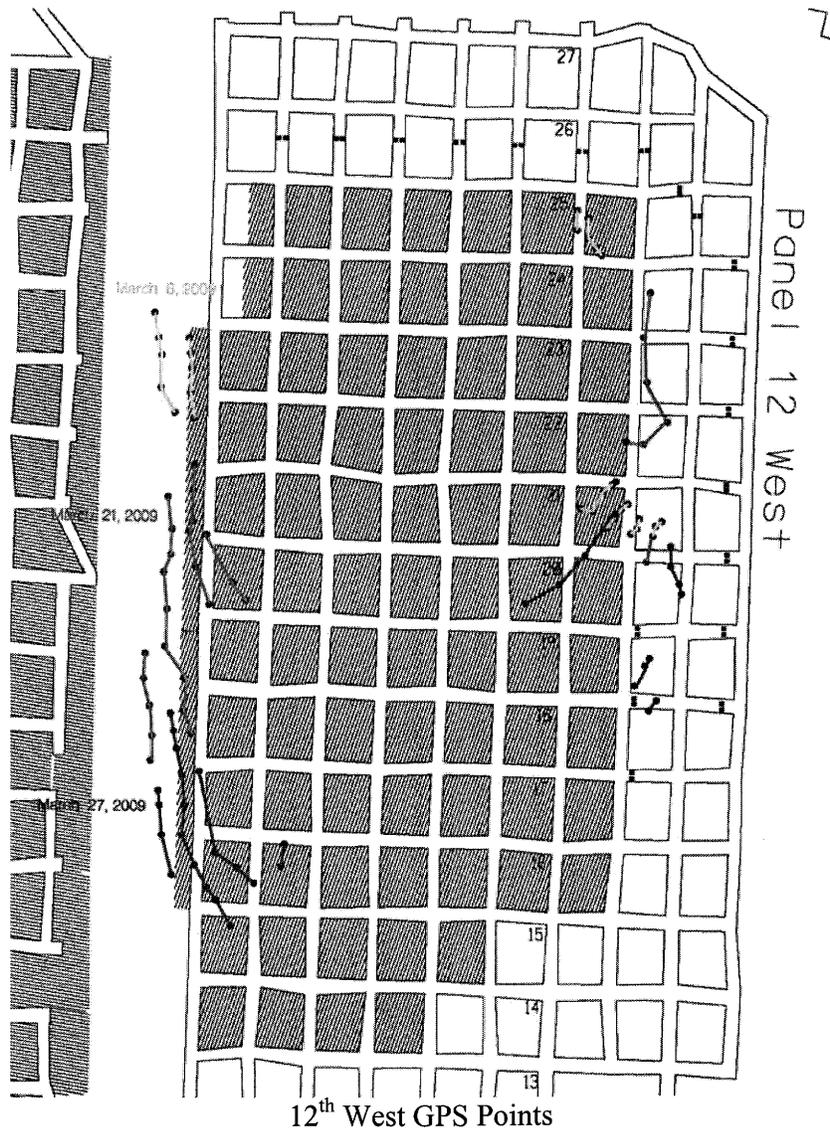
12th West – Walked 12th West and took GPS points (see blue below). Marked current pillared location in the center of the panel with a stake. This is now approximately about 50 yards away from the road. JJ

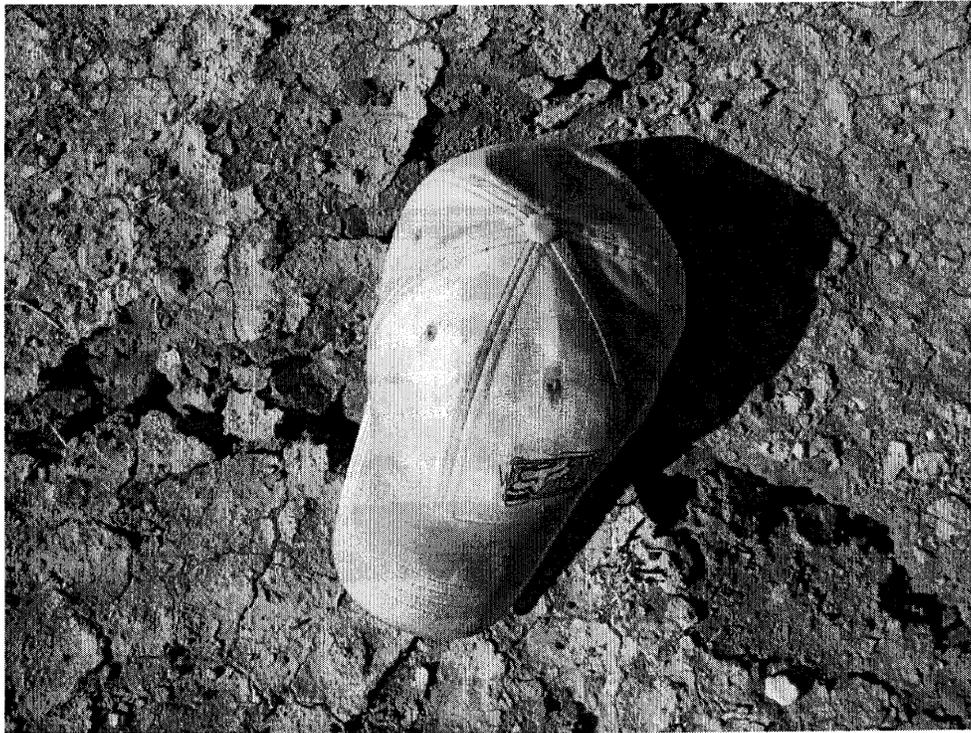
Cracks on right side of 12th West Panel

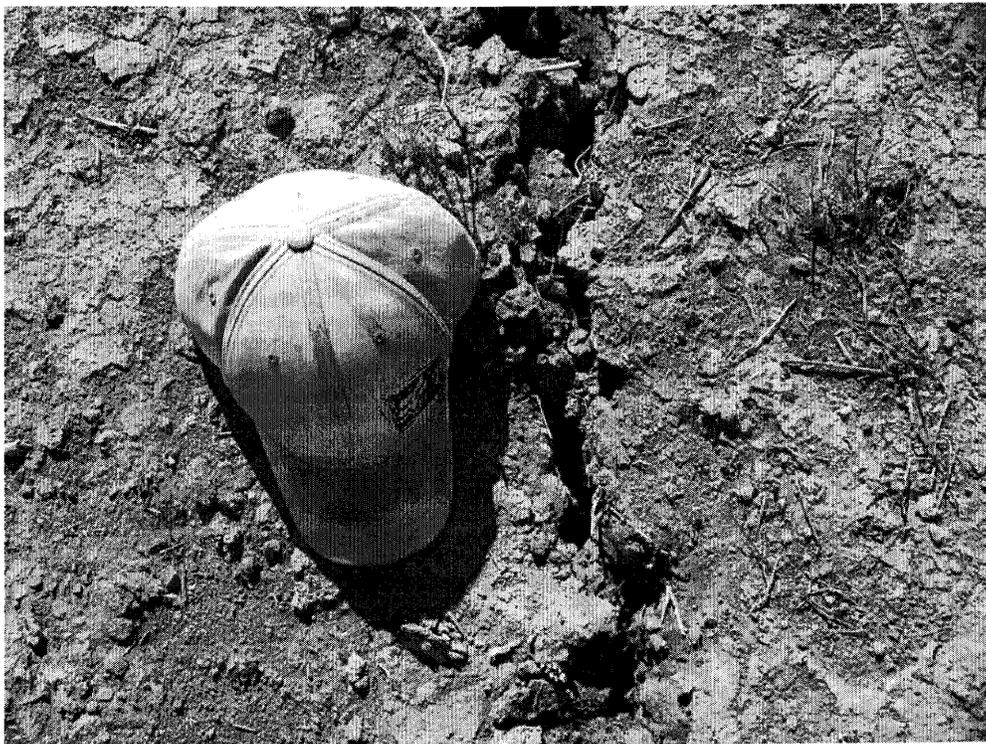
Cracks on left side of 12th Panel

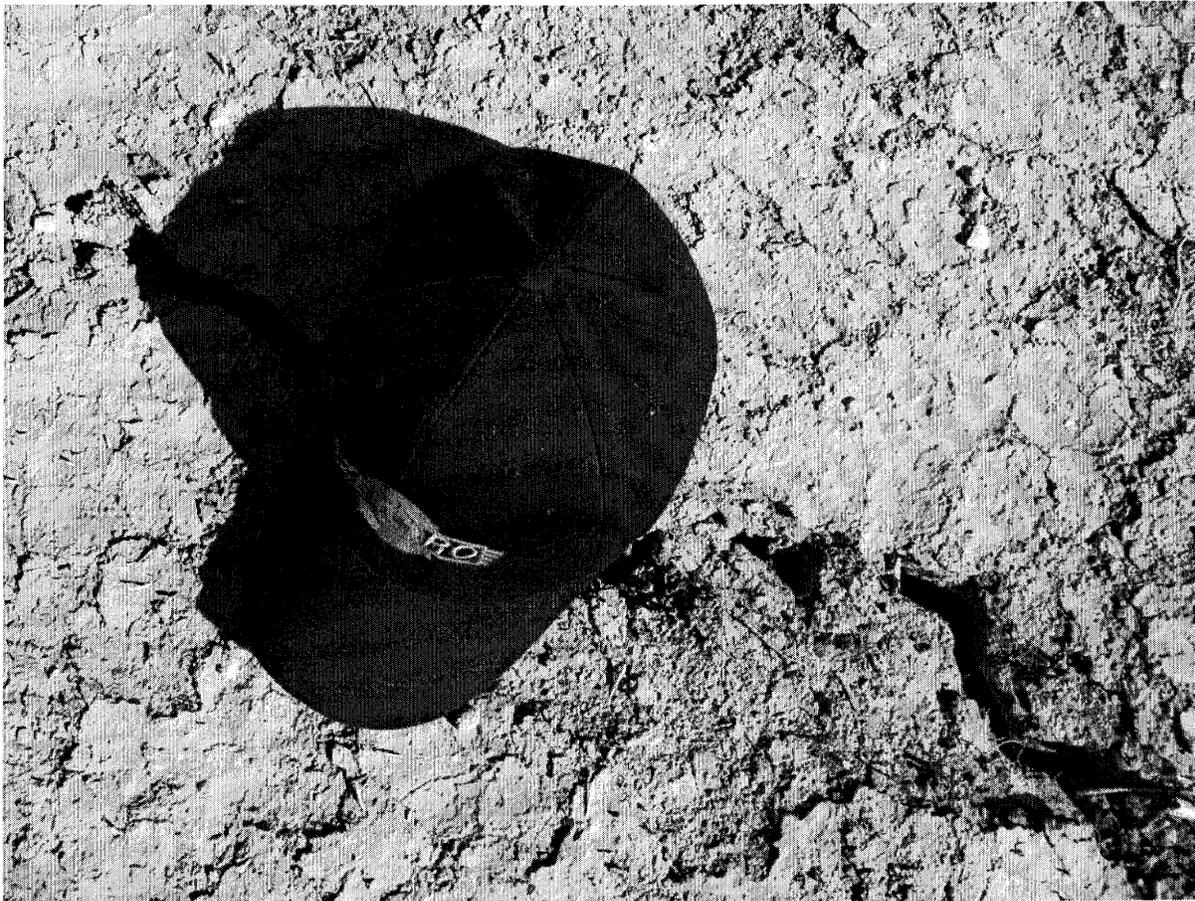
12th West – Walked 12th West Panel and found cracks advancing with the face. On the south side of the panel, the cracks are larger than 1-2” in size. The distance between these cracks on the south end varies between 5-10’. On the north side of the panel cracks are smaller and more difficult to find. These cracks range from 0.5-1” in size and come in 5’ or less intervals. Older subsidence cracks above Panel 12 West are starting to weather in as the mine retreats back the 12th West Panel. JJ

Cracks on South Side of Panel 12th West

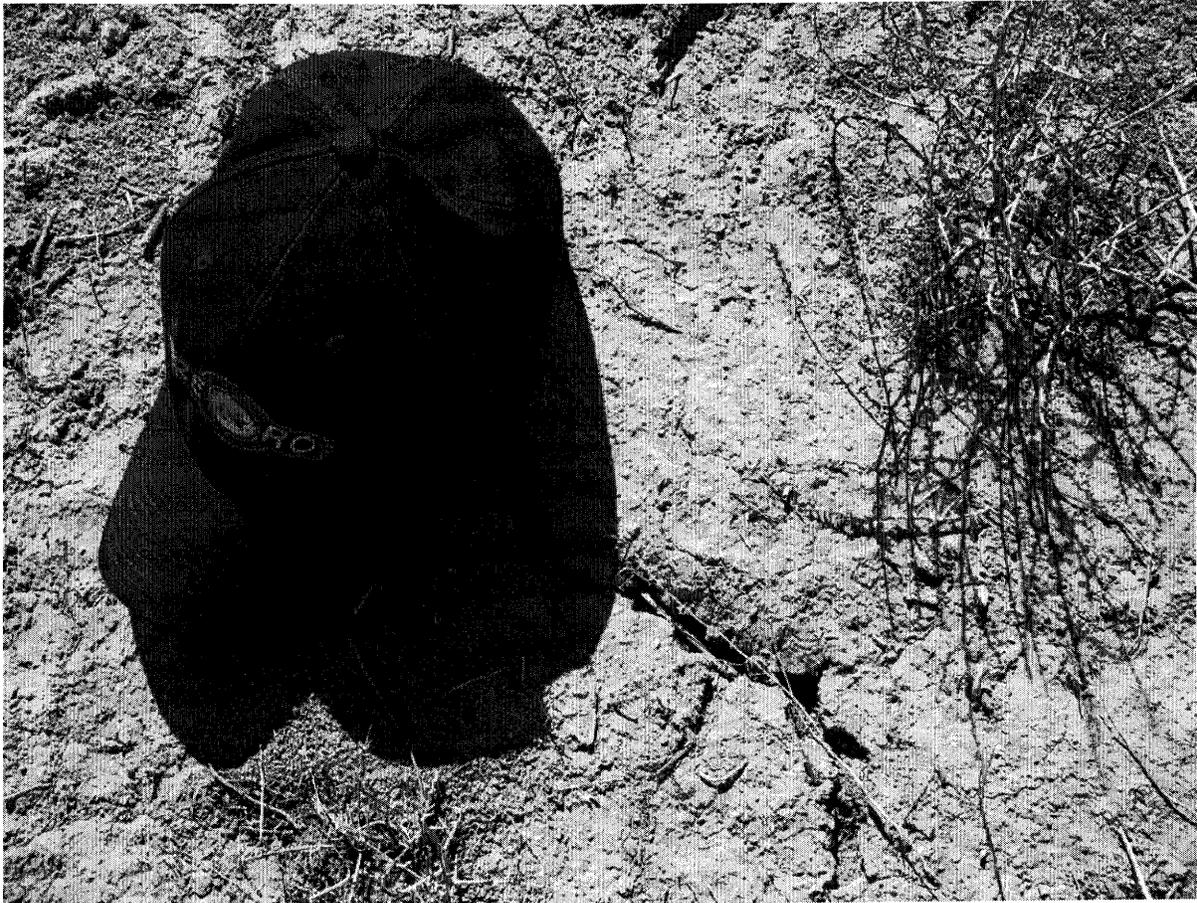
Cracks on North Side of Panel 12th West
