**From:** "McClain, Ian" <IanMcClain@consolenergy.com>  
**To:** "ogmcoal@utah.gov" <ogmcoal@utah.gov>  
**CC:** "SteveChristensen@utah.gov" <SteveChristensen@utah.gov>, "karlhouskee...  
**Date:** 5/29/2009 12:27 PM  
**Subject:** Emery Subsidence report  
**Attachments:** Emery Subsidence 04-2009.pdf

Attached please find the monthly subsidence report for the Emery Mine.

## Consolidation Coal Emery Mine Subsidence Report for April 2009

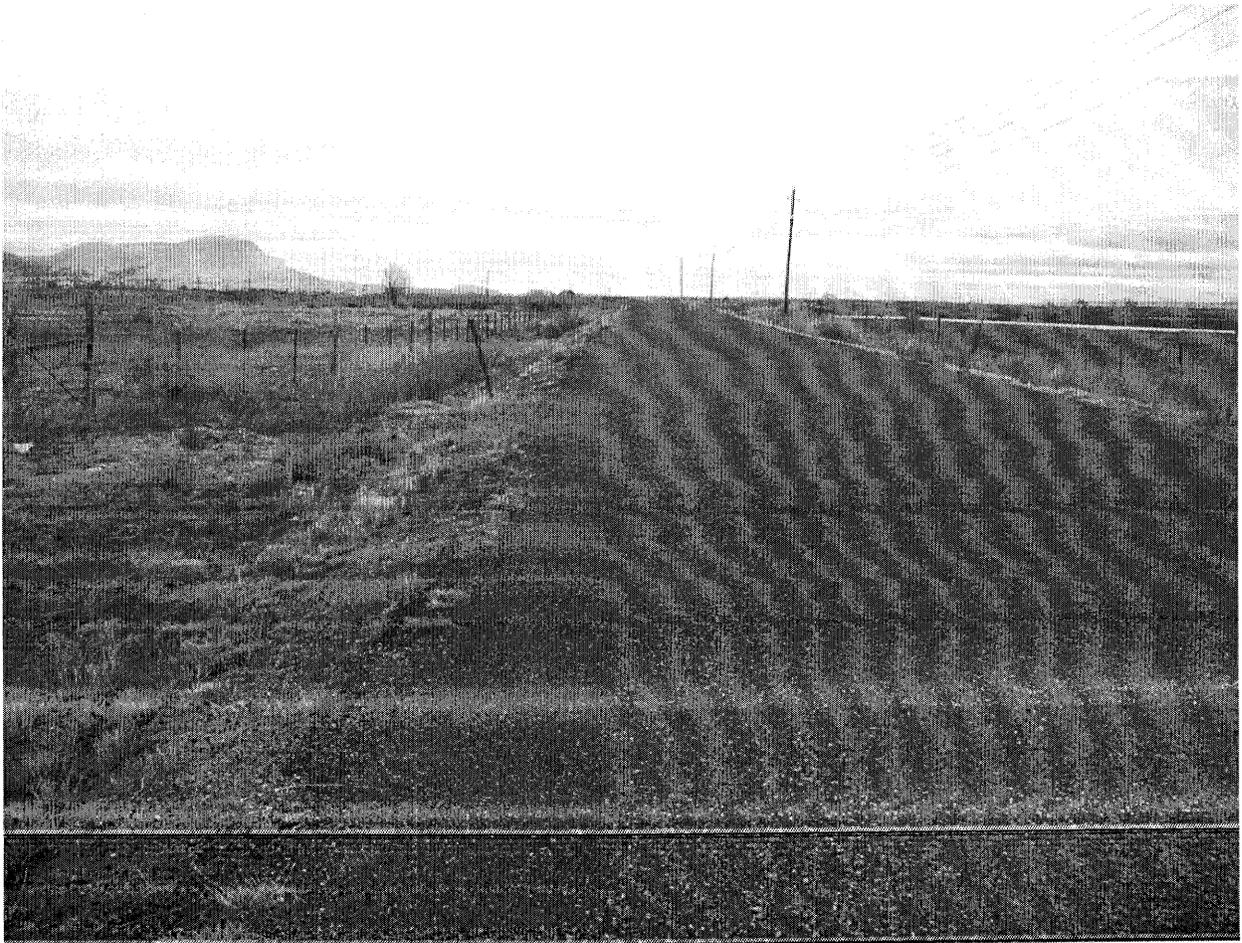
12<sup>th</sup> West – No new cracks were found. Cave underground has advanced to cross-cut 13 and stopped. From cross-cut 12 outby, we are pillaring in the lower seam. The pillar line has advanced under the road and power line. Underground pillar area is sagging but no immediate signs of caving. On the surface, the road fence and power-line show no signs of cracks. On the fence, the fence post may be slightly off vertical. It is unknown of the cause. Looking down the road no large bumps or offsets are apparent. In one picture there is a crack across the road. The crack has small pebbles and dirt in the void. It doesn't appear to be new. RH & JJ

12<sup>th</sup> West Road and Fence

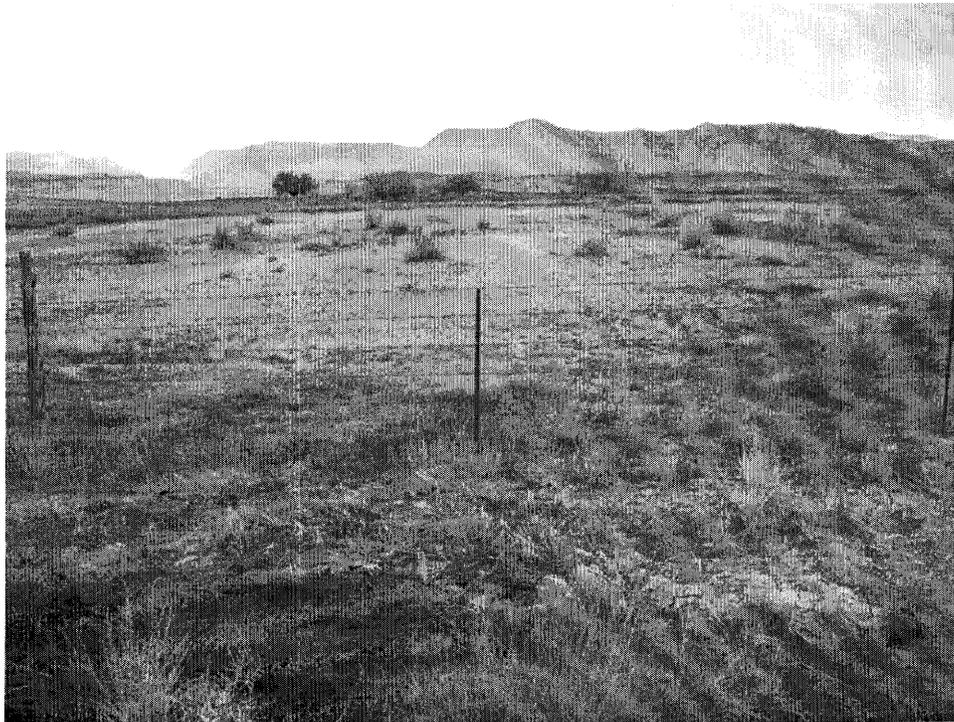
12<sup>th</sup> West Fence and Post

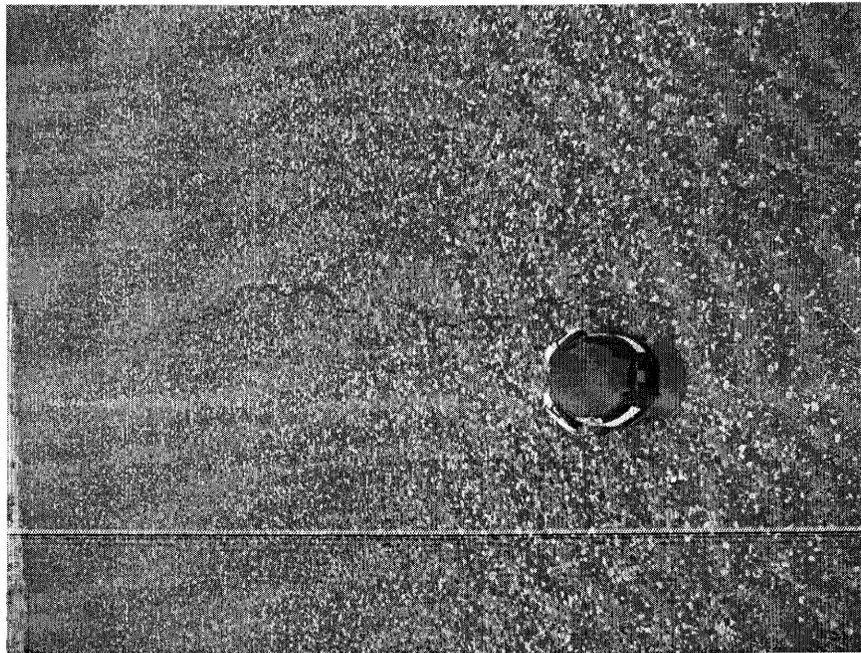
12<sup>th</sup> West Crack Along Road

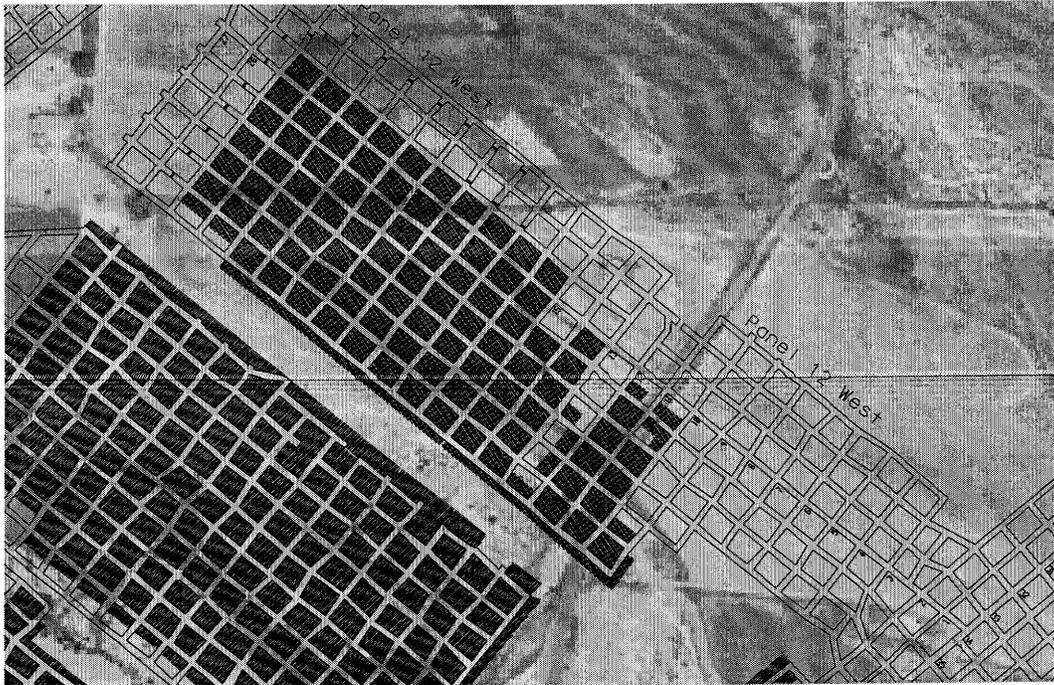
12<sup>th</sup> West Pillared area as of 4-17-09

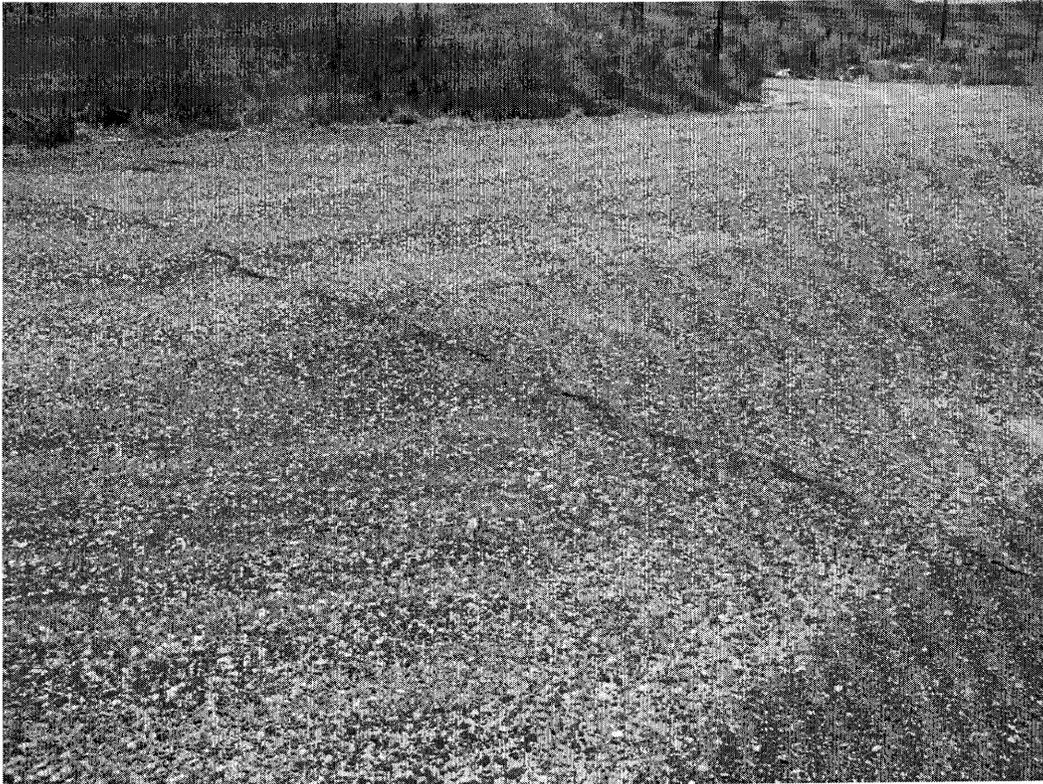
12<sup>th</sup> West – Daily check on county road was taken. No new cracks were found at this time. There is one crack that we are monitoring. It has caused a slight bump in the road, but does not seem to create a road hazard at this time. Other crack areas have been hard to find because of the amount of brush. JJ

12<sup>th</sup> West Crack/Bump on the Road

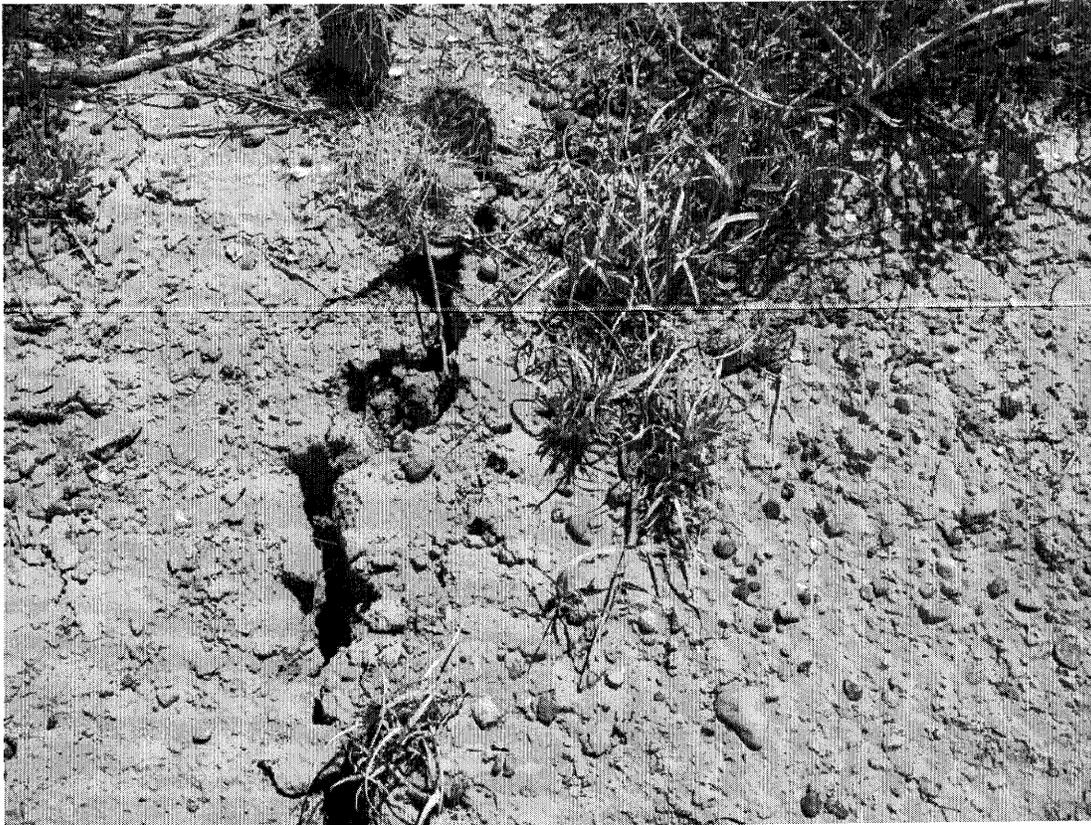
12<sup>th</sup> West – Still following a crack pattern in the panel formation. On the left of the panel, cracks are in a gully and hard to find. These cracks appear to be ranging from 0.5” to 1” in width and atleast 5’ to 6’ apart. The right side of the panel the cracks are harder to find. These cracks are very small and sometimes not visible. The road still remains hazard free although the bump is rougher and seems a little wider, but the crack appears to have remained the same. JJ

12<sup>th</sup> West Crack Along Left Side of Panel

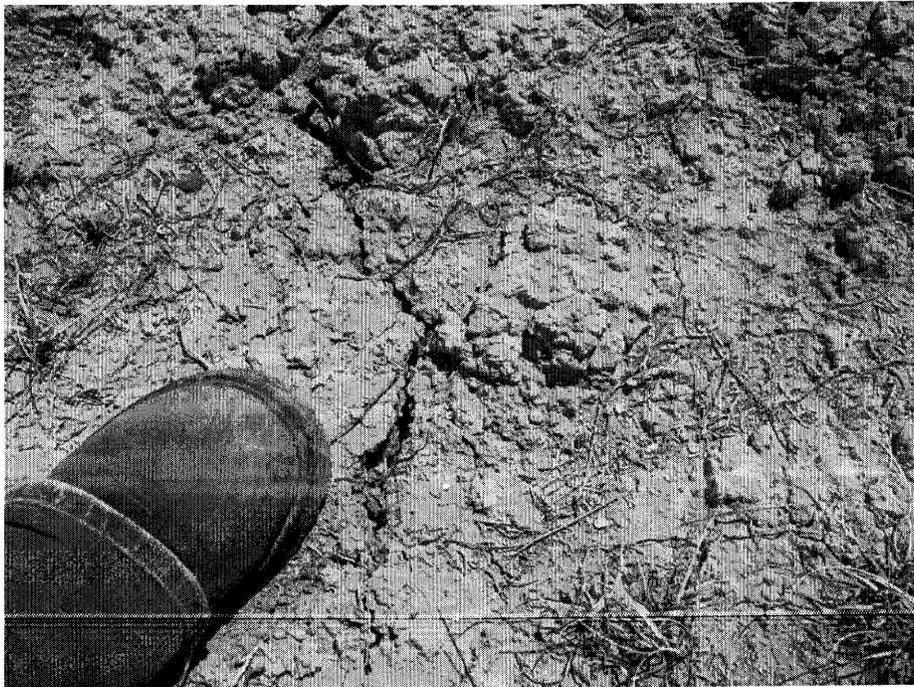
12<sup>th</sup> West Crack Along Right Side of the Panel

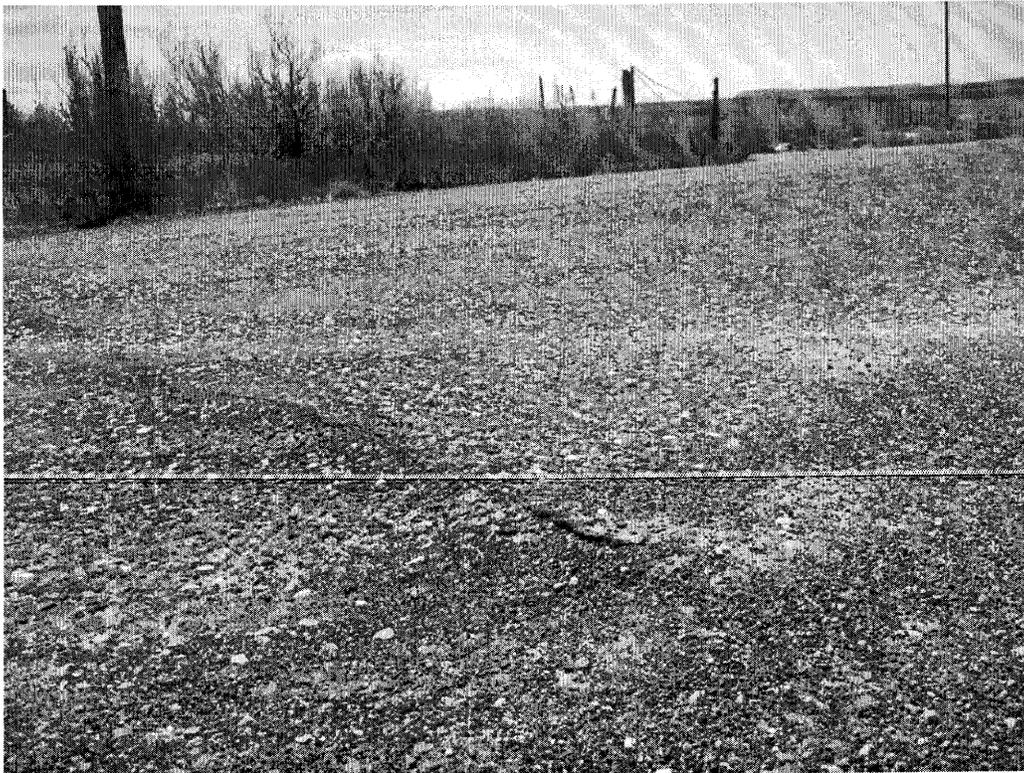
12<sup>th</sup> West Road Bump

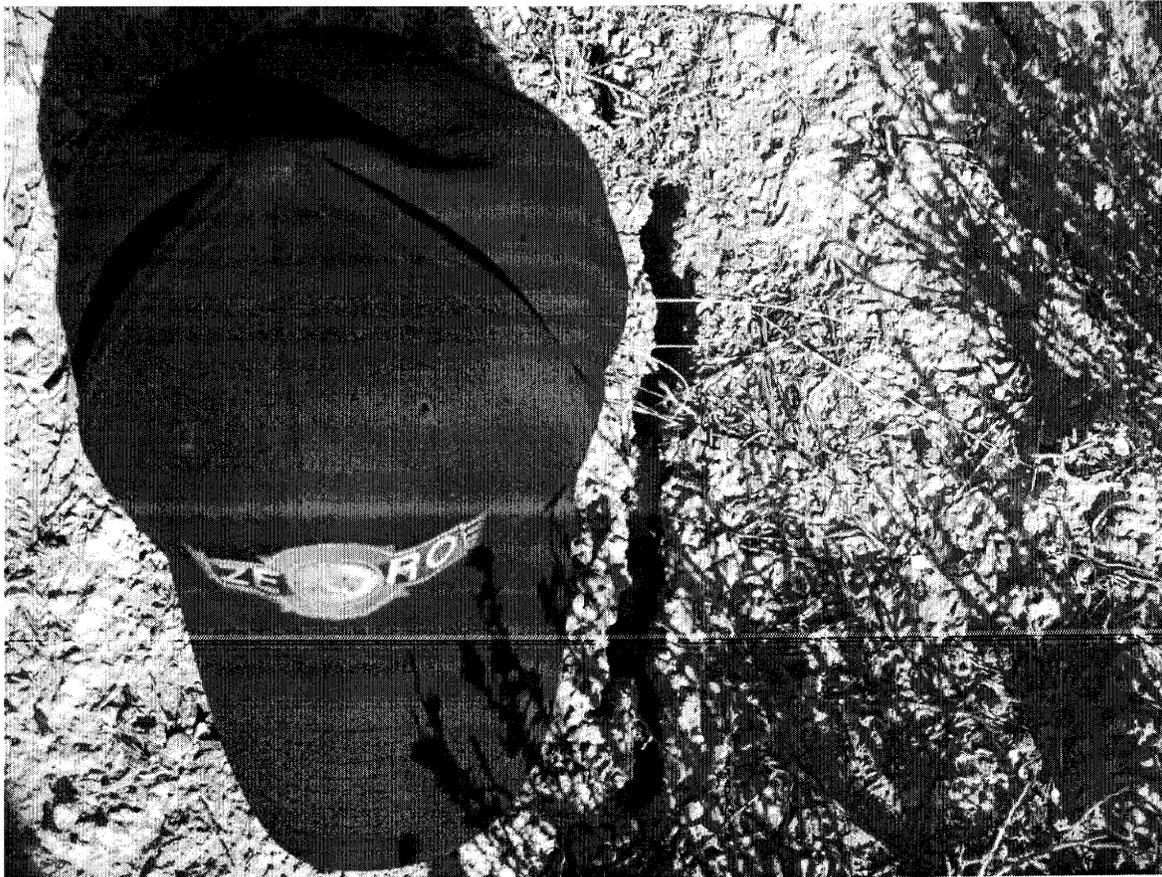
12<sup>th</sup> West Left Side of Panel Crack

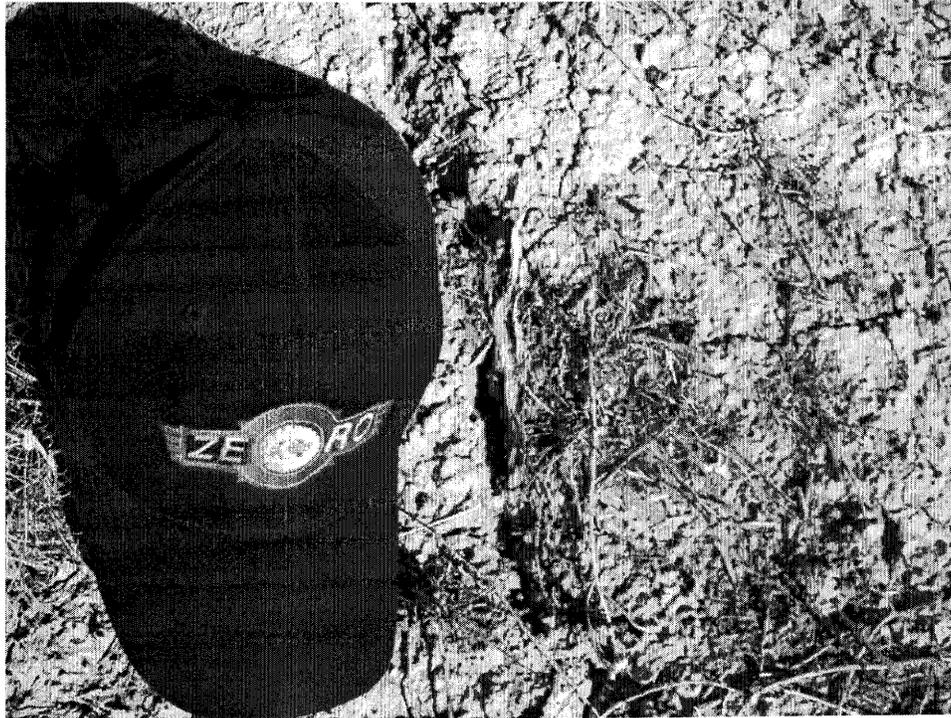
12<sup>th</sup> West Right Side of Panel Cracks

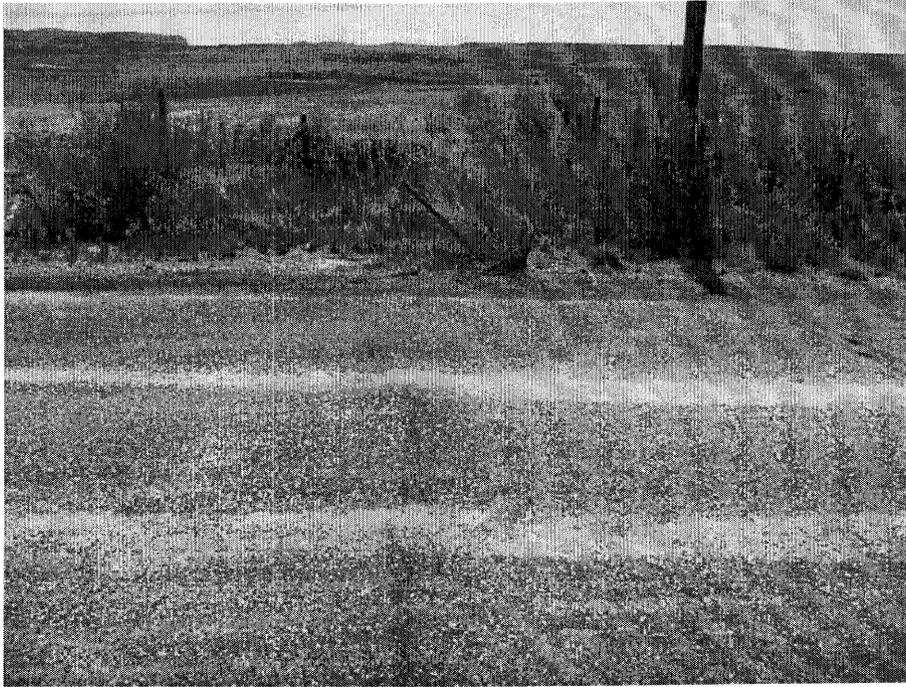
12<sup>th</sup> West - The county road crack has remained the same. JJ

12<sup>th</sup> West Road Bump/Crack
