From: "McClain, Ian" <IanMcClain@consolenergy.com>
To: "ogmcoal@utah.gov" <ogmcoal@utah.gov>
CC: "SteveChristensen@utah.gov" <SteveChristensen@utah.gov>, "karlhouskee...
Date: 7/6/2009 7:28 AM
Subject: Emery Subsidence report
Attachments: Emery Subsidence 05-2009.pdf

Consolidation Coal Emery Mine Subsidence Report for May 2009

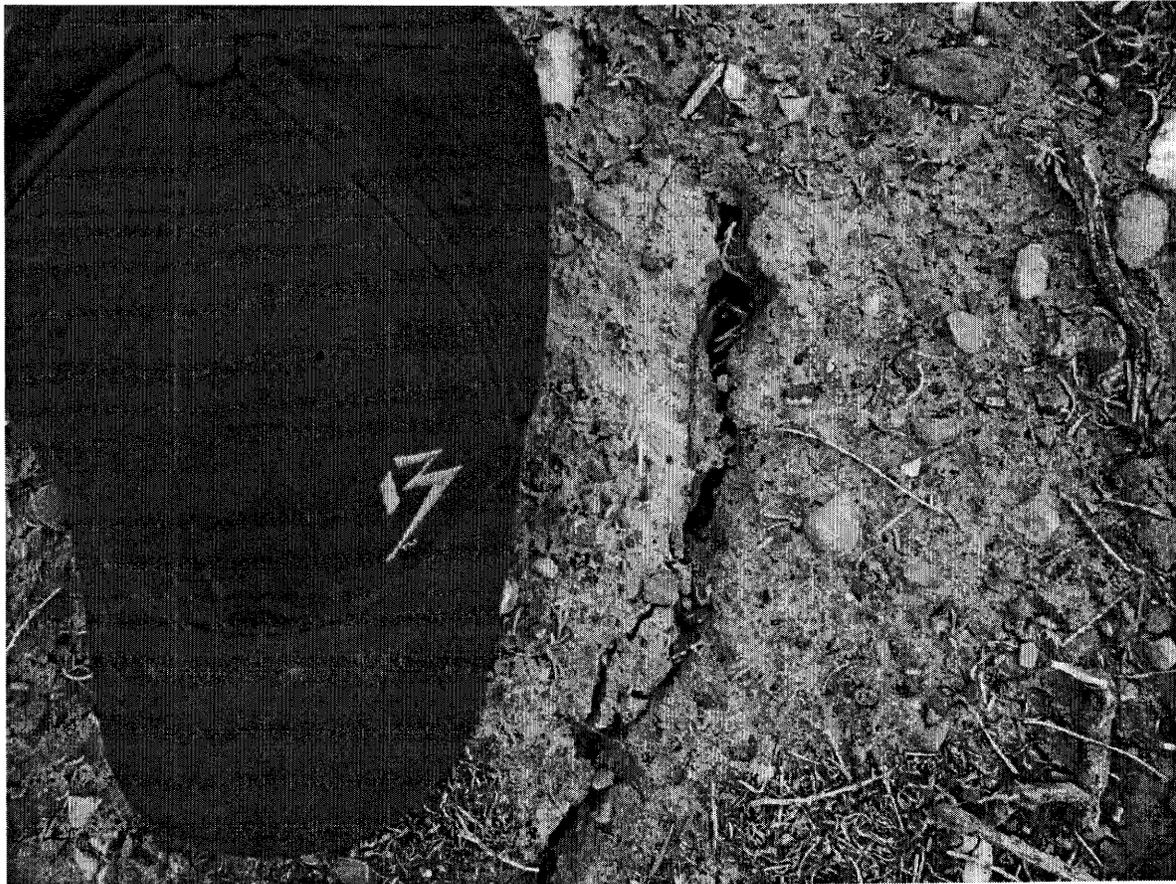
5-18-09 12th West – Cracks are hard to find entering farmer's field wet area. Although did find cracks before the field. These cracks range from ¼" to 1" in width. IM & JJ

12th West Crack before the field

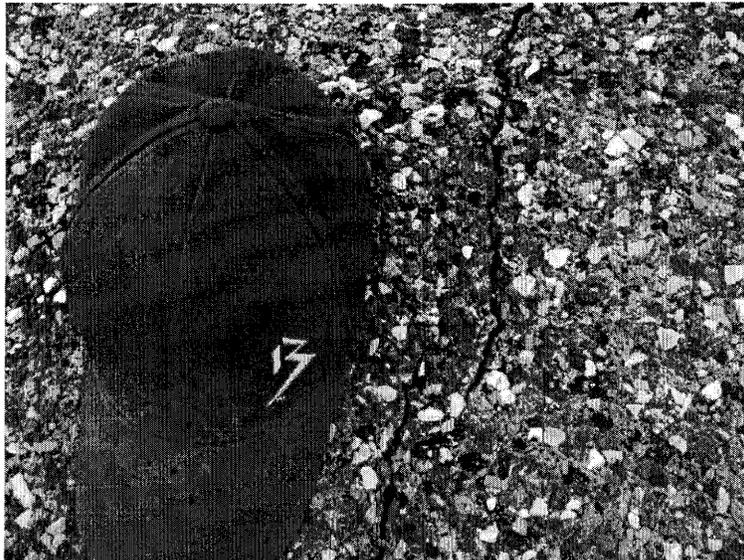
12th West Crack/Bump on the Road

12th West – The ripple in the county road is still not a hazard at this time. We have finished pillaring as mentioned earlier and subsidence now lies in an irrigated field where it is difficult to view any new cracks. Old cracks appear to be the same with a little bit of weather. JJ

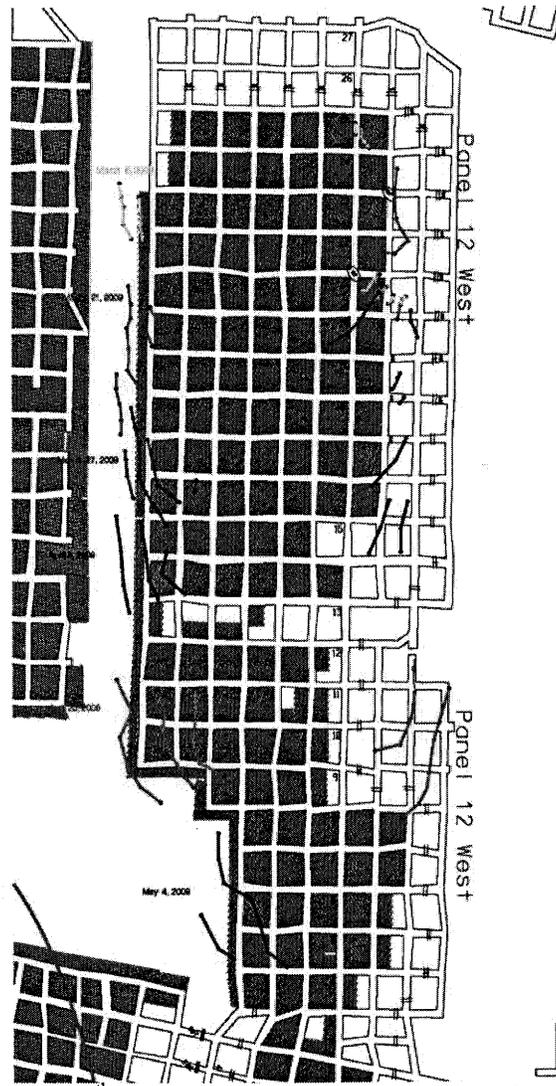
12th West – Showing completed panel w/ GPS points

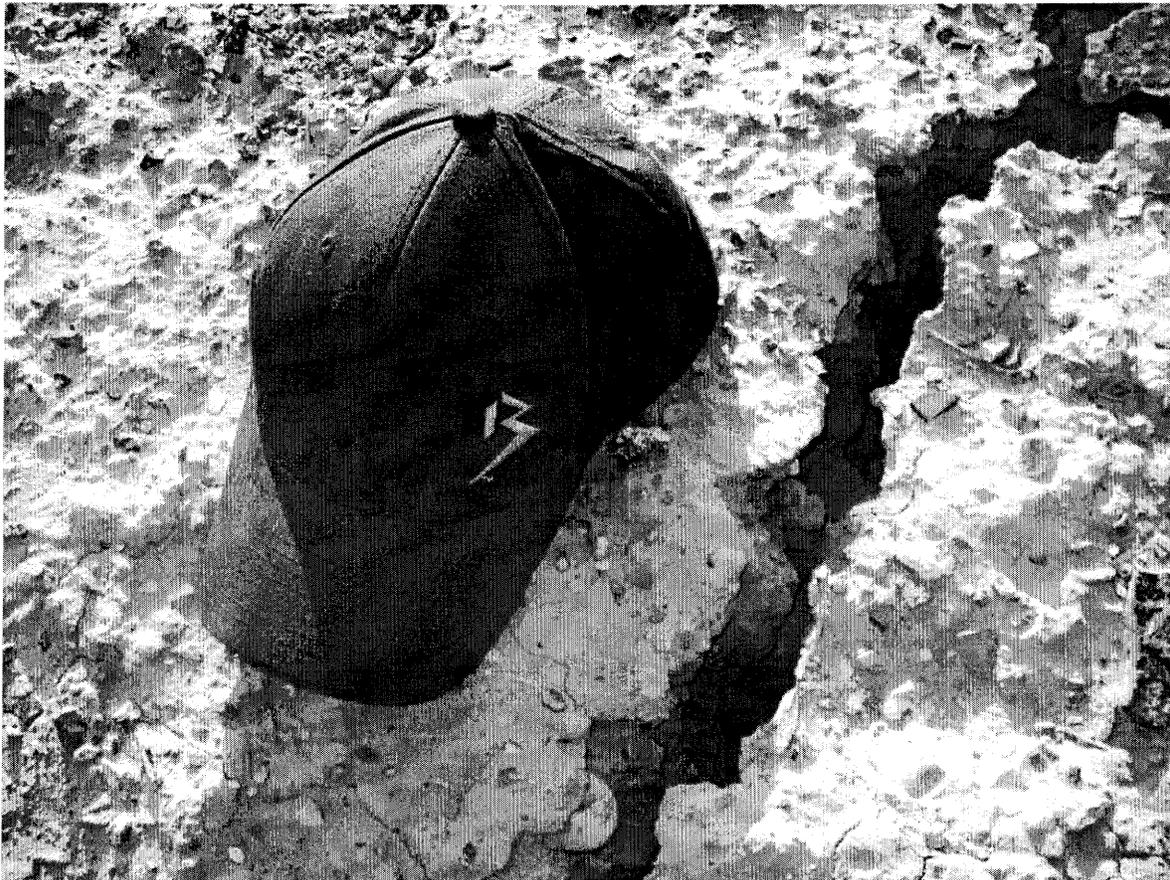
7th West – Seeing new cracks following the panel. These cracks are about ¼” to ½” in width and remain about 5’ to 6’ apart.

7th West Subsidence crack
