From: "McClain, Ian" <IanMcClain@consolenergy.com>
To: "ogmcoal@utah.gov" <ogmcoal@utah.gov>
CC: "SteveChristensen@utah.gov" <SteveChristensen@utah.gov>, "karlhousee...
Date: 9/1/2009 8:37 AM
Subject: Emery Subsidence report
Attachments: Emery Subsidence 07-2009.pdf

Consolidation Coal Emery Mine Subsidence Report for July 2009

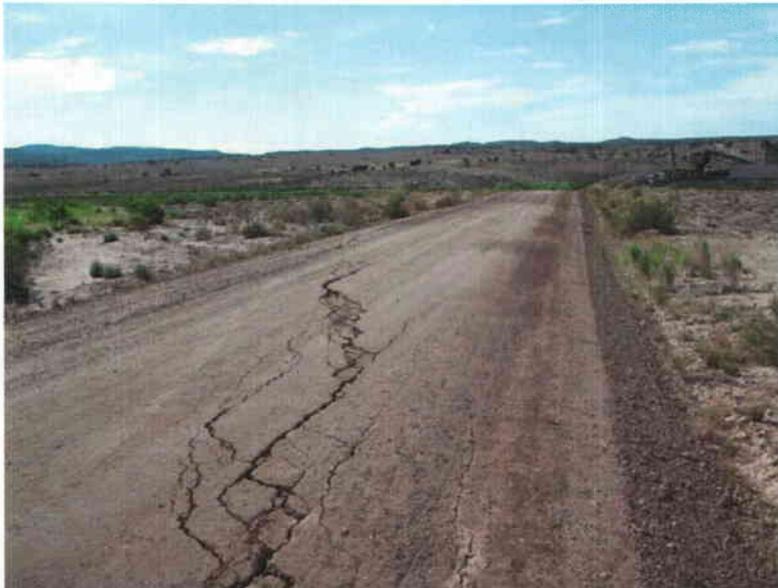
7th West – Performed daily check on the road. Road is still the same with many cracks. Called county road service to come and fill the road subsidence. JJ & IM

County Road Subsidence

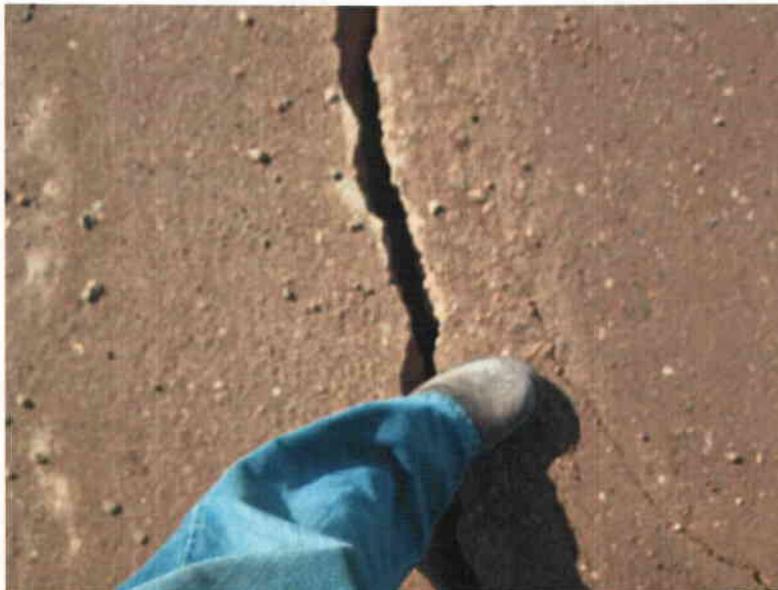
County Road Crack

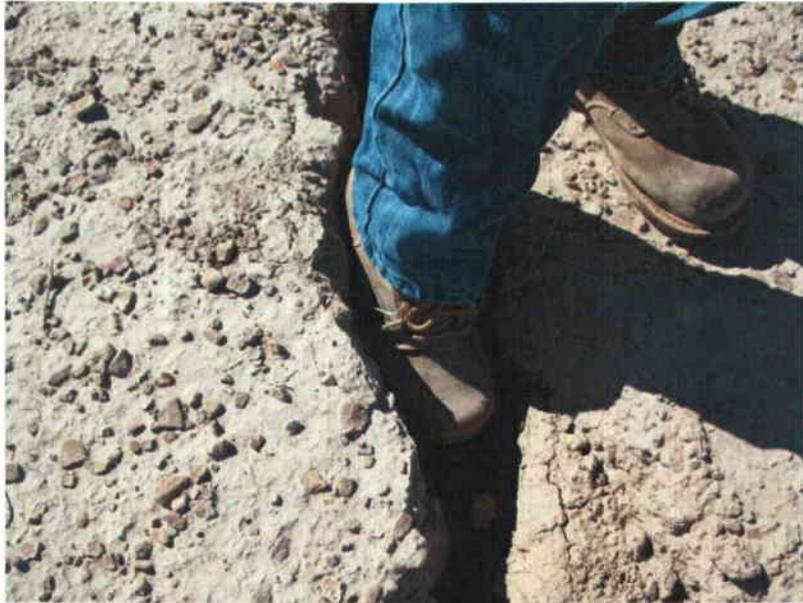
7th West – No new changes to county road. Just performing a weekly check and no new hazards are apparent at this time. JJ & IM

Crack along side of County Road

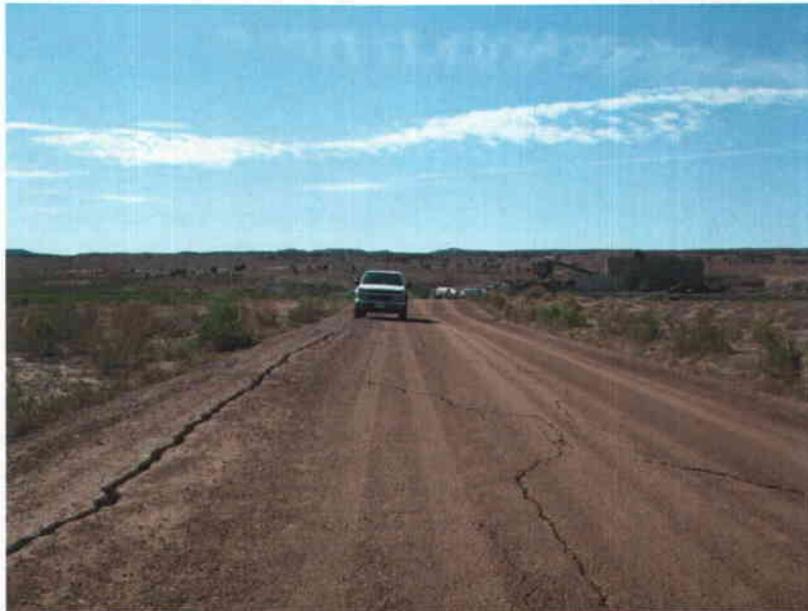
County Road Subsidence

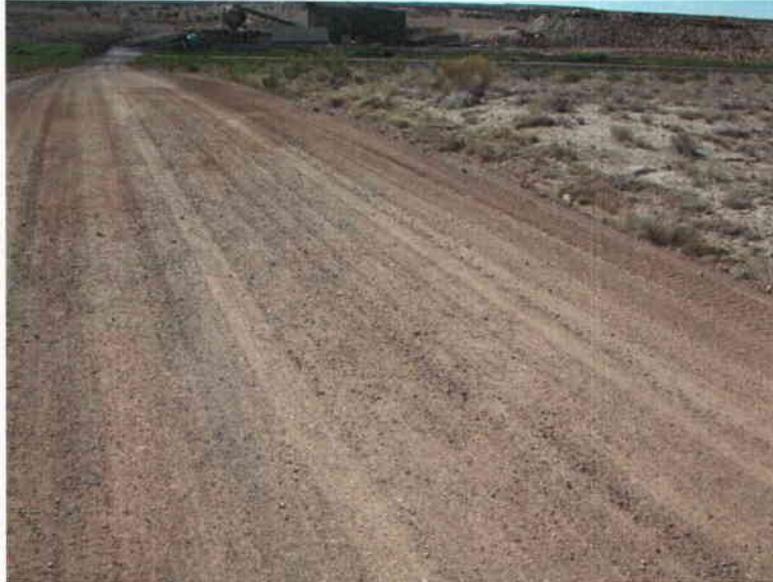
7th West –The county road service has come and fixed the road subsidence. Cracks that are surrounding the road do not seem to be getting larger. Some are even filling-in now. JJ

County Road Fixed

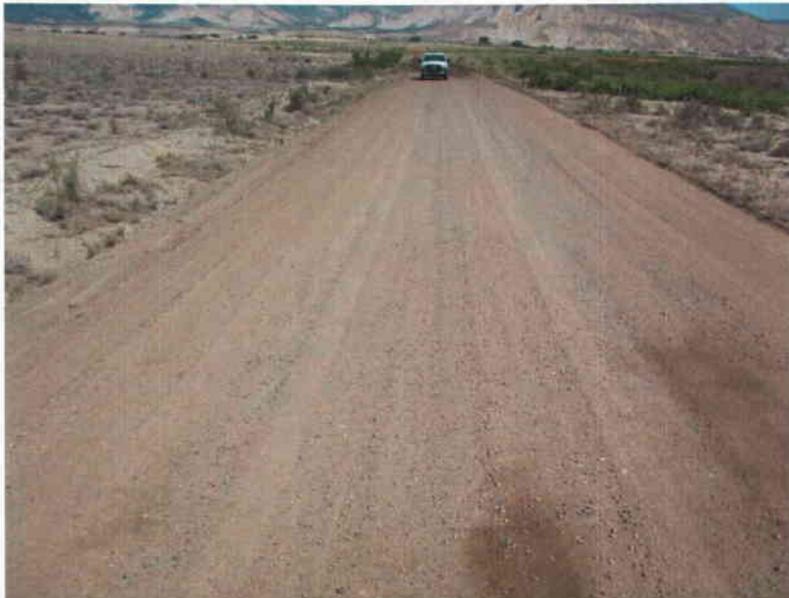
7th West – No new changes to the county road since it has been fixed. Old cracks around the county road continue to fill-in. Cracks also seem to have stopped lengthening. JJ

County Road Maintaining Condition

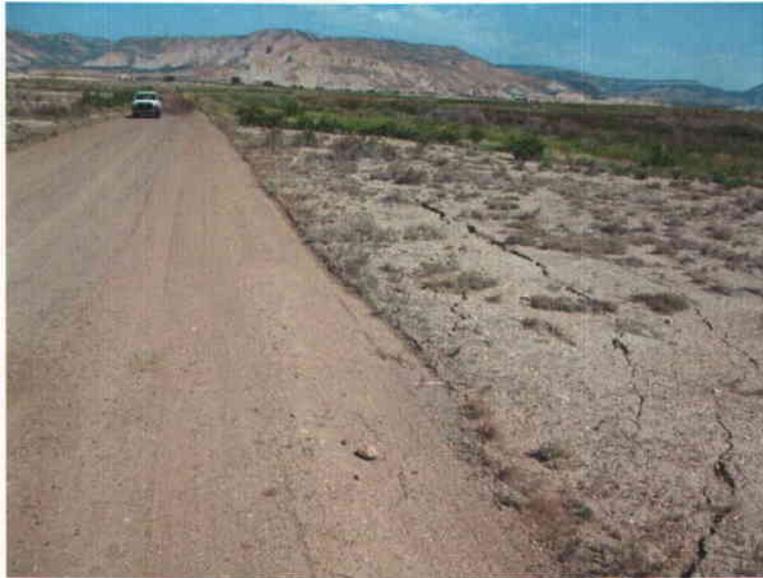
7th West – The road continues to maintain good condition since being fixed. Old cracks are continually filling in diminishing their size. JJ

Subsidence off to the side of the County Road
