CONSOLIDATION COAL COMPANY

EMERY MINE

PERMIT ACT/015/015

ANNUAL REPORT FOR 2009

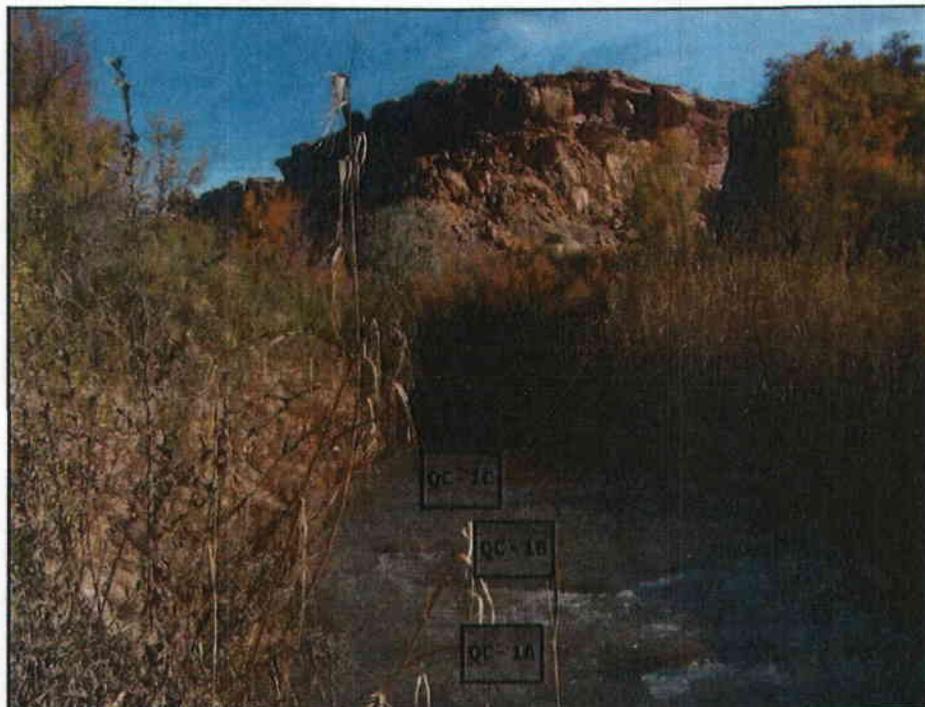
Figure 2. View Upstream at QC-1 with Individual Sample Locations Marked

This station is on lower Quitchupah Creek, downstream of the confluence with Christiansen Wash. As in past years, macroinvertebrate sampling conditions are not ideal within the reach. The reach consists of a long deep run, with a steep rocky riffle that empties into a large pool. The substrate throughout the reach is composed of large cobbles that are cemented into clay particles, with no interstitial spaces or smaller particles between the cobbles. The vegetation in the area is mostly shrubby riparian with tamarisk (*Tamarix* spp.), willow (*Salix* spp.), and rabbitbrush (*Chrysothamnus* spp.). Some grasses, rushes, greasewood (*Sarcobatus* spp.), and russian olive (*Elaeagnus angustifolia*) are also present. There was little evidence of the large flood in this reach at sampling; however, the riffle area seemed a bit more defined than in the past and may have been scoured by the flood. Figure 2 shows the reach looking upstream with the individual locations sampled (n = 3; labeled A – C). Figure 3 shows the reach looking downstream.

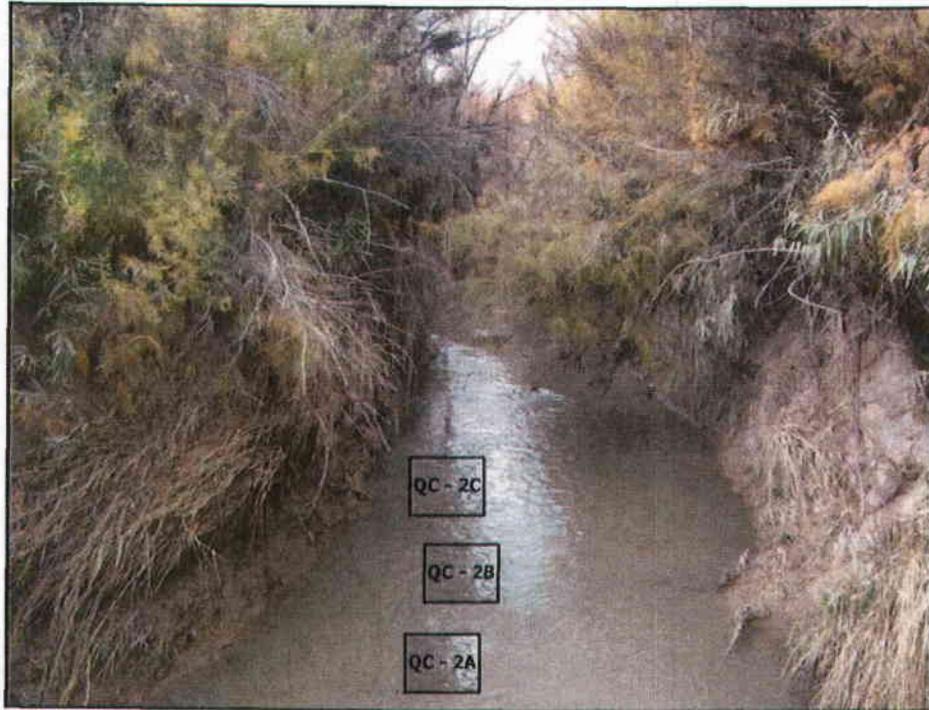
Figure 4. View Upstream at QC-2 with Individual Sample Locations Marked

This station is located on Quitchupah Creek upstream of its confluence with Christiansen Wash, upstream of QC-1, and downstream of the UPDES groundwater discharges from the mine. This reach is characterized by long, relatively deep runs, with infrequent drops. Conditions in the reach appeared similar to past sampling. However, the reach showed extensive scouring from the large flood event and the channel was very deeply incised. As with QC-1, macroinvertebrate sampling conditions are less than ideal due to the substrate composition and deep, silty water. The substrate is noncohesive, and is composed almost entirely of very fine particles of sand and coarse sands mixed with clay. Minimal cobbles and woody debris are present, associated with the few drops. The riparian vegetation includes tall grasses, tamarisk, and abundant willow; the streamside area grades into a terrace of greasewood, rabbitbrush, and clematis (*Clematis* spp.). Individual samples were located in areas where the water was as shallow as possible, so that there was minimal water flowing over the surber sampler. Figure 4 shows the reach looking upstream with the individual sample locations shown (n = 3; labeled A – C). Figure 5 shows the reach looking downstream.

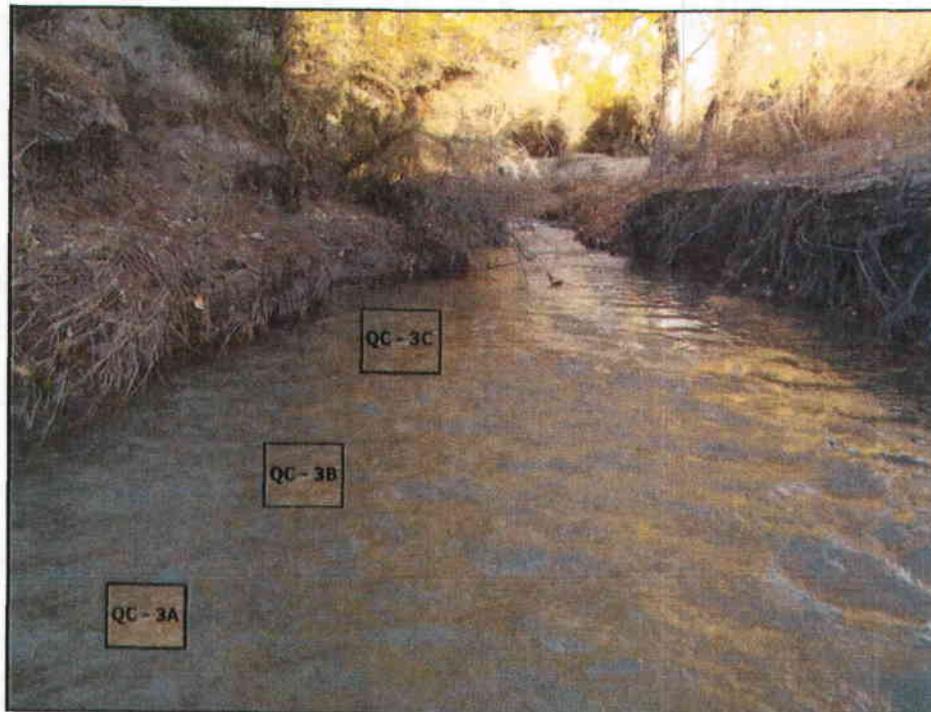
Figure 6. View Upstream at QC-3 with Individual Sample Locations Marked

This station is located on Quitchupah Creek upstream of the crossing with US Highway 10. The reach is upstream of all other sample locations, and upstream of the UPDES groundwater discharges from the mine. The reach has more suitable macroinvertebrate habitat than the other three stations. The reach is composed of long runs and shallow riffles. Substrate is composed of gravel and sand mixed with clay. Similar to QC-2, this site showed extensive scouring from the recent large flood event, with a more deeply entrenched channel than was observed at the same site prior to the flood. The riparian vegetation includes Fremont cottonwood (*Populus fremontii*), willow, tamarisk, and grasses. Individual samples were located in a long riffle located approximately 100 feet upstream of Highway 10. Figure 6 shows the reach looking upstream with the individual sample locations shown (n = 3; labeled A – C). Figure 7 shows the reach looking downstream.

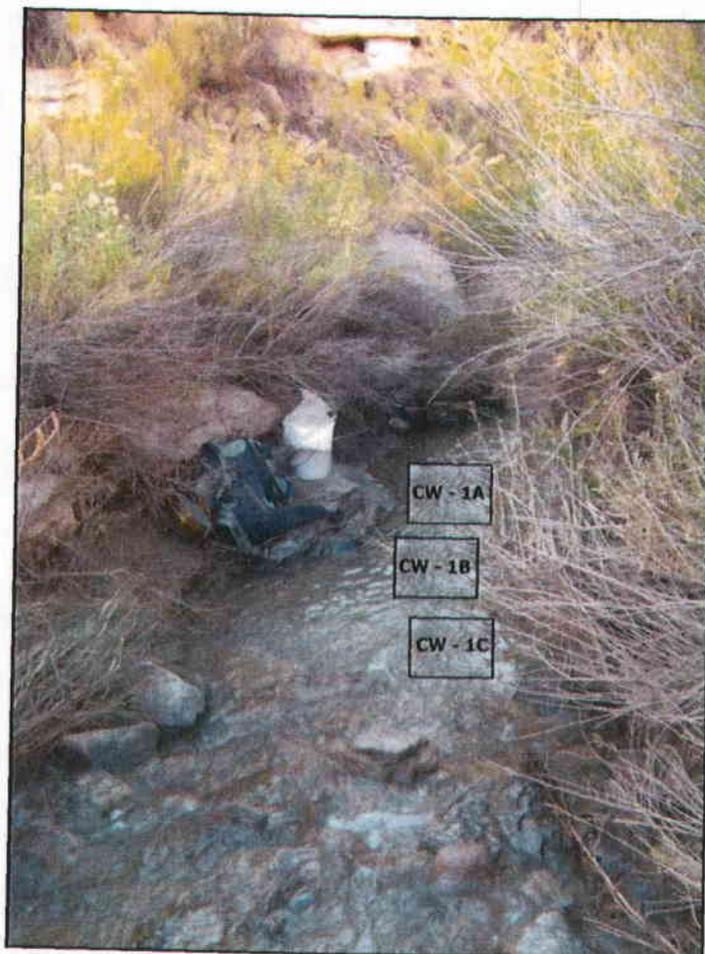
Figure 8. View Downstream at CW-1 with Individual Sample Locations Marked

This station is located on Christiansen Wash above the confluence with Quitchupah Creek. Christiansen Wash usually maintains perennial flow due to springs, and seasonally includes irrigation return flows; it is not influenced by UPDES mine water discharges. The channel is narrow and rocky in this area, flowing through exposed bedrock with little alluvial material present. The substrate is similar to QC-1, in that it is cemented with larger rock. Although the substrate is not ideal for macroinvertebrates (due to the lack of interstitial spaces) or macroinvertebrates sampling, the channel form is more conducive to sampling, with several small riffles. The riparian area is similar to QC-1 with larger banks of rush and grasses. The terrace habitat is narrower; few large trees are present. Individual samples were taken from the tail of a small riffle and are shown ($n = 3$; labeled A – C) in Figure 8. Figure 9 shows the reach looking upstream.
