# State of Utah

Division of Oil, Gas and Mining

## Inspection Report

Permittee: **CONSOLIDATION COAL CO**  
 Operator: **CONSOLIDATION COAL CO**  
 Site: **EMERY DEEP MINE**  
 Address: **PO BOX 566, SESSER IL 62884**  
 County: **EMERY**  
 Permit Type: **PERMANENT COAL PROGRAM**  
 Permit Status: **ACTIVE**

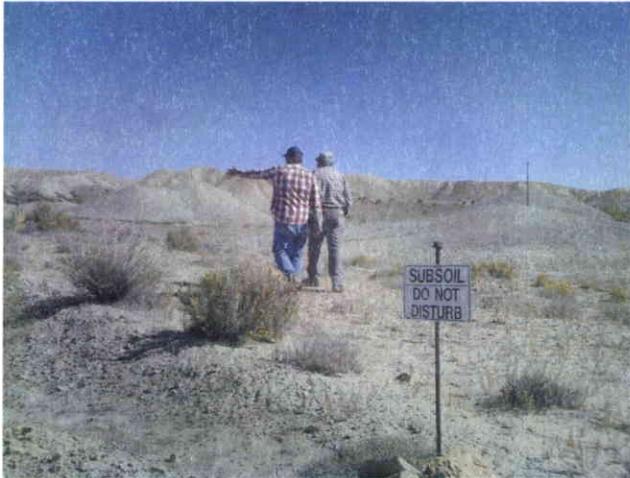
For topsoil and subsoil stockpile Sites # 1, #2, #9, #10, the vegetation on the level surface of these stockpiles appeared quite similar to the gently sloping, undisturbed surroundings. But on all piles, lower vegetation on the slopes was less than that of the desert shrub reference area. The reference area is located on fairly level ground, on top of the ridge. The difference in % desirable cover between these stockpiles and the reference area is likely due to topographic differences. Therefore, no action is recommended on these sites.

Below, site #1, Subsoil Pile from Ponds 4 & 5 (11.8% desirable cover in 2003)

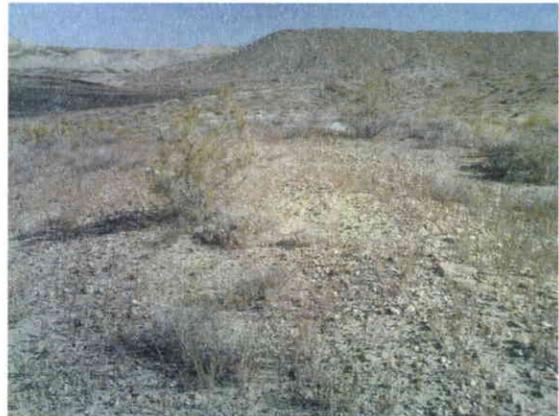
Right, site #2, Coal Pile Topsoil, (10.13% desirable cover in 2003)

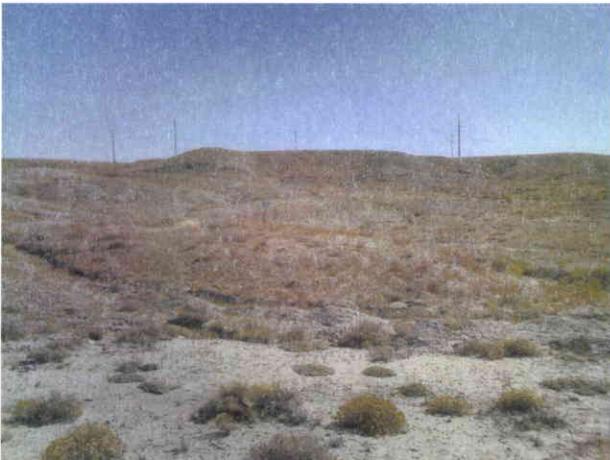
Below, site #9, Substation Topsoil Pile (6.4% desirable cover in 2003)

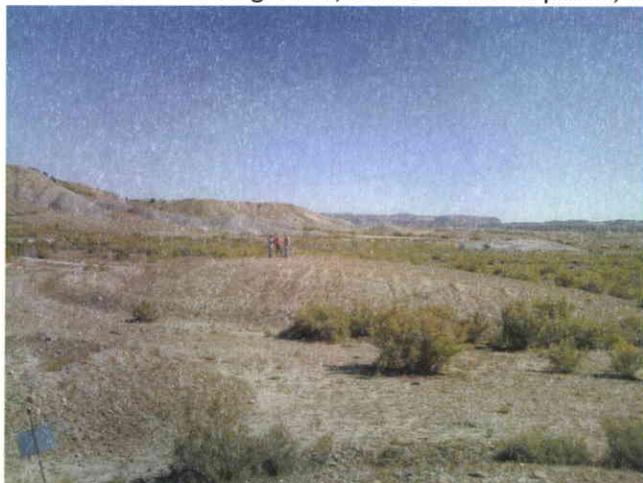
Sites #3 "pond 6 topsoil," Site #4 "pond 6 subsoil East", and Site #5 "subsoil pile West" from pond 6 construction had 0.27%, 11.14%, and 1.38% desirable cover in 2003. At the time of the inspection, all the piles appeared to have less than 1% cover. At the time the site visit, there were 20 head of horses grazing the topsoil and subsoil piles. The management of these piles is documented in Appendix III-1. Grazing on the piles has been historically a problem. The conical shape of the piles also likely has an effect on vegetation establishment. The recommendation action for these three piles is to remove grazing animals by fencing and grade the piles so that they have a lower profile, and are contiguous, but are still contained within the established footprint of the soil storage area. Sites 3 and 4 had very similar chemistry and their boundaries can be blurred. The subsoil west pile, site #5 had higher pH and SAR values and its boundaries should remain distinct. The regraded piles should then be seeded with a revised seed mix that emphasizes the shrubs noted to be successful on other topsoil and subsoil stockpiles: 4-wing saltbush, shadscale, gardner saltbush, mat saltbush, greasewood.

Sites #3, #4, #5 , Pond #6 Topsoil and Subsoil stockpiles (0.27%, 11.14% and 1.38% desirable cover reported in 2003). Lack of cover due in part to 20 head of horses enclosed in topsoil/subsoil location. Below site #4 in background, site#3 on left of photo, berm of site #5 barely visible at bottom of photo.

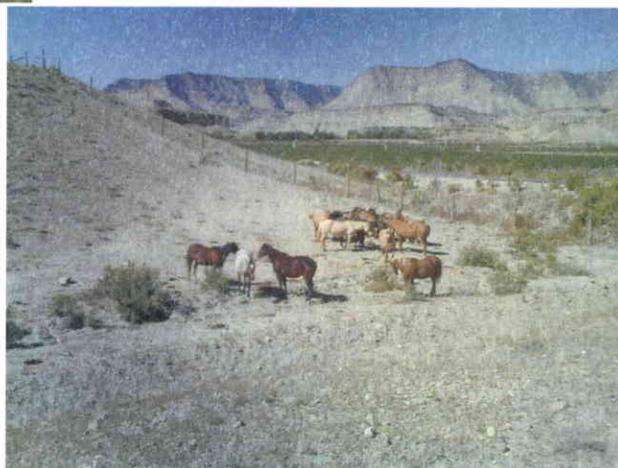
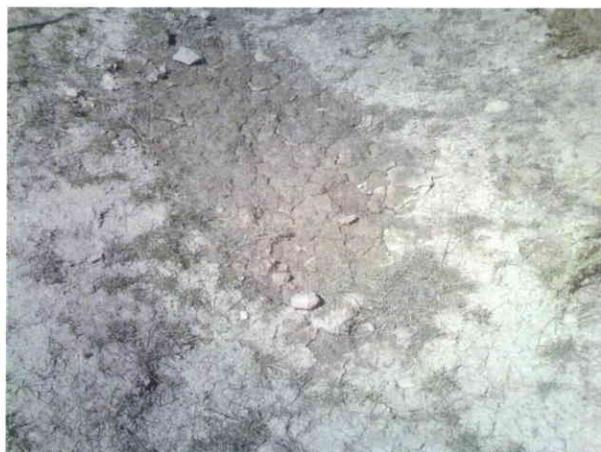
Twenty horses were enclosed within the topsoil/subsoil area.

Horses graze on grasses growing in the low spots. Overgrazing does not allow grasses to produce seed and reduces cover.

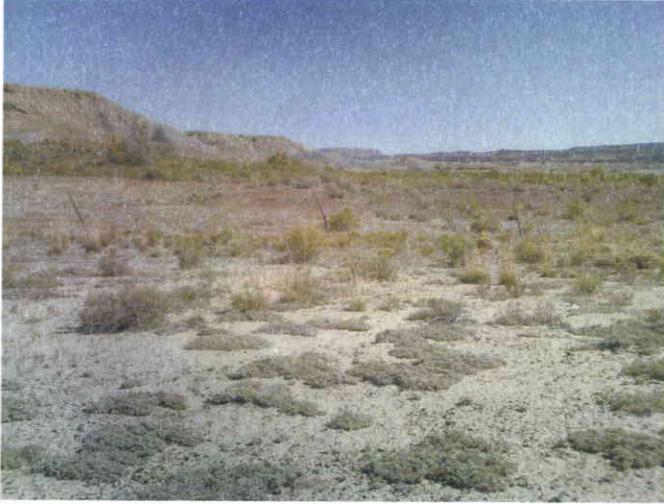
The pond 6 pipeline road was reclaimed in 1987. It was not part of the Appendix III-1 study. According to Steve Behling, it had straw incorporated into the soil with discing and was seeded. The site is marked by roof bolts, but otherwise is undistinguishable from its surroundings. The vegetation is a monoculture of mat saltbush. Some seeded grasses are in low lying areas down wind. All agreed that this site has successfully reclaimed after 24 years. The discing of straw into the soil should be applied to other reclamation sites.

Successful reclamation on the Pond #6 Pipeline Road, reclaimed in 1987. This location was not part of the 2003 study.

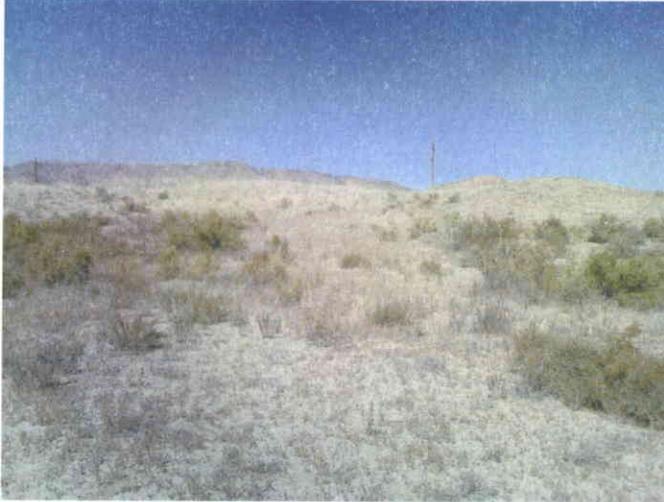
Site #8, the borehole reclaimed road had only 2.6% desirable cover. This road had no topsoil removed and reclamation treatments were limited to seeding. In retrospect, this site might have benefitted from deep ripping, incorporation of straw and hydroseed/mulching methods.

Compare the above photo with Site #8, Borehole reclaimed road (2.6% desirable cover in 2003). This site is a half mile east with the same aspect, but gently sloping topography.

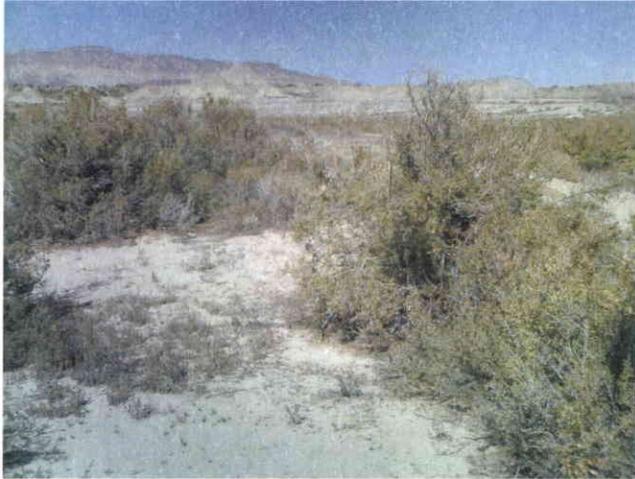
Below, site #10, Topsoil Pile from Pond #1 (10.53% cover in 2003)

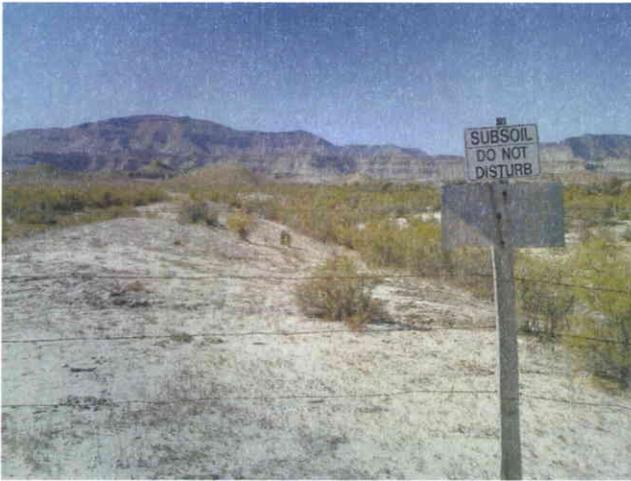
Site #14, Pond #1 subsoil stockpile.

Site 14, the subsoil for pond #1 may be incorrectly referenced, according to Steve Behling it may be topsoil from the adjacent swale that runs parallel to it. In any event it could be reseeded.

Site #14, is labeled "Pond #1 Subsoil Stockpile." However, it is very far from pond 1 and appears to be soil excavated from the adjacent trench for a pipeline. Site #14 has 3.2% desirable cover. It is recommended that this site be reclaimed using the techniques recommended under the Revegetation section below.

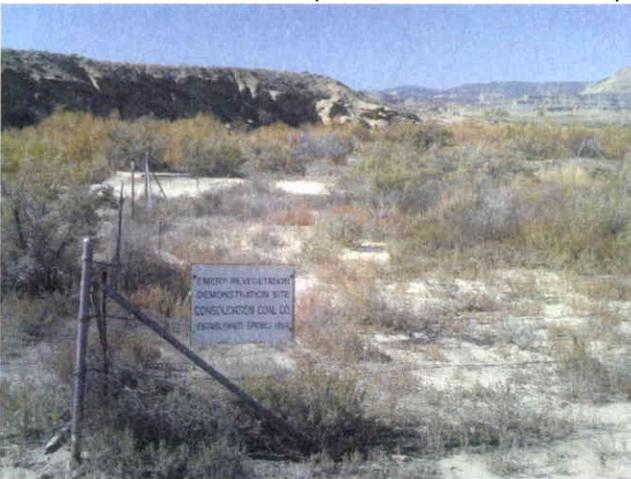
Site 19, Test Plot. The combined treatments of the test plots were reported to have 46% desirable cover. However the irrigated portion of the testplot had visibly more cover, approaching 80%. (Although only a few plots remained labeled, the irrigated portion was assumed to be that area where pipes and hoses remained.) The successful vegetation including grasses on the test plot was most likely due to irrigation. The importance of water to reclamation of the sites was evident in the vegetation surrounding site #6 pond 6, site #7 pond 5, and site #11 pond 1 banks.

Site #19 Test Plot location (46% desirable cover likely due to success of irrigation treatments.)
