Inspection Report

Permit Number:	C0150015
Inspection Type:	TECHNICAL
Inspection Date:	Wednesday, October 12, 2011
Start Date/Time:	10/12/2011 9:30:00 AM
End Date/Time:	10/12/2011 4:00:00 PM
Last Inspection:	Wednesday, October 12, 2011

Site: **EMERY DEEP MINE**

Technical Inspection Report #2985
Wednesday, October 12, 2011
Attachment A

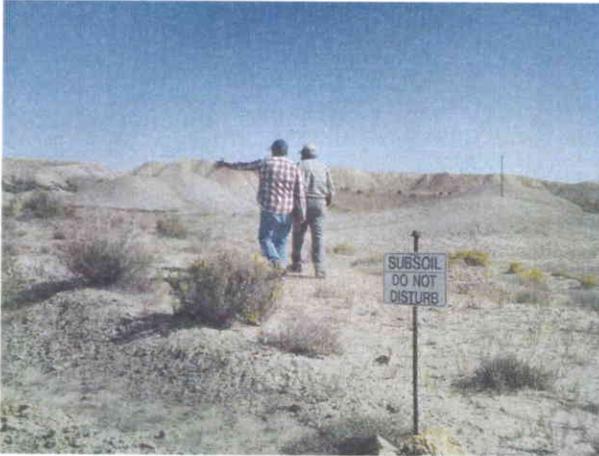
For topsoil and subsoil stockpile Sites # 1, #2, #9, #10, the vegetation on the level surface of these stockpiles appeared quite similar to the gently sloping, undisturbed surroundings. But on all piles, lower vegetation on the slopes was less than that of the desert shrub reference area. The reference area is located on fairly level ground, on top of the ridge. The difference in % desirable cover between these stockpiles and the reference area is likely due to topographic differences. Therefore, no action is recommended on these sites.

Below, site #1, Subsoil Pile from Ponds 4 & 5 (11.8% desirable cover in 2003)

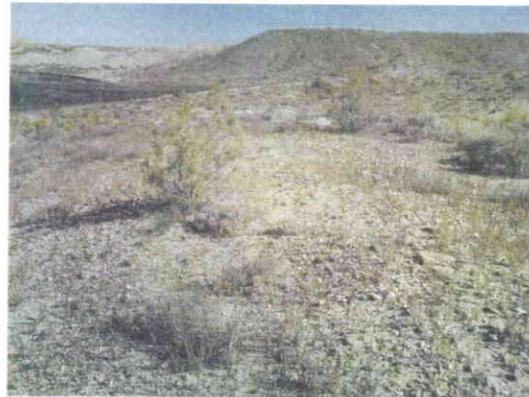
Right, site #2, Coal Pile Topsoil, (10.13% desirable cover in 2003)

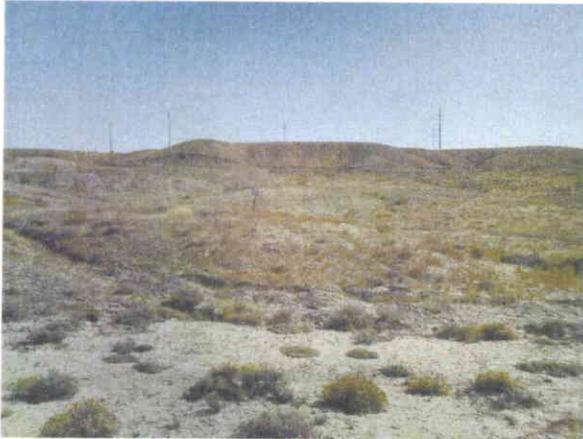
Below, site #9, Substation Topsoil Pile (6.4% desirable cover in 2003)

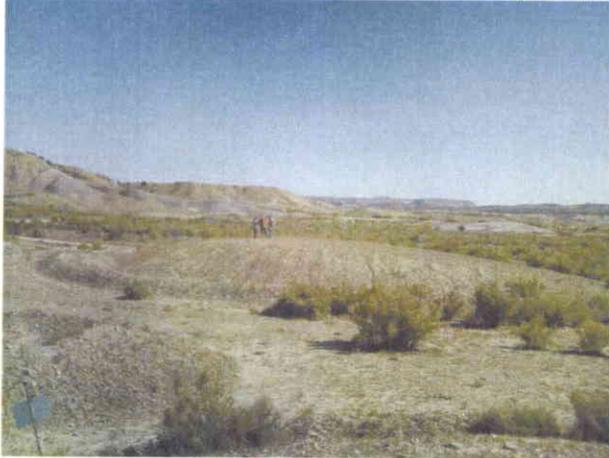
Sites #3 "pond 6 topsoil," Site #4 "pond 6 subsoil East", and Site #5 "subsoil pile West" from pond 6 construction had 0.27%, 11.14%, and 1.38% desirable cover in 2003. At the time of the inspection, all the piles appeared to have less than 1% cover. At the time the site visit, there were 20 head of horses grazing the topsoil and subsoil piles. The management of these piles is documented in Appendix III-1. Grazing on the piles has been historically a problem. The conical shape of the piles also likely has an effect on vegetation establishment. The recommendation action for these three piles is to remove grazing animals by fencing and grade the piles so that they have a lower profile, and are contiguous, but are still contained within the established footprint of the soil storage area. Sites 3 and 4 had very similar chemistry and their boundaries can be blurred. The subsoil west pile, site #5 had higher pH and SAR values and its boundaries should remain distinct. The regraded piles should then be seeded with a revised seed mix that emphasizes the shrubs noted to be successful on other topsoil and subsoil stockpiles: 4-wing saltbush, shadscale, gardner saltbush, mat saltbush, greasewood.

Sites #3, #4, #5, Pond #6 Topsoil and Subsoil stockpiles (0.27%, 11.14% and 1.38% desirable cover reported in 2003). Lack of cover due in part to 20 head of horses enclosed in topsoil/subsoil location. Below site #4 in background, site#3 on left of photo, berm of site #5 barely visible at bottom of photo.

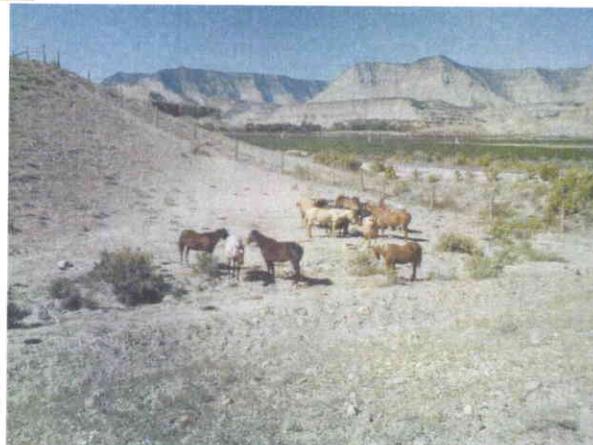
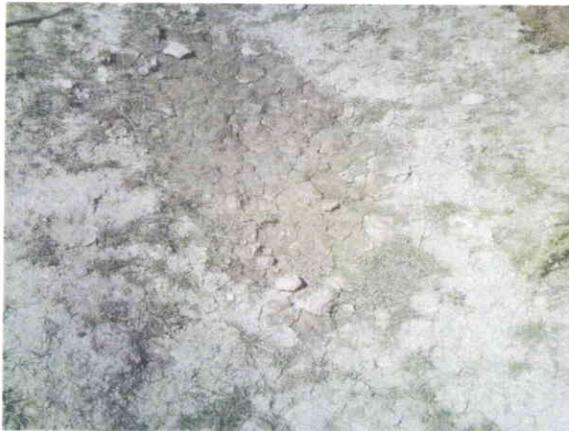
Twenty horses were enclosed within the topsoil/subsoil area.

Horses graze on grasses growing in the low spots. Overgrazing does not allow grasses to produce seed and reduces cover.

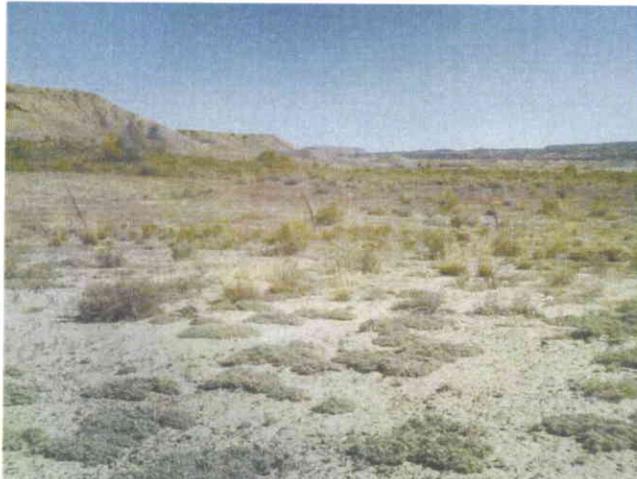
The pond 6 pipeline road was reclaimed in 1987. It was not part of the Appendix III-1 study. According to Steve Behling, it had straw incorporated into the soil with discing and was seeded. The site is marked by roof bolts, but otherwise is undistinguishable from its surroundings. The vegetation is a monoculture of mat saltbush. Some seeded grasses are in low lying areas down wind. All agreed that this site has successfully reclaimed after 24 years. The discing of straw into the soil should be applied to other reclamation sites.

Successful reclamation on the Pond #6 Pipeline Road, reclaimed in 1987. This location was not part of the 2003 study.

Lastly, we recommended that the final reclamation methodology is revised for all sites, to reflect the successful methods used at the 4th east portal topsoil pile and on the Pond 6 pipeline road. The 4th East portal reclamation treatments included the incorporation of 1T/ac straw with surface roughening and hydroseed and hydromulch with a mixture of cool season grasses as well as shrubs noted to be successful on topsoil and subsoil sites in Appendix III-1 (i.e. 4-wing saltbush, mat saltbush, gardner saltbush, shadscale, greasewood). Irrigation may not be practical, but seeding should be timed for late August to January to take advantage of either the late summer/early fall rains and/ or the early spring snow melt.

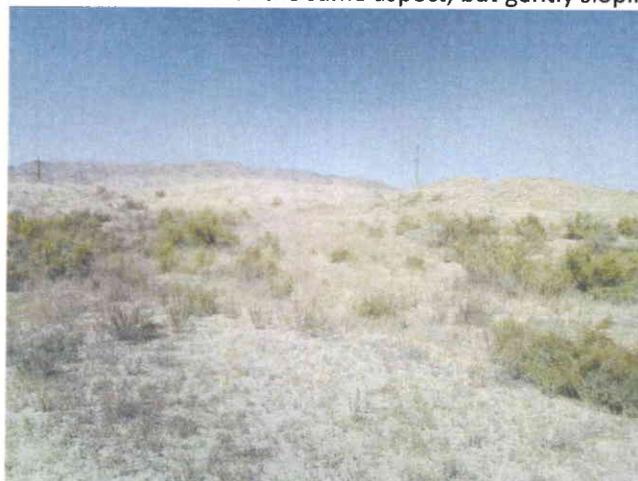
Site #8, the borehole reclaimed road had only 2.6% desirable cover. This road had no topsoil removed and reclamation treatments were limited to seeding. In retrospect, this site might have benefitted from deep ripping, incorporation of straw and hydroseed/mulching methods.

Compare the above photo with Site #8, Borehole reclaimed road (2.6% desirable cover in 2003). This site is a half mile east with the same aspect, but gently sloping topography.

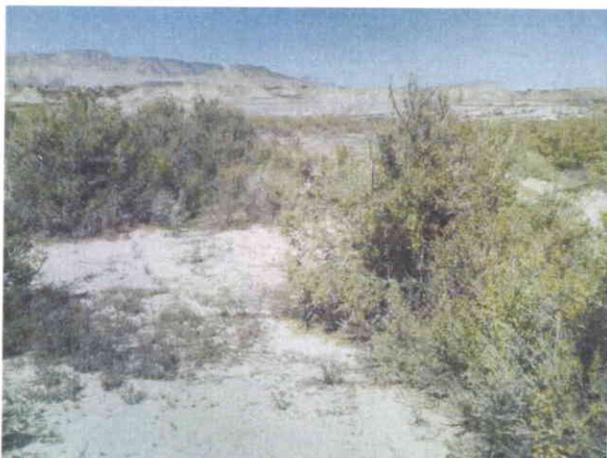
Below, site #10, Topsoil Pile from Pond #1 (10.53% desirable cover in 2003)

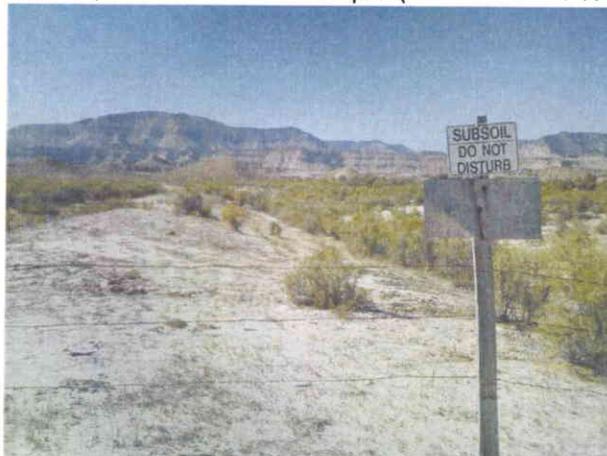
Site 14, the subsoil for pond #1 may be incorrectly referenced, according to Steve Behling it may be topsoil from the adjacent swale that runs parallel to it. In any event it could be reseeded.

Site #14, is labeled "Pond #1 Subsoil Stockpile." However, it is very far from pond 1 and appears to be soil excavated from the adjacent trench for a pipeline. Site #14 has 3.2% desirable cover. It is recommended that this site be reclaimed using the techniques recommended under the Revegetation section below.

Site #14, Pond #1 subsoil stockpile (3.2% desirable cover in 2003)

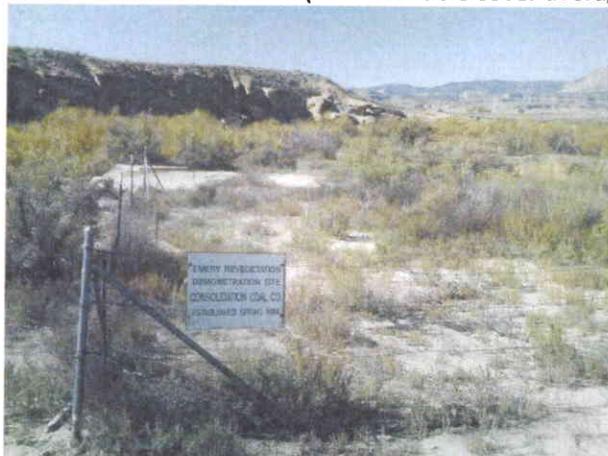
Site 19, Test Plot. The combined treatments of the test plots were reported to have 46% desirable cover. However the irrigated portion of the testplot had visibly more cover, approaching 80%. (Although only a few plots remained labeled, the irrigated portion was assumed to be that area where pipes and hoses remained.) The successful vegetation including grasses on the test plot was most likely due to irrigation. The importance of water to reclamation of the sites was evident in the vegetation surrounding site #6 pond 6, site #7 pond 5, and site #11 pond 1 banks.

Site #19 Test Plot location (46% desirable cover averaged over all treatments)
