Consolidation Coal Company

Re: Emery Deep Mine Permit C/015/015  
Midterm Review task id #4363  
2013 Subsidence Update

Subject: Emery Mine Subsidence Inspection

**Photographs of Subsidence  
(Date: 18 Sep 2013)**

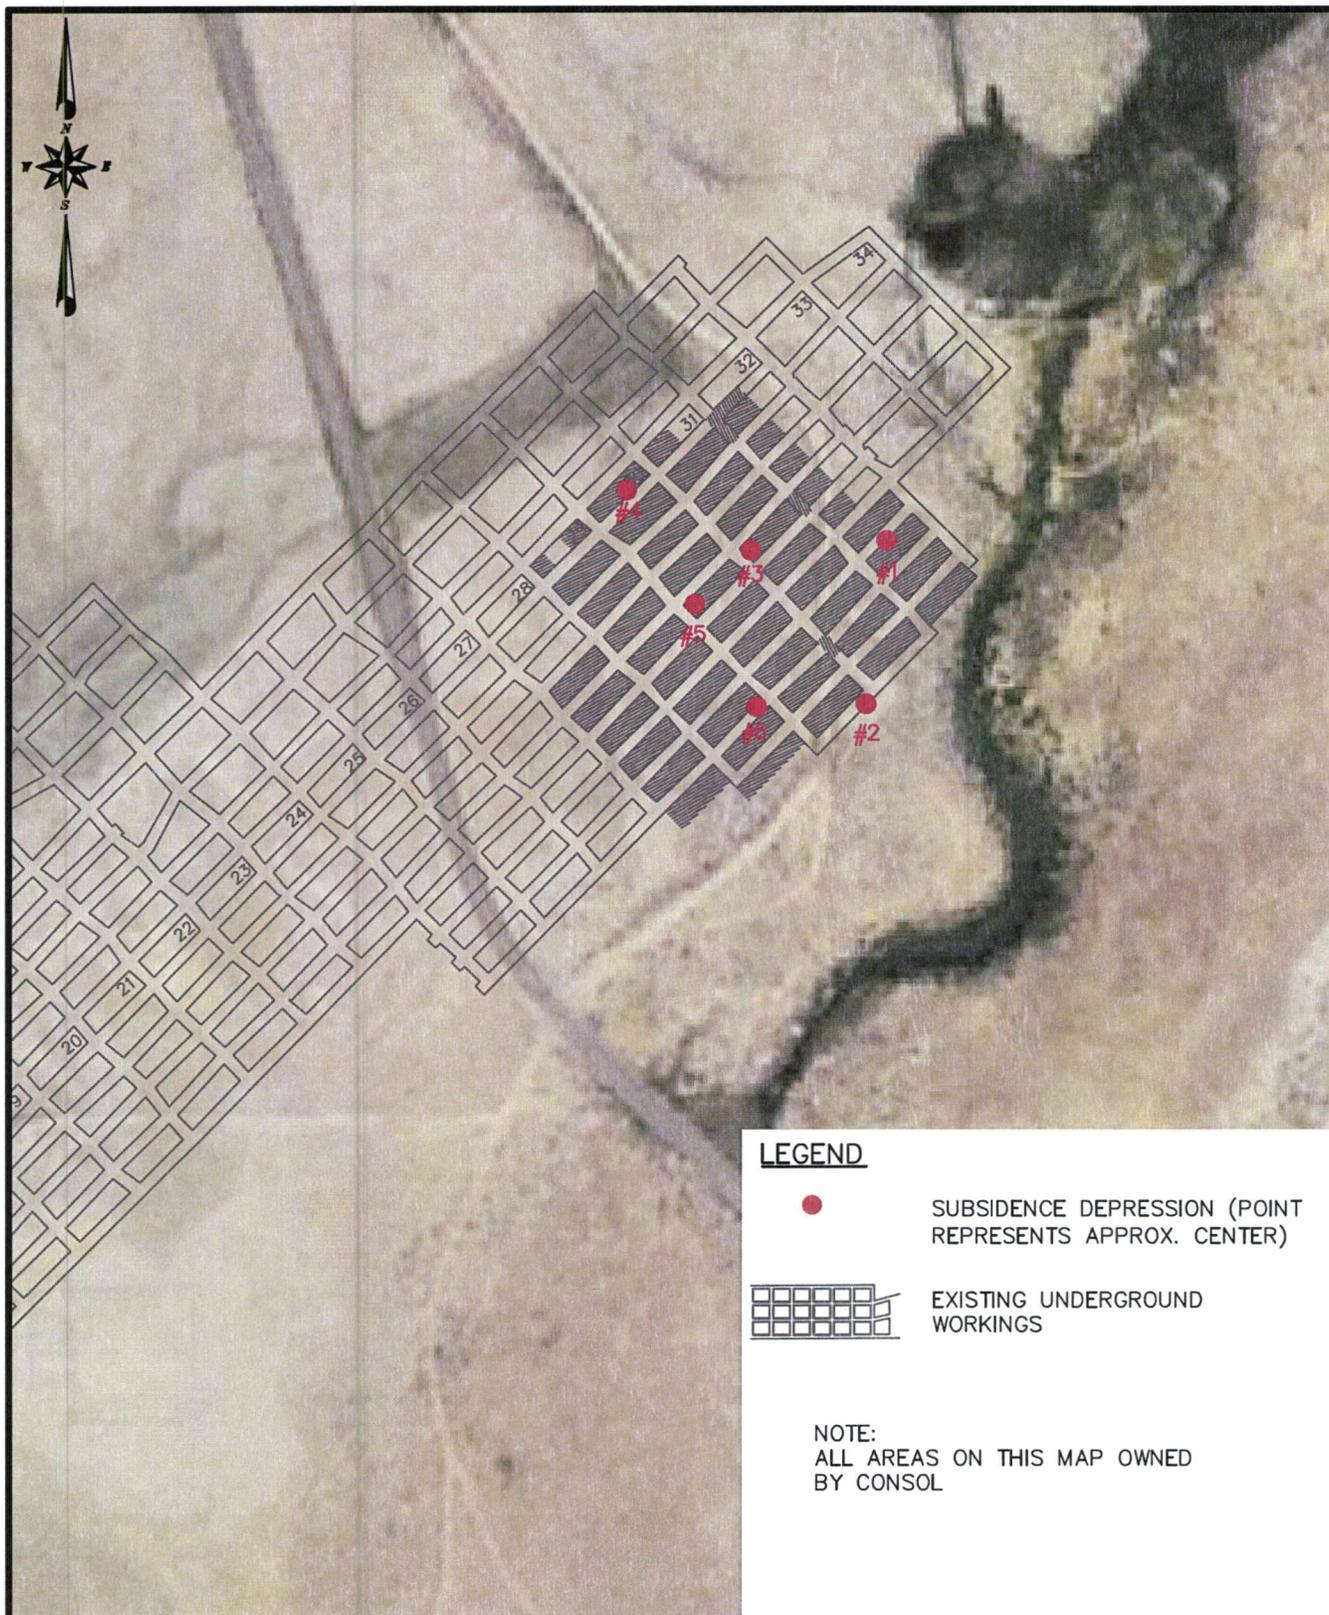
FIGURE 1. EMERY MINE SUBSIDENCE DEPRESSIONS

During the September 18, 2013 inspection, I observed six subsidence depressions in the subject area. The coordinates of these depressions are provided in Table 1 and the locations relative to the 00 North panel are shown on Figure 1. Photographs of conditions in each depression are provided in Attachment A. These conditions are briefly described below. All depressions are located on land owned by Consol.

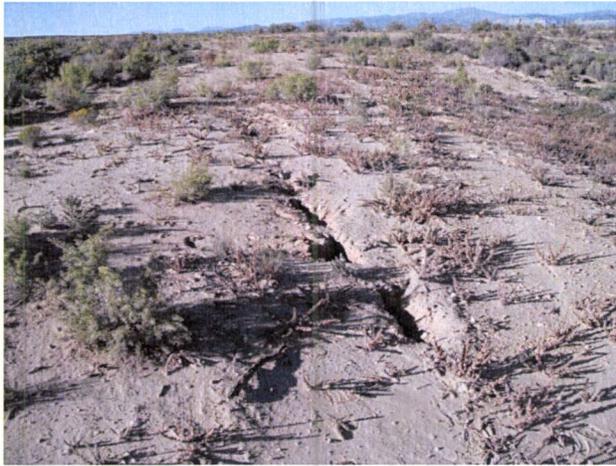
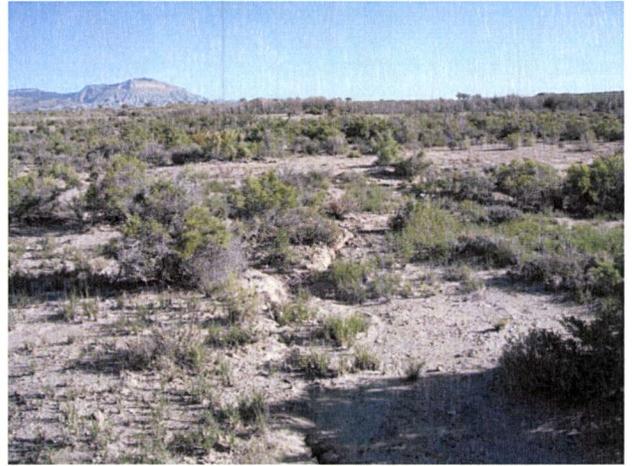
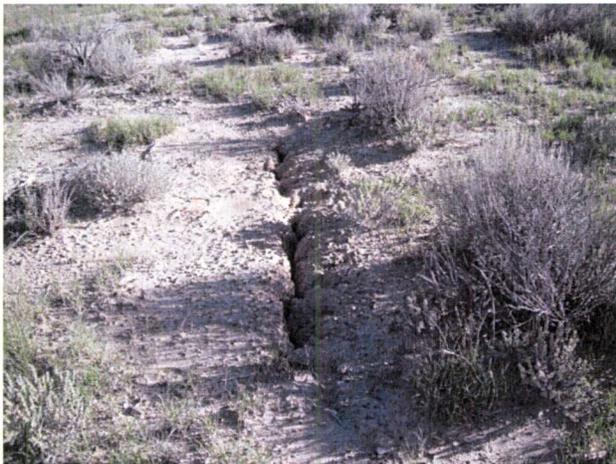
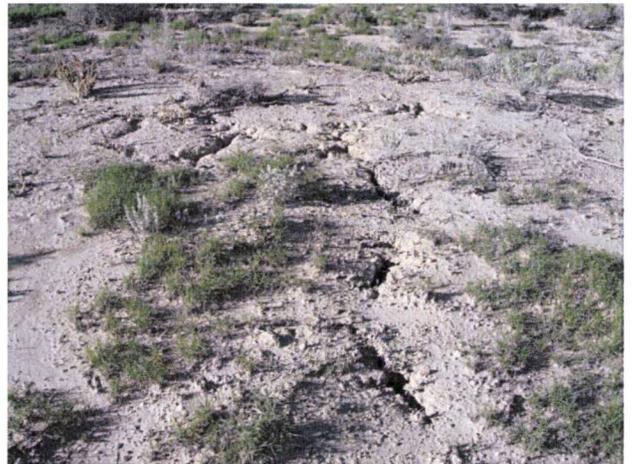
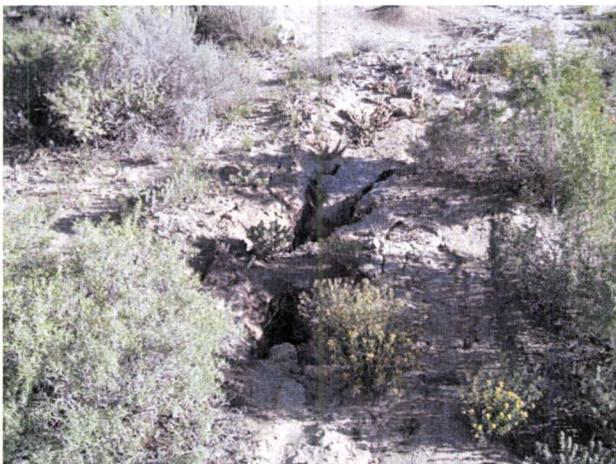
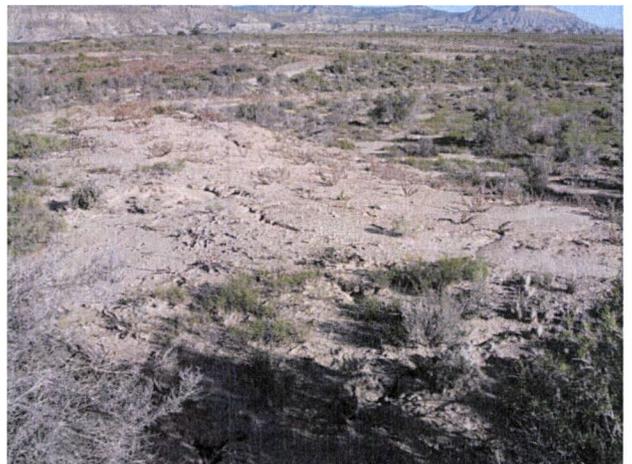
DEPRESSION #1

This depression covers an area of approximately 300 feet (North-South) by 150 feet (East-West). Subsidence cracks were observed primarily around the periphery of the depression. These cracks range up to a few inches in top wide and greater than 3 feet deep in some areas.

From observations of sediment in several of the subsidence cracks and surface rills, it appears that the surface expressions of the subsidence cracks were enhanced by localized runoff from recent storm events. To ensure that the crack surfaces are not bridged by future grading, it is recommended that the deeper cracks be filled first by hand shoveling. The areas can then be graded with a dozer or other large equipment. During grading, the mitigated areas should be compacted by repeated passes of the grading equipment.

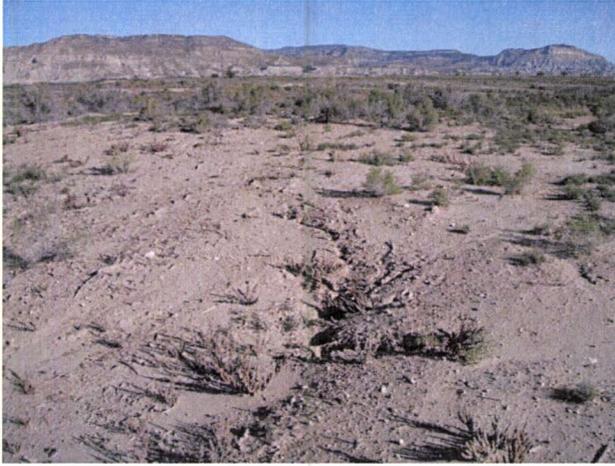
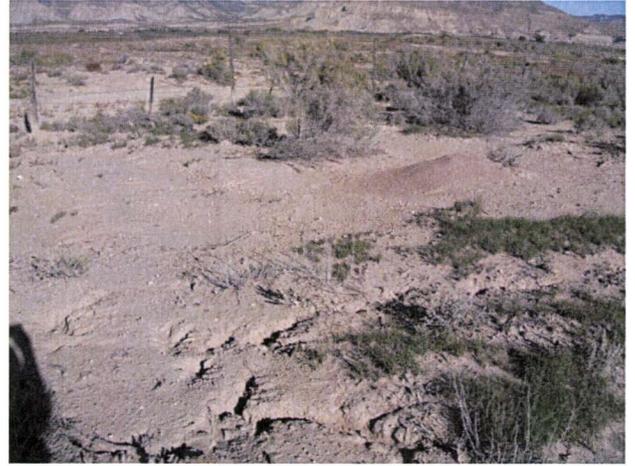
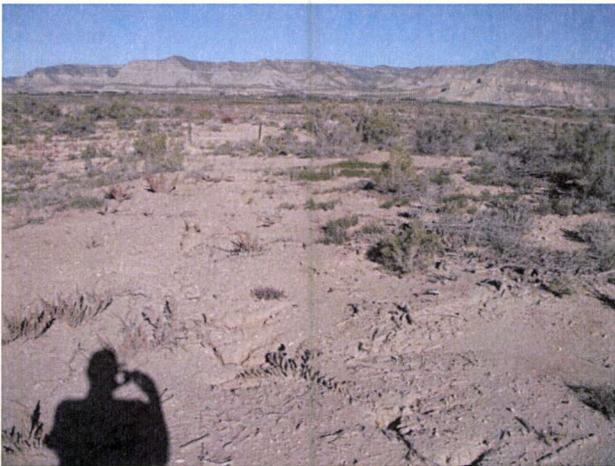
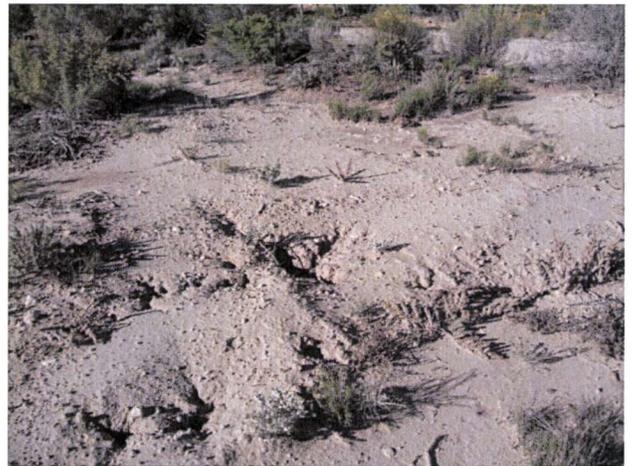
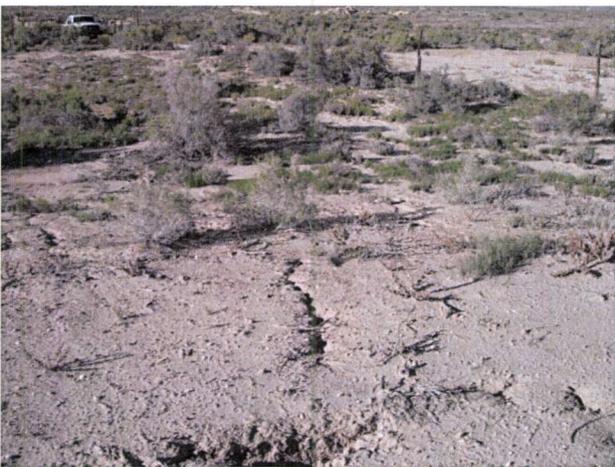
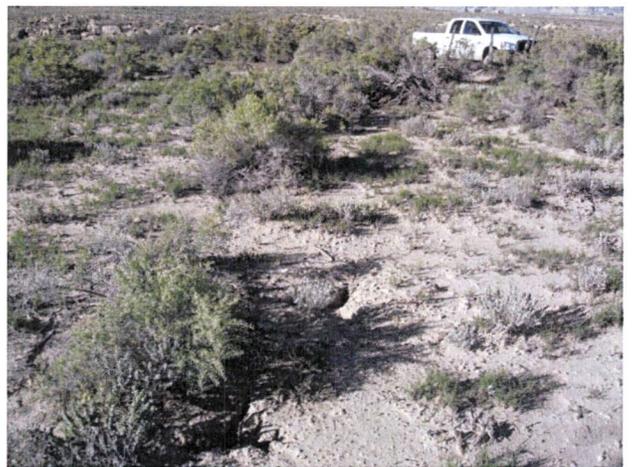
DEPRESSION #2

This depression measures approximately 120 feet (N-S) by 70 feet (E-W) and is located immediately south of Depression #1. Subsidence cracks were observed primarily around the periphery of the depression. These cracks range up to a few inches in top wide and greater than 3 feet deep in some areas.

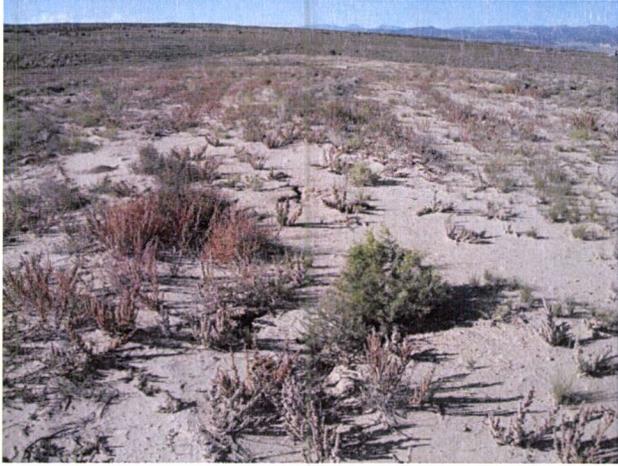
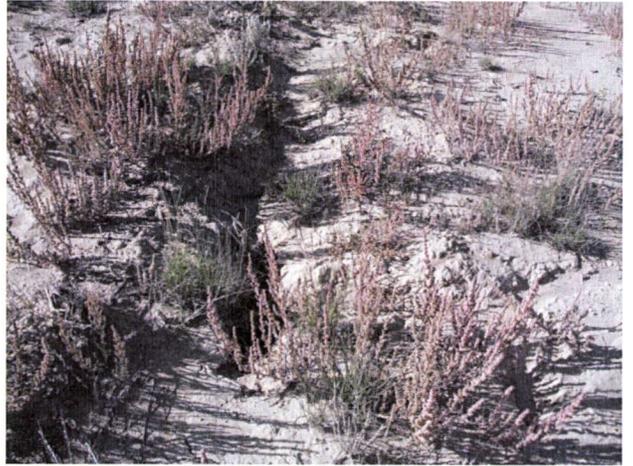
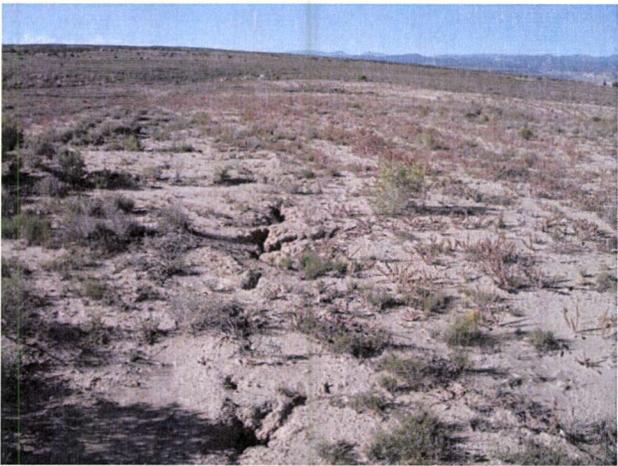
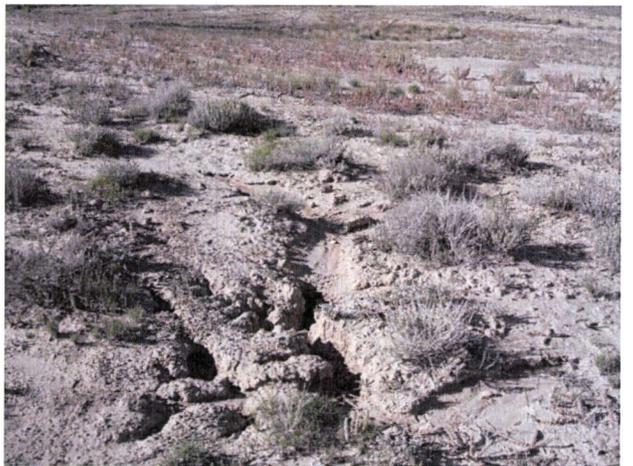
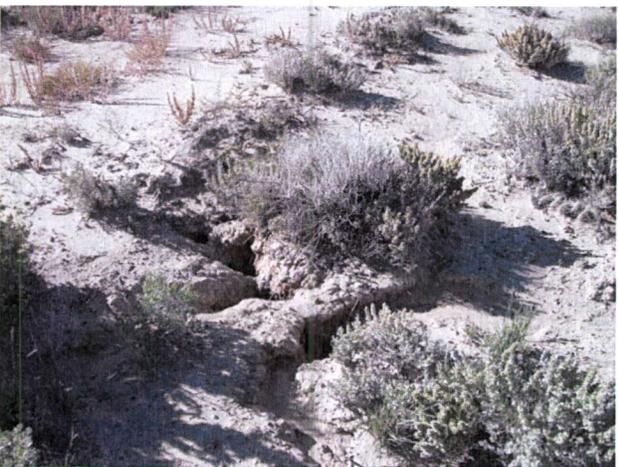
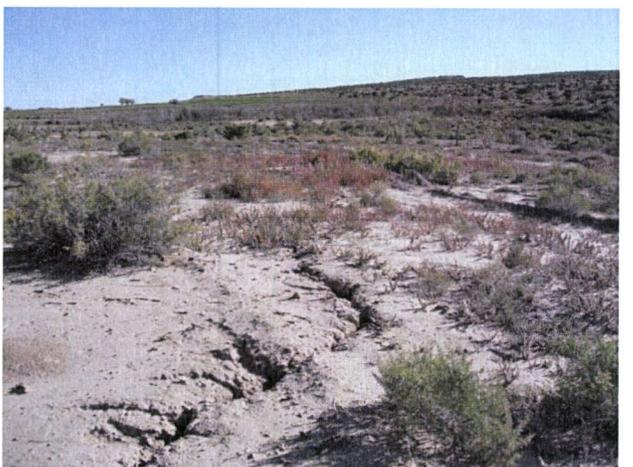
DEPRESSION #3

This depression is located immediately west of Depression #1. It covers an area that measures about 300 feet (N-S) by 220 feet (E-W). Most of the observed cracks are on the west side of the depression. Most cracks are less than 1 foot deep, but a few exceed 3 feet in depth.

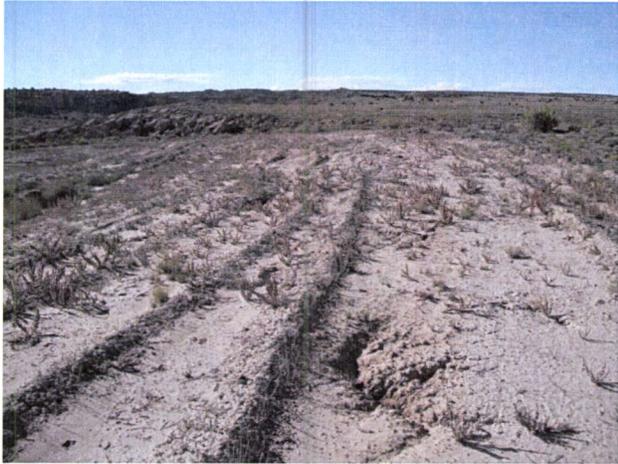
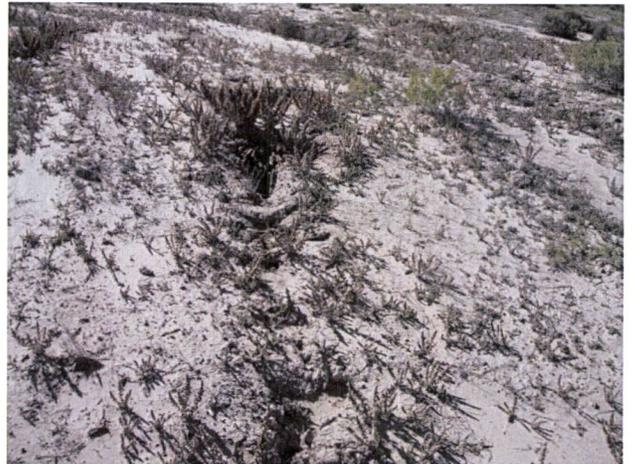
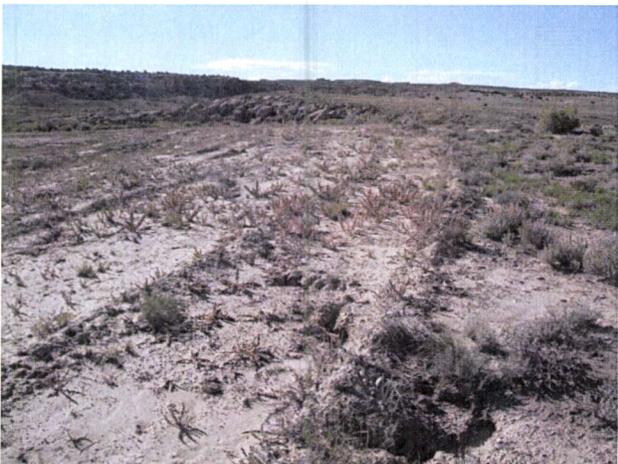
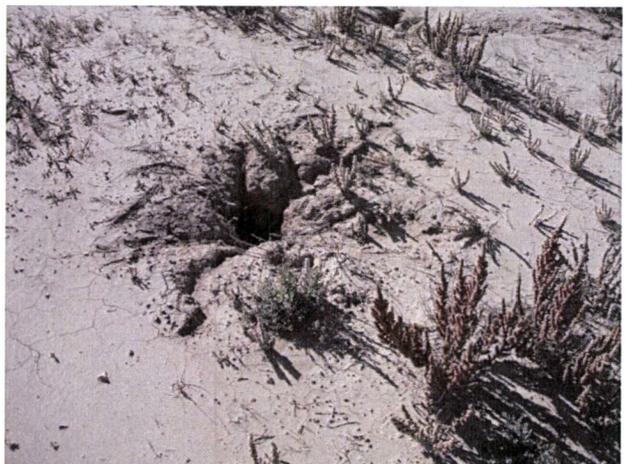
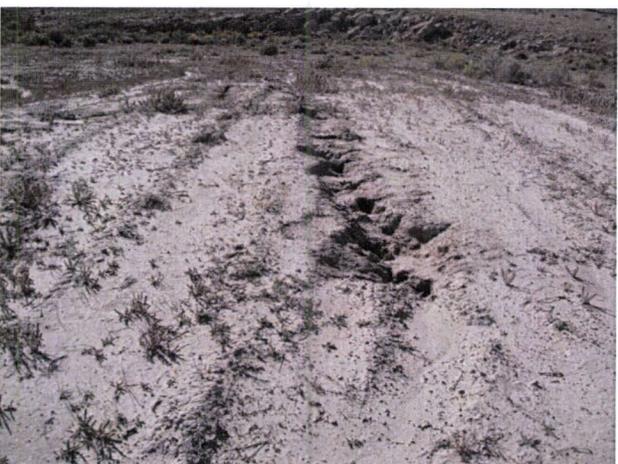
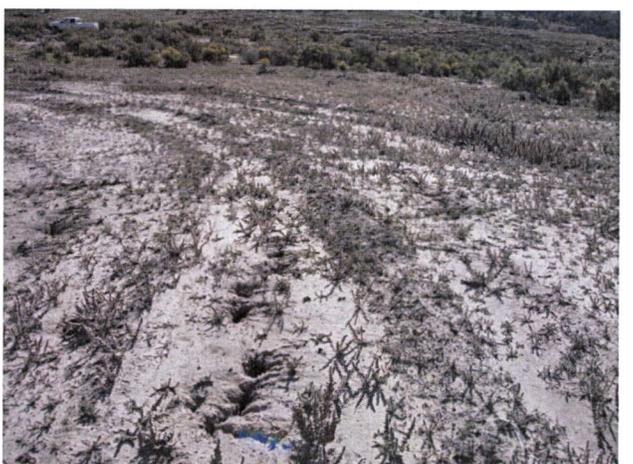
DEPRESSION #5

This depression is nearly circular, measuring about 180 feet (N-S) by 200 feet (E-W). Subsidence cracks were observed primarily around the periphery of the depression. These cracks range up to a few inches in top wide and greater than 3 feet deep in some areas.

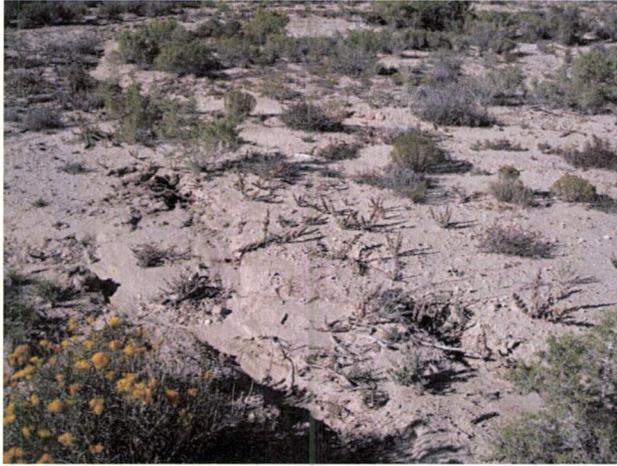
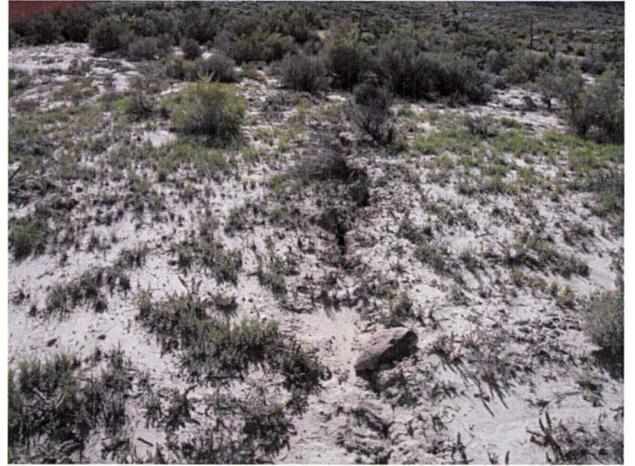
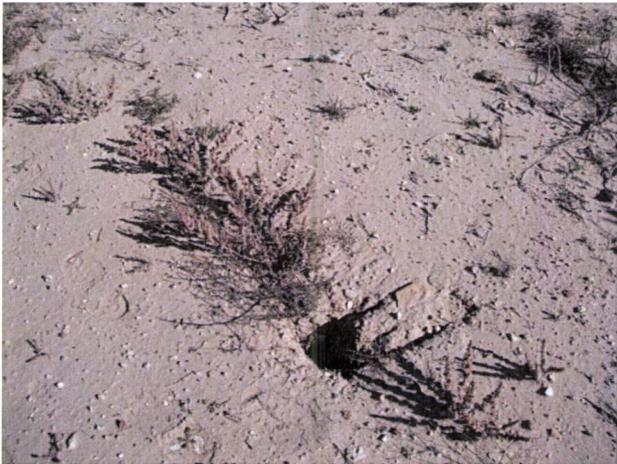
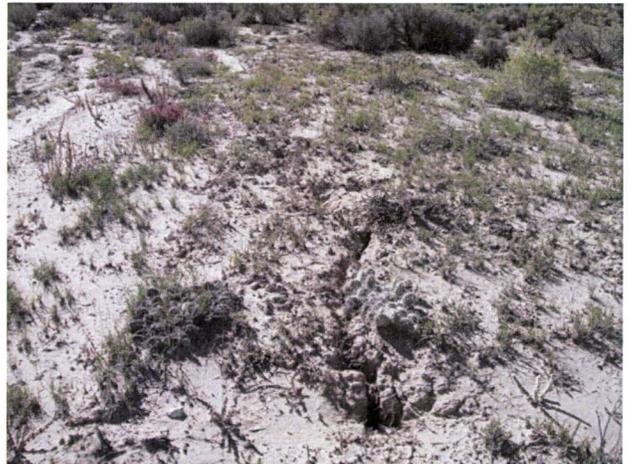
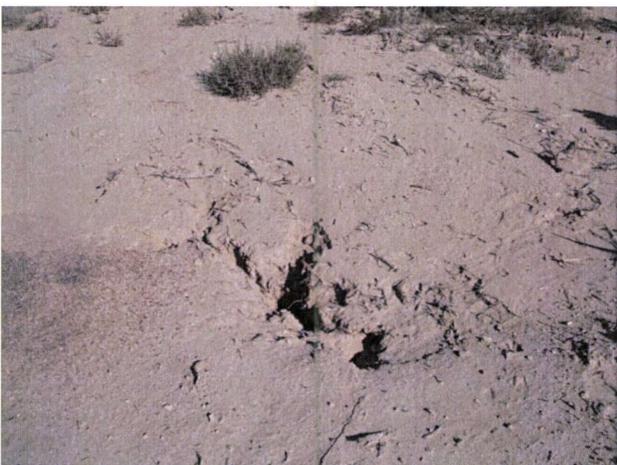
DEPRESSION #6

This depression is located between Depressions #2 and #5. It is approximately circular, measuring about 120 feet (N-S) by 100 feet (E-W). The depression contains a few cracks around the periphery, with one crack on the south side of the depression measuring more than 3 feet deep. Most of the other cracks are less than 1 foot deep.
