# WATER QUALITY MEMORANDUM

## Utah Coal Regulatory Program

RE: 4<sup>th</sup> Quarter 2013 Water Monitoring, Consolidation Coal Company, LLC, Emery Deep Mine, C/015/0015, WQ13-4, Task ID #4474

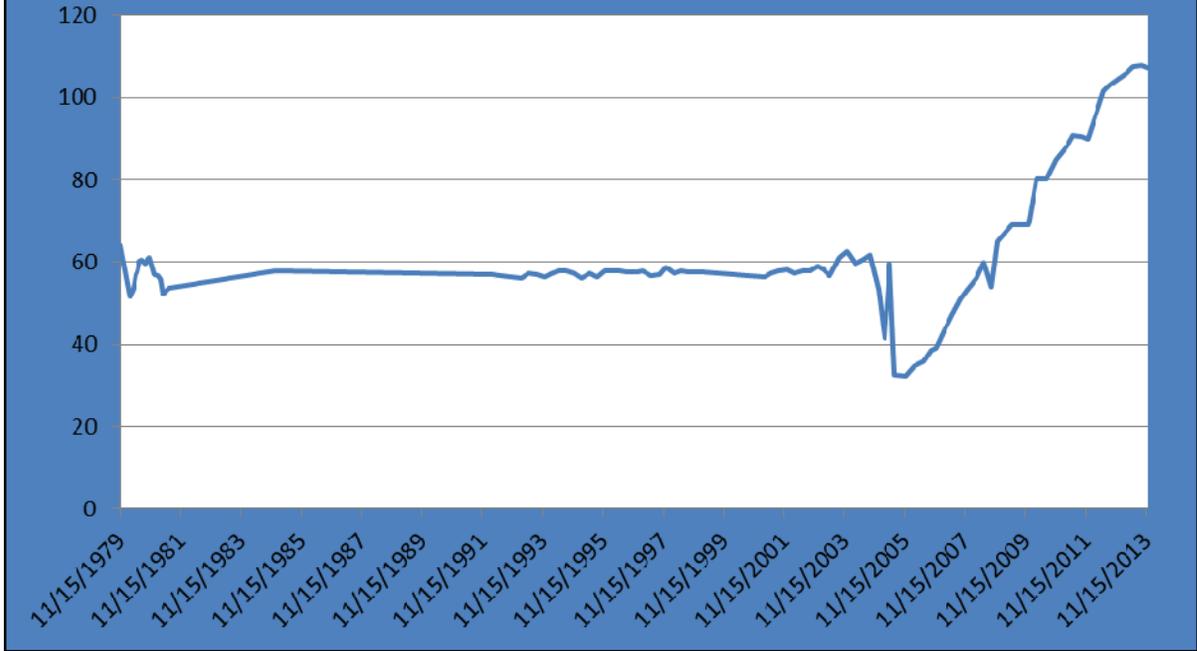
### H-U Depth to Water (ft)

Sample ID	Date	Type of Site	Parameter	Value	Average	STD. Deviations
H-U	12/06/2013	Monitoring Well	Depth	107.2'	58.14'	4.08
T1-U	12/05/2013	Monitoring Well	Depth	43'	326.22'	2.60

Water monitoring well H-U continues to show a drop in water level. The water level in monitoring well H-U has developed a downward trend since November 24<sup>th</sup>, 2010. It's unclear as to what is causing the drop in water level.

The Division will continue monitoring efforts at the Sundstrom property. Water depth levels in monitoring well H-U will also continue.
