# WATER QUALITY MEMORANDUM

## Utah Coal Regulatory Program

RE: 2<sup>nd</sup> Quarter 2014, Water Monitoring, Consolidation Coal Company, LLC, Emery Deep Mine, C/015/0015, WQ14-2, Task ID #4615

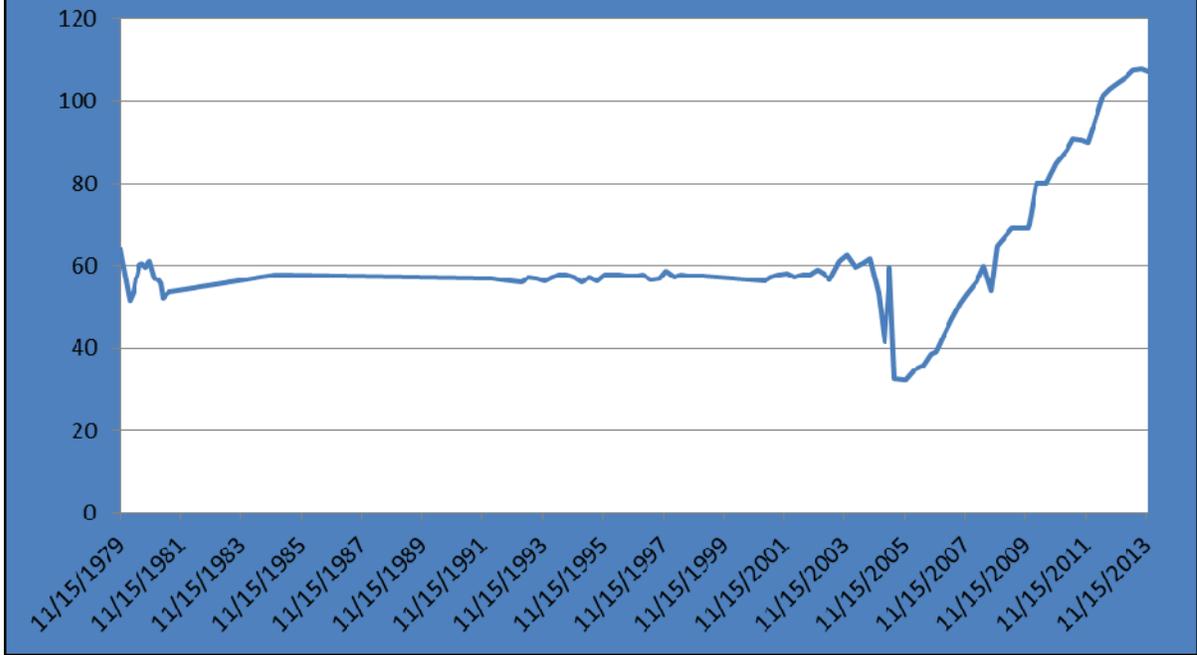
### H-U Depth to Water (ft)

The depth to water data for water monitoring well H-U has produced significant variations. Water levels were fairly consistent from the early 1980's to approximately mid-2005 (50-60' depth to water). In the summer months of 2005, the water level rose to the 30-40' range before exhibiting a significant drop that continues to the present. The current depth to water at monitoring well H-U is 106' based on the most recent data provided by the Permittee (See chart below).
