C/015/0015
Received 3/23/15
Task ID #4821

Annual Report

Company Name	CONSOL Mining Company LLC	Mine Name	Emery Deep Mine
Permit Number	C/015/0015	Permit expiration Date	1/07/2016
Operator Name	CONSOL Mining Company LLC	Phone Number	+1 (724) 485-4267
Mailing Address	1000 CONSOL Energy Drive	Email	kerrygoodballet@consolenergy.com
City	Canonsburg		
State	PA	Zip Code	15317

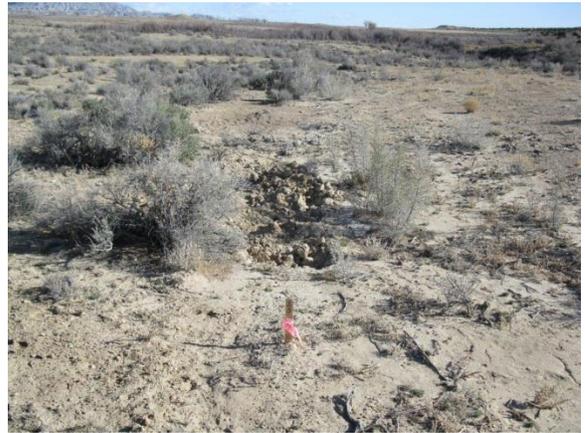
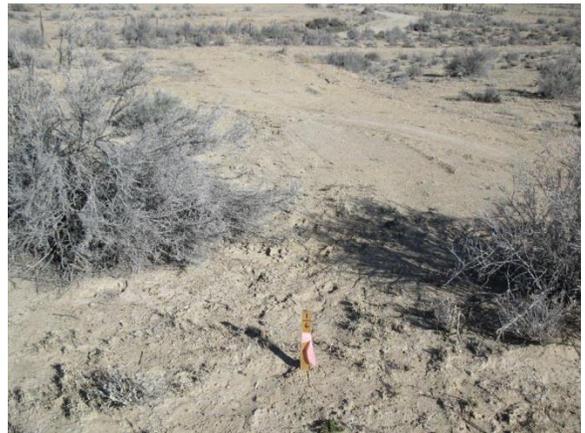
Depression #1 - March 28, 2014

On March 28, 2014, Russel Jensen of Consol Energy walked the area over the 00 North section of the Emery Mine. No new subsidence cracks or additional movement were observed. Mr. Jensen photographed all staked subsidence locations. Copies of these photographs are provided in Attachment A.

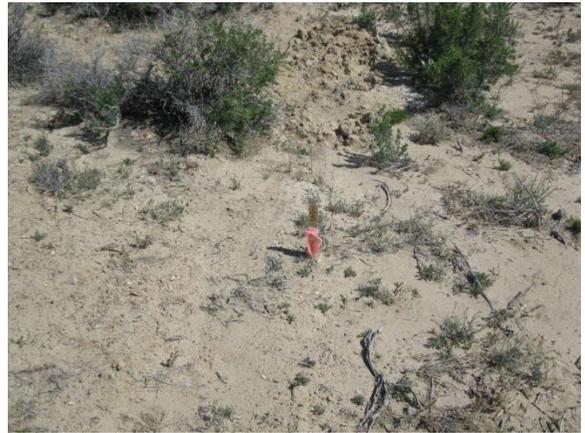
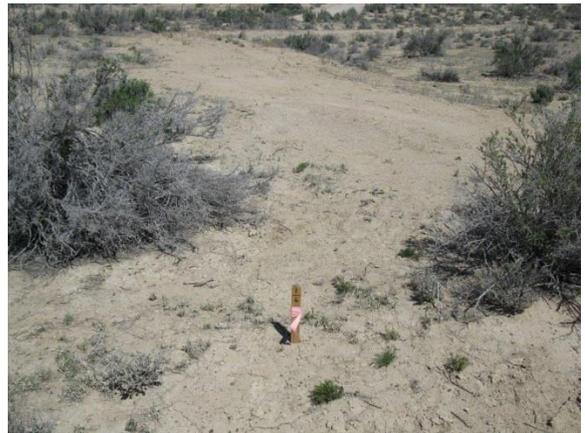
Depression #1 - April 29, 2014

On April 29, 2014, Russel Jensen of Consol Energy walked the area of six known subsidence depressions and photographed all staked areas. No new movement or new cracks were observed. He also walked the entire area around the outside of the known subsidence areas and observed no new depressions or cracks. Copies of the photographs are provided in Attachment A.

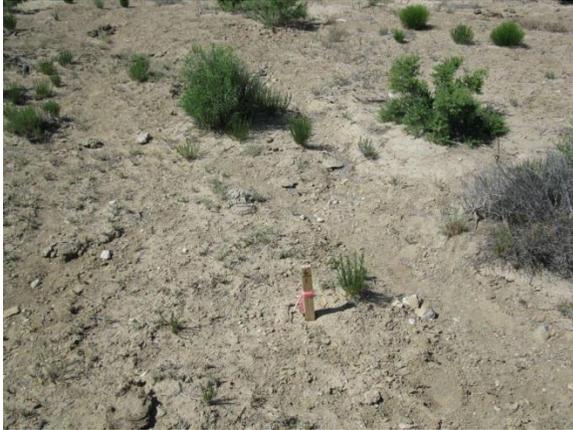
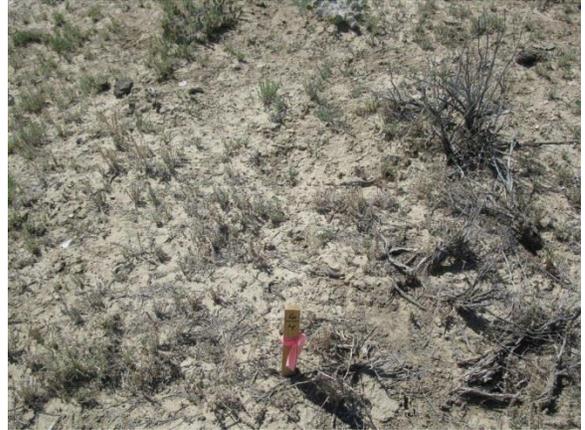
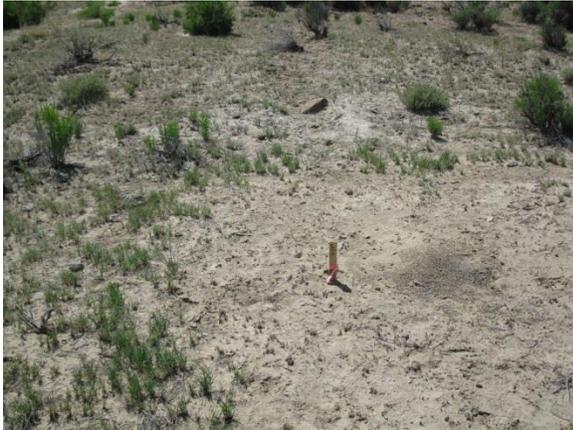
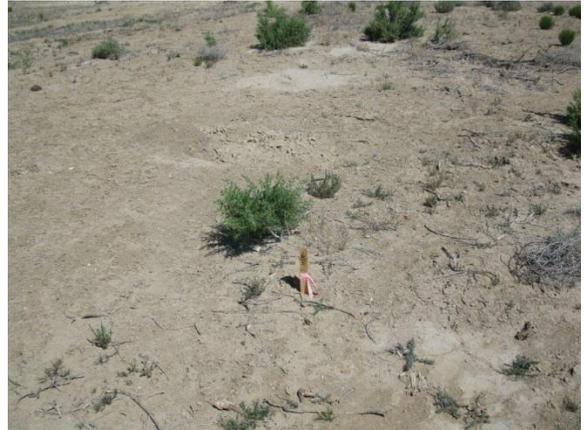
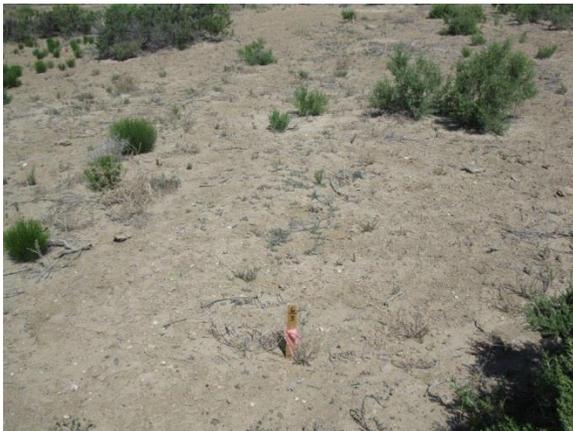
Depression #6 - May 30, 2014

On May 30, 2014, Russel Jensen of Consol Energy walked the area of six known subsidence depressions over 00 North and photographed all staked areas. He observed no new cracks. He also walked the surrounding area and observed no new depressions or cracks. Copies of the photographs are provided in Attachment A.

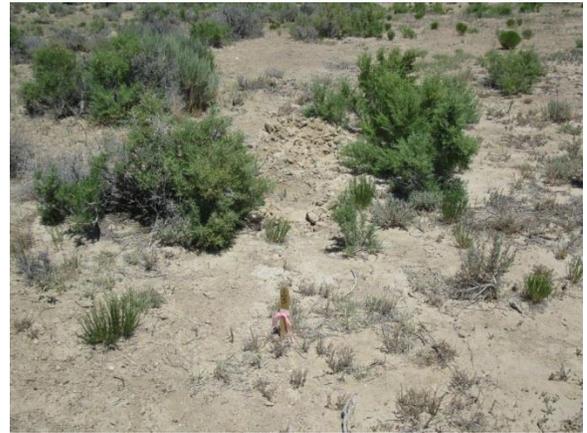
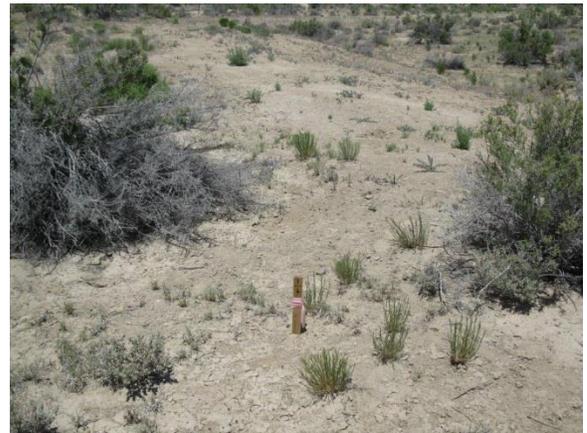
Depression #1 - June 25, 2014

On June 26, 2014, Russel Jensen of Consol Energy walked the area of six known subsidence depressions over 00 North and photographed all staked areas. He observed no new cracks. He also walked the surrounding area and observed no new depressions or cracks. Copies of the photographs are provided in Attachment A.

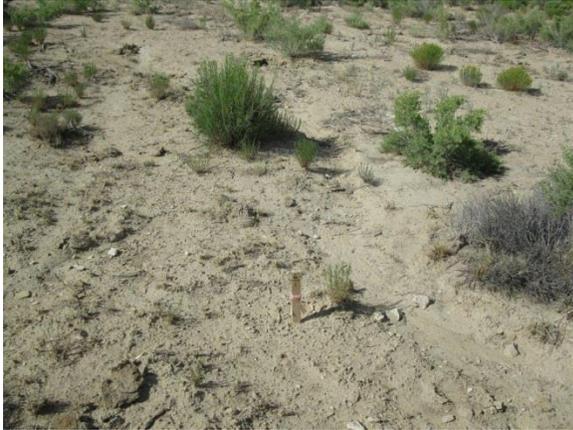
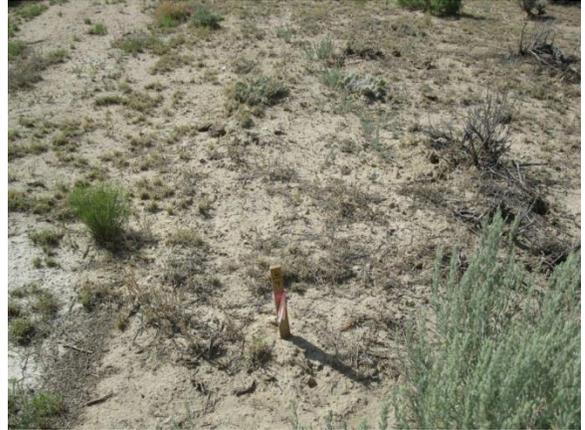
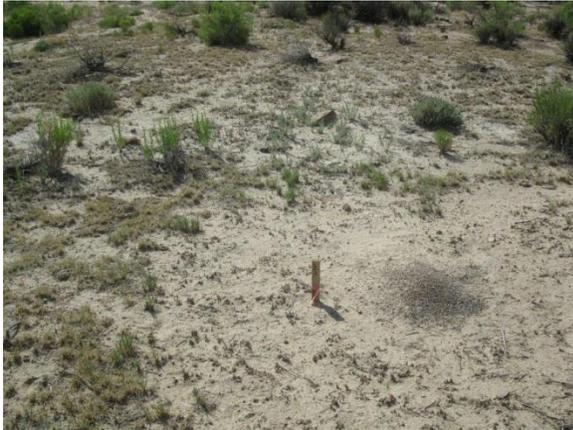
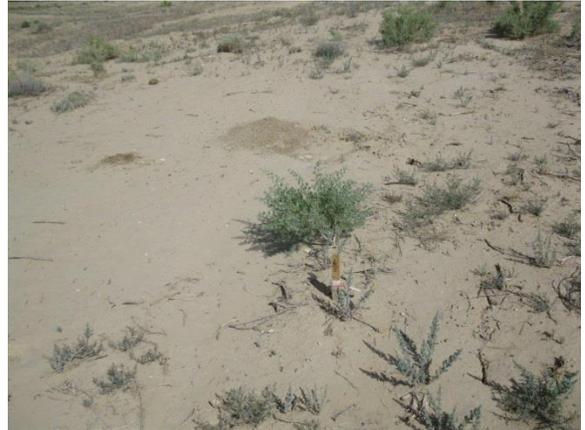
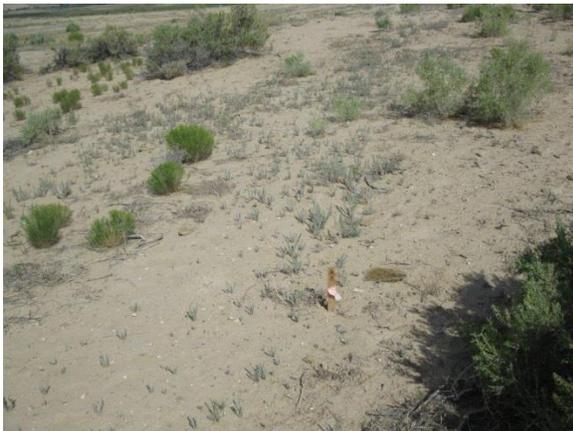
Depression #6 - July 25, 2014

On July 25, 2014, Russel Jensen of Consol Energy walked the area of the six known subsidence depressions over 00 North and photographed all staked areas. He observed no new cracks. He also walked the surrounding area and observed no new depressions, cracks, or damage. Copies of the photographs are provided in Attachment A.

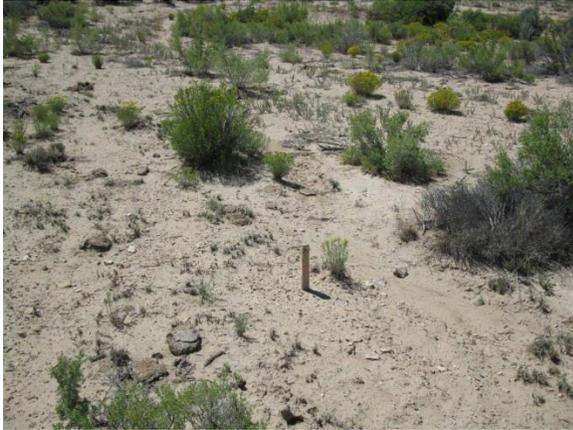
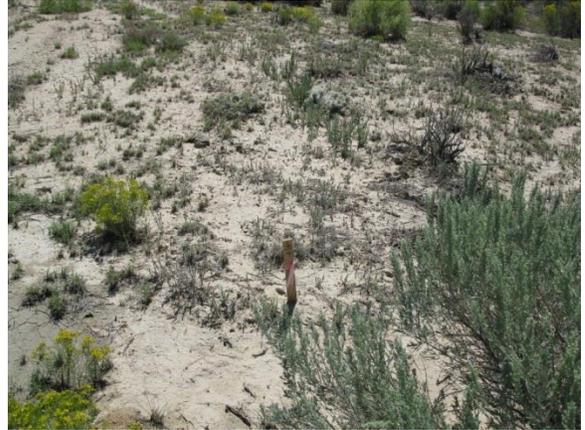
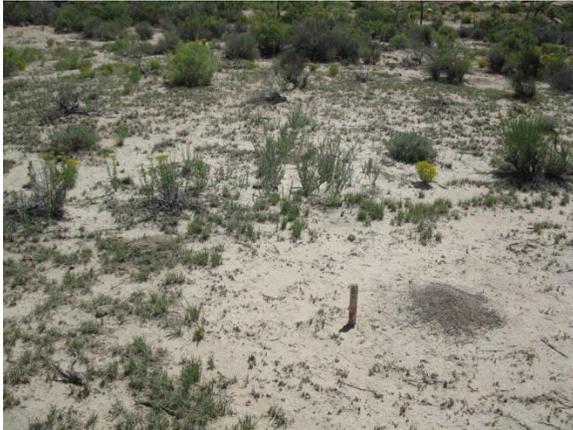
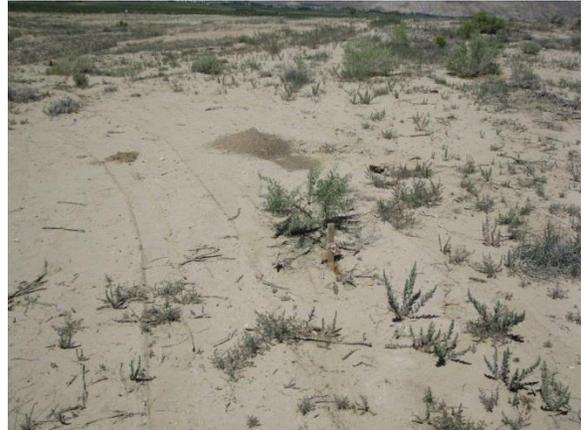
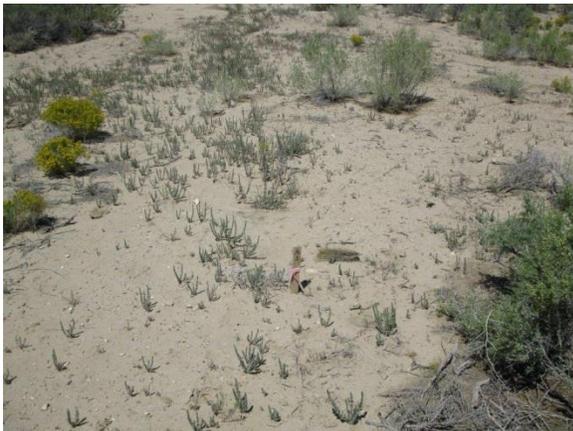
Depression #6 - August 25, 2014

On August 25, 2014, Russel Jensen of Consol Energy walked the area of the six known subsidence depressions over 00 North and photographed all staked areas. He observed no new cracks or damage. He also walked the surrounding area and observed no new depressions, cracks, or damage. Copies of the photographs are provided in Attachment A.

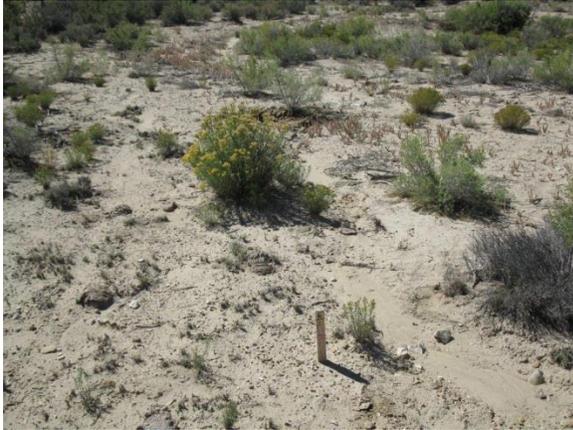
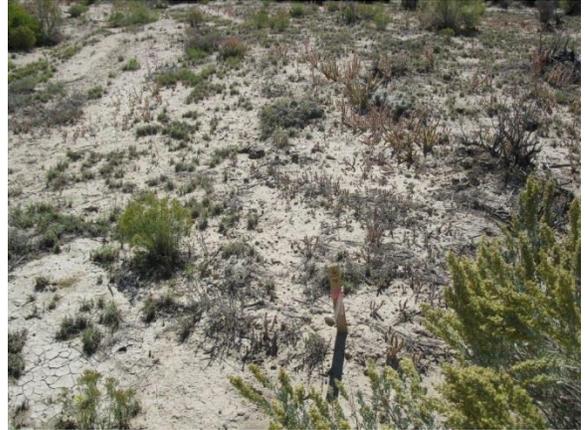
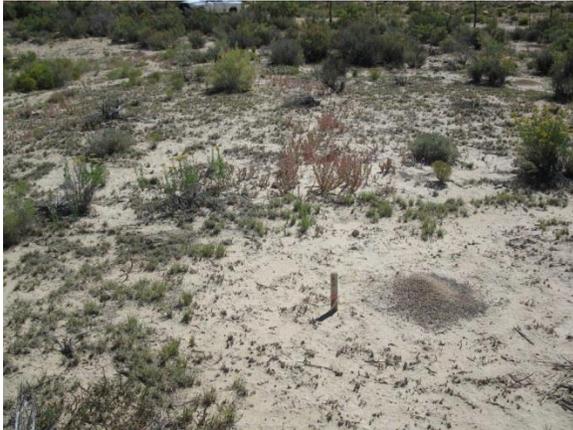
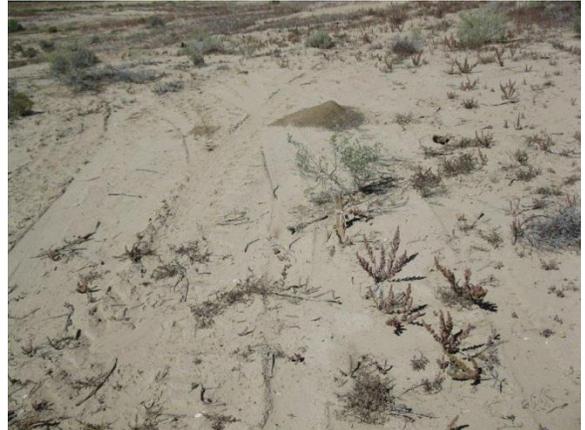
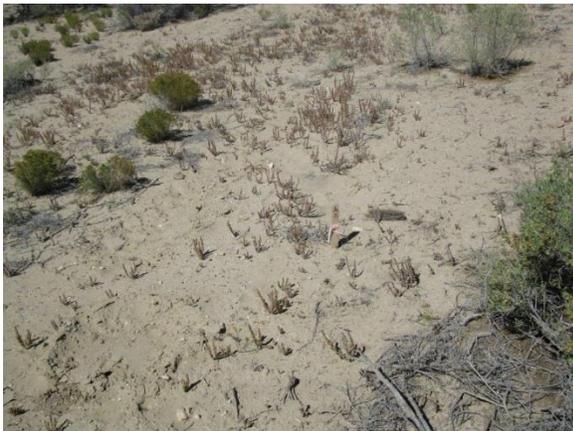
Depression #6 - September 24, 2014

On September 24, 2014, Russel Jensen of Consol Energy walked the area of the six known subsidence depressions over 00 North and photographed all staked areas. He observed no new cracks or damage from subsidence. He also walked the surrounding area and observed no new depressions, cracks, or damage. Copies of the photographs are provided in Attachment A.

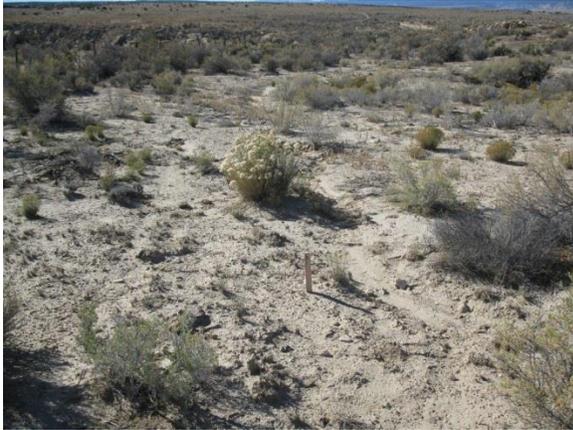
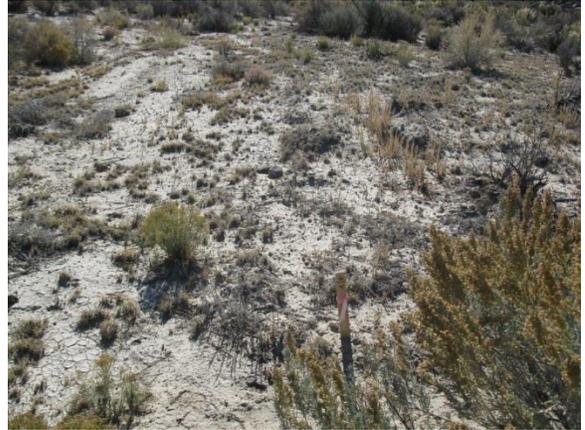
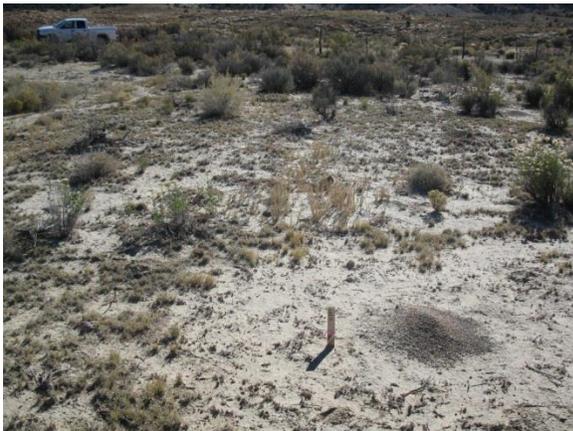
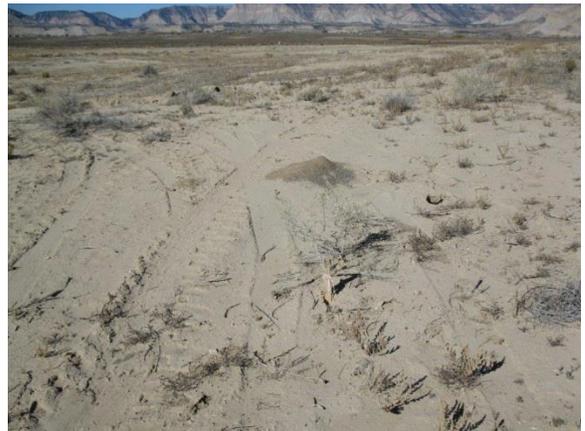
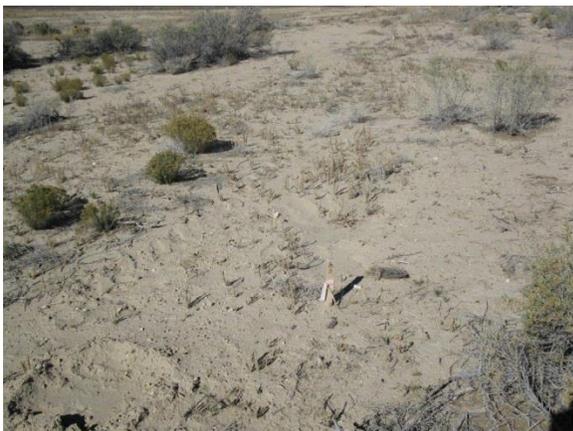
Depression #6 - October 28, 2014

On October 28, 2014, Russel Jensen of Consol Energy walked the area of the six known subsidence depressions over 00 North and photographed all staked areas. He observed no new cracks or damage from subsidence. He also walked the surrounding area and observed no new depressions, cracks, or damage. Copies of the photographs are provided in Attachment A.

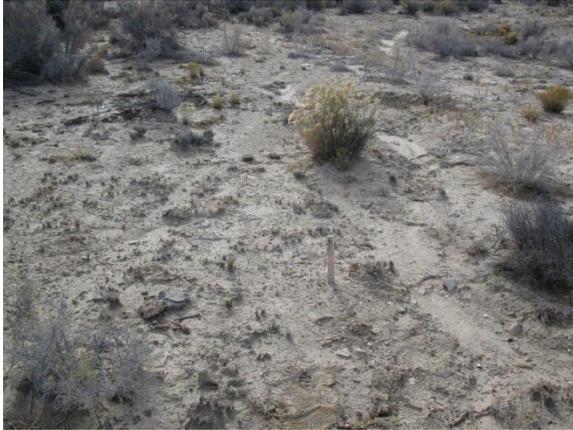
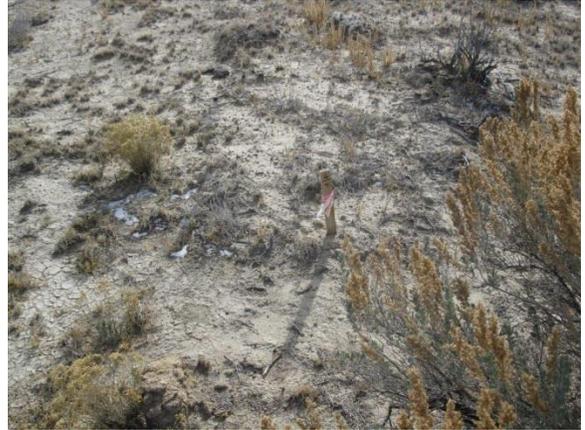
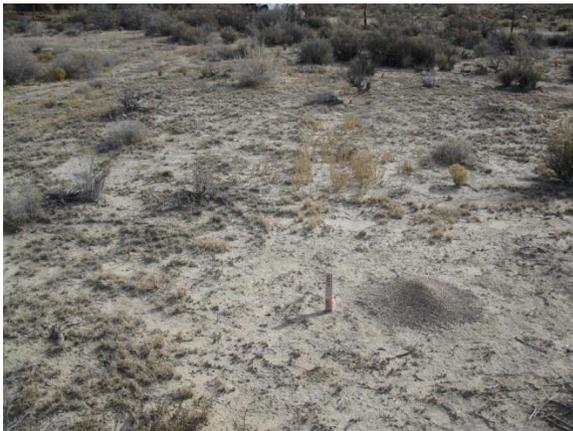
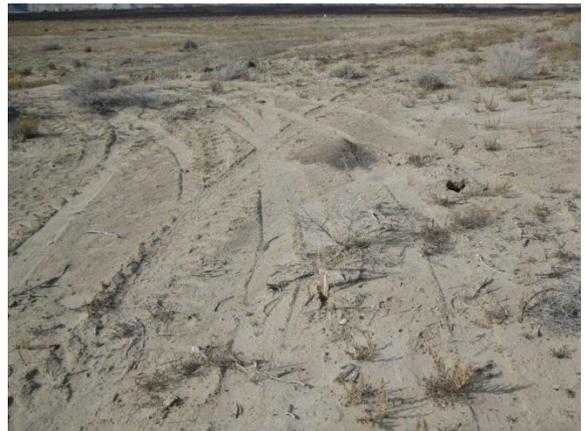
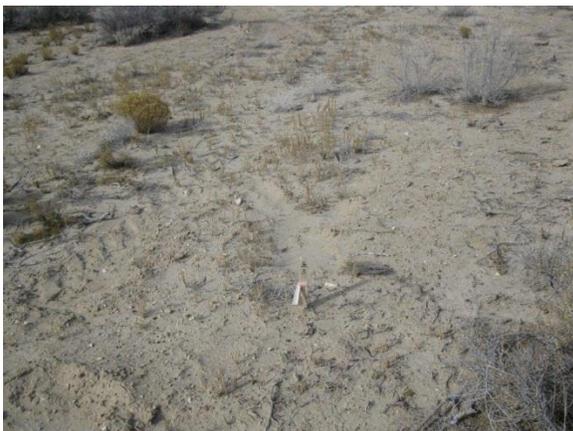
Depression #6 - November 23, 2014

On November 25, 2014, Russel Jensen of Consol Energy walked the area of the six known subsidence depressions over 00 North and photographed all staked areas. He observed no new cracks or damage from subsidence. He also walked the surrounding area and observed no new depressions, cracks, or damage. Copies of the photographs are provided in Attachment A.
