State of Utah
 DEPARTMENT OF NATURAL RESOURCES
 MICHAEL R. STYLER
Executive Director
 Division of Oil, Gas and Mining
 JOHN R. BAZA
Division Director

Inspection Report

Permit Number:	C0150015
Inspection Type:	PARTIAL
Inspection Date:	Monday, March 06, 2017
Start Date/Time:	3/6/2017 10:30:00 PM
End Date/Time:	3/6/2017 1:30:00 PM
Last Inspection:	Thursday, February 16, 2017

Permittee: **BRONCO UTAH OPERATIONS, LLC**
 Operator: **BRONCO UTAH OPERATIONS, LLC**
 Site: **EMERY DEEP MINE**
 Address: **PO BOX 527, EMERY UT 84522**
 County: **EMERY**
 Permit Type: **PERMANENT COAL PROGRAM**
 Permit Status: **ACTIVE**

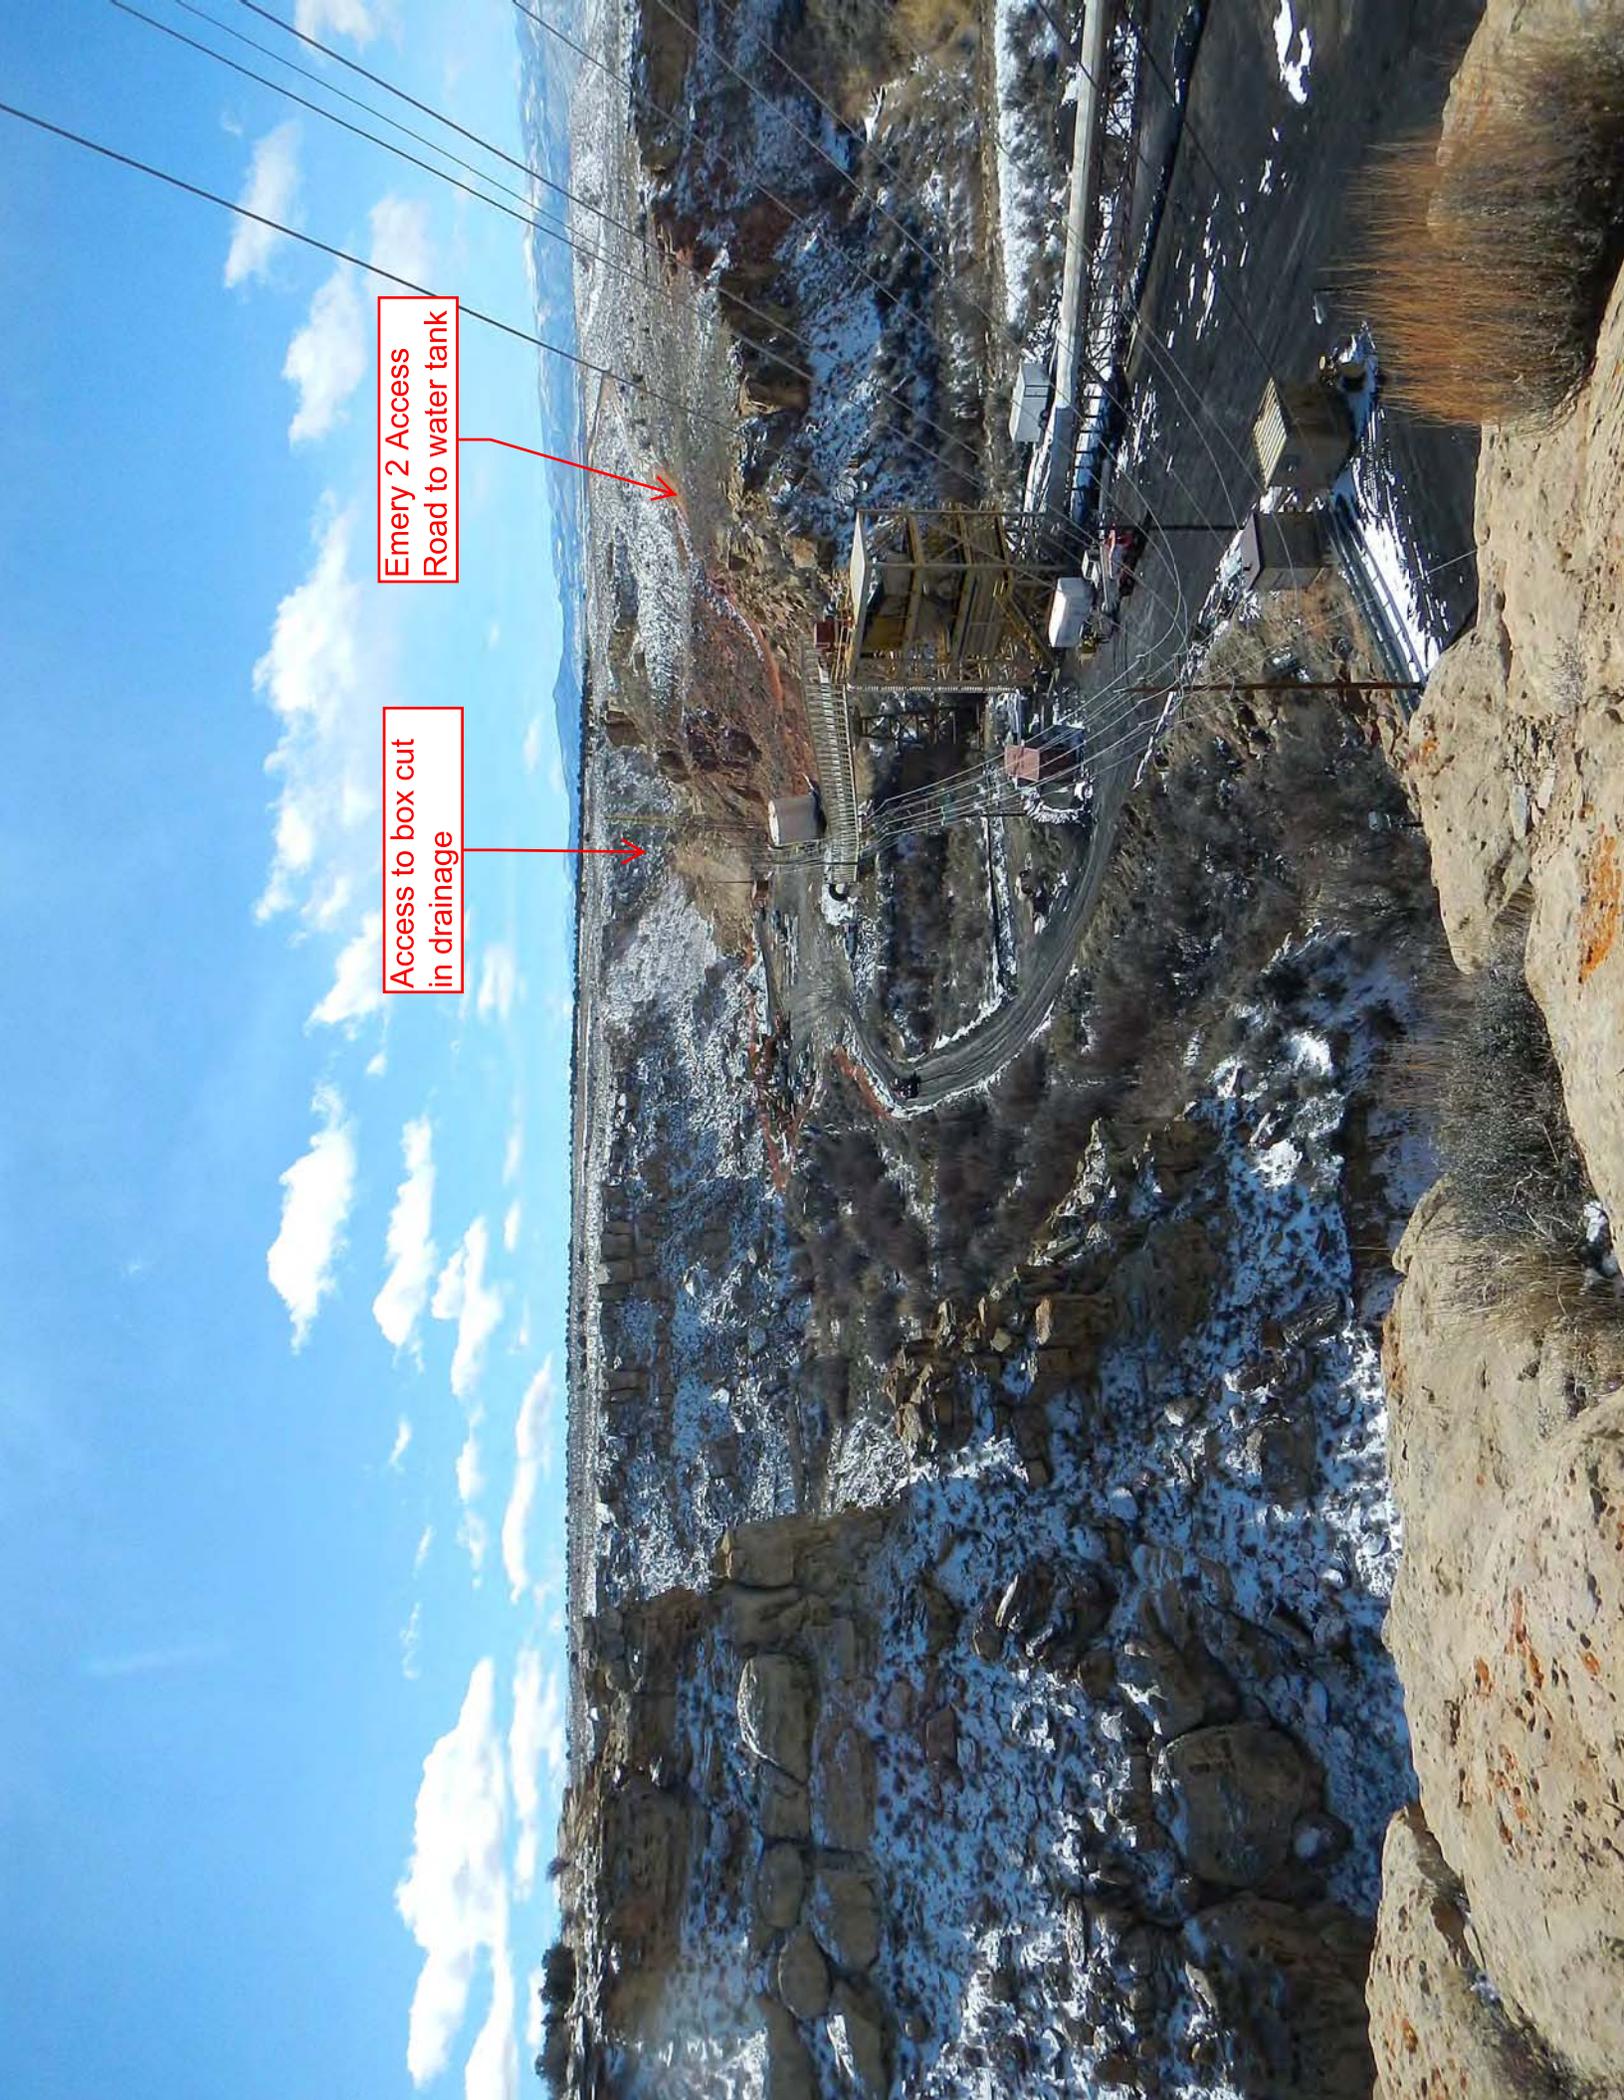
The access road to the water tank pad is roughed in, but is not at final grade. The final configuration will not have two switchbacks as shown on Plate IV-8a. An as-built of the road construction will be submitted.

Emery 2 Access
Road to water tank

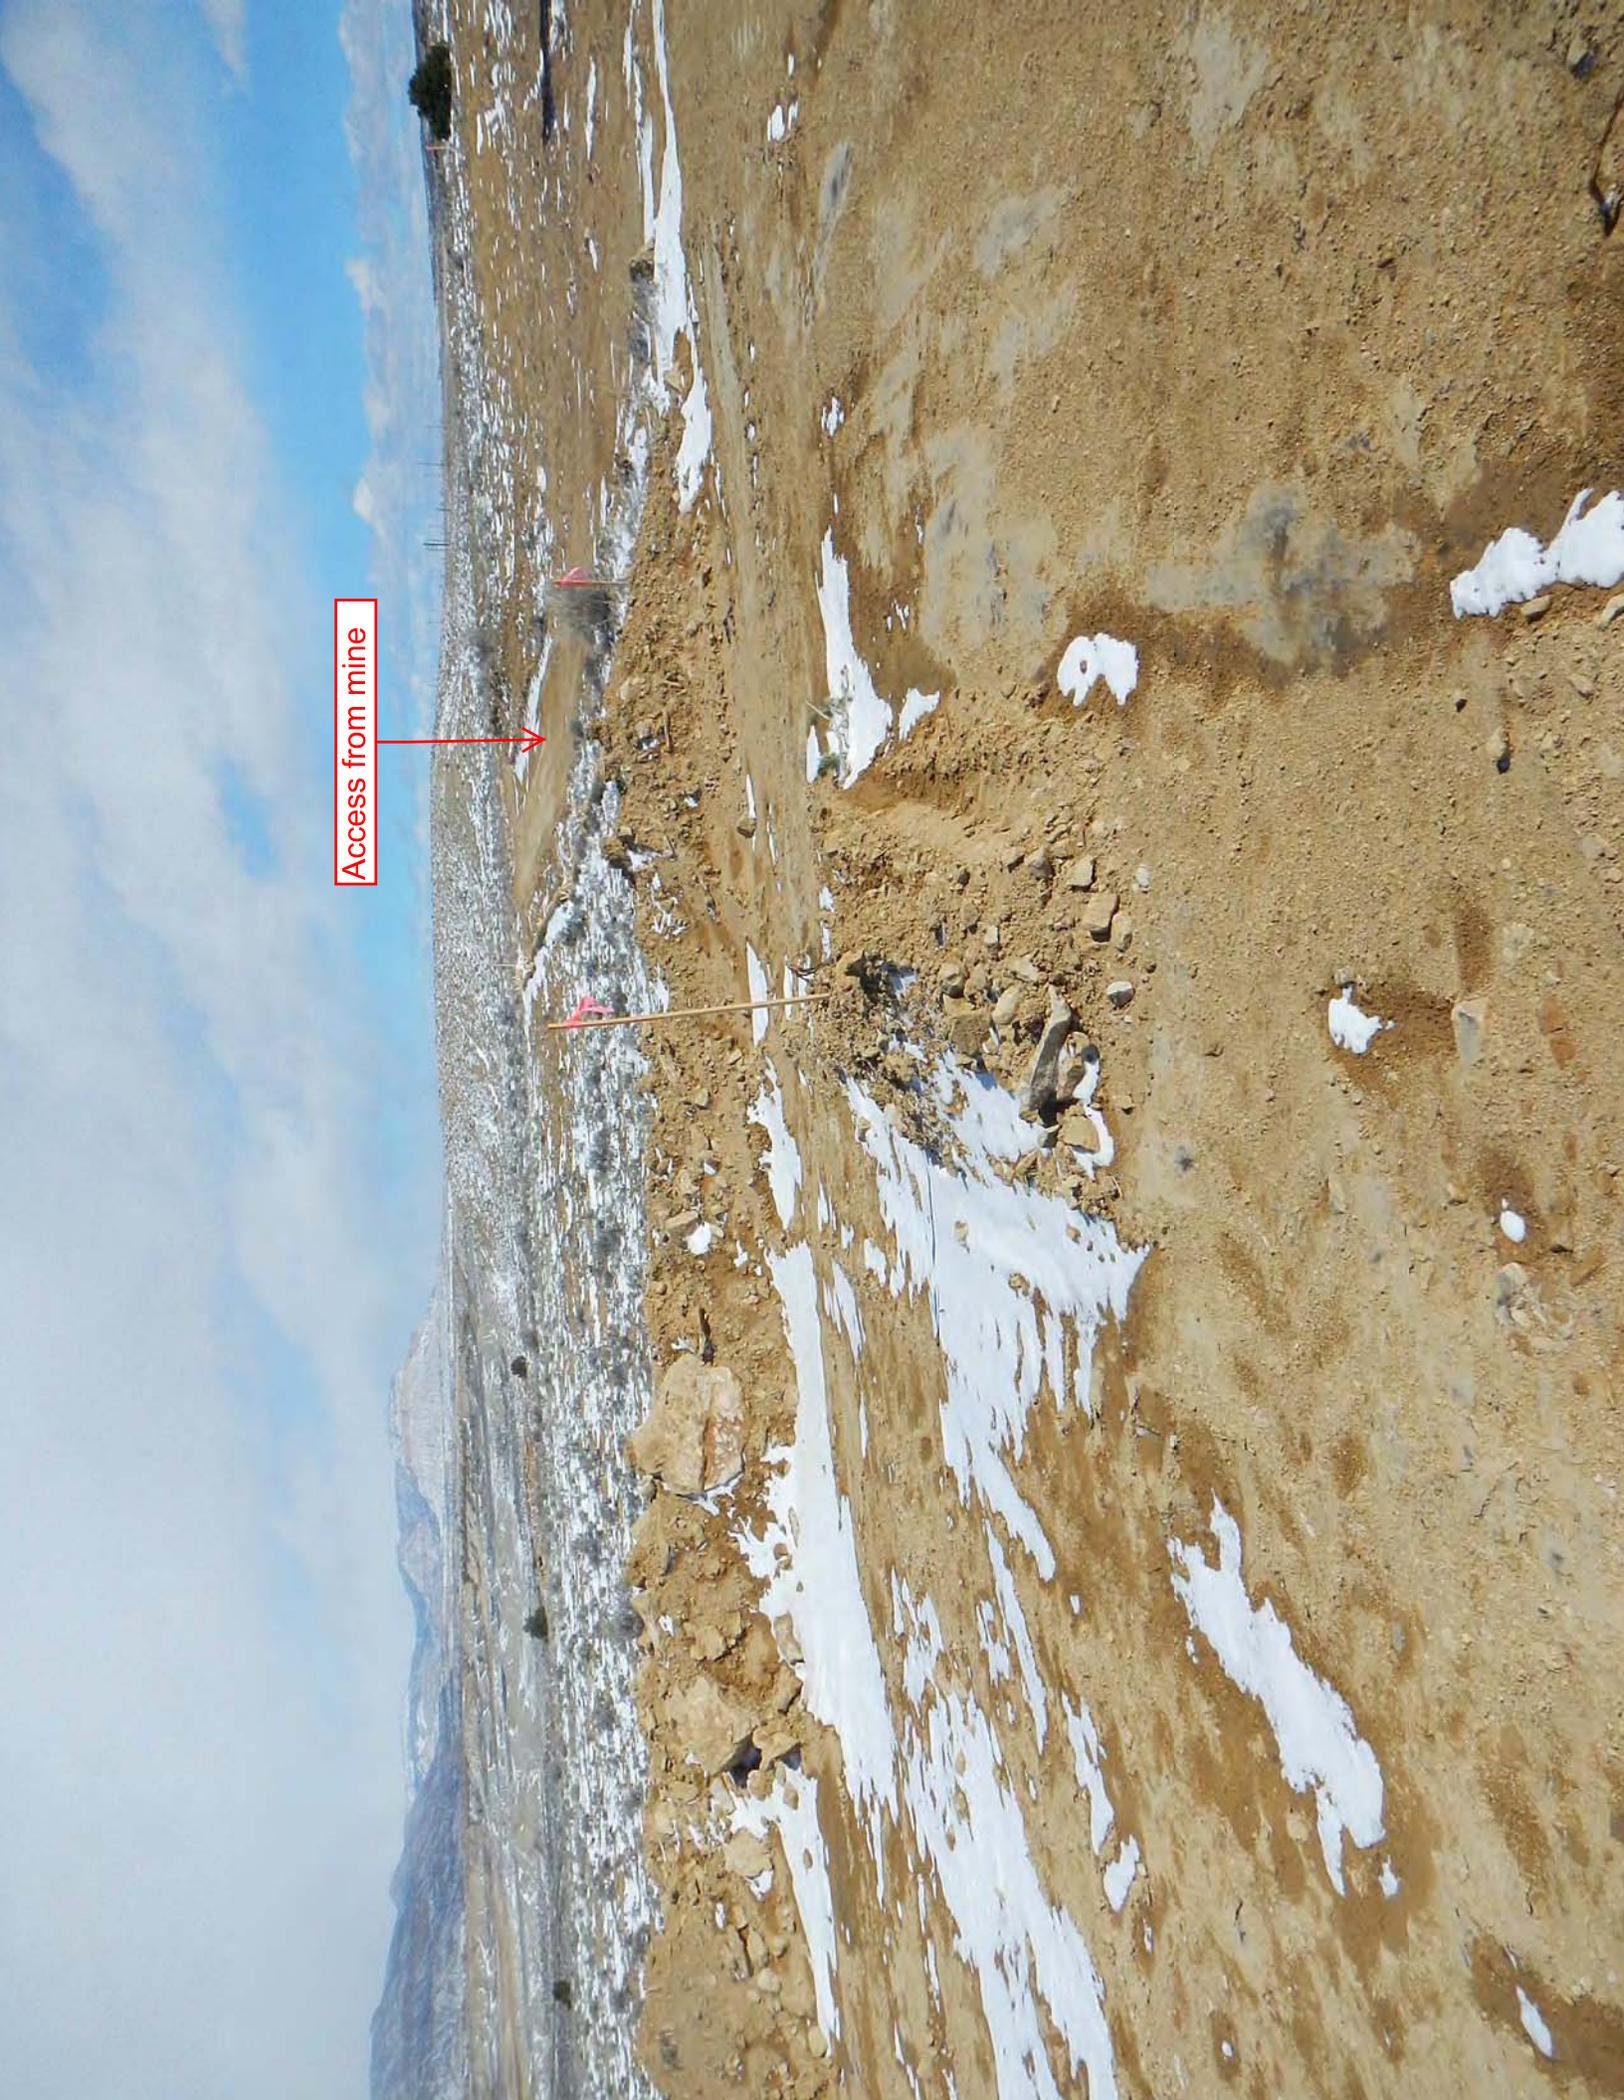
Access from mine

blocked access
from Hwy 10

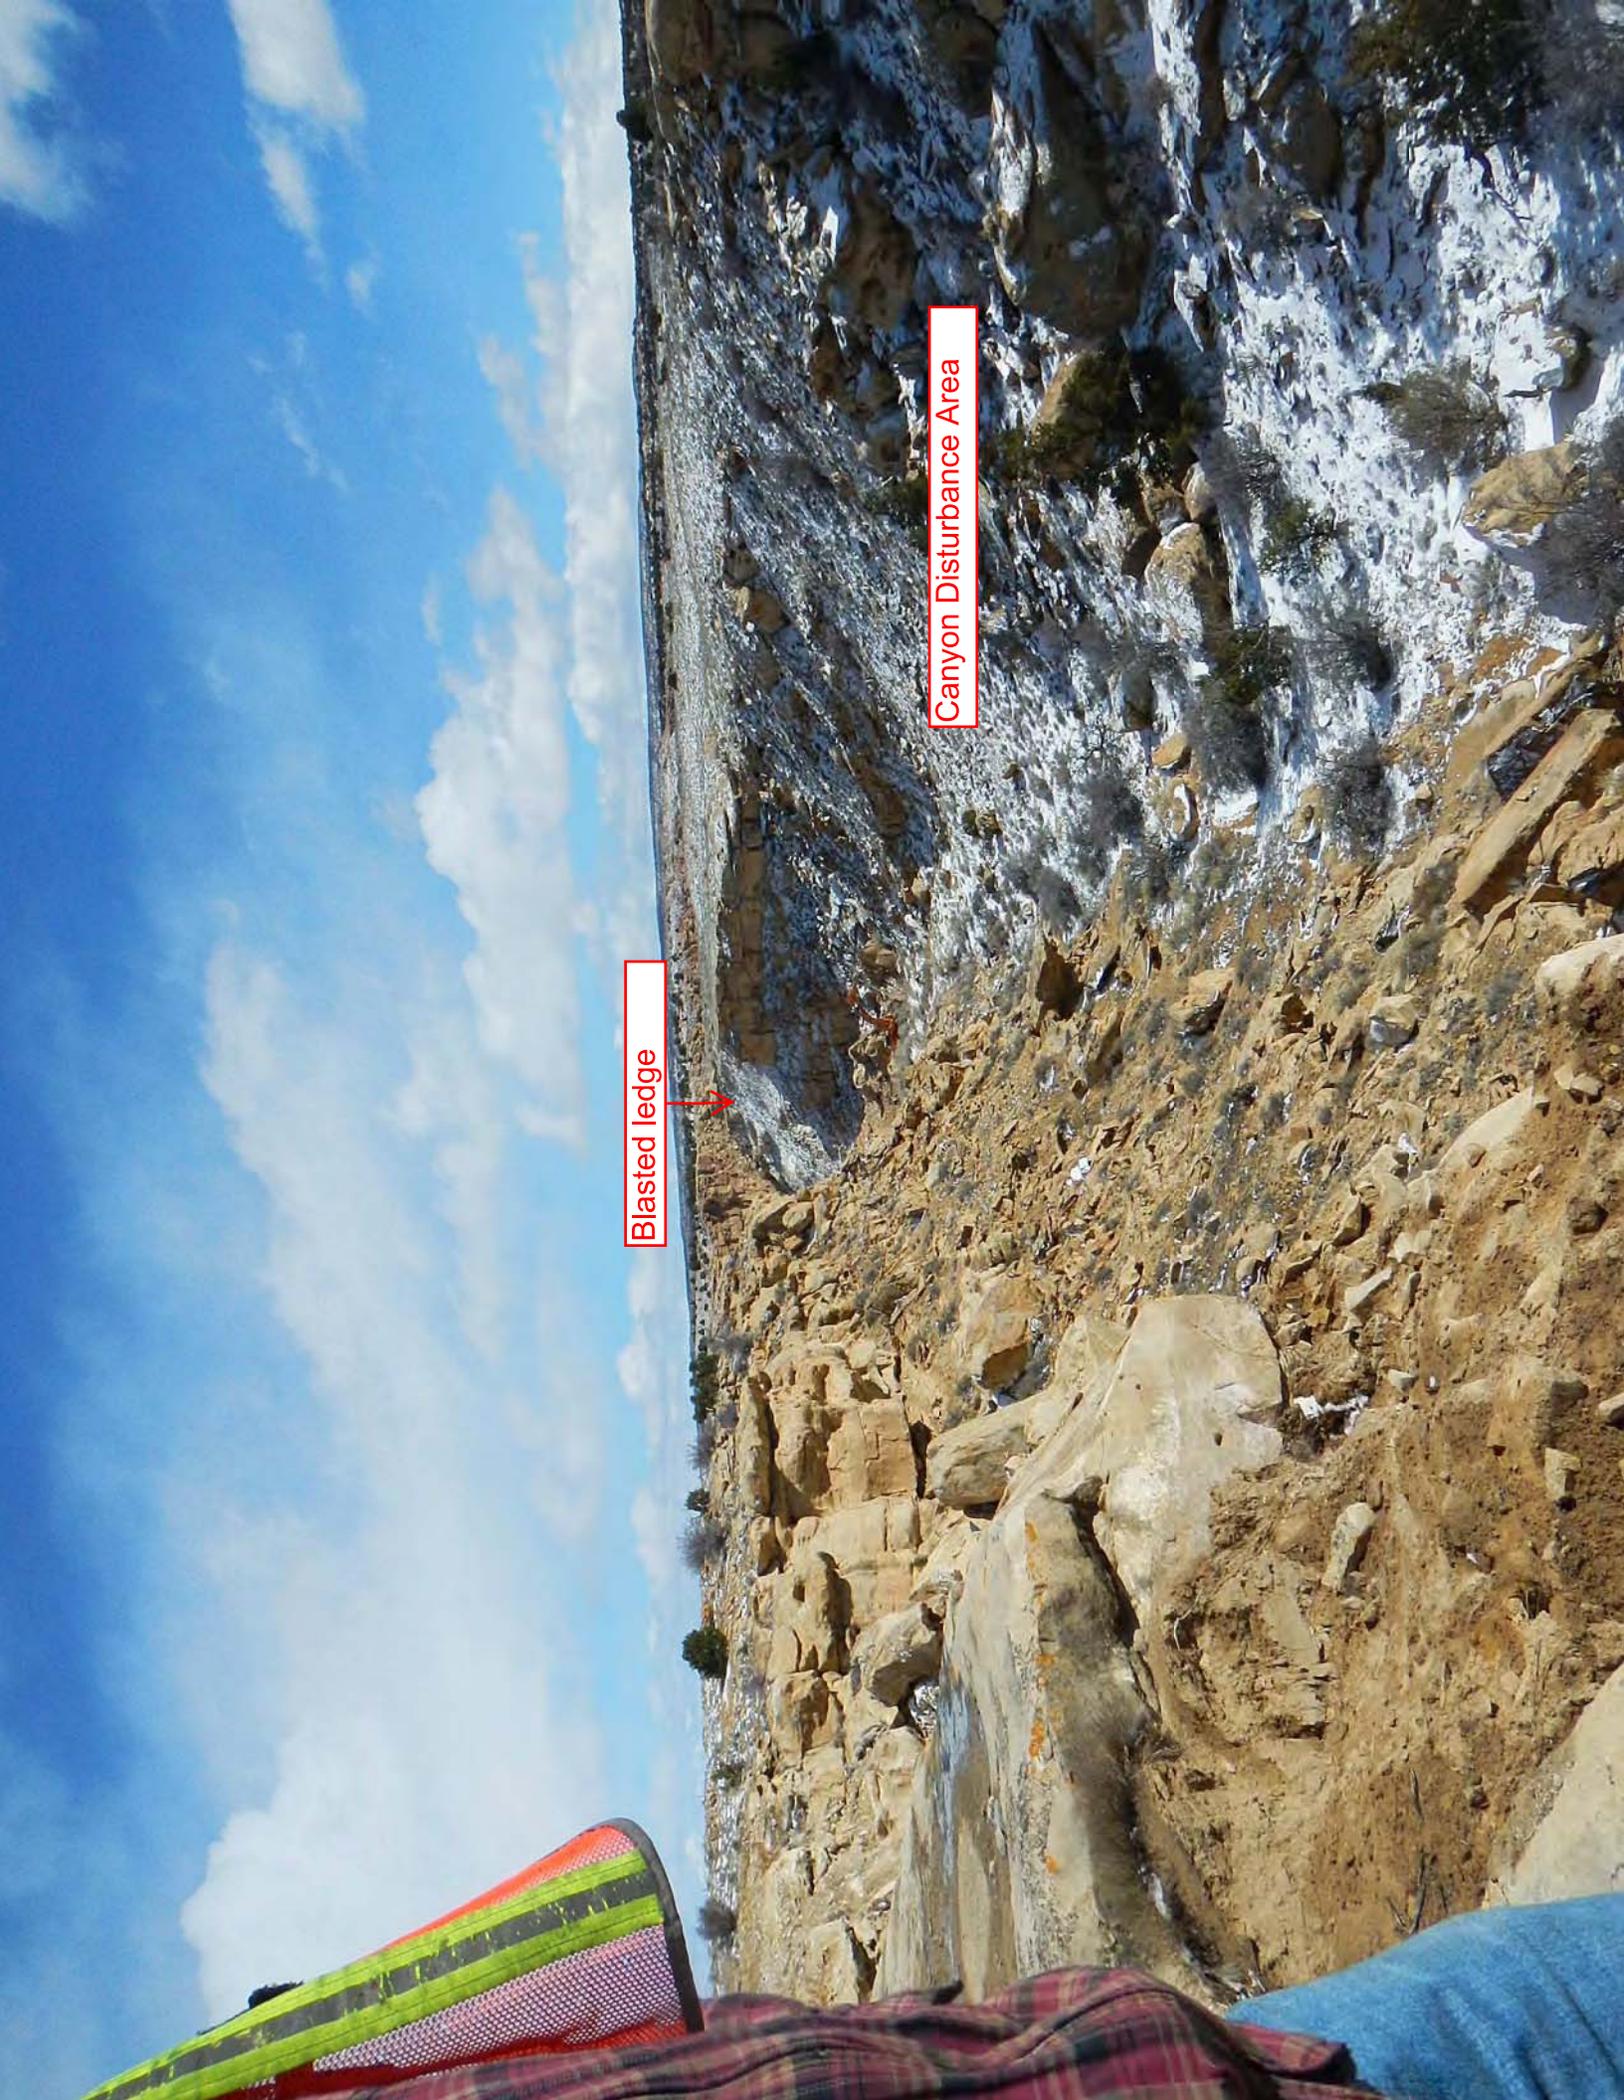
Blasted ledge

Canyon Disturbance Area

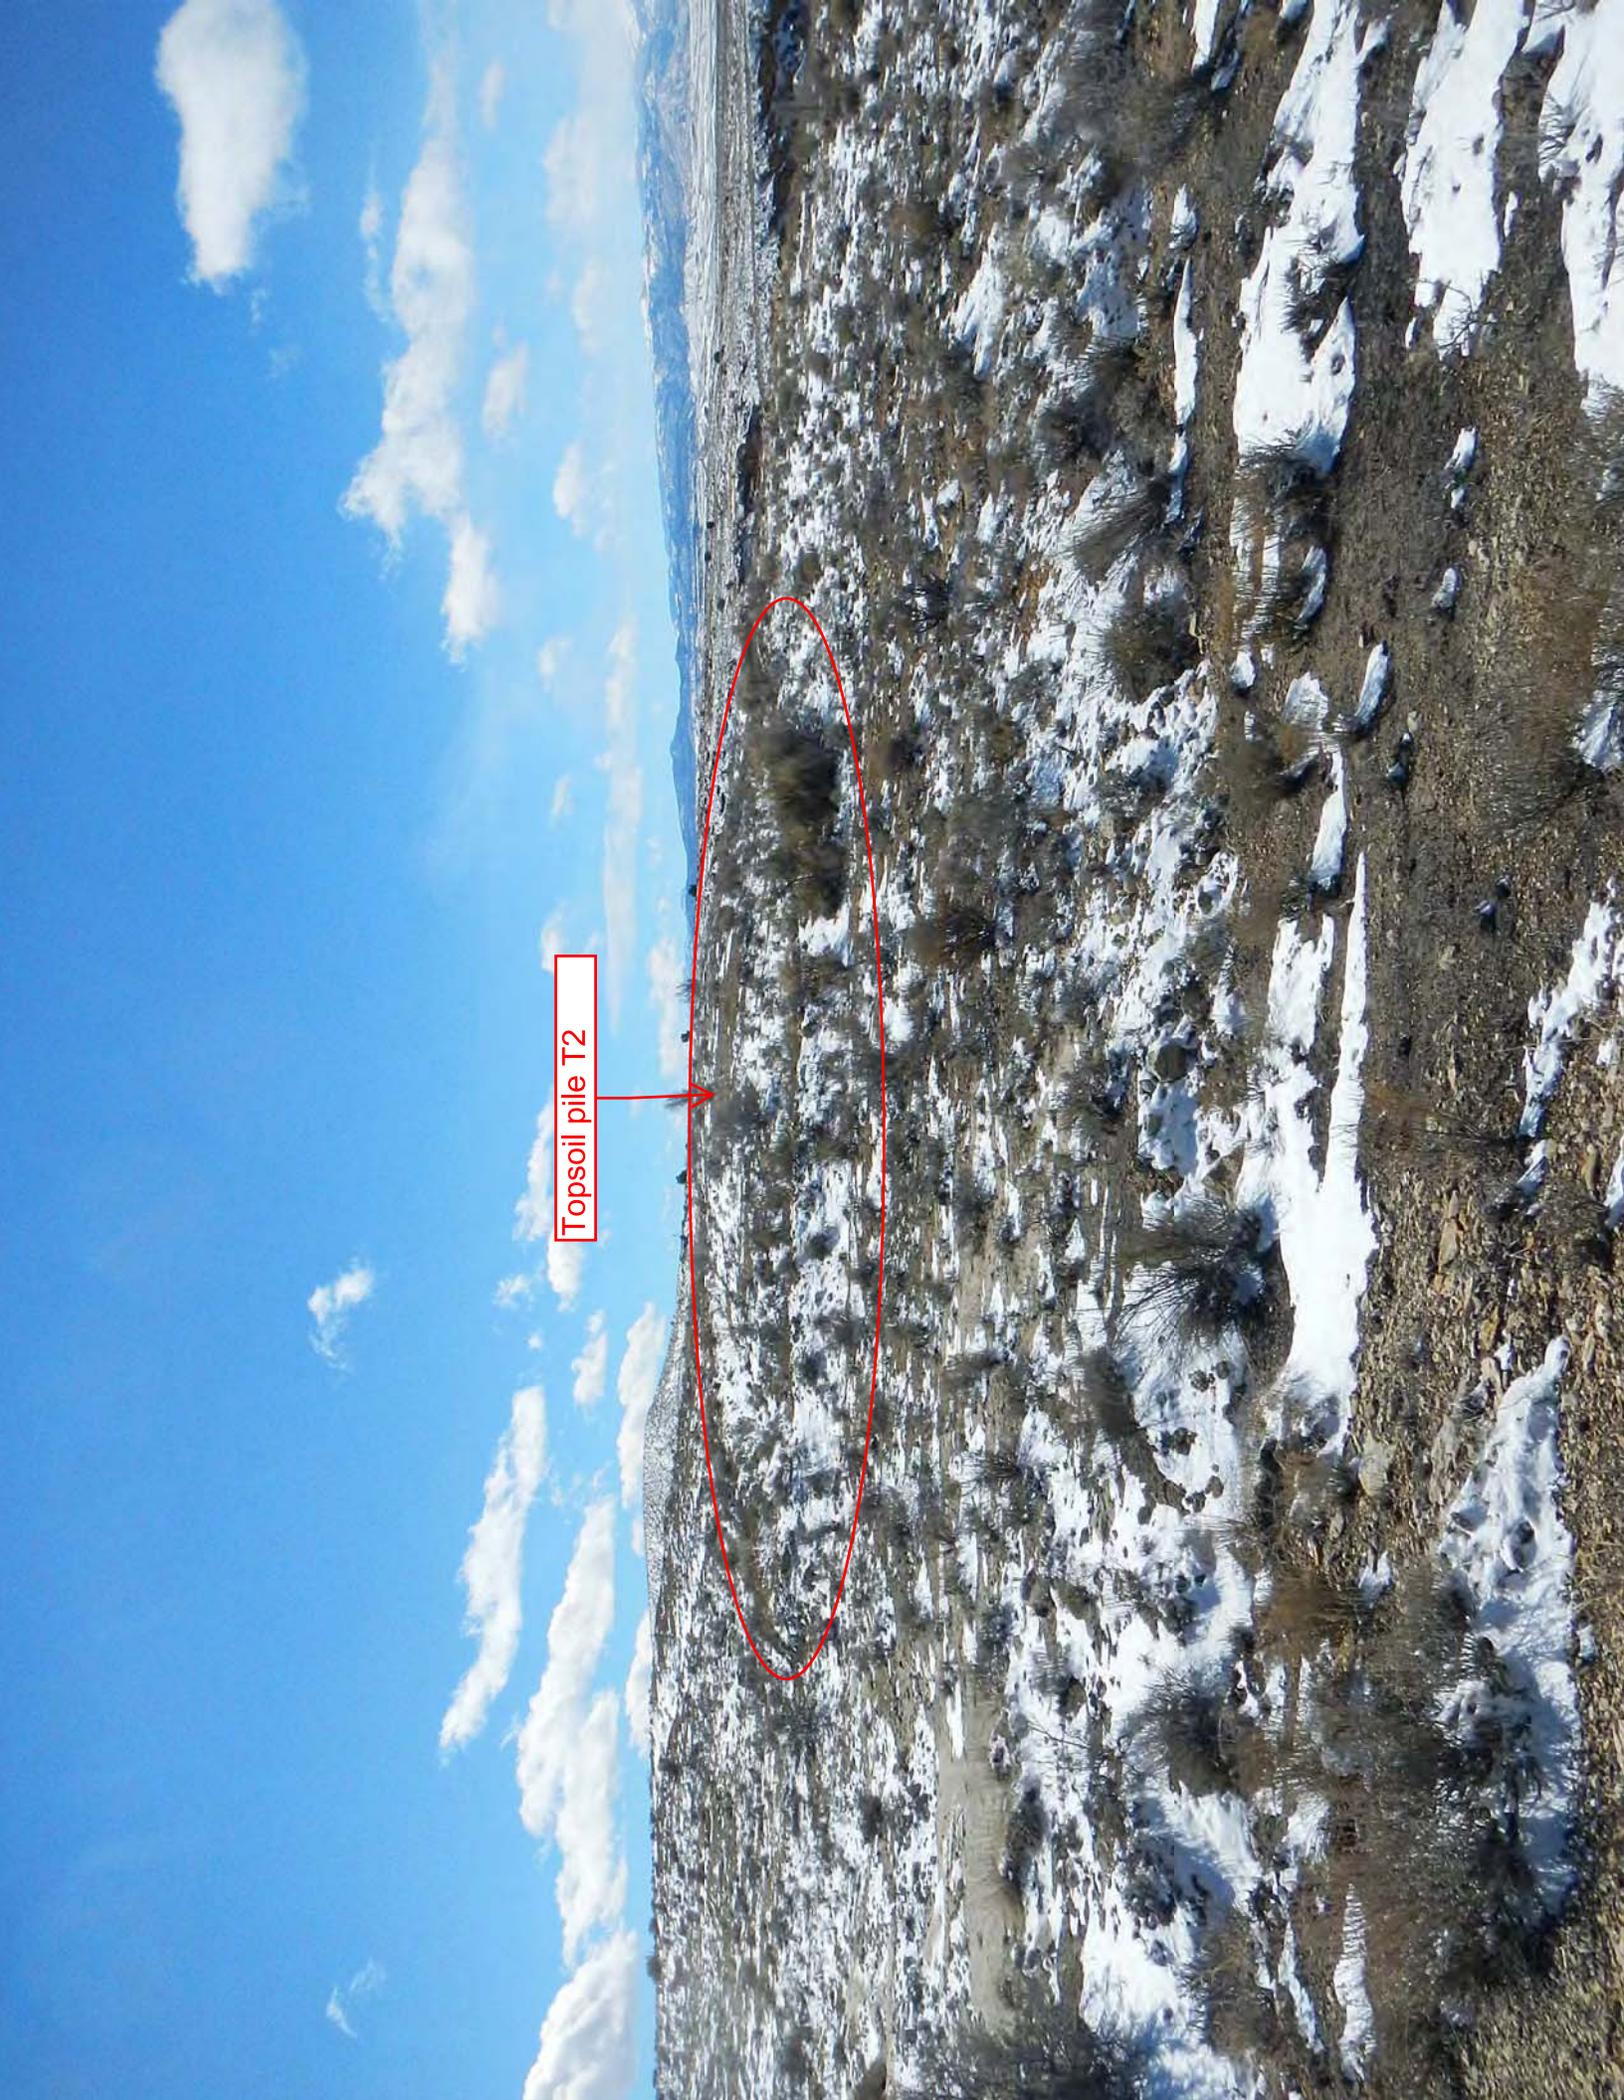
Topsoil will be collected and placed on Topsoil pile T2, shown on Plate II-1. Topsoil pile T2 was observed and photographed. This stockpile pile has been in existence for many years. The current volume of this pile will be surveyed. The vegetation observed on this pile was exclusively low growing shrubs, such as *Atriplex canescens*.

Topsoil pile T2
