**RE: Bronco Utah Operations LLC
Emery Mine
DOGM Permit No. C/015/0015
Emery 2 Full Extraction Revision**

Title: Emery 2 Full Extraction

The purpose of this report is to present baseline surface conditions prior to full extraction operations from the Emery 2 portal of the Bronco Utah Operations, LLC. (Bronco) Emery Mine, Emery County, Utah. The areas covered in this report include the following:

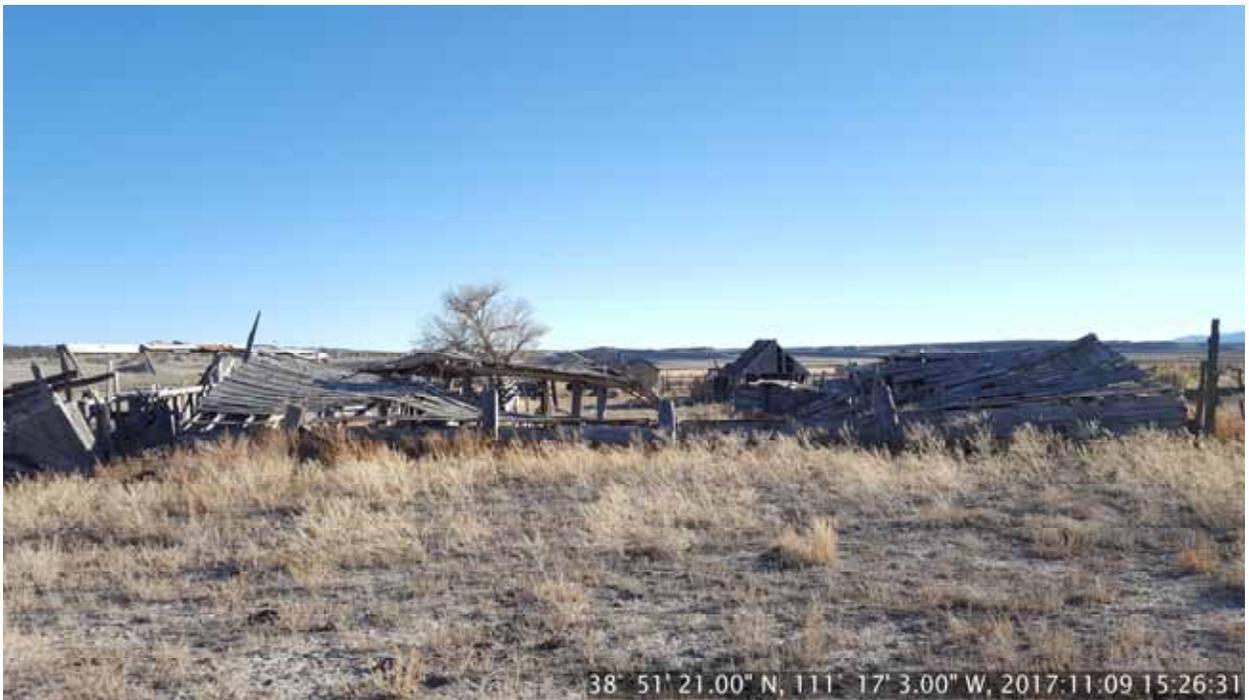
Feature 1. Ranch House, Buildings, and Corrals. Corrals.

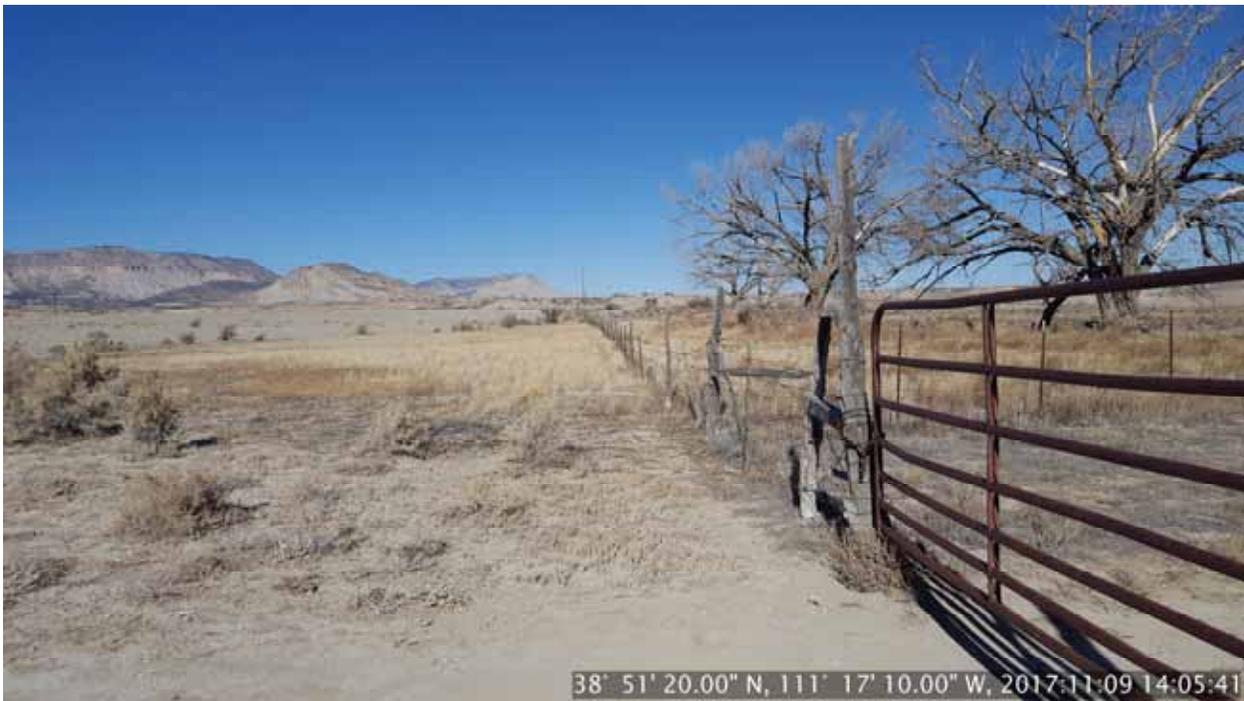
Feature 3. Ranch Fence Line. The description of this feature has been updated from the Valley Engineering (1980) report. This fence line is located west of the ditch in Feature 2. The fence posts are natural rough cut tree limbs. The fencing fabric consists of wire mesh and two strands of barbed wire above the mesh. It is approximately 4 feet from the ground to the upper barbed wire strand. The fence is in fair condition. A metal gate in the fence line controls access to the ranch house (Feature 1). South of this location, the fence line becomes a 4-strand barb wire fence, constructed of natural wood posts with intermittent steel t-posts. This section of fence is also in fair condition.

Feature 3. Ranch Fence Line. Looking north along gated entrance to Feature 1.

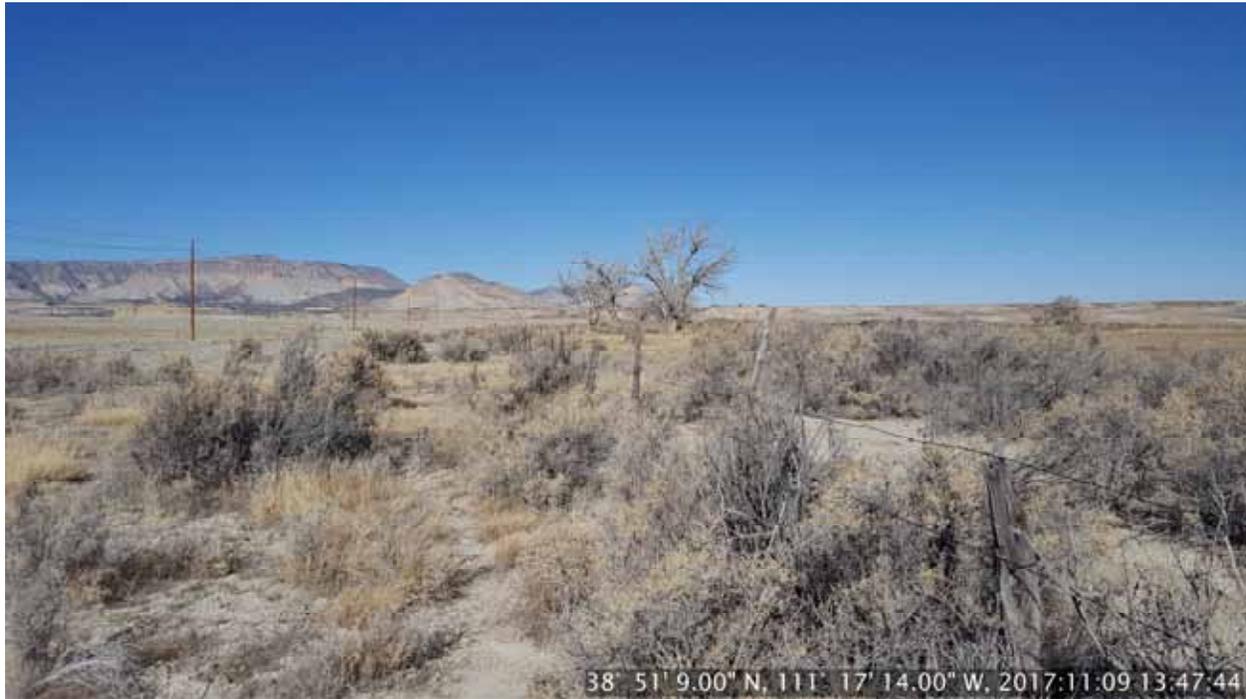
Feature 3. Ranch Fence Line. Looking north.

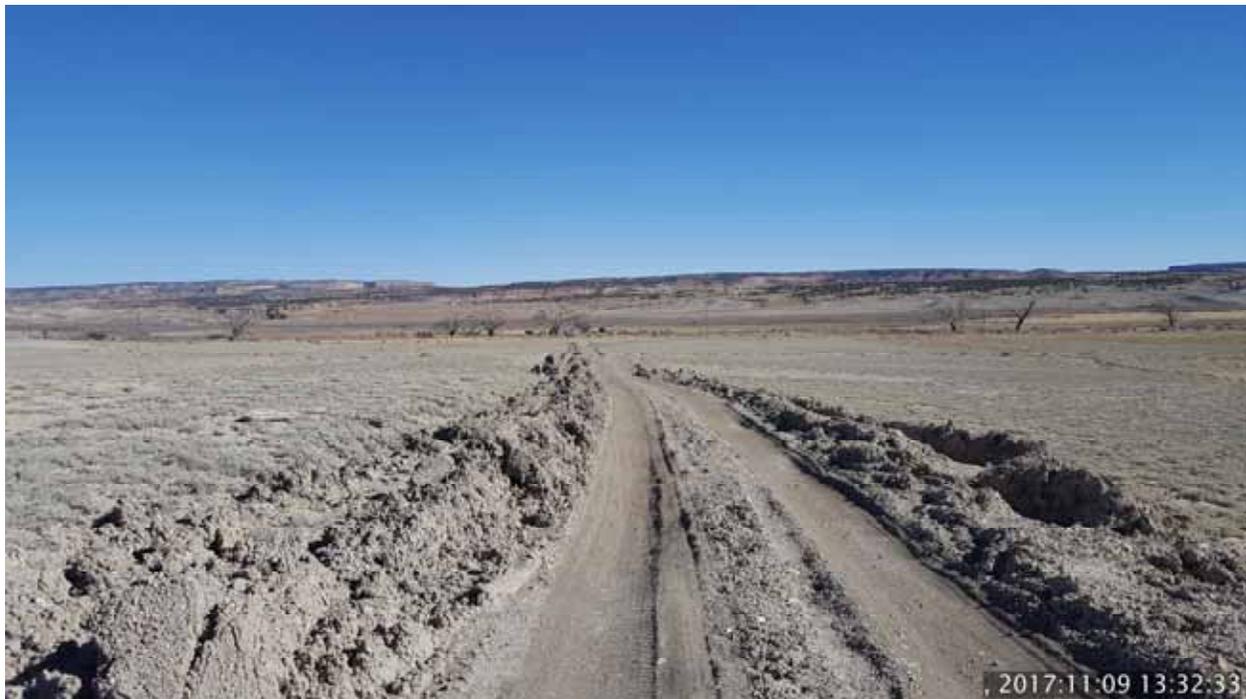
Feature 4. Ranch Access Road. Looking east.

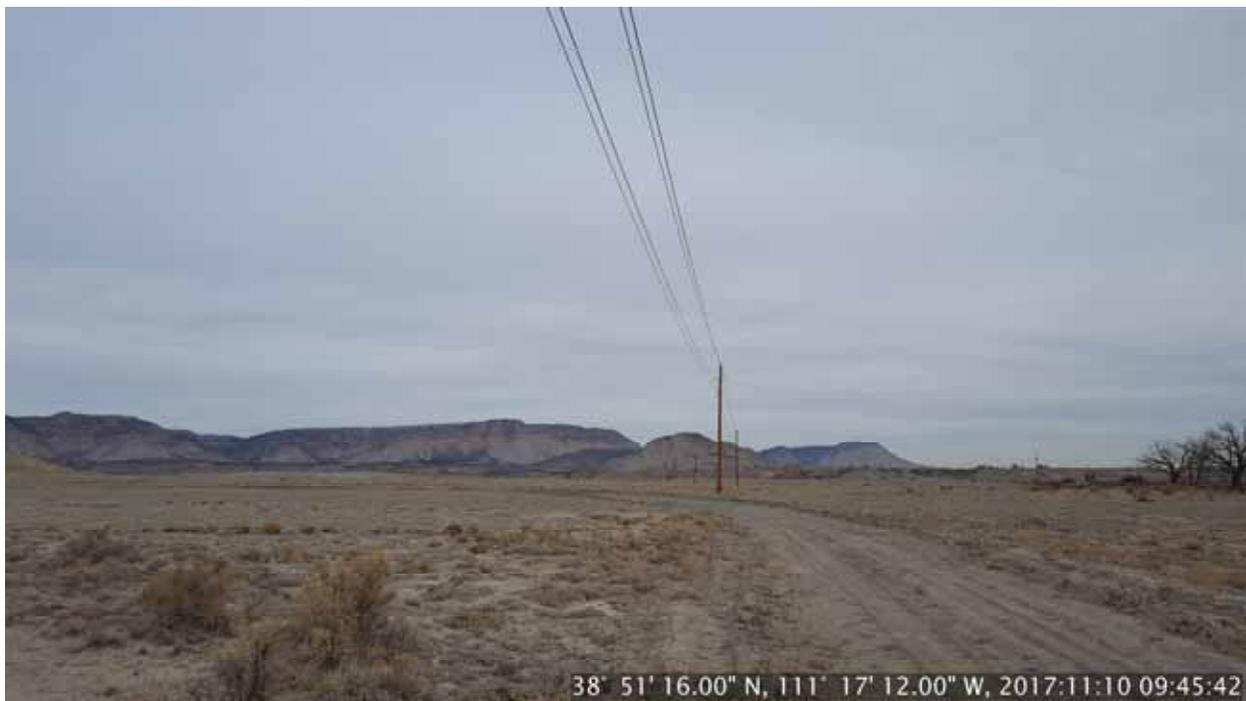
Feature 5. Utility Power Lines. This feature is essentially unchanged from how it is described in the Valley Engineering (1980) report, which states the following: "These power lines are located approximately 200 yards to the west of the ranch buildings (Feature 1). The poles run north and south and are approximately 40 feet high." It appears that several of the poles have been replaced since the 1980 survey. The poles are in good condition.

Feature 5. Utility Power Lines. Looking north.

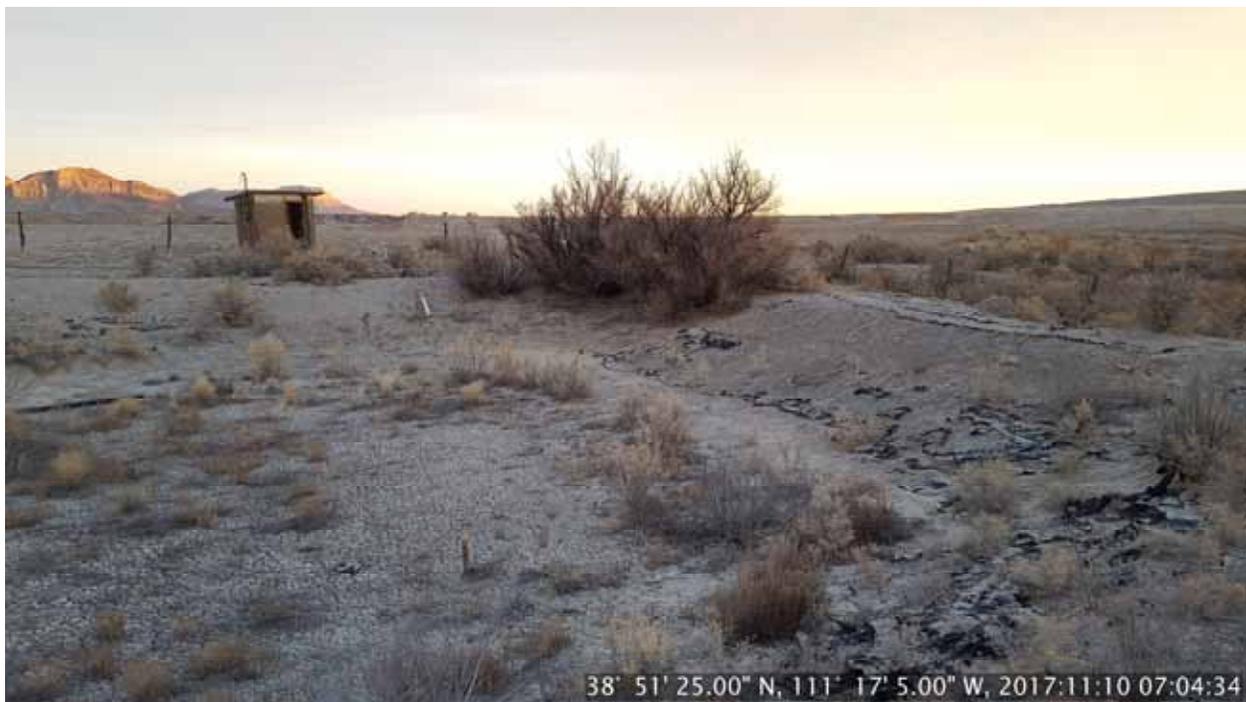
Feature 6. Pond. The description of this feature has been updated from the Valley Engineering (1980) report. The pond, cut into a small hill on its northwestern corner and diked on the surrounding edges, is roughly square in shape and measures approximately 75 feet x 75 feet x 5 feet deep. A black plastic liner is exposed at numerous locations around the dike. Exposure to the elements has severely degraded the liner and it is no longer functional. An erosion channel has formed on the slope at the northwest corner of the pond. The pond is dry and it appears that it has been quite some time since it has held water. A fence, constructed of natural rough cut tree limbs, surrounds the pond. The fencing material consists of wire mesh with one strand of barb wire at the top. The fence is in dilapidated condition.

Feature 6. Pond. A well (Feature 8.) is in the background.

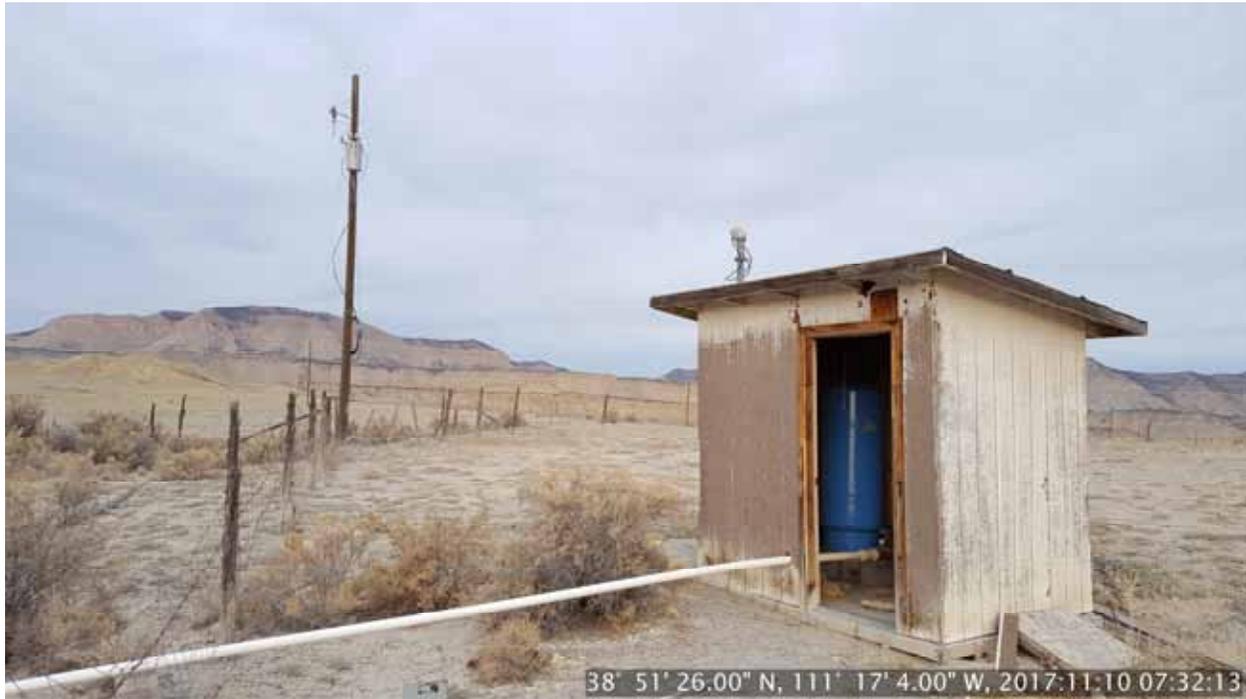
Feature 8. Well. Power line from pole to pump-house is disconnected.

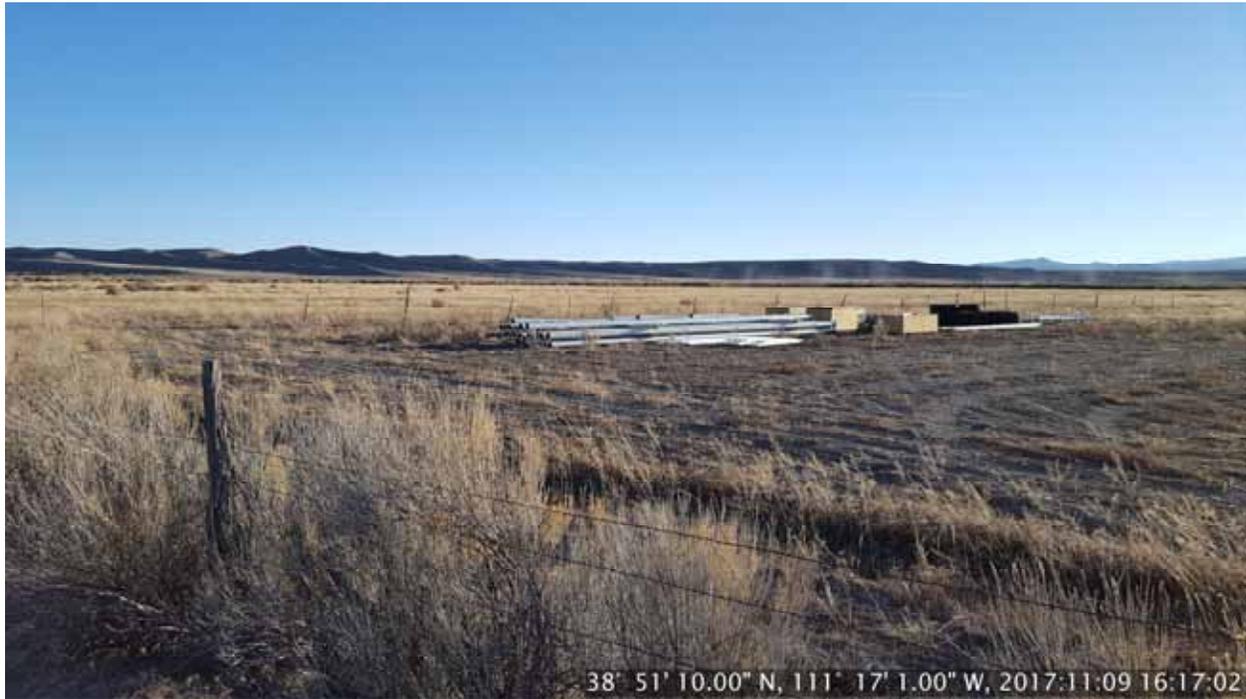
Feature 9. Farm Lands. Piping supplies for future sprinkler pivot lying on ground.

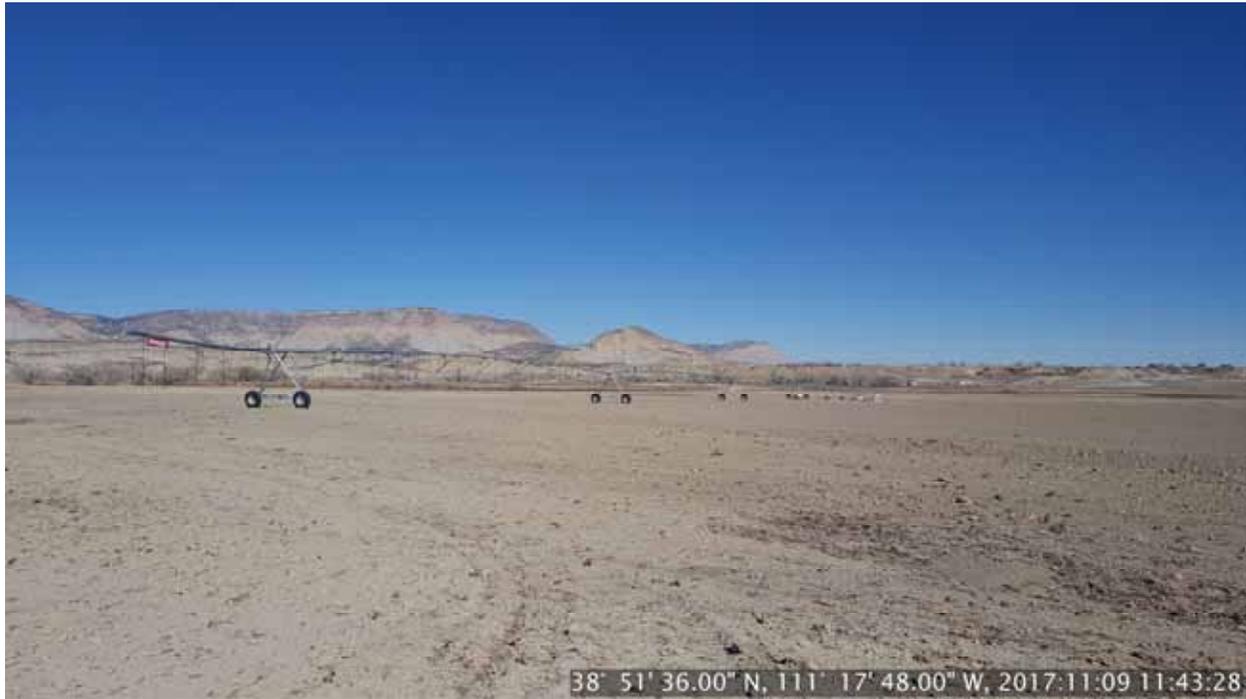
Feature 32. Irrigation Ditch and Farm Land. The description of this feature has been updated from the Valley Engineering (1980) report. The farm land has been expanded in size to the north and east. The freshly plowed ground has been regraded, eliminating portions of the ditch on the west and south side of this farm land. Underground irrigation piping and an irrigation pivot have been installed in the center of this farm land. A 16 foot by 12 foot by 10 inch thick concrete slab foundation installed in 2017, as evidenced by names and a date scratched into the concrete surface on a corner of the pad, and underground power conduits have been installed in preparation for another pivot on the eastern border of this farm land. A six strand barb wire fence with rough cut 4x6 inch timbers extends east/west along the northern margin of this farm land. This fence intersects the Highway 10 right-of-way fence at its western edge. This fence is in good shape.

Feature 32. Irrigation Ditch and Farm Land. Ditch replaced with pivot sprinklers.

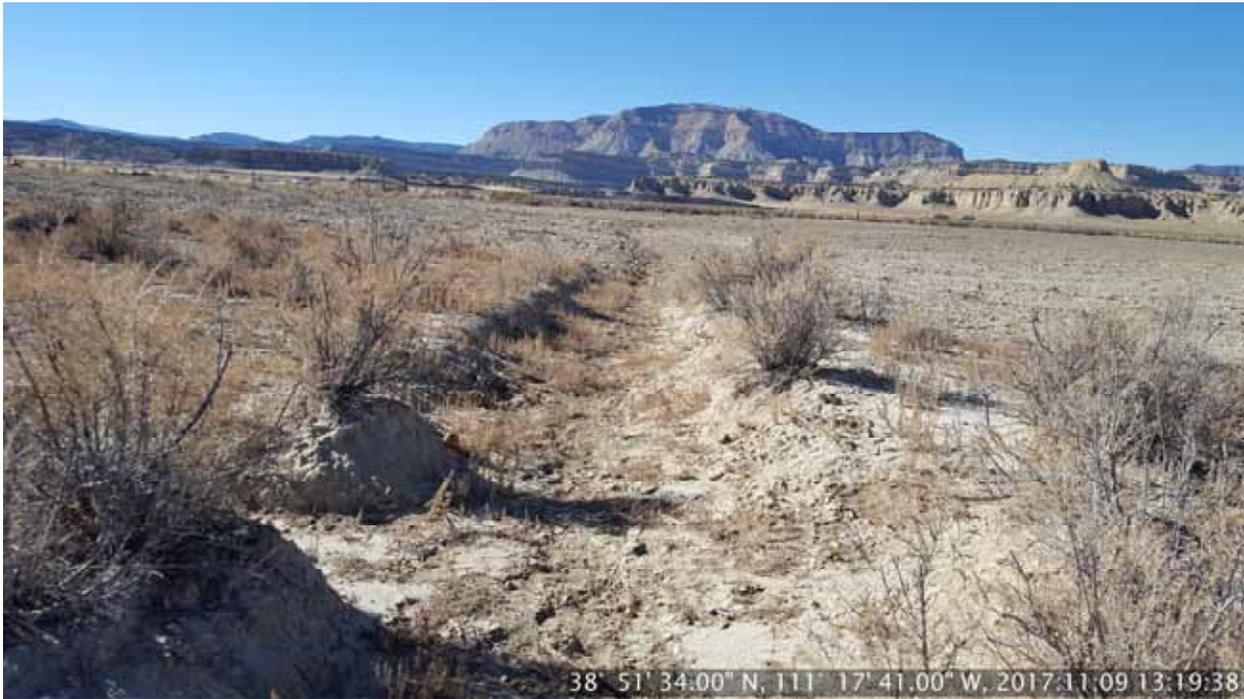
Feature 32. Irrigation Ditch and Farm Land. Southern edge of farmland. Return irrigation ditch in foreground. Field has been regraded, eliminating need for irrigation ditch, background.

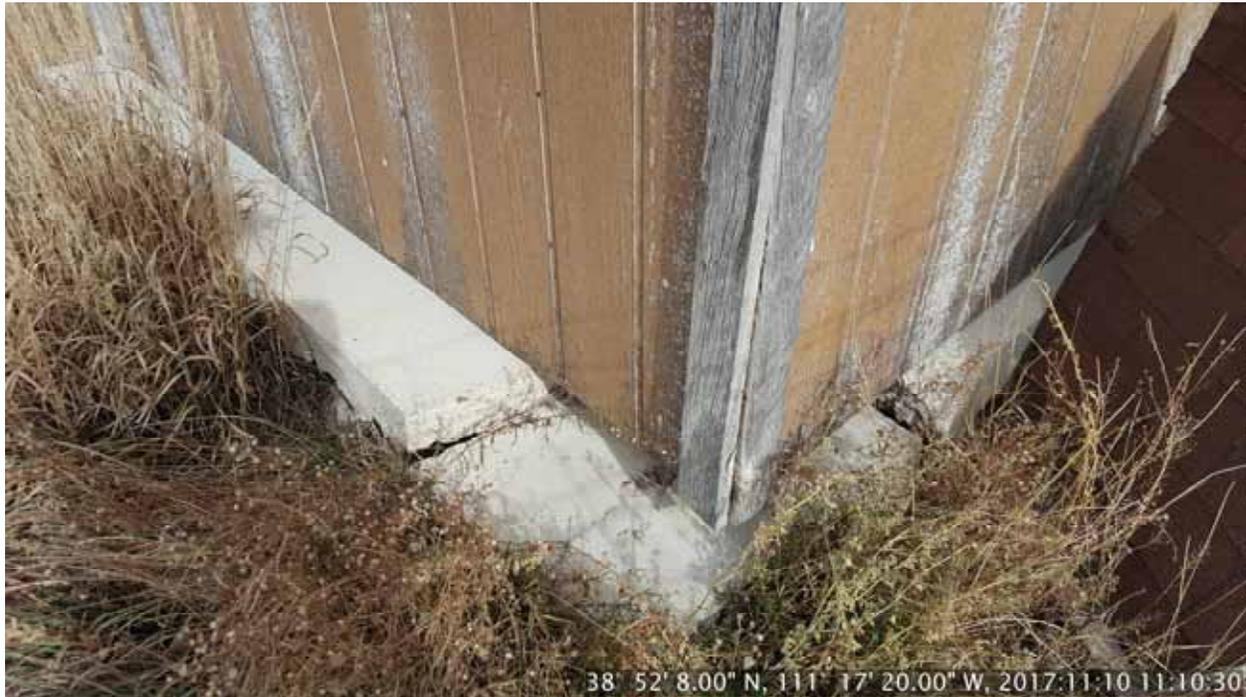
Feature 34. Culinary Well. The corner of the cracked concrete pad surrounds the wellhead located in the well house.

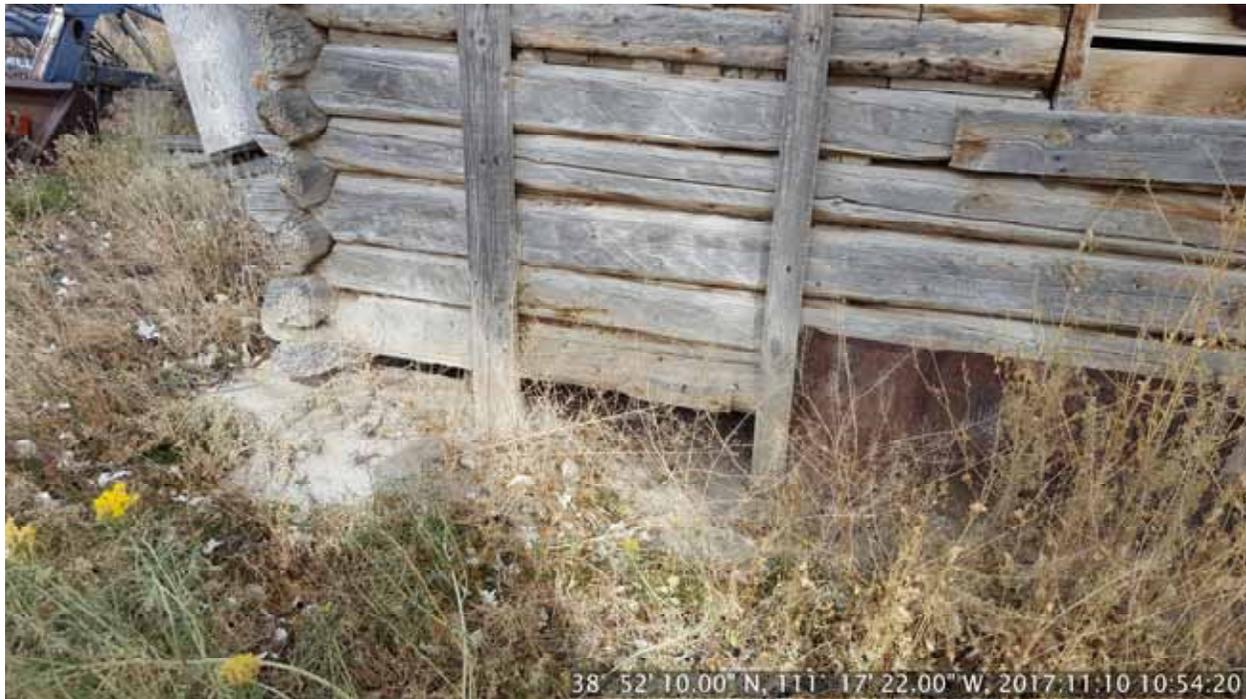
- Wood building constructed of natural rough cut logs. Intermittently placed sandstone rocks serve as a foundation for the structure. The structure is in dilapidated condition.

Feature 35. Ranch House and Buildings. Wood building. View of foundation.

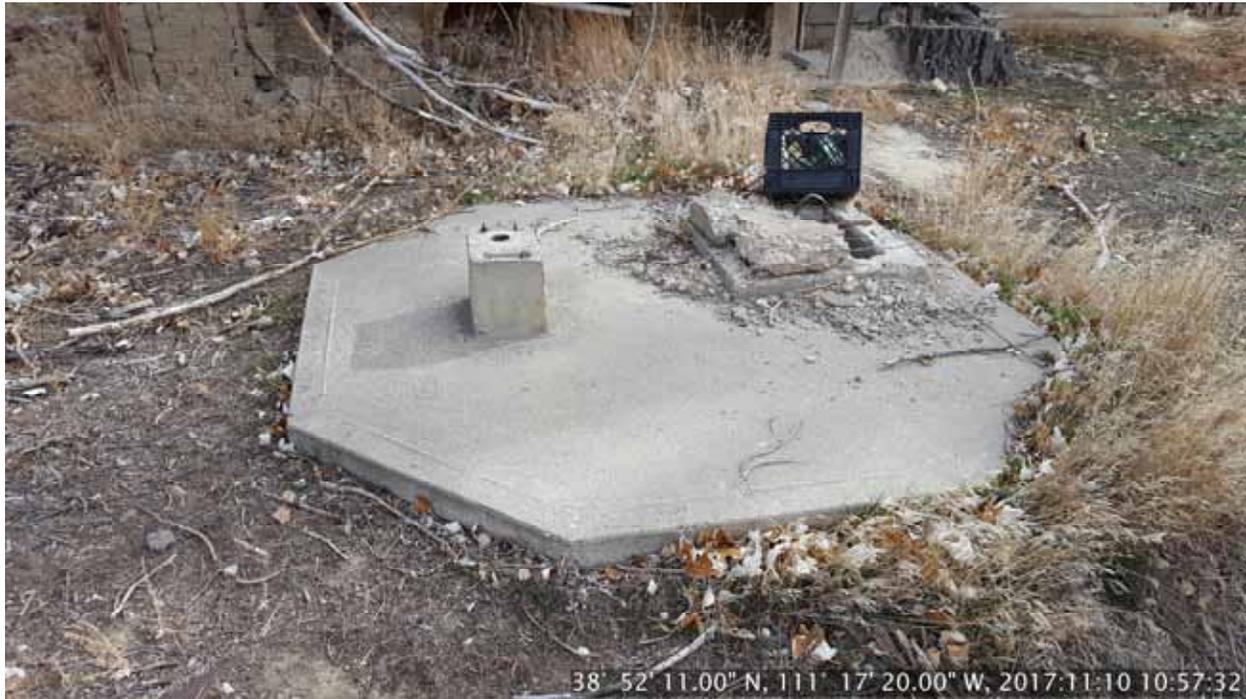
Feature 35. Ranch House and Buildings. Concrete structure. This may be an old septic tank.

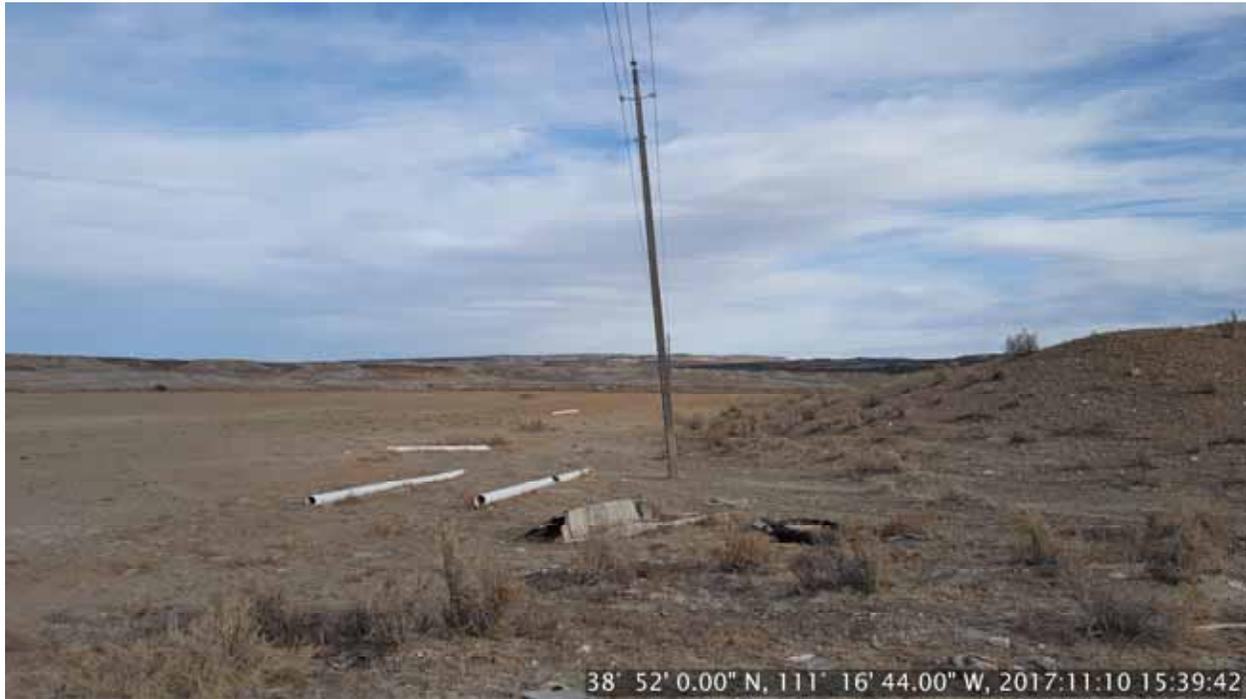
Feature 39. Log Cabins. Looking east along power line. Top of pole in foreground leans to left.

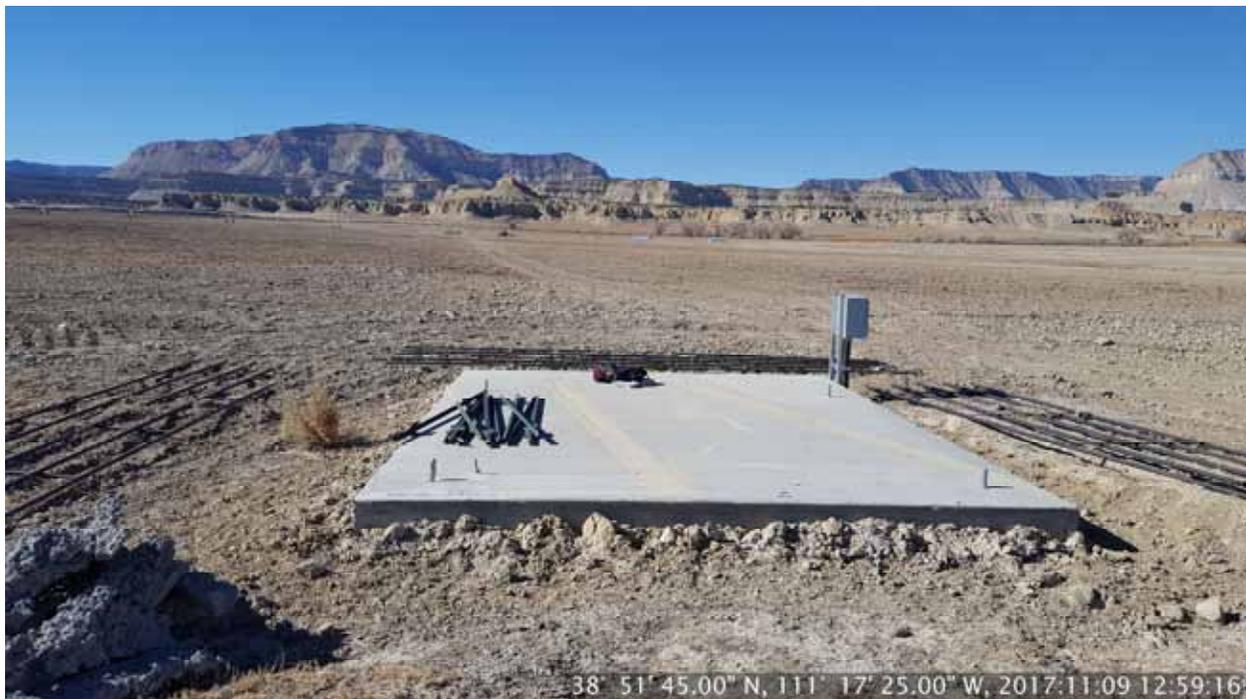
Feature 127. Sprinkler Pivot Foundation. This feature was constructed after the Valley Engineering (1980) report was written. The current landowner is in the process of converting from an open ditch irrigation system to a more efficient pressurized irrigation system consisting of underground buried pipe and irrigation pivots. Newly constructed pivots, pivots under construction, miscellaneous piping and piping supplies, and evidence of recent trenching were encountered in numerous farm land locations within the pre-subsidence survey area.

Feature 127. Sprinkler Pivot Foundation. 1st location.

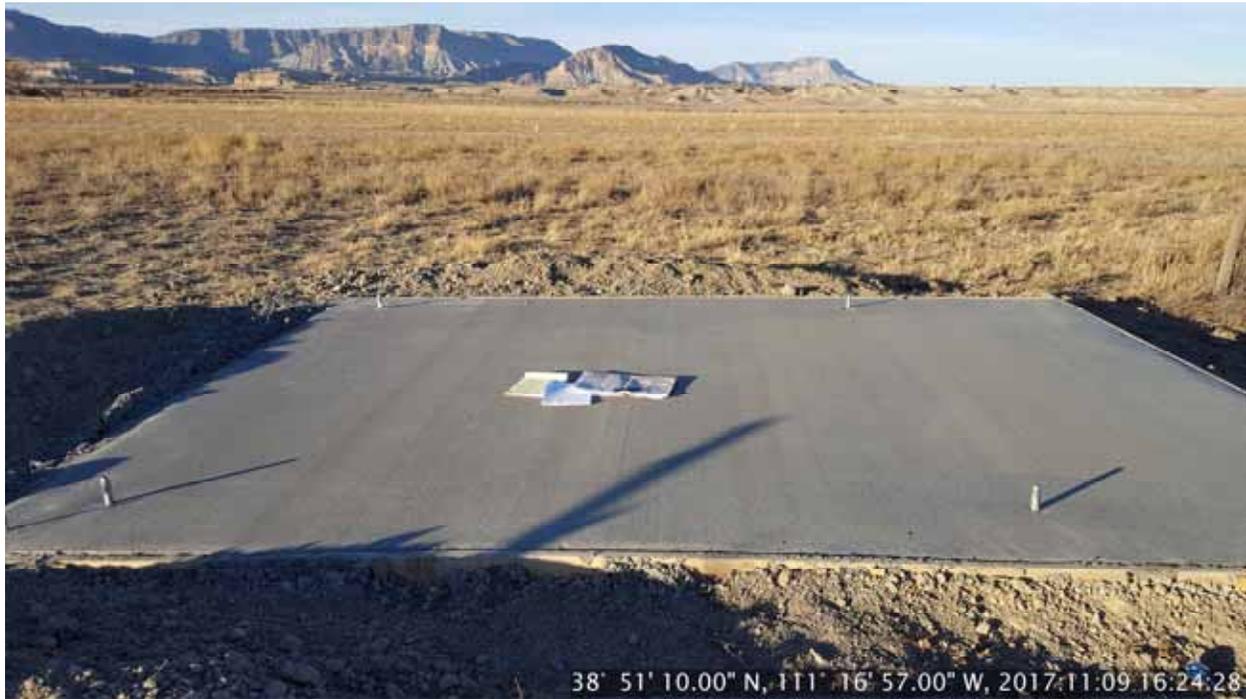
Feature 127. Sprinkler Pivot Foundation. 2nd location.

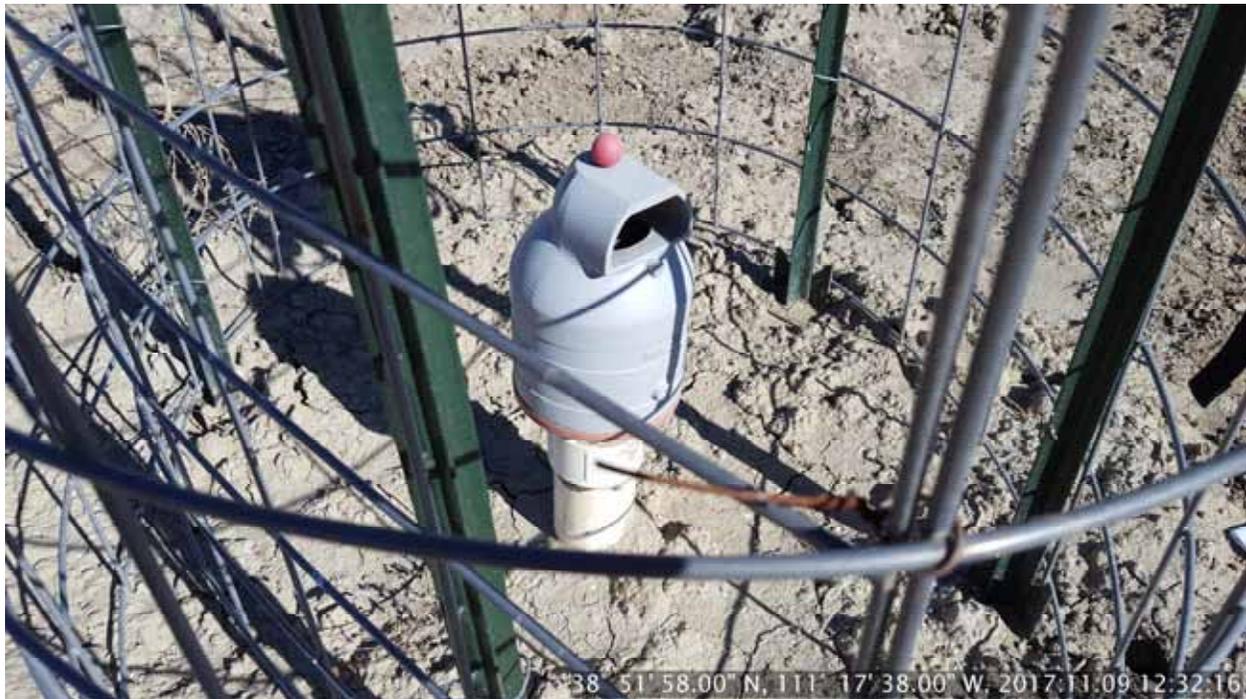
Feature 128. Water Line Air Vent. This feature was constructed after the Valley Engineering (1980) report was written. A water line air vent (Wade Rain PRVC 300) is installed on an underground water line. It is protected from livestock damage by metal tee posts and heavy gauge galvanized wire mesh. The current landowner is in the process of converting from an open ditch irrigation system to a more efficient pressurized irrigation system consisting of underground buried pipe and irrigation pivots. Newly constructed pivots, pivots under construction, miscellaneous piping and piping supplies, and evidence of recent trenching were encountered in numerous locations near this feature.

Feature 128. Water Line Air Vent.
