State of Utah
 DEPARTMENT OF NATURAL RESOURCES
 MICHAEL R. STYLER
Executive Director
 Division of Oil, Gas and Mining
 JOHN R. BAZA
Division Director

Inspection Report

Permit Number:	C0150015
Inspection Type:	PARTIAL
Inspection Date:	Wednesday, May 30, 2018
Start Date/Time:	5/30/2018 8:30:00 AM
End Date/Time:	5/30/2018 1:30:00 PM
Last Inspection:	Wednesday, April 25, 2018

Permittee: **BRONCO UTAH OPERATIONS, LLC**
 Operator: **BRONCO UTAH OPERATIONS, LLC**
 Site: **EMERY DEEP MINE**
 Address: **PO BOX 527, EMERY UT 84522**
 County: **EMERY**
 Permit Type: **PERMANENT COAL PROGRAM**
 Permit Status: **ACTIVE**

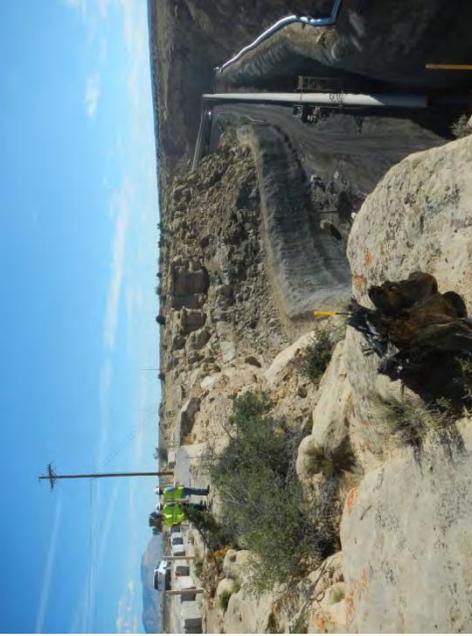
PHOTO 1 Emery 2 Box cut

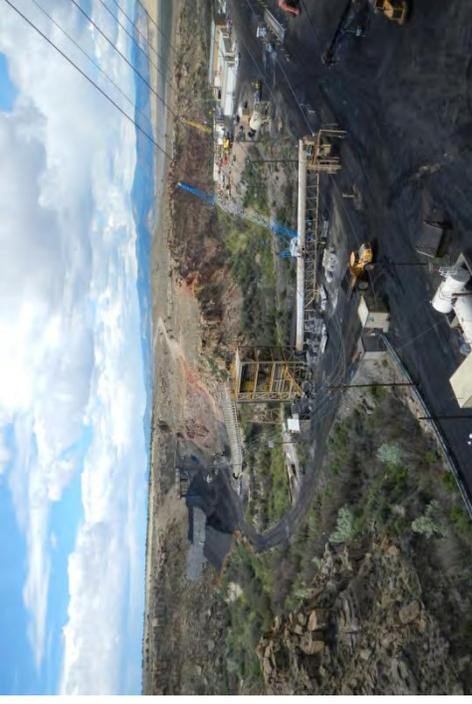
PHOTO 2 Emery 2 facilities

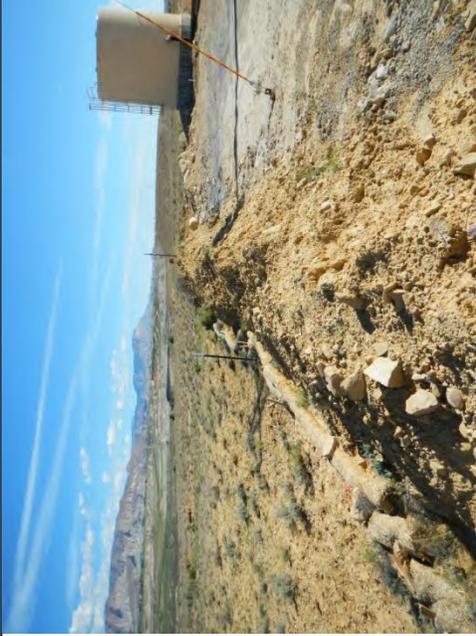
Topsoil from the Emery 2 construction is stored in berms along the boundary of the fan pad and with the existing the topsoil pile at the temporary waste rock site. Both locations of topsoil storage were seeded in February 2018 (Incoming 2152018). Only volunteer vegetation was growing on the pile. No seeded species were noticed (western wheatgrass, thickspike wheatgrass, crested wheatgrass, slender wheatgrass or Russian wildrye). The rock mulch on the stockpile at the waste rock site was fragments of 4" or less. Coverage was about 25%. The final volume of the stockpiled topsoil will be provided with as-builts of the construction.

PHOTO 3 Topsoil berm on fan bench

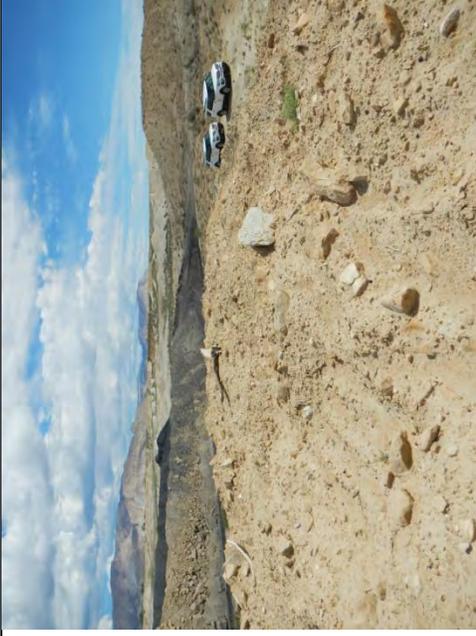
PHOTO 4 Emery 2 topsoil pile

Maintenance items: Repair breeched berm on East side of topsoil pile at the waste rock site. Re-set subsoil sign on stockpile to West of 4th East Portal access road.

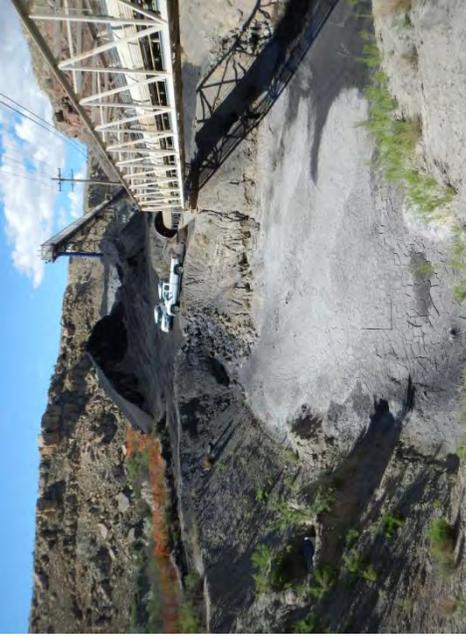
Sediment pond 3 (Pond 3) was observed during the field inspection. The embankments of Pond 3 were stable (i.e. no sign of excessive erosion rill formation). The primary and secondary spillways were inspected. Upon review of Plate VI-15B, Pond 3 Modifications, the primary spillway is in need of maintenance. The spillway was surrounded by a wall of soil that extended to an elevation above the top spillway elevation of 5,911'. The Permittee was instructed to remove the soil from around the spillway. The sediment marker shown on Plate VI-15B was observed in the south-east portion of the pond as designed. The secondary spillway was observed and found to be constructed as designed and depicted on Plate VI-15B.

PHOTO 5 Pond 3

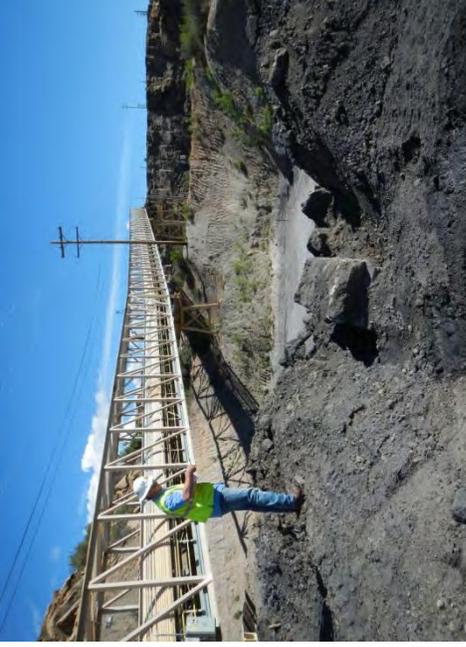
A portion of Jersey barrier was observed in the south-east inlet of Pond 3. The Permittee informed the Division that MSHA inspectors had directed them to place the barrier there in order to prevent someone from accidentally driving into the pond given its position to the access road to the No. 2 mine. It was discussed that the barrier needed to be removed in order to facilitate the reporting of stormwater runoff to Pond 3. The Permittee indicated that they would work with MSHA and devise some other type of deterrent/marker to prevent an accident. The idea of placing posts and a chain at the south-east Pond 3 inlet was discussed as possible alternative.

PHOTO 6 pond 3 inlet

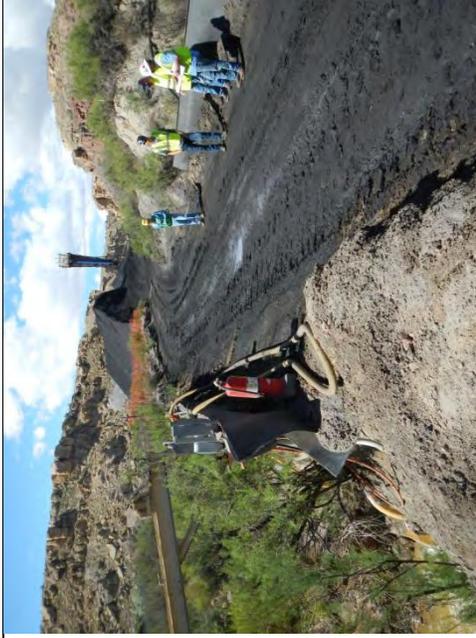
PHOTO 7

Coal fine accumulations were observed downstream of the road-crossing bridge of Quitchupah Creek on the approach to the No. 2 Mine. Approximately 4-6" of coal fine material was observed on either side of the creek. The Permittee indicated that the road bridge pools water during rainfall events. Coal fine accumulations were not observed on the upstream side of the bridge; however, the water was deeper in this more narrow section of the creek as well as more vegetated. The Permittee needs to fortify the berms/diversions adjacent to and on the road crossing bridge to prevent the coal fine accumulations in Quitchupah Creek. The Permittee indicated that hand tools would be used to remove the coal fine accumulations from the Quitchupah Creek channel.

Emery 2 access across Quitchupah

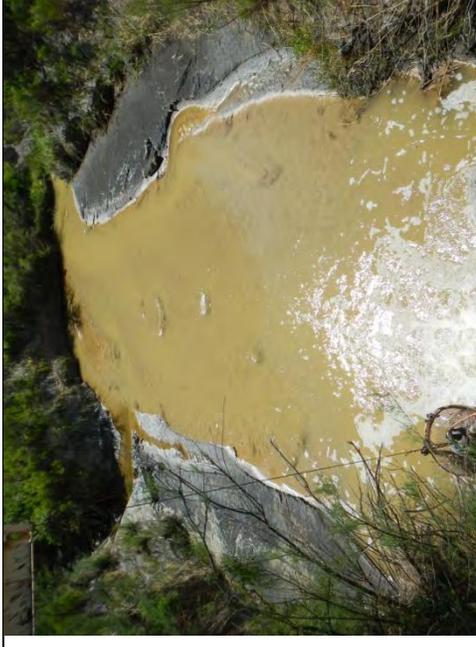
PHOTO 8

Quitichupah Creek downstream

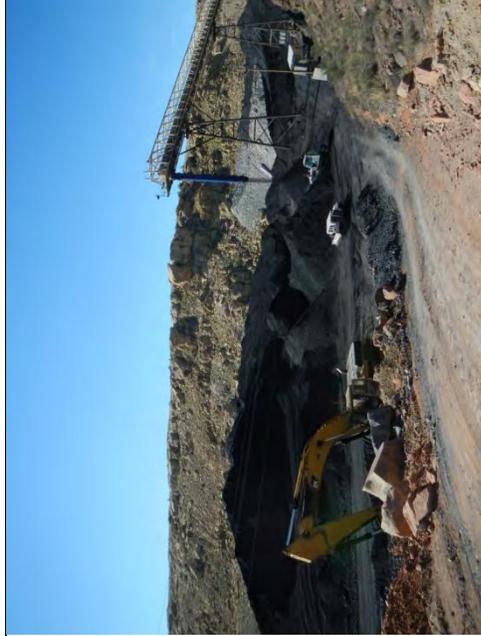
PHOTO 9 Emery2 ROM Coal and high ash coal piles. Dozer is working lump coal pile

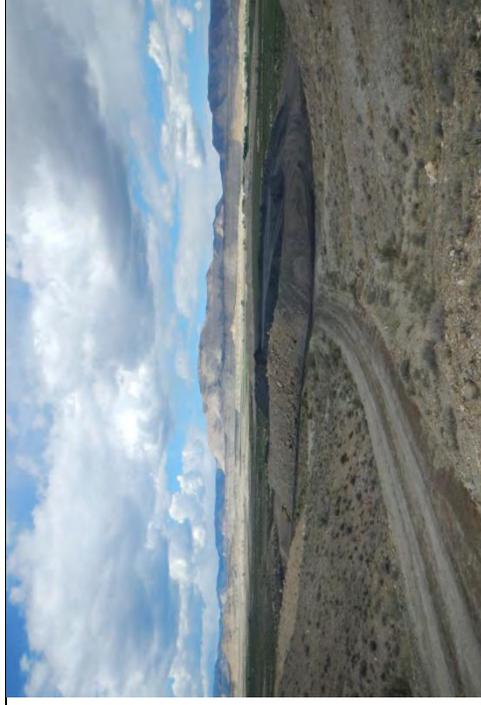
The volume of refuse and excess cut stored at the temporary waste rock site is approximately 93,000 CY (2017 Annual Report). Final volumes will be reported with the as-built. The final reclamation of the waste rock is described in Appendix VII-2. We observed the final reclamation location.

PHOTO 10 Temporary storage pile of excess cut and mine waste

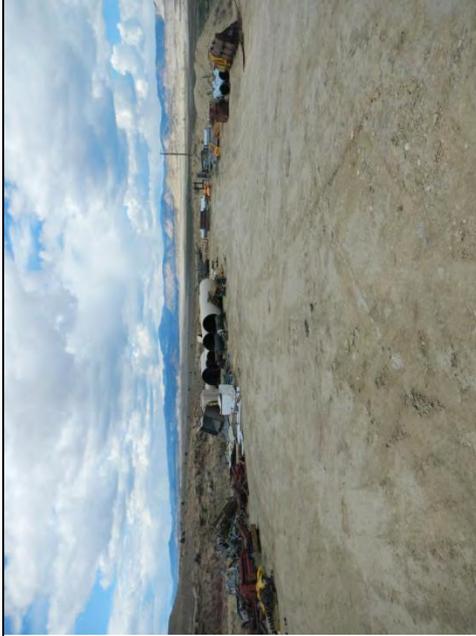
PHOTO 11 storage yard and proposed permanent waste disposal site

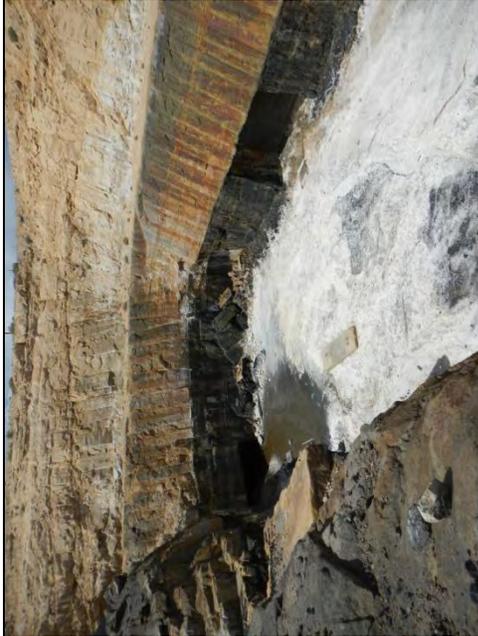
The 4th East portals have been sealed since 2011

PHOTO 9
Sealed 4th East portals

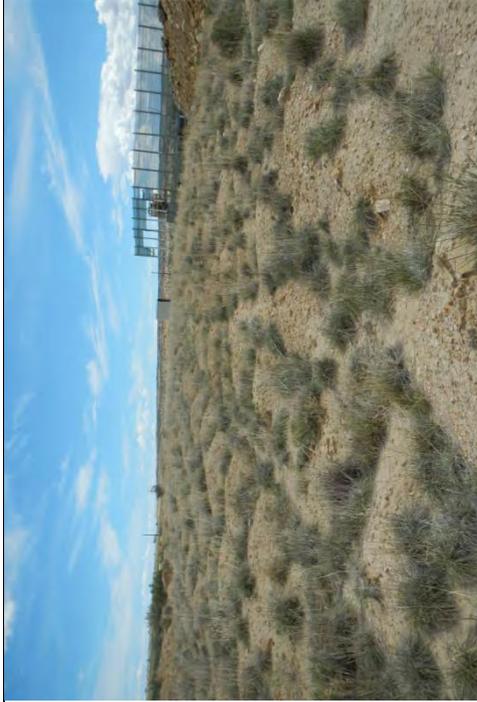
Topsoil stockpiled at the 4th East portal is in a large stockpile and in berms along the West side of the site. The stockpile is very well vegetated.

PHOTO 11
4th East portal topsoil stockpile

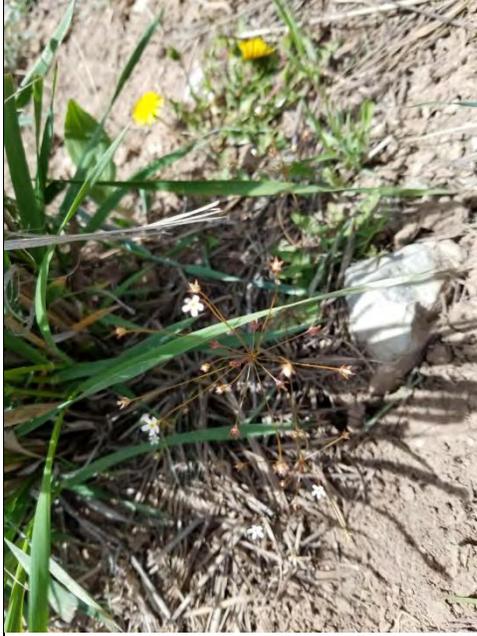
PHOTO 12 4th E portal topsoil plants

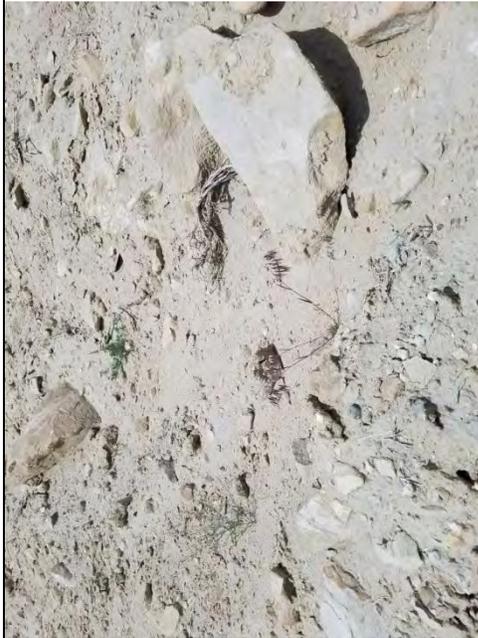
PHOTO 9 Emery 2 topsoil stockpile

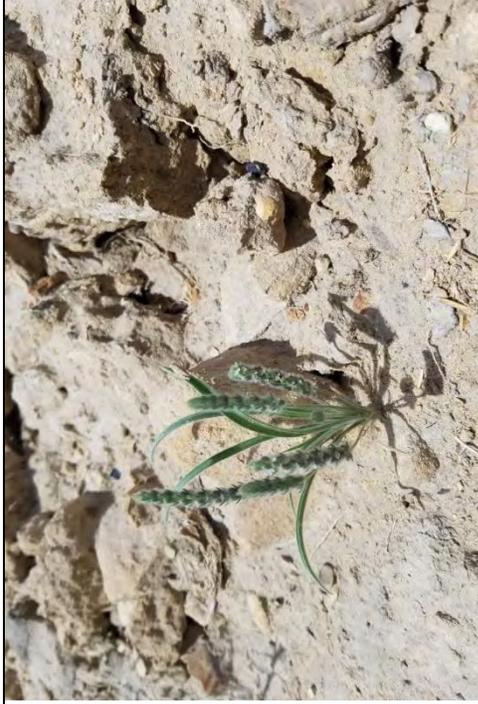
PHOTO 10 Emery 2 topsoil stockpile
