Inspection Report

Permit Number:	C0150015
Inspection Type:	PARTIAL
Inspection Date:	Tuesday, December 11, 2018
Start Date/Time:	12/11/2018 9:00:00 AM
End Date/Time:	12/11/2018 12:00:00 PM
Last Inspection:	Wednesday, November 14, 2018

Permittee: **BRONCO UTAH OPERATIONS, LLC**

Site: **EMERY DEEP MINE**

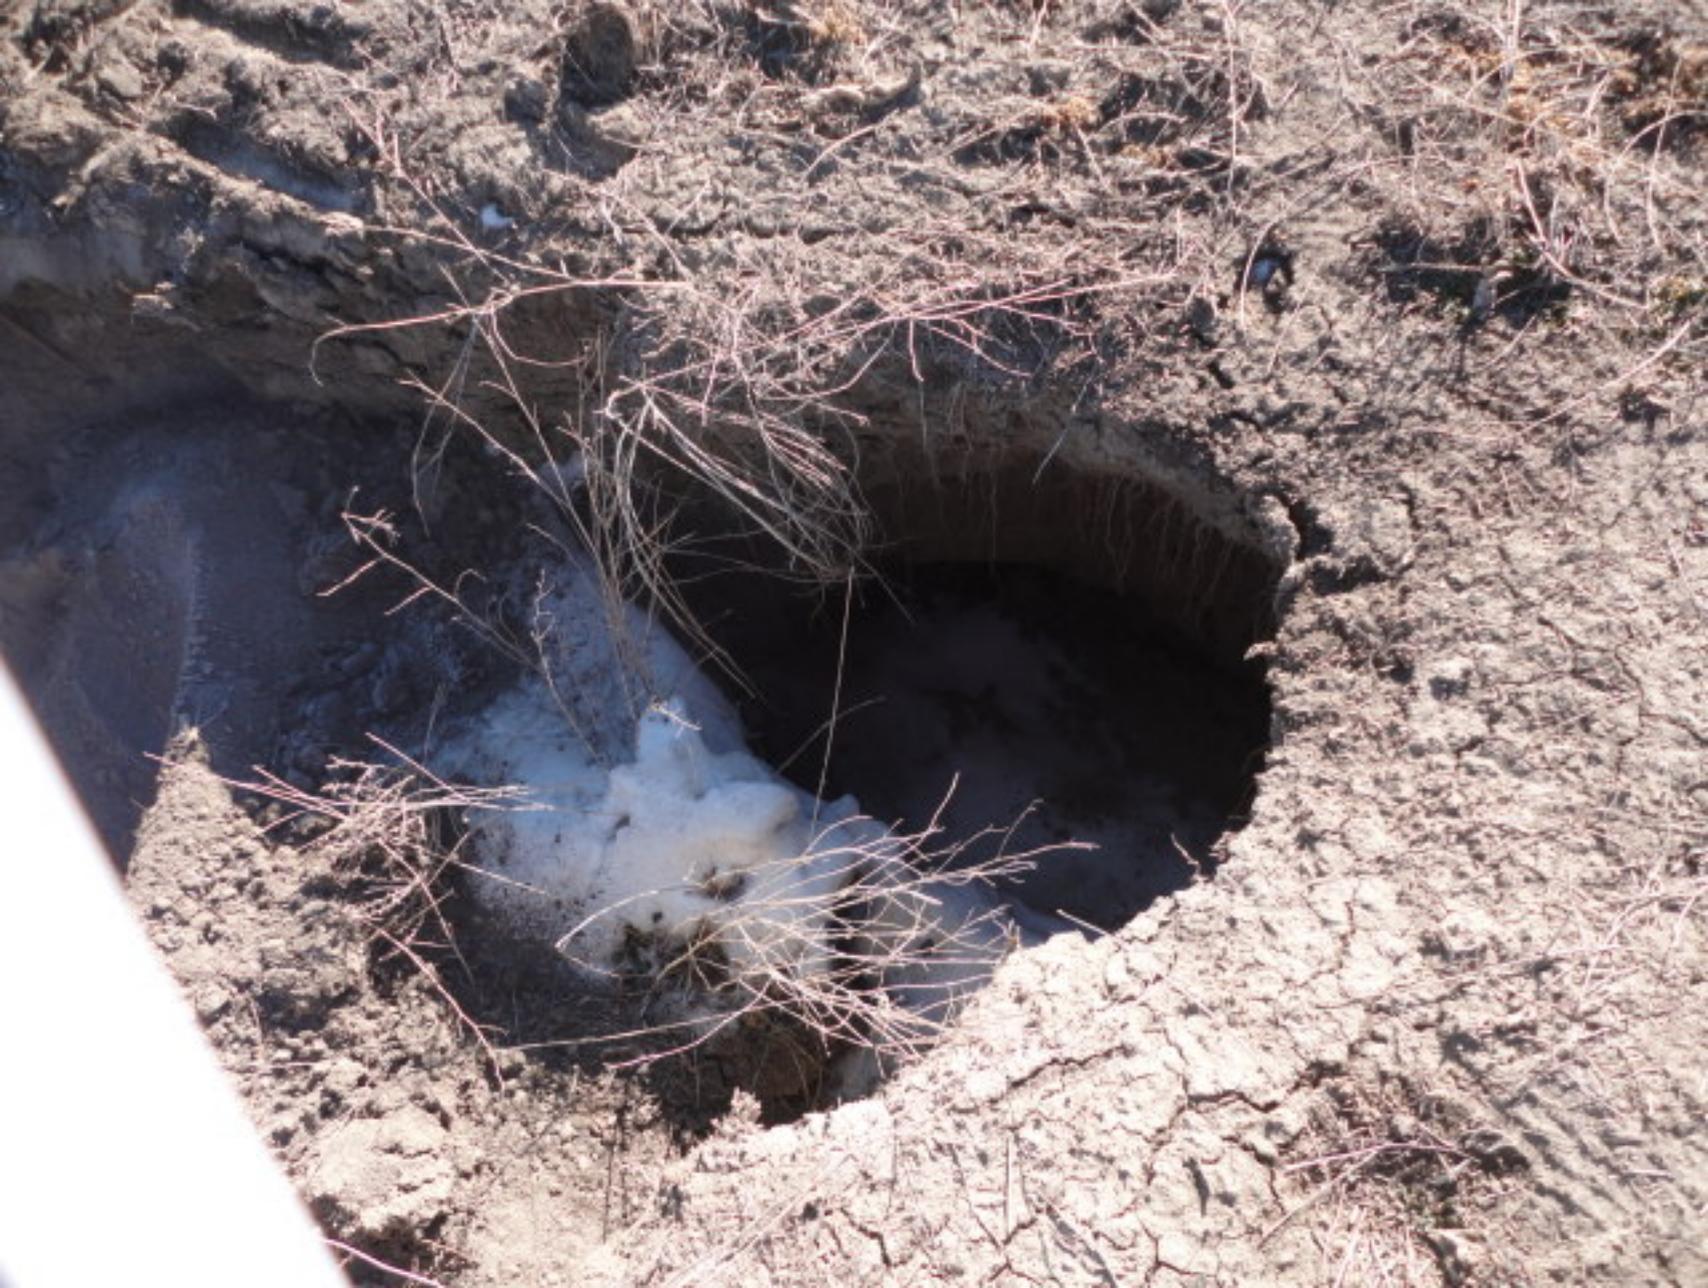
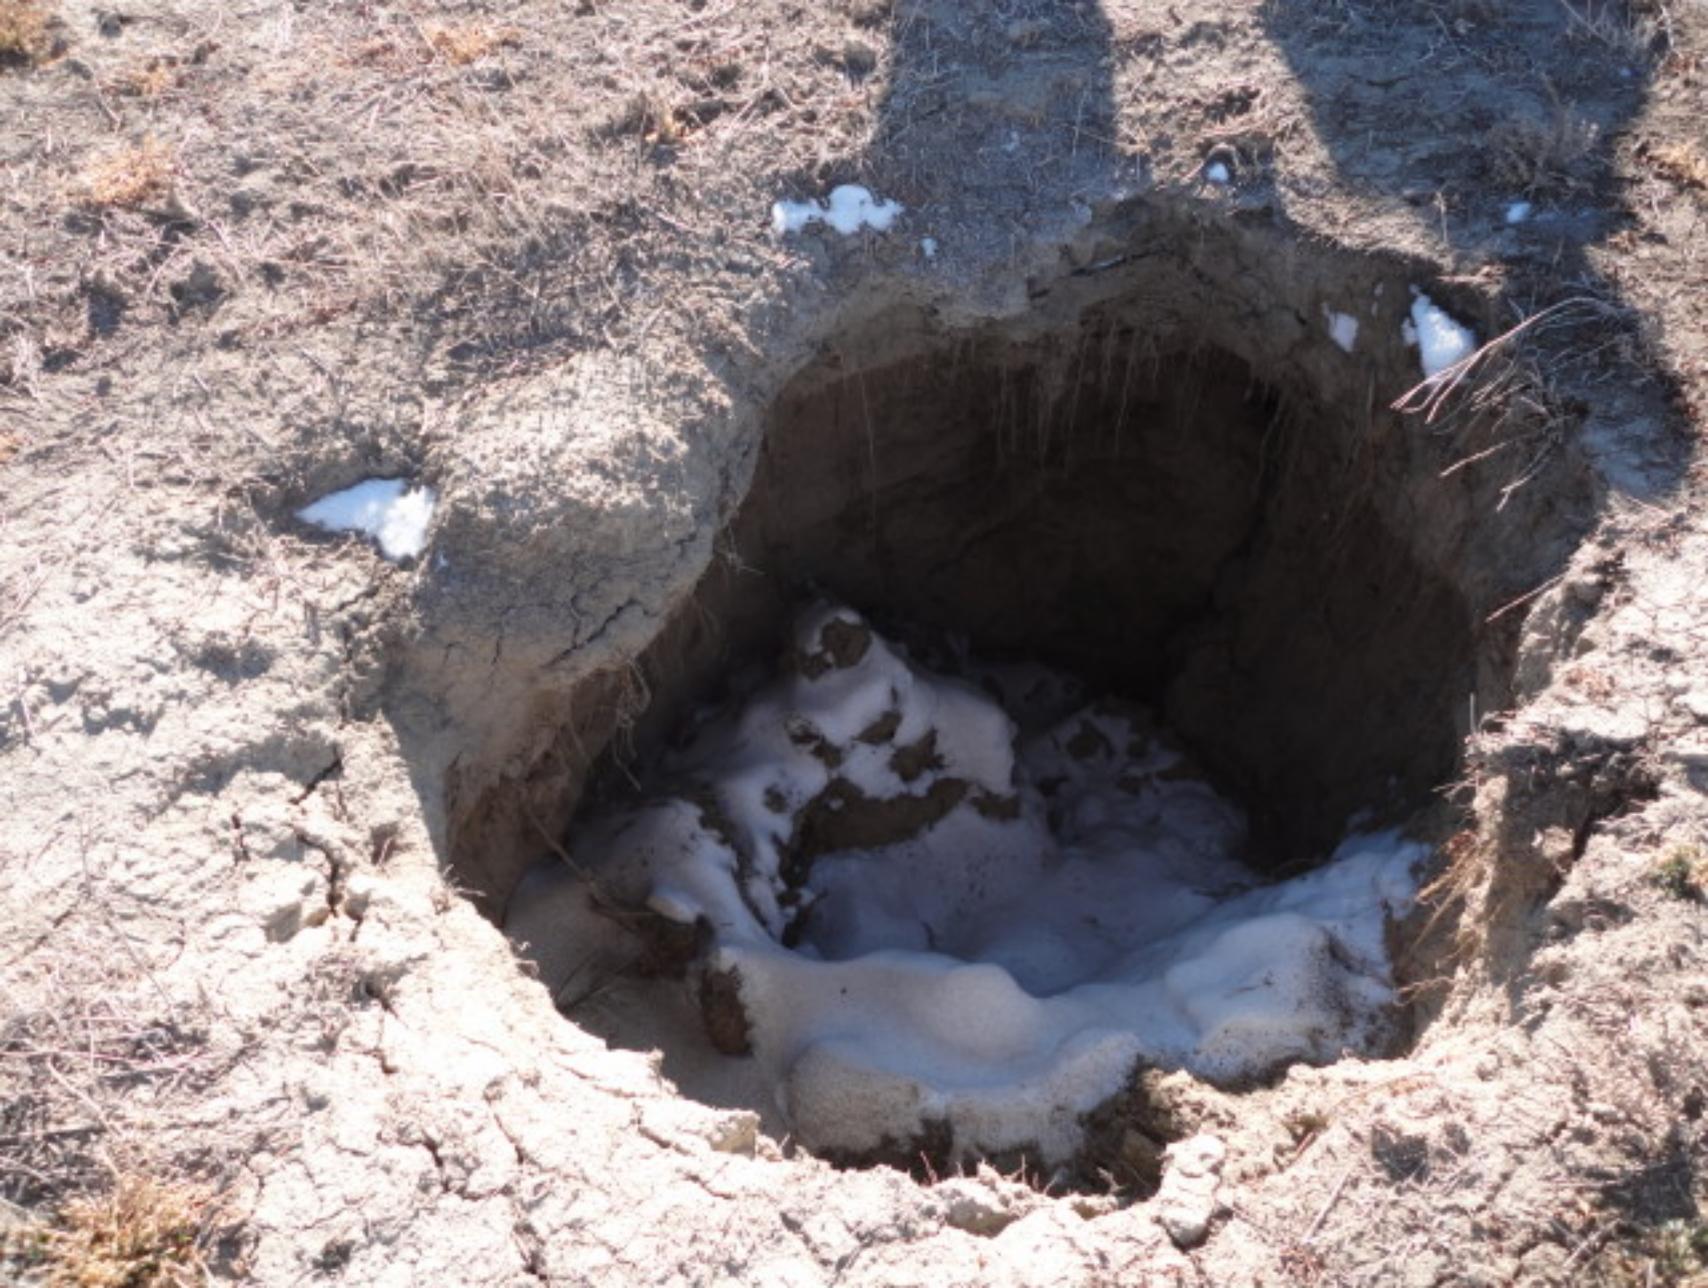
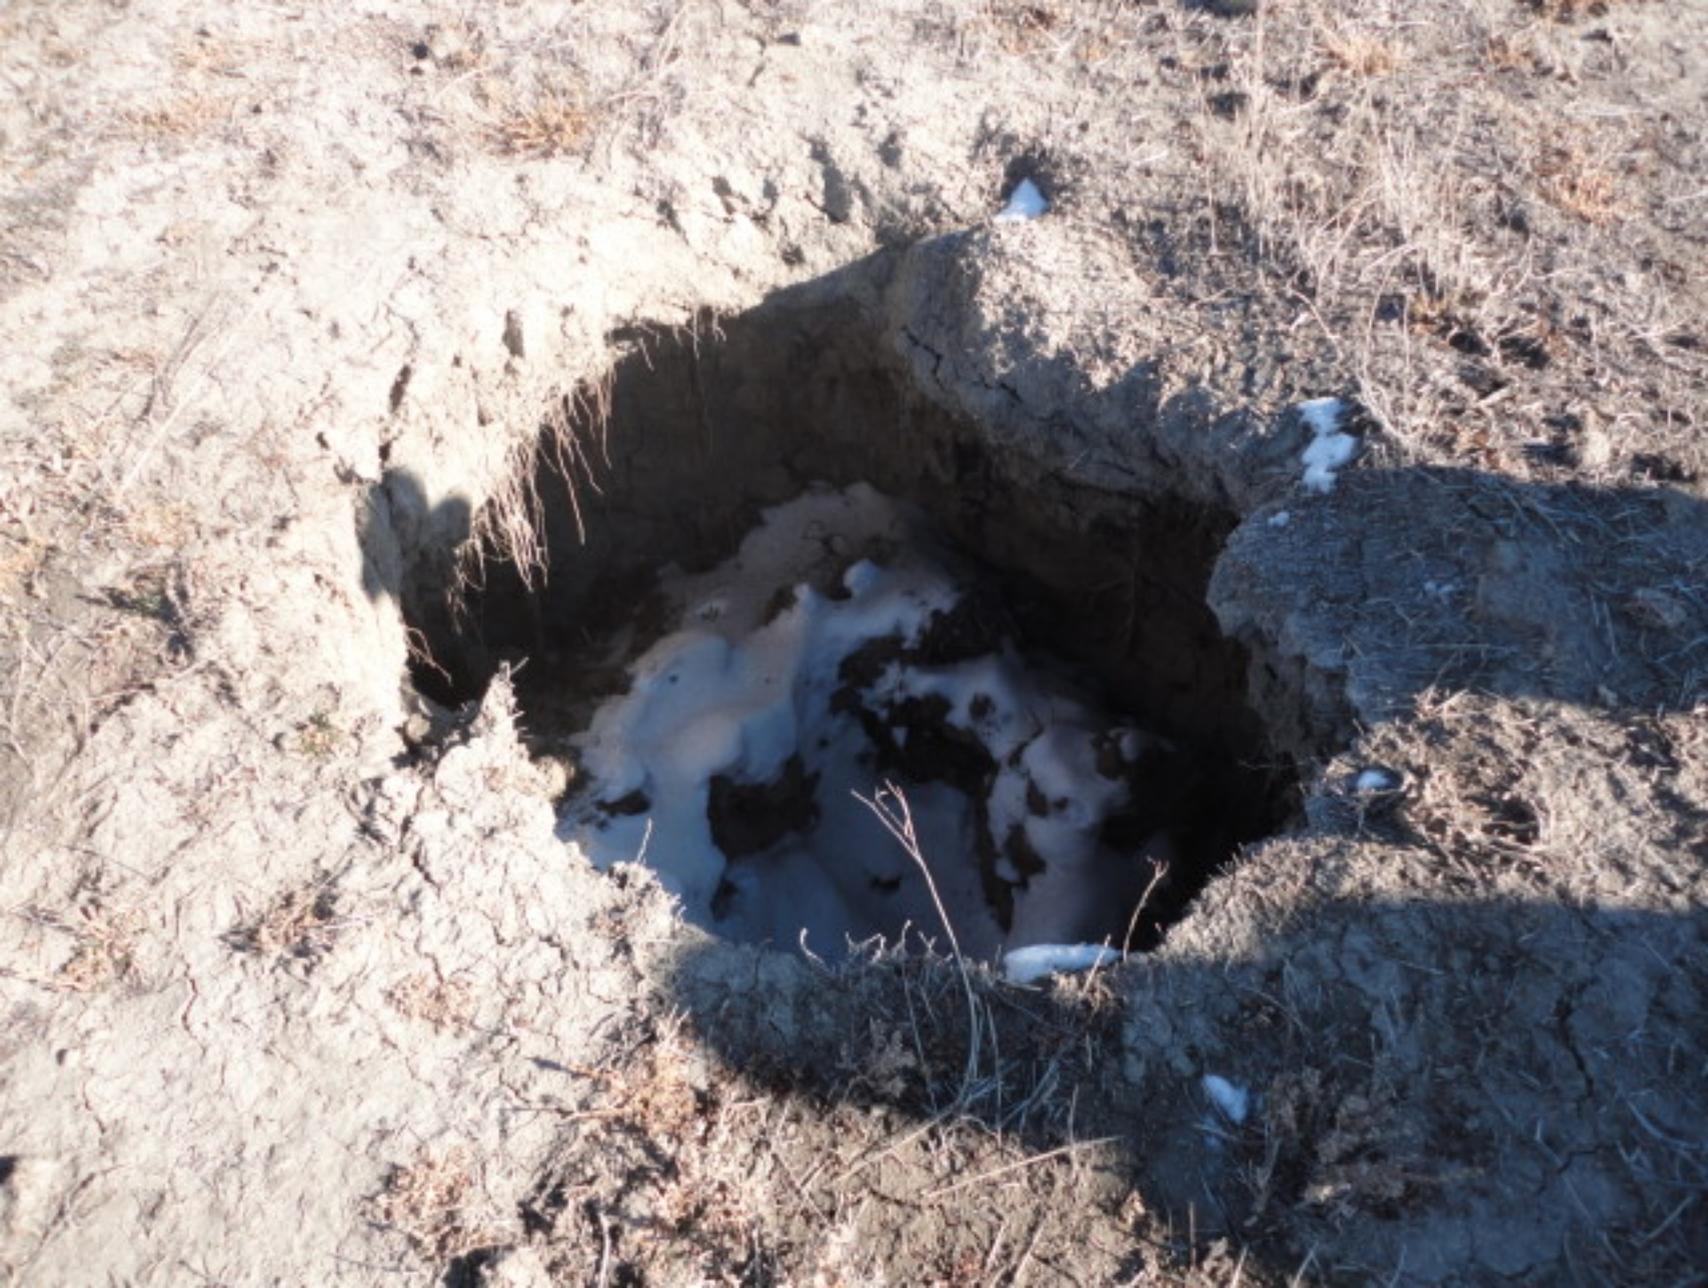
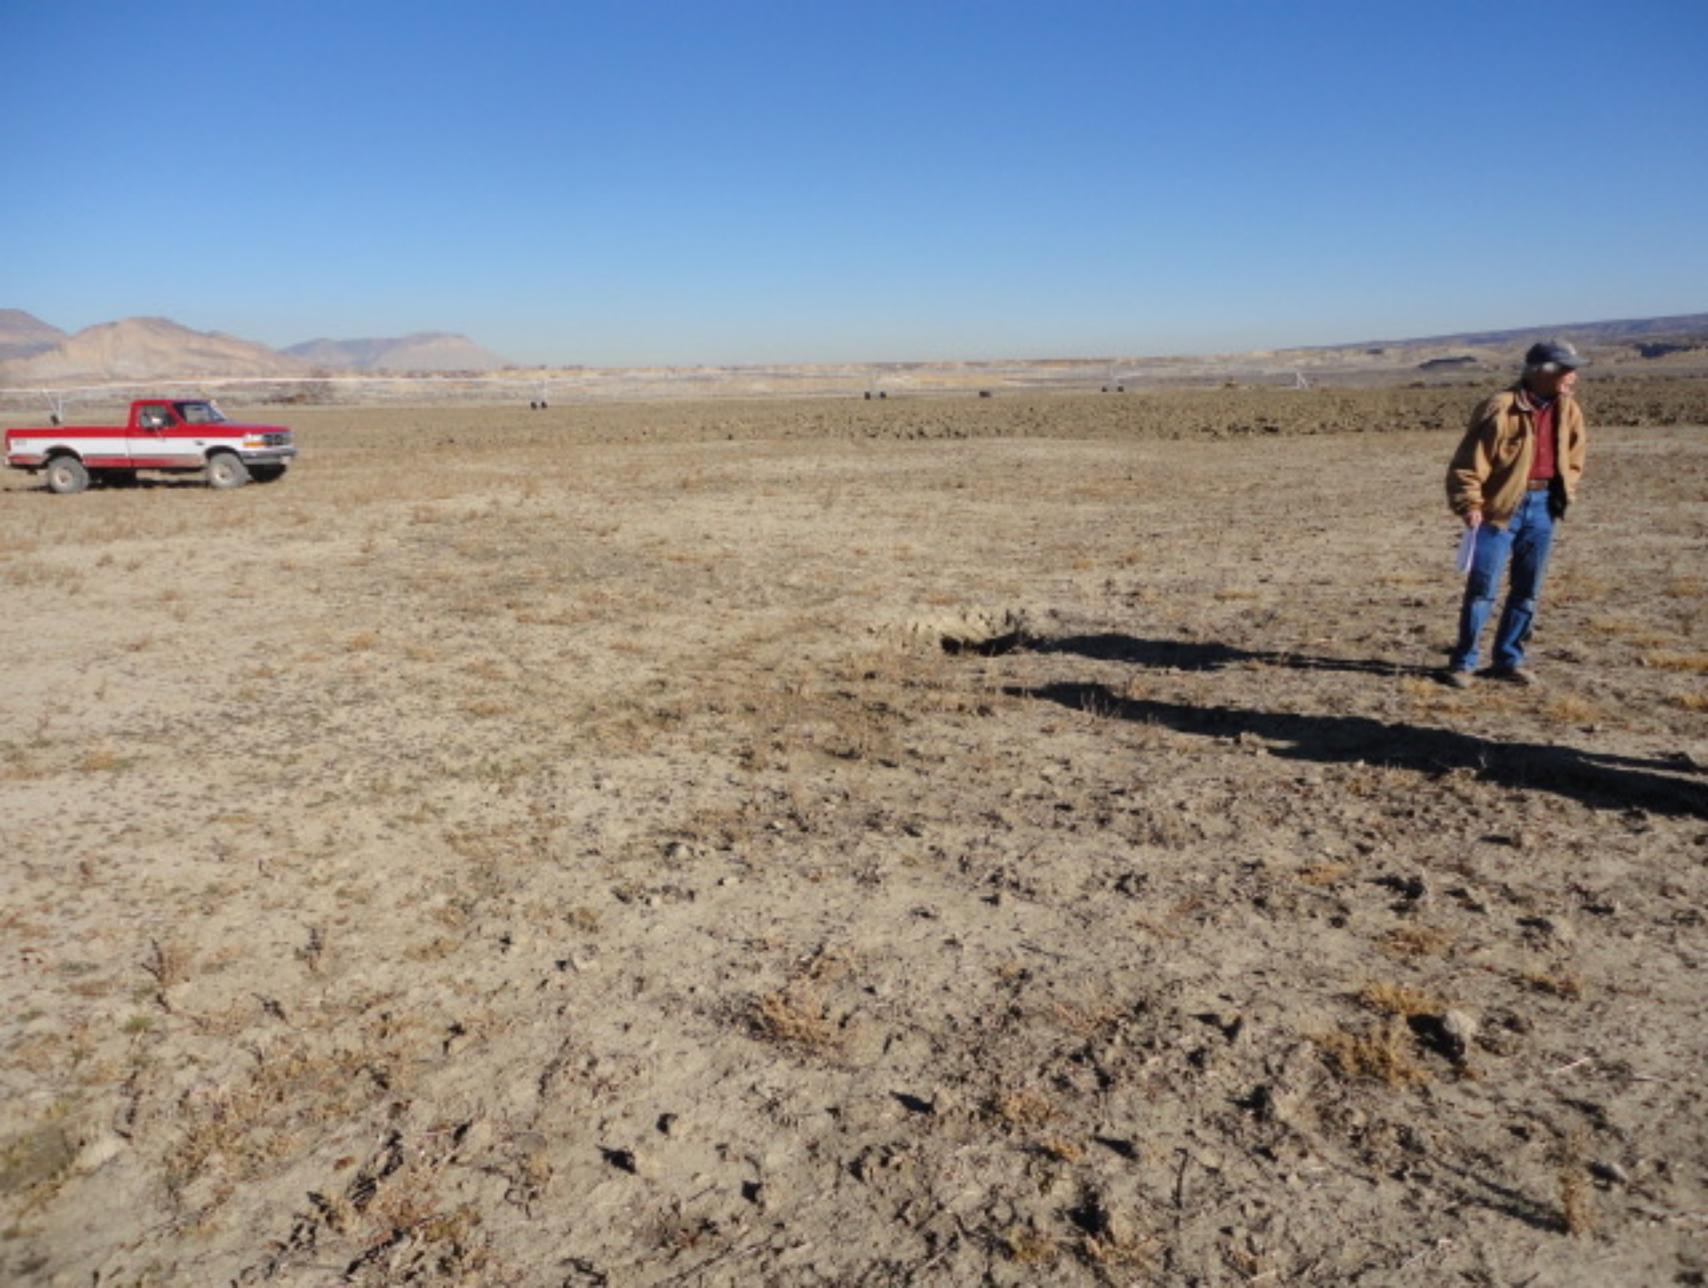
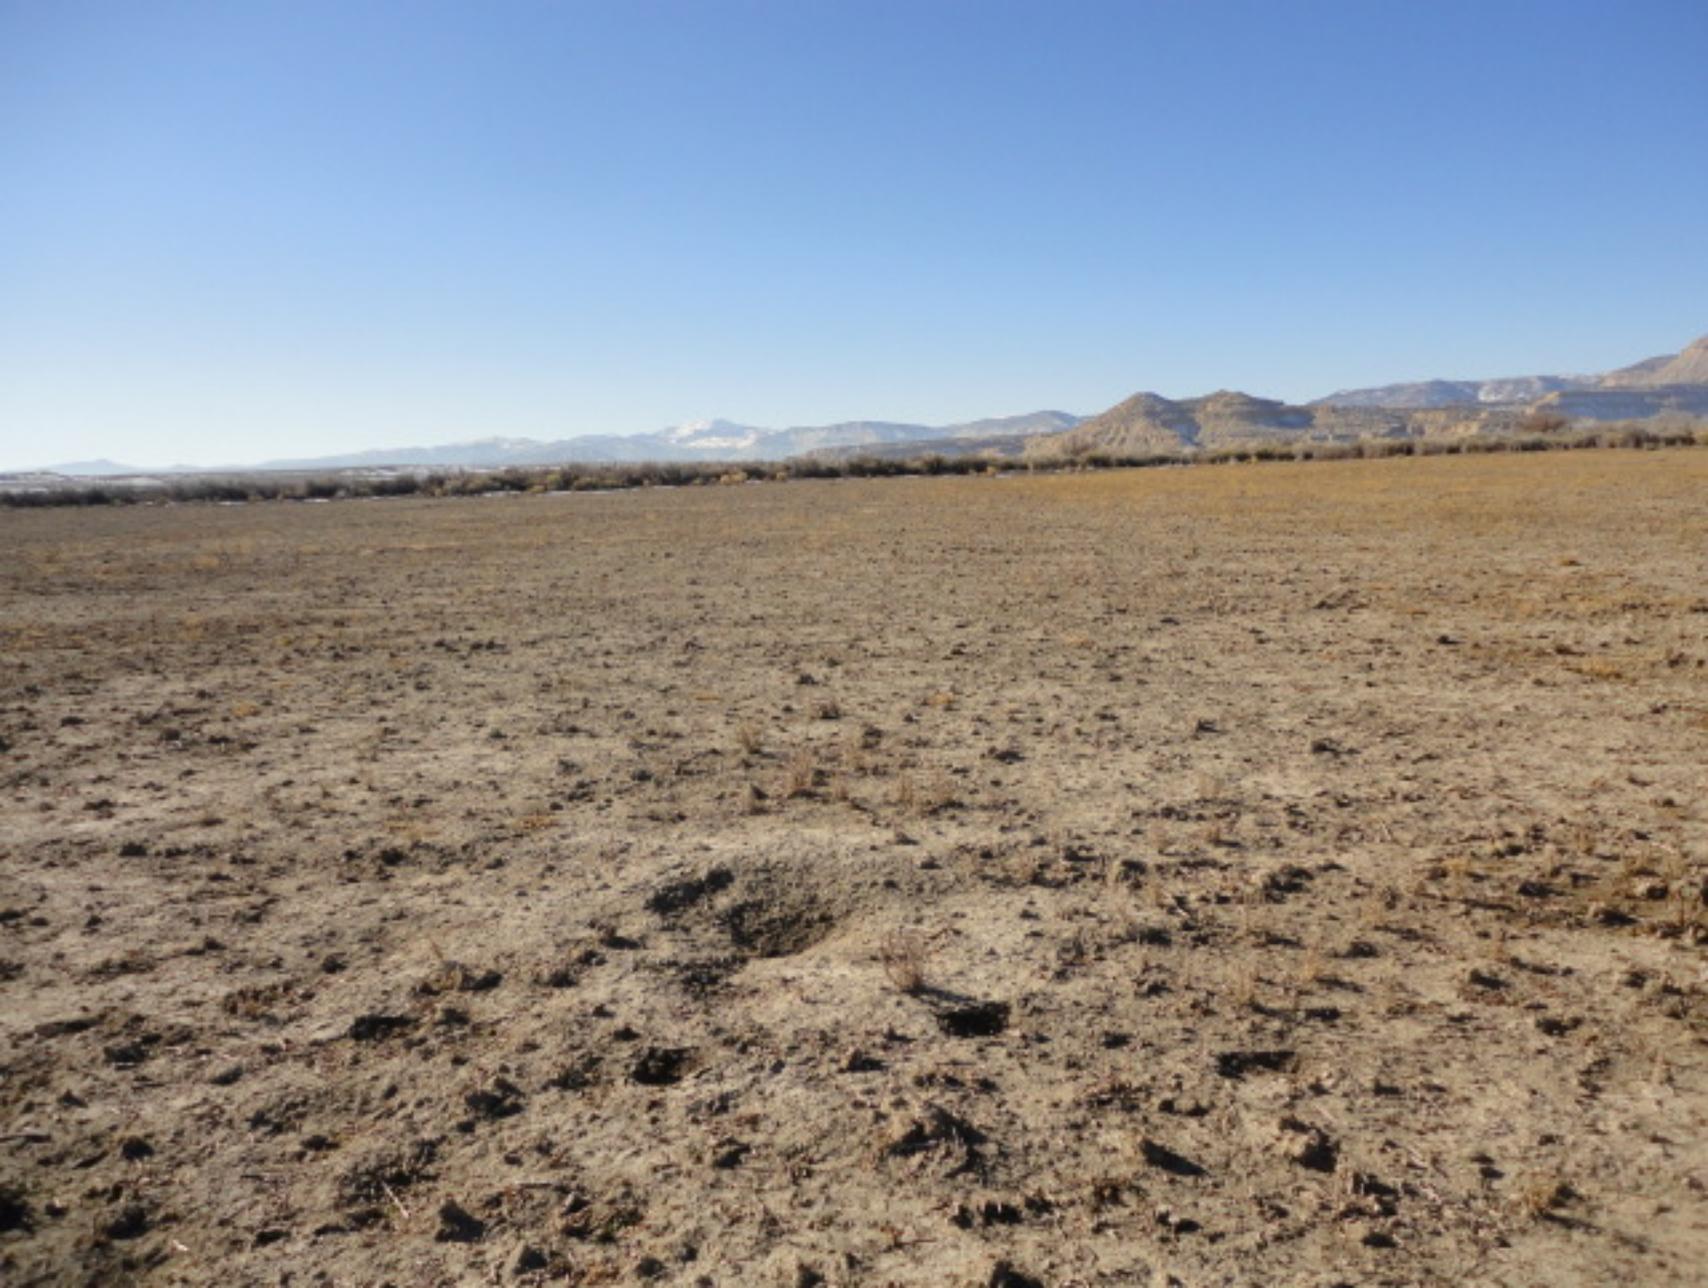
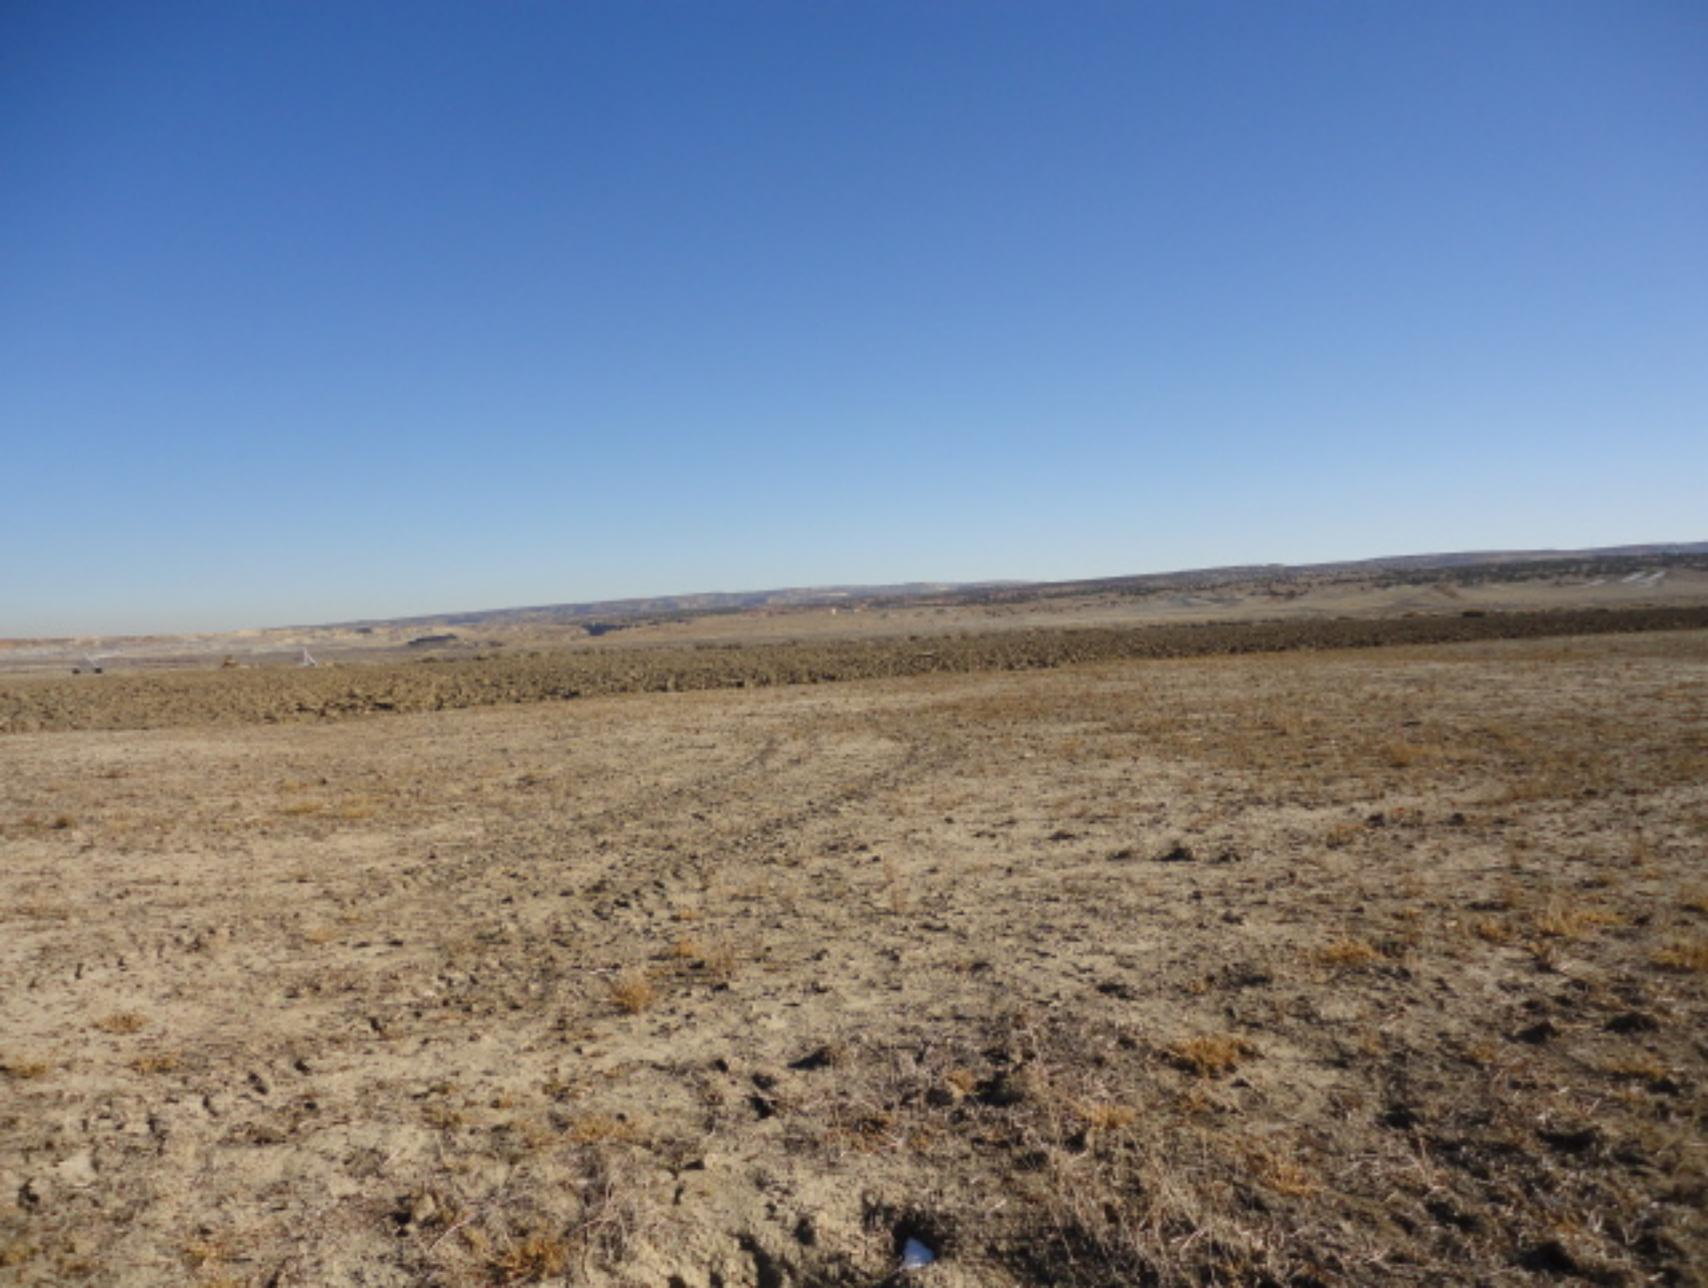
Karl Houskeeper received a phone call on December 10th from Bill Stansfield about subsidence in his field. Mr. Stansfield is an adjacent landowner to the Bronco mine. We inspected the field where there were sink holes. There were approximately 4 sink holes. See Photos The nearest underground mined area was approximately over ¼ to ½ miles away. I do not see any possible linkage to the sink holes and the underground mining activity. The angle of draw and distance from the mine working could not influence this area. Further, study show that the sink holes could be connected underground by a tunneling effect. It is my suggestion that there is an underwater stream or seep causing the sink holes. These sink holes are not mining related.
