**RE: Bronco Utah Operations LLC
Emery Mine
DOGM Permit No. C/015/0015
Emery 2 Second Left Panel Full Extraction Revision**

GEOLOGY AND SUBSIDENCE

The purpose of this report is to present baseline surface conditions prior to full extraction operations from the Emery 2 portal of the Bronco Utah Operations, LLC. (Bronco) Emery Mine, Emery County, Utah. The areas covered in this report include the following:

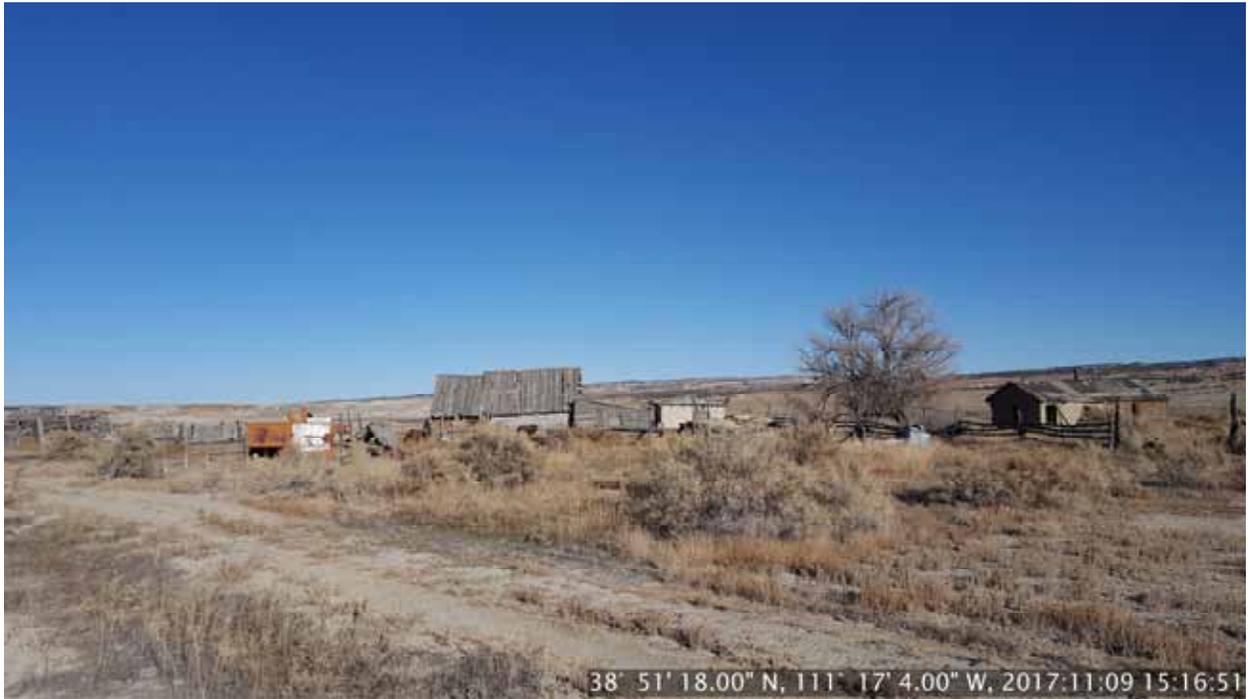
Feature 1. Ranch House, Buildings, and Corrals. The description of this feature has been updated from the Valley Engineering (1980) report. The ranch house, buildings, and corrals all appear to be several decades old and are in dilapidated condition. The rough cut wood walls of the ranch house are intact, however, the adobe walls are beginning to crumble. The walls in a framed wood extension, built onto the eastern side of ranch house, have failed and the roof in

Feature 1. Ranch House, Buildings, and Corrals. Feature overview, looking east.

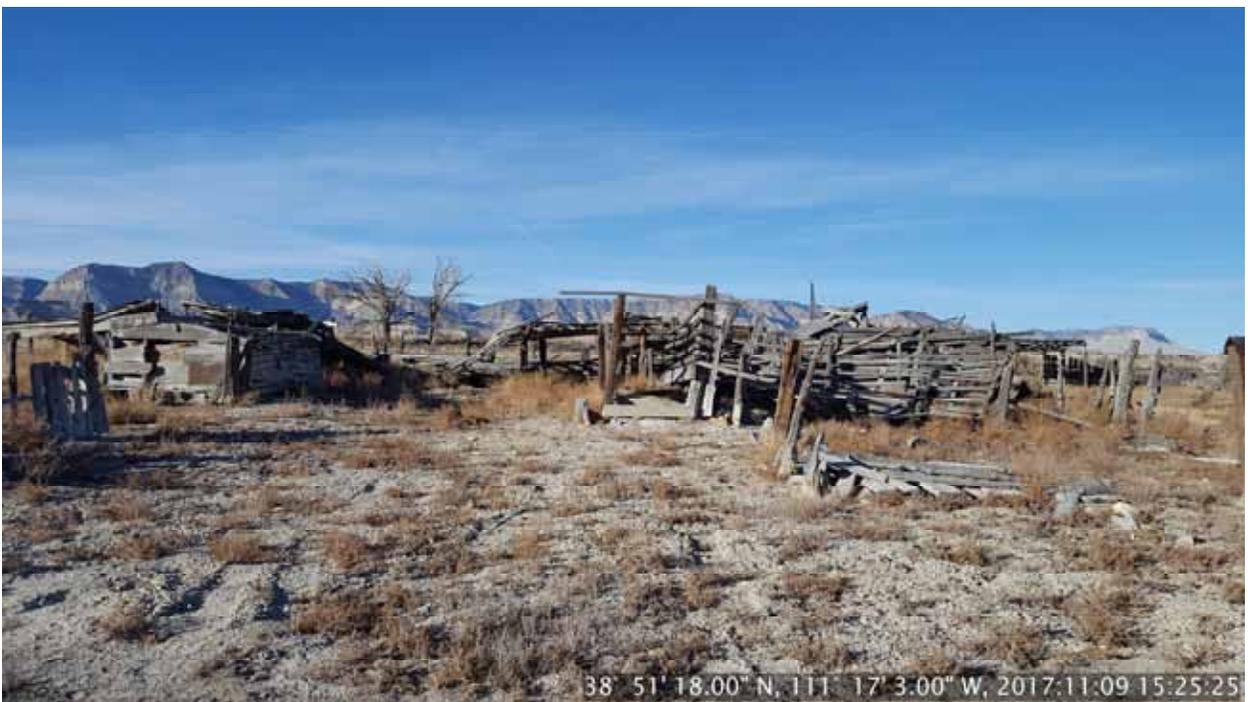
Feature 1. Ranch House, Buildings, and Corrals. Corrals.

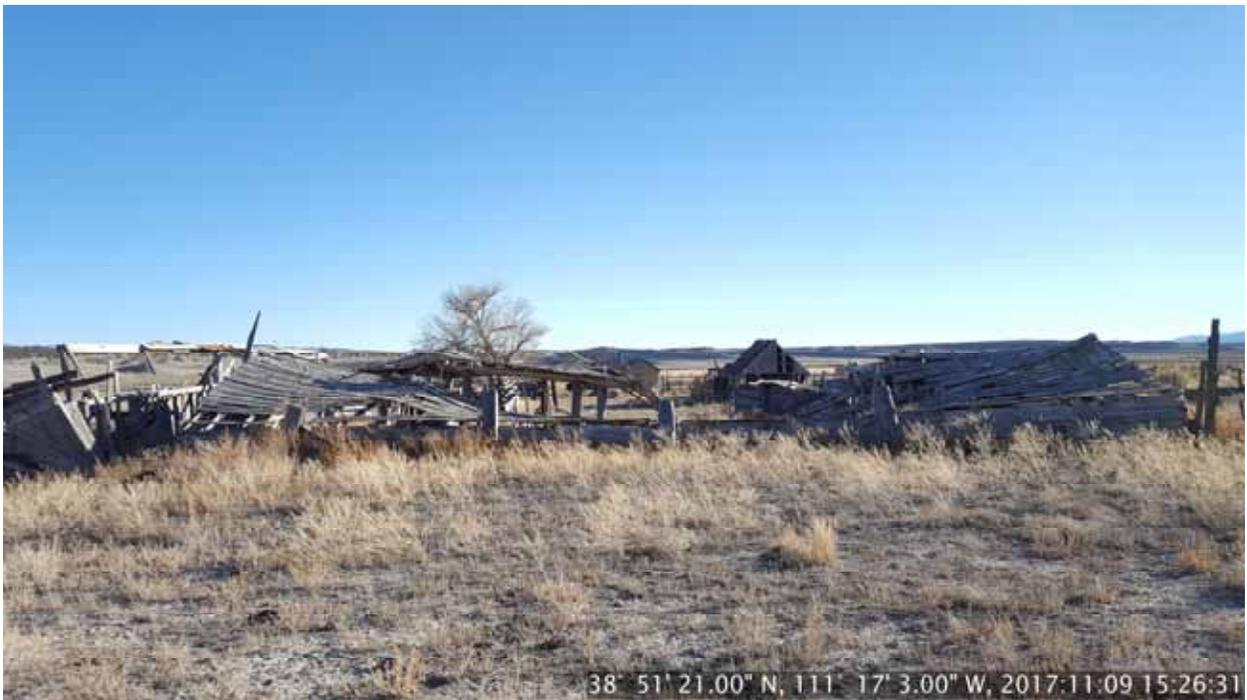
Feature 1. Ranch House, Buildings, and Corrals. Corrals.

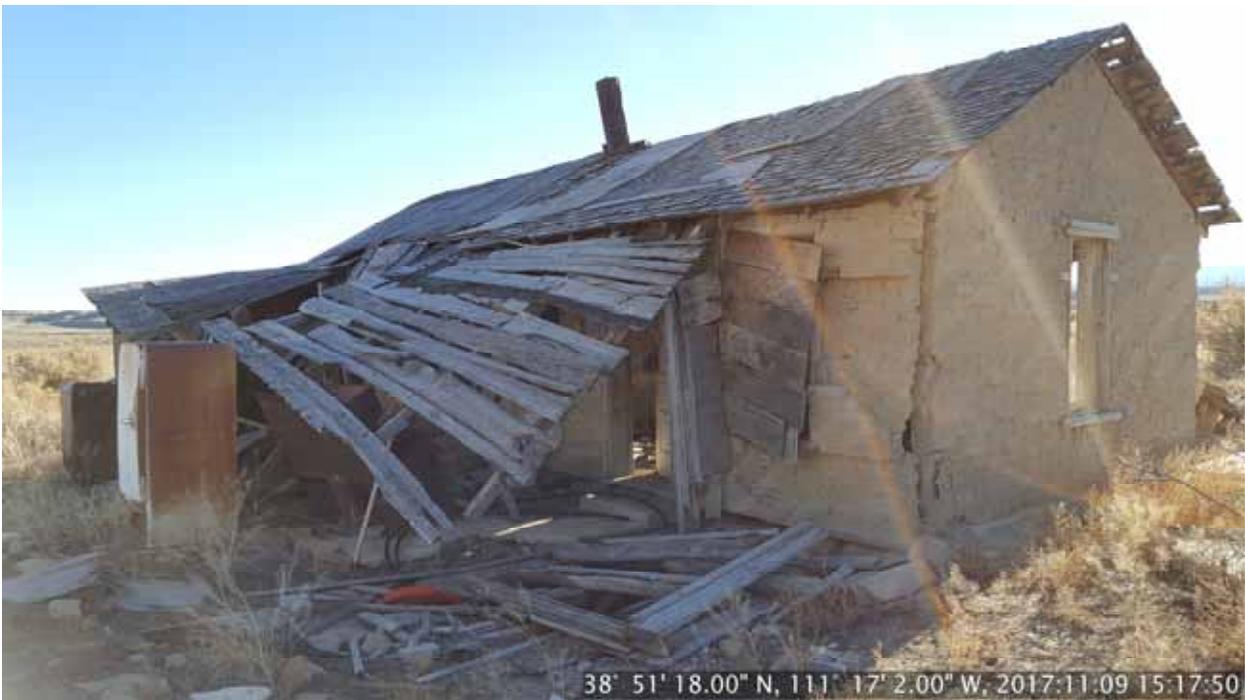
that section of the house has collapsed. One corner of the cinder block building has collapsed. The remaining buildings and corrals are constructed of rough wood logs and rough cut boards. The wood roofs on these building are failing. The corrals are unusable and have mostly fallen to the ground. There are several types of fences in the area; the most common was barbed wire or wire mesh on the bottom with barbed wire above the mesh. Fence posts were mainly steel or rough cut tree limbs.

Feature 1. Ranch House, Buildings, and Corrals. Ranch House.

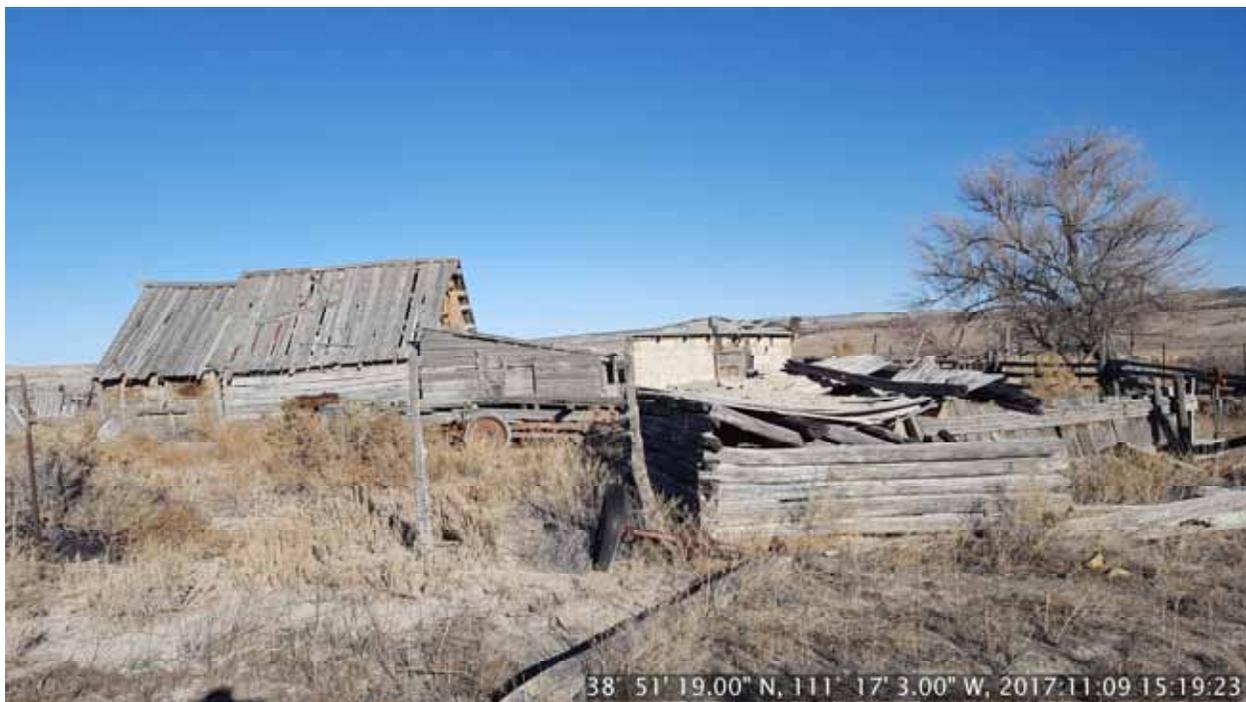
Feature 1. Ranch House, Buildings, and Corrals. Buildings.

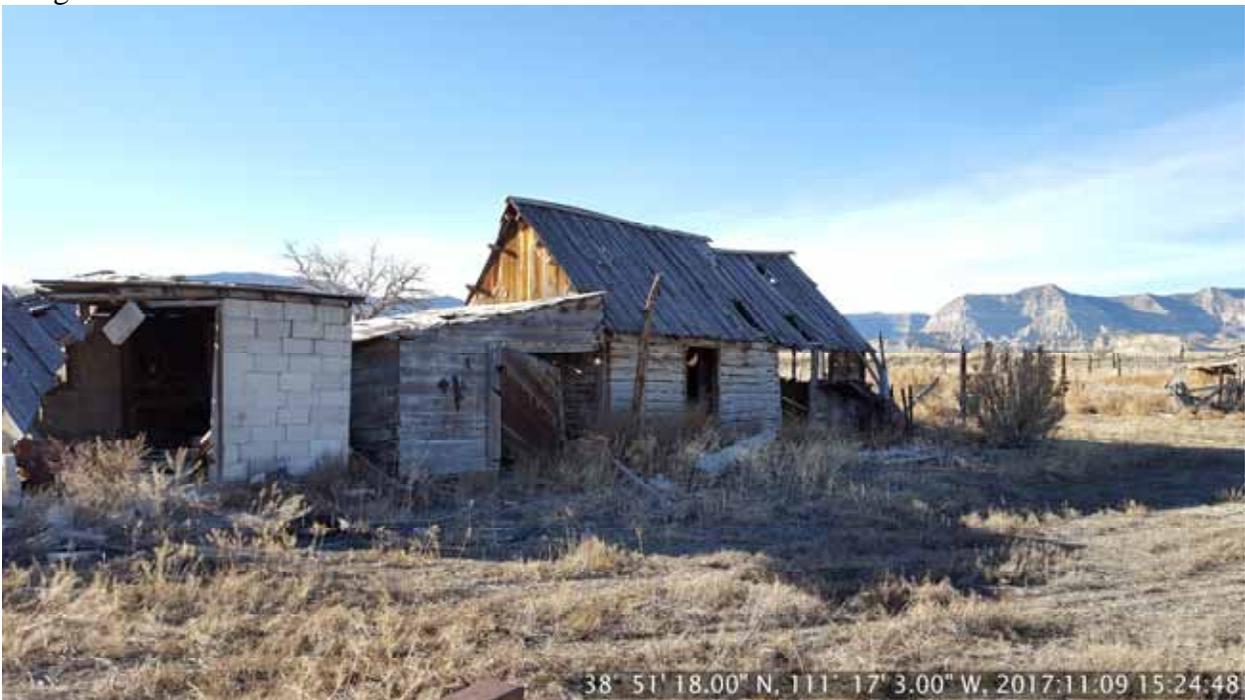
Feature 1. Ranch House, Buildings, and Corrals. Buildings.

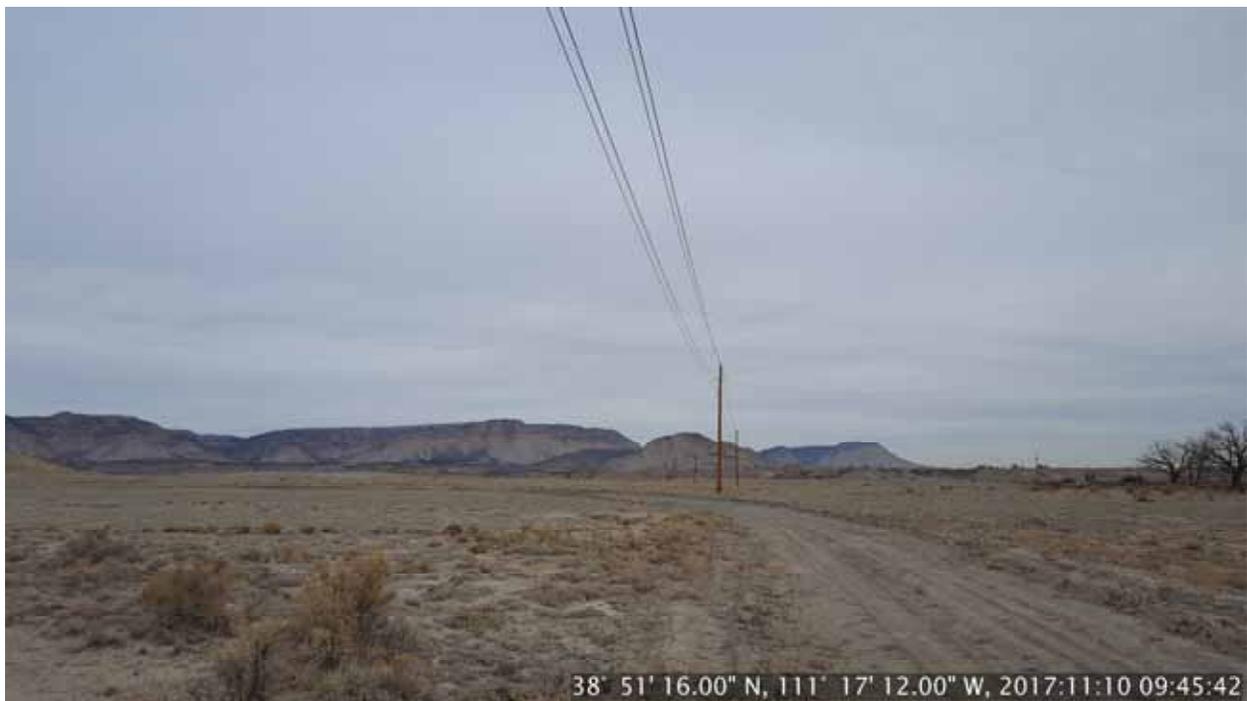
Feature 5. Utility Power Lines. This feature is essentially unchanged from how it is described in the Valley Engineering (1980) report, which states the following: "These power lines are located approximately 200 yards to the west of the ranch buildings (Feature 1). The poles run north and south and are approximately 40 feet high." It appears that several of the poles have been replaced since the 1980 survey. The poles are in good condition.

Feature 5. Utility Power Lines. Looking north.

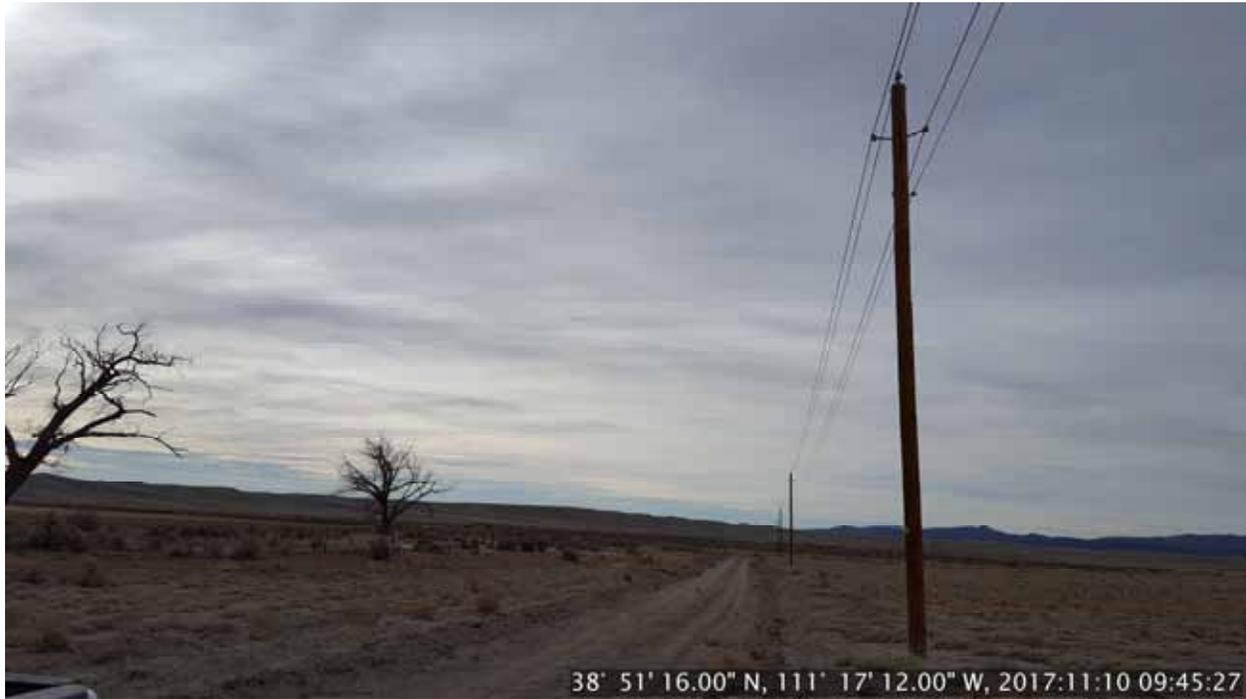
Feature 5. Utility Power Lines. Looking south.

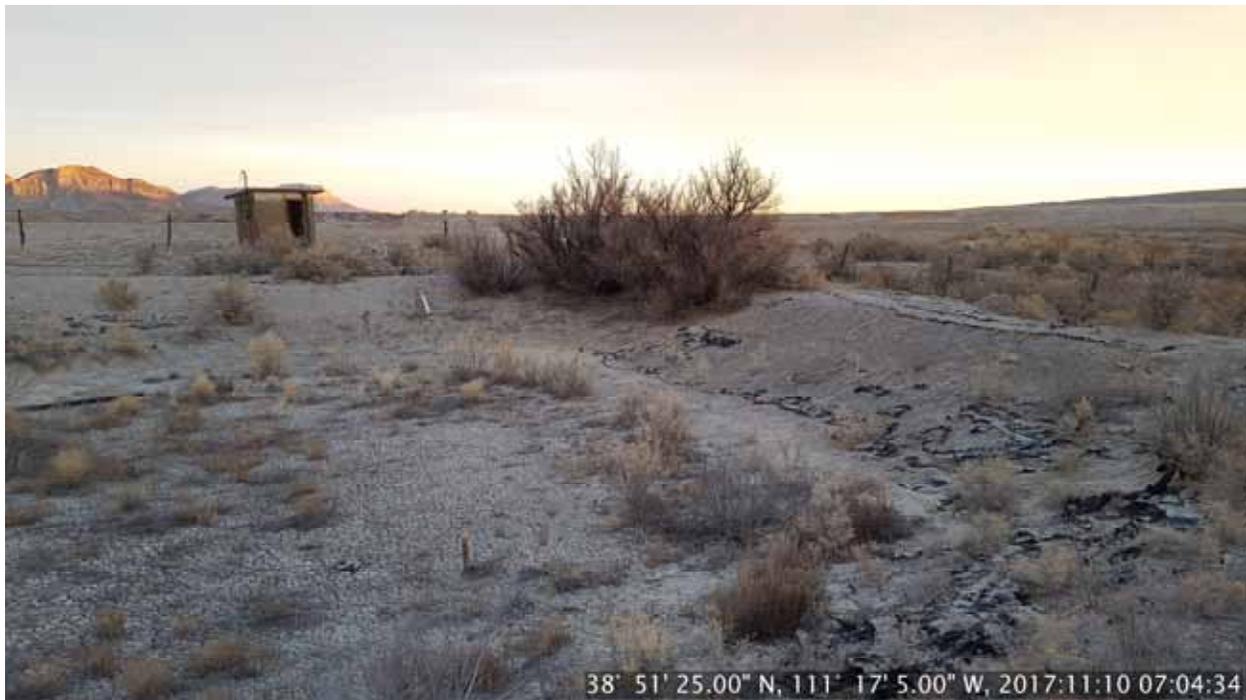
Feature 6. Pond. The description of this feature has been updated from the Valley Engineering (1980) report. The pond, cut into a small hill on its northwestern corner and diked on the surrounding edges, is roughly square in shape and measures approximately 75 feet x 75 feet x 5 feet deep. A black plastic liner is exposed at numerous locations around the dike. Exposure to the elements has severely degraded the liner and it is no longer functional. An erosion channel has formed on the slope at the northwest corner of the pond. The pond is dry and it appears that it has been quite some time since it has held water. A fence, constructed of natural rough cut tree limbs, surrounds the pond. The fencing material consists of wire mesh with one strand of barb wire at the top. The fence is in dilapidated condition.

Feature 6. Pond. A well (Feature 8.) is in the background.

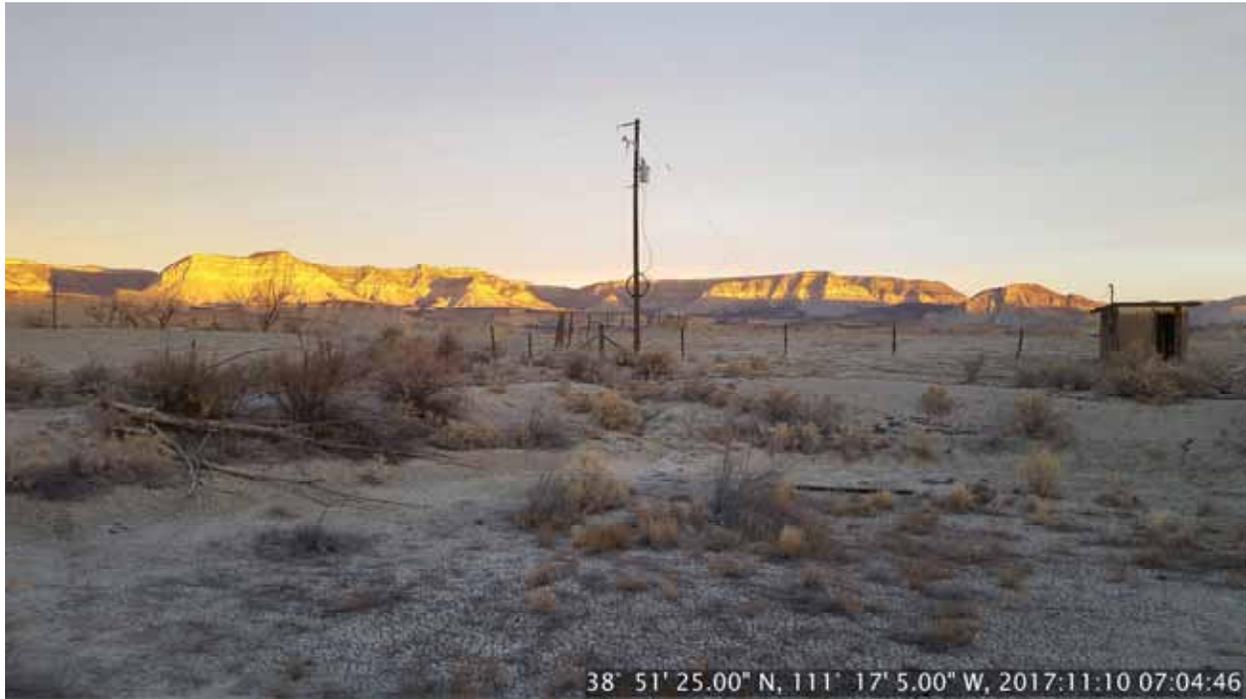
Feature 6. Pond. Bank erosion at far corner of pond.

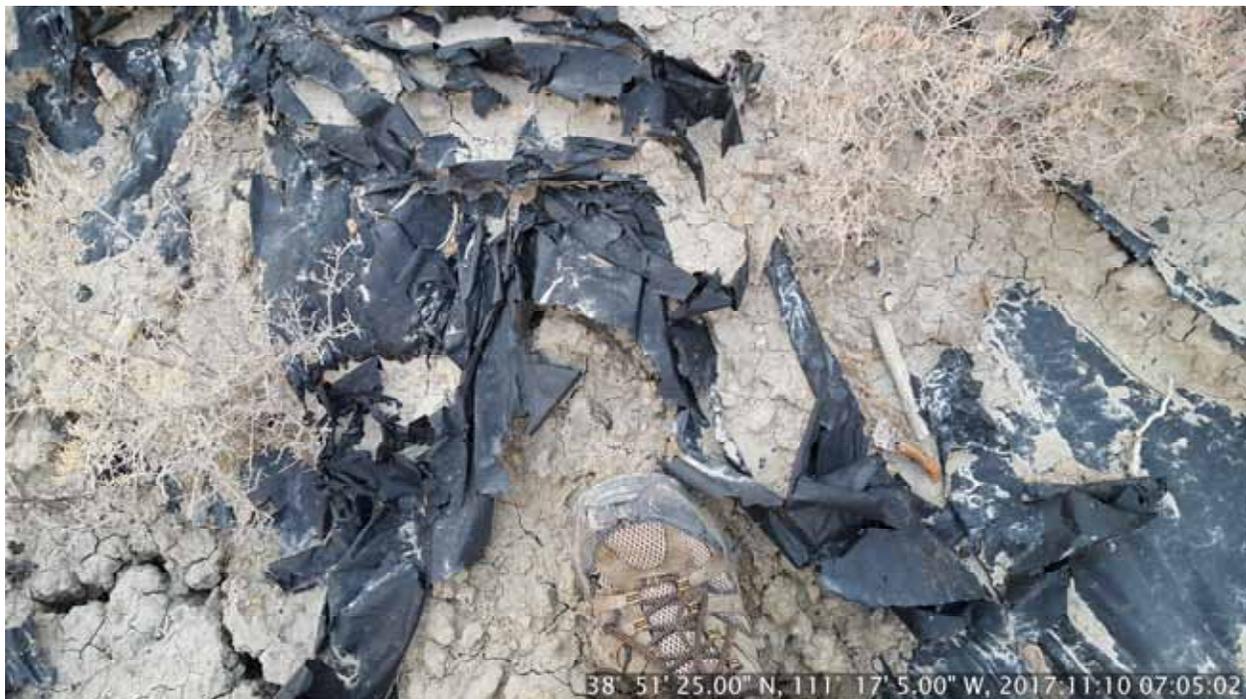
Feature 6. Pond. Disintegrated pond liner.

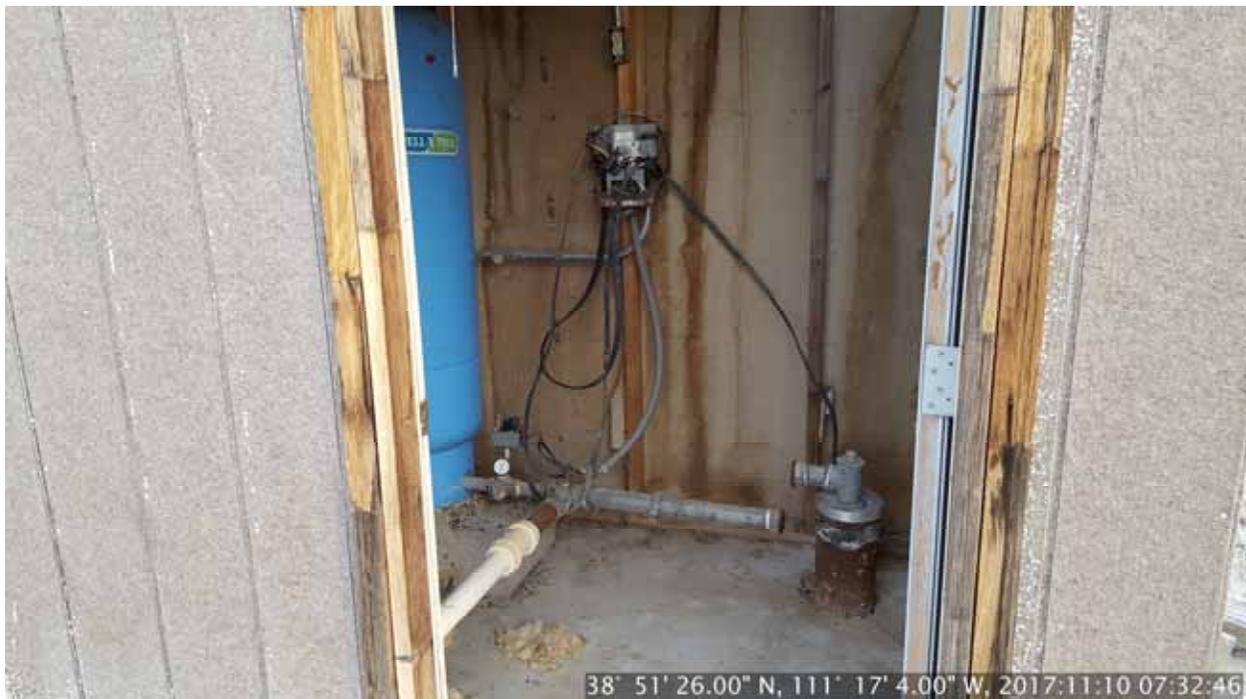
Feature 8. Well. Piping is disconnected from wellhead.

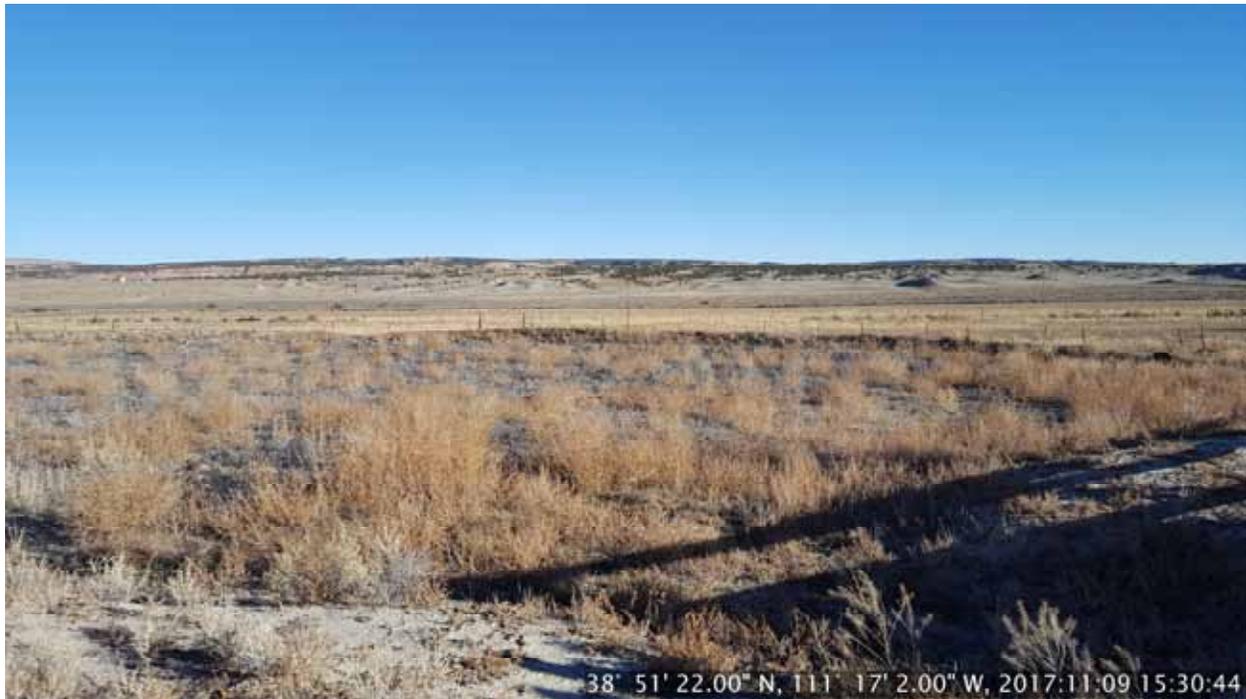
Feature 15. Pond. Breached berm in foreground.

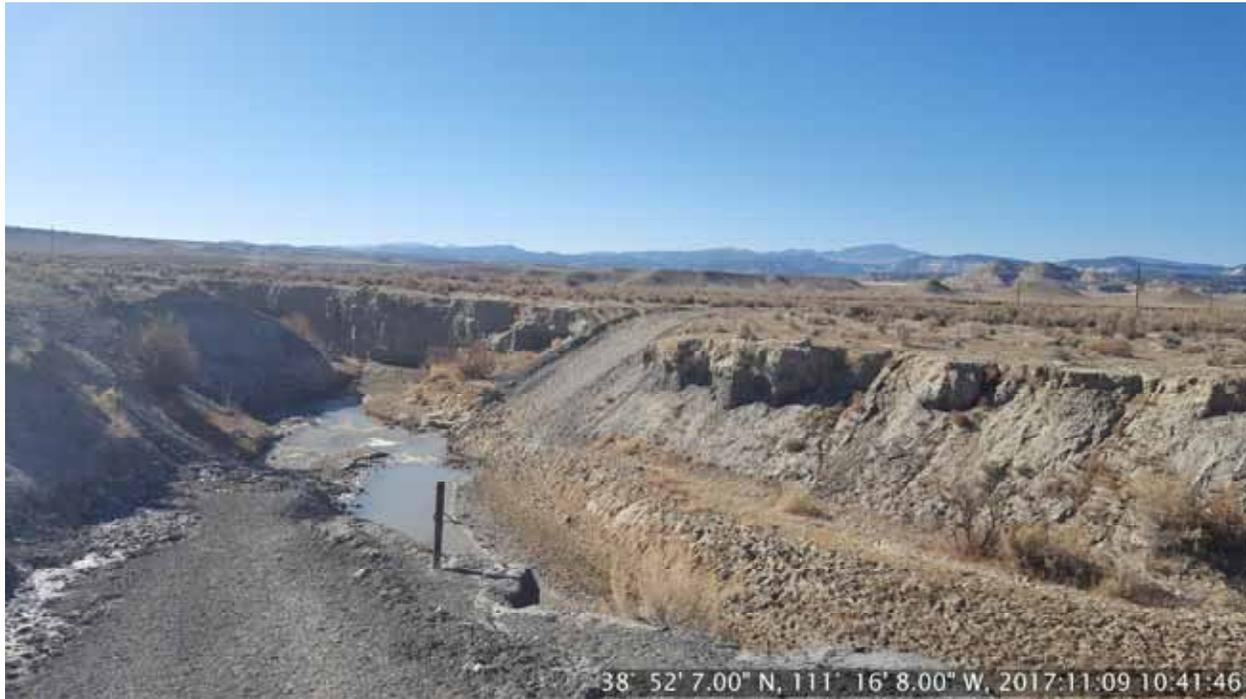
Feature 27. Area Roads. Looking south. Road is impassable and bisected by Quitchupah Creek.

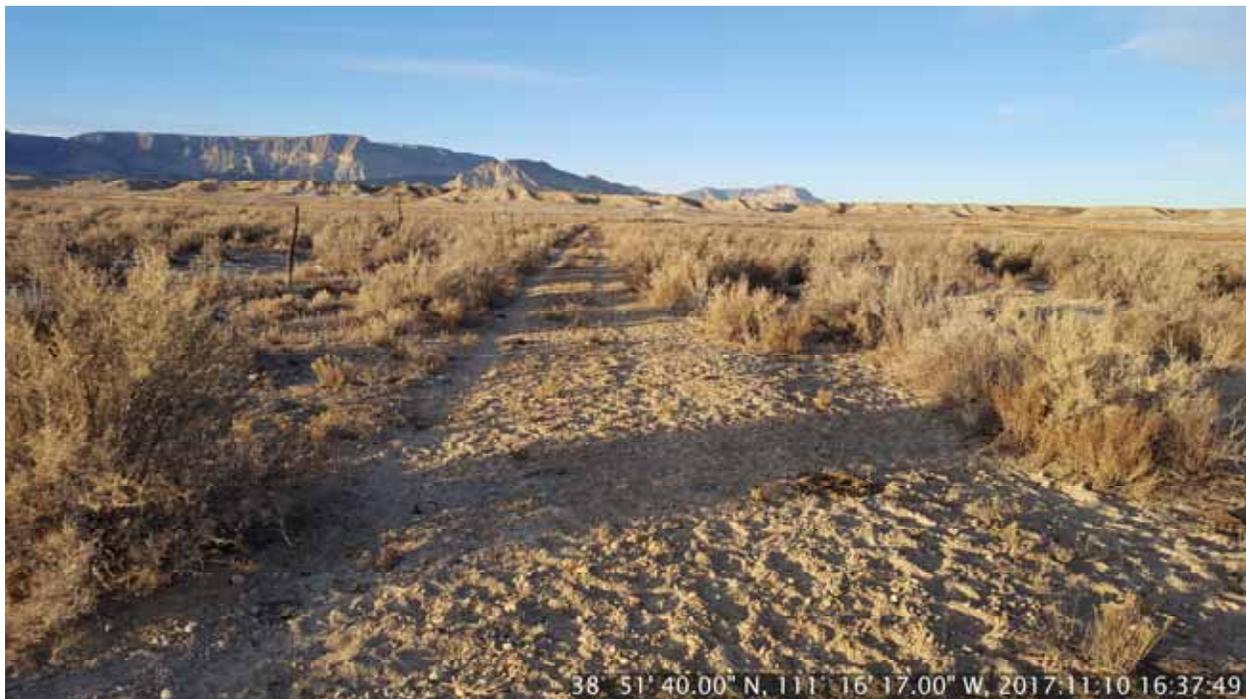
Feature 27. Area Roads. Looking north. Road disappears south of this location.

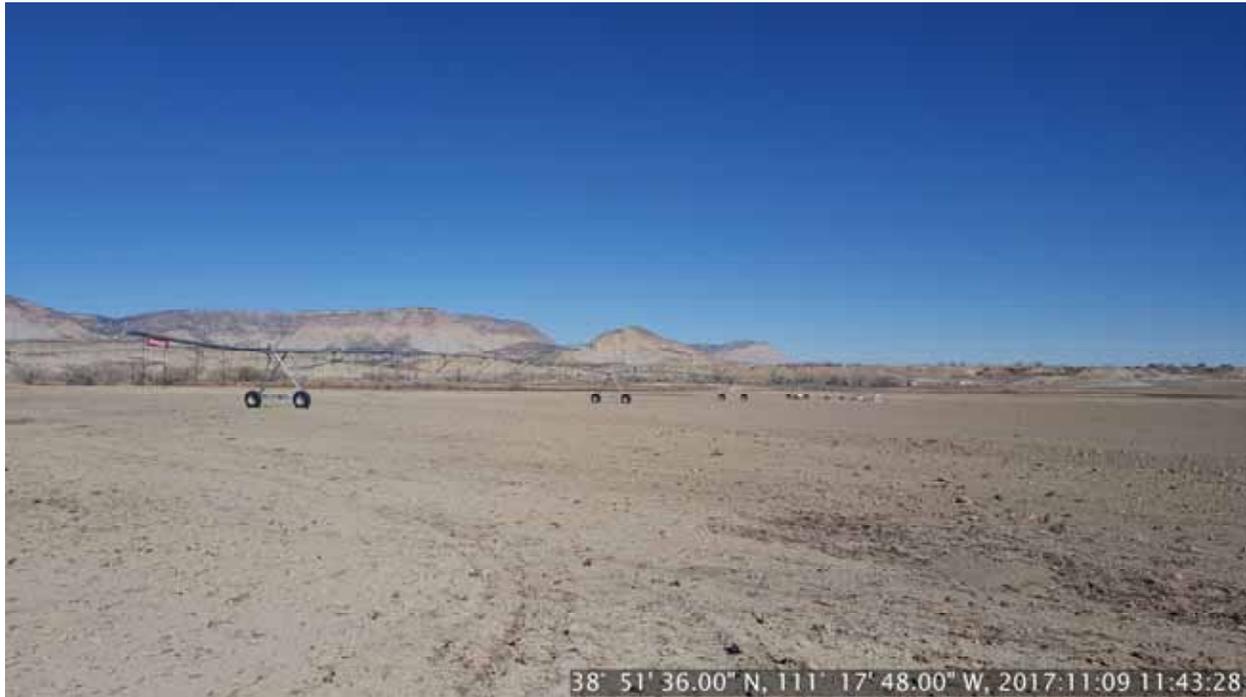
Feature 32. Irrigation Ditch and Farm Land. The description of this feature has been updated from the Valley Engineering (1980) report. The farm land has been expanded in size to the north and east. The freshly plowed ground has been regraded, eliminating portions of the ditch on the west and south side of this farm land. Underground irrigation piping and an irrigation pivot have been installed in the center of this farm land. A 16 foot by 12 foot by 10 inch thick concrete slab foundation installed in 2017, as evidenced by names and a date scratched into the concrete surface on a corner of the pad, and underground power conduits have been installed in preparation for another pivot on the eastern border of this farm land. A six strand barb wire fence with rough cut 4x6 inch timbers extends east/west along the northern margin of this farm land. This fence intersects the Highway 10 right-of-way fence at its western edge. This fence is in good shape.

Feature 32. Irrigation Ditch and Farm Land. Ditch replaced with pivot sprinklers.

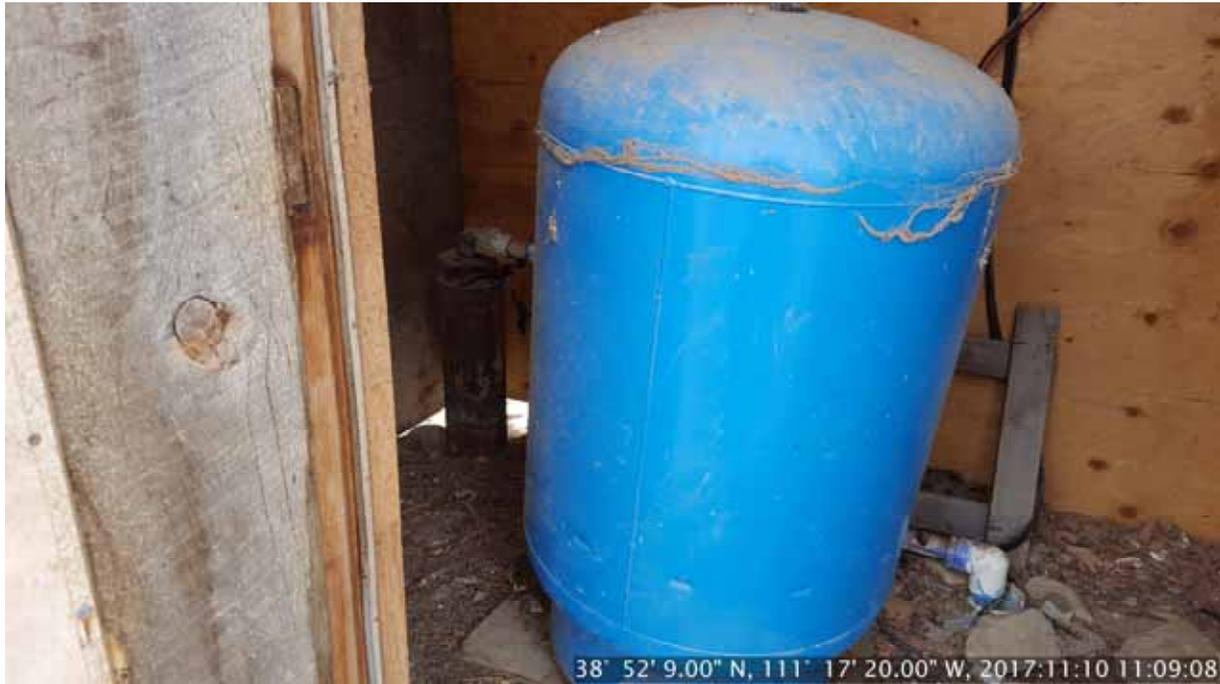
the Lewis Well, formerly provided water for a ranch house and buildings (Feature 35) located to the north. Water is currently provided to this ranch house by Emery Town municipal water. The concrete slab poured around the well casing and which supports the small well house covering the well casing has experienced differential settlement of several inches. The slab slopes from north to south. The worst settlement has occurred at the well casing. The concrete slab surrounding the casing has cracked, separated, and dropped in elevation approximately 4 inches.

Feature 34. Culinary Well. Concrete pad surrounding wellhead is cracked and separated from rest of pad.

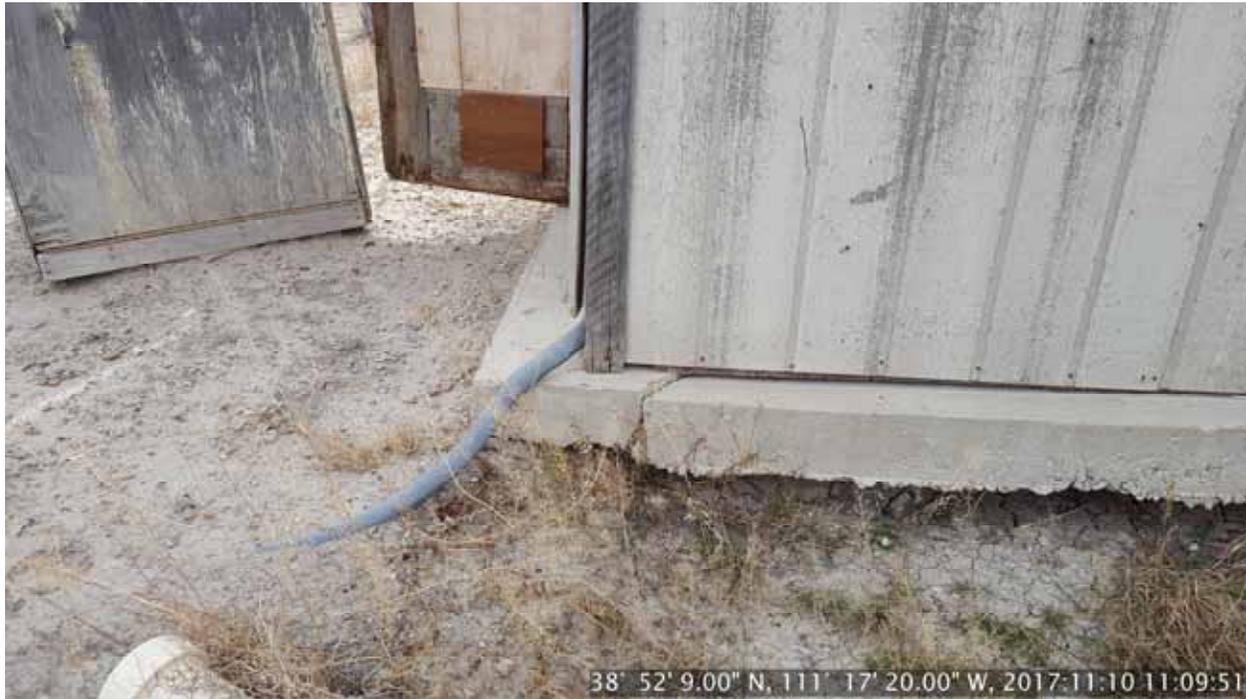
Feature 34. Culinary Well. Concrete pad near conduit is cracked and offset.

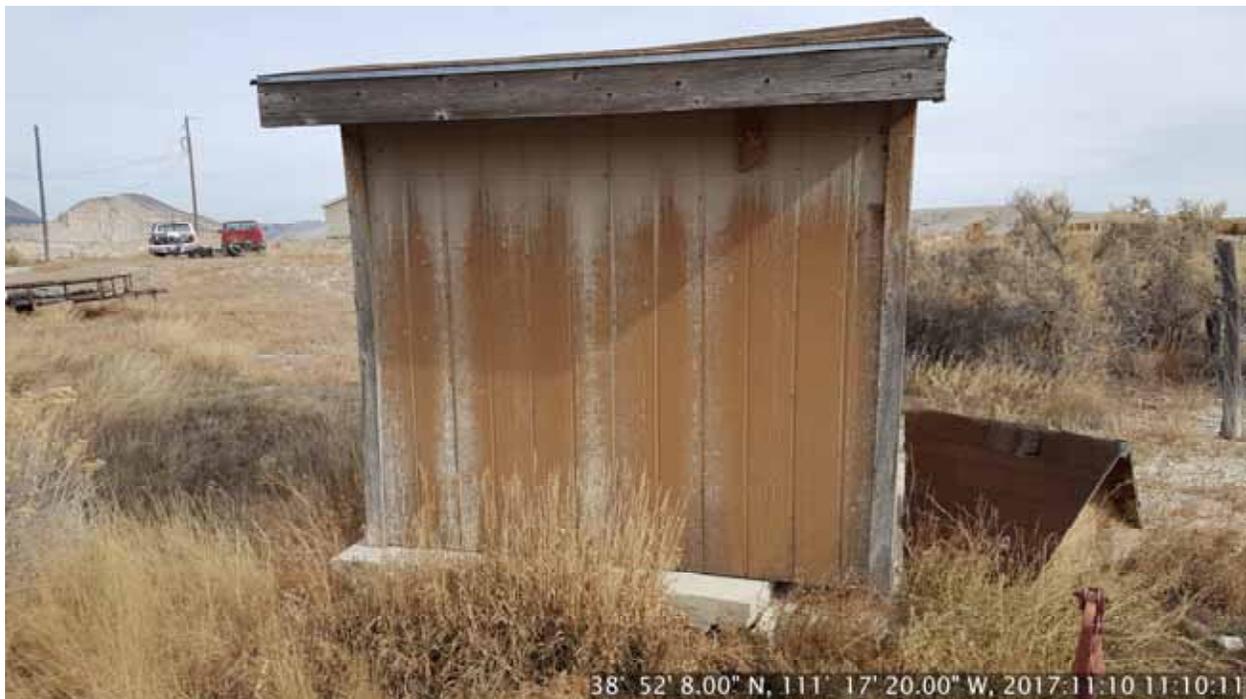
Feature 34. Culinary Well. Looking north. Concrete pad is cracked and offset.

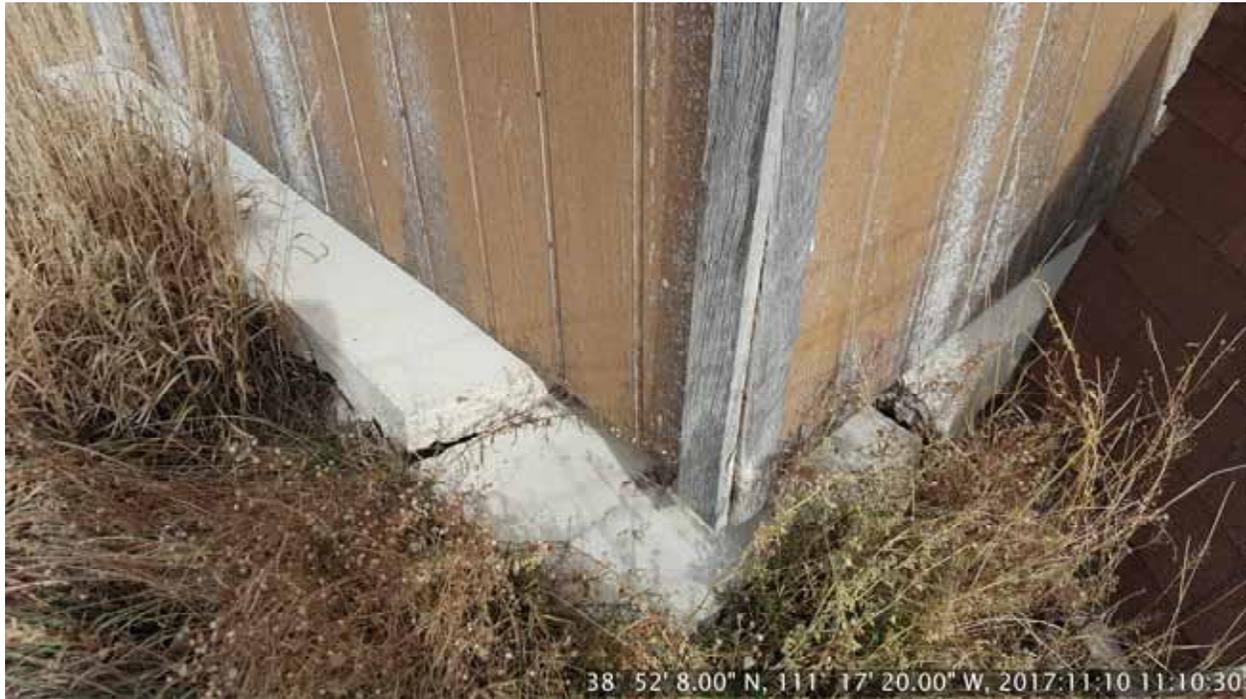
Feature 34. Culinary Well. The corner of the cracked concrete pad surrounds the wellhead located in the well house.

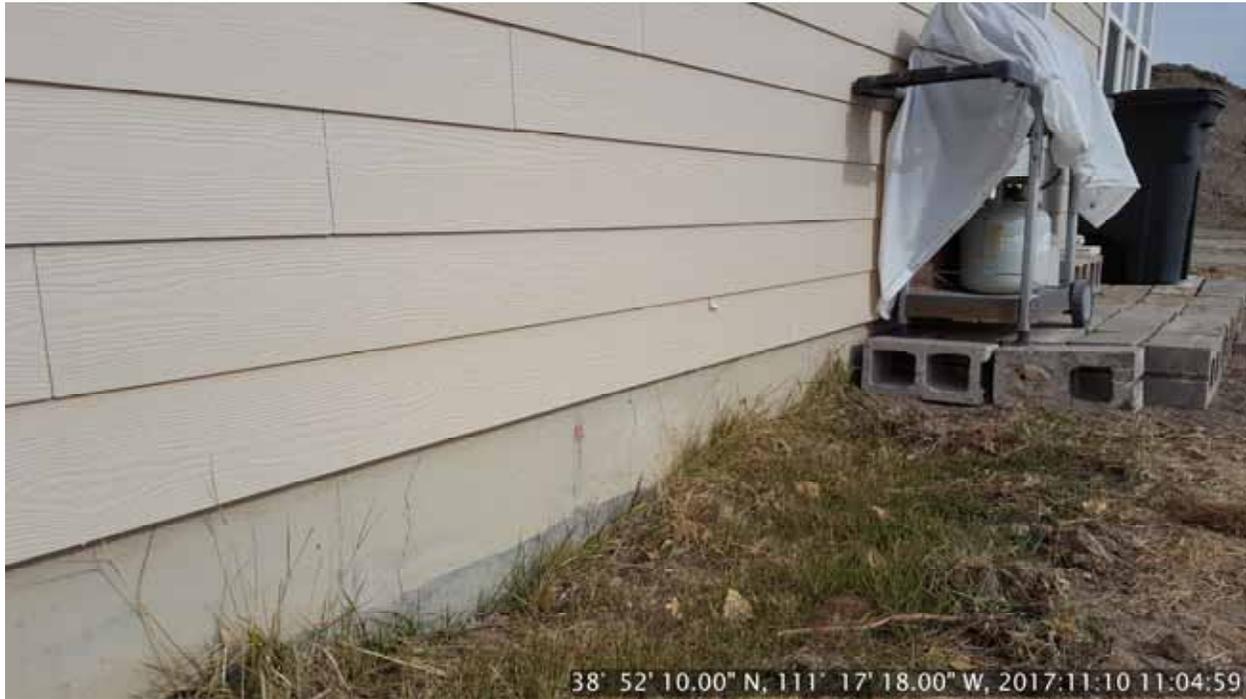
- A double wide manufactured home installed after the 1980 report. This home is installed on a concrete foundation that is intact with only two small cracks that are typical of cracks found in most residential home foundations. Overall, the home appears to be in good condition.

Feature 35. Ranch House and Buildings. Manufactured home. Small cracks in foundation.

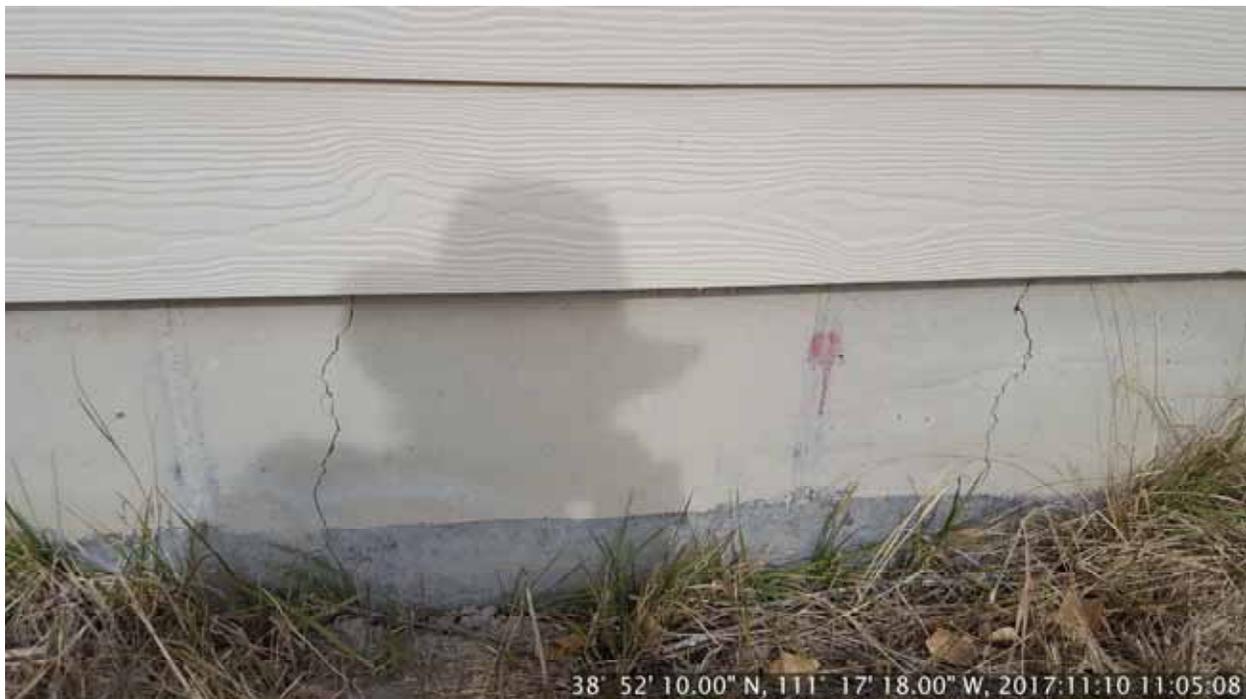
Feature 35. Ranch House and Buildings. Manufactured home. Small foundation cracks, close-up.

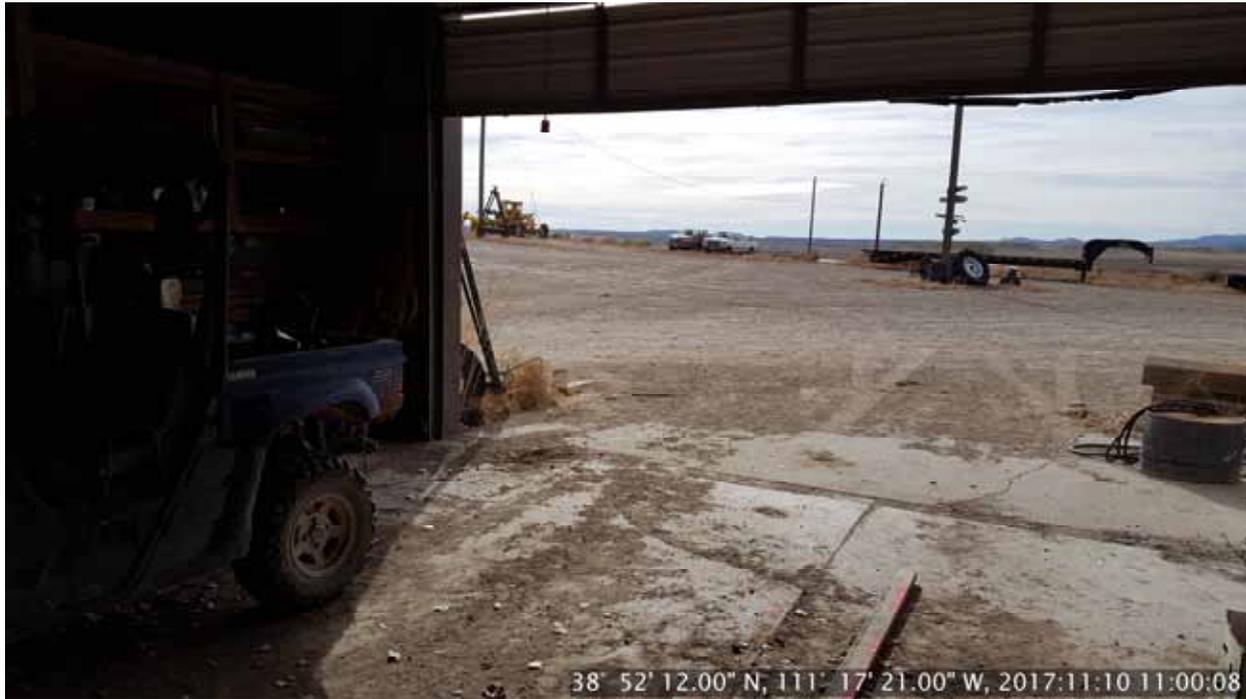
- Metal shed on a concrete slab. The metal shed is in good condition. The concrete slab is in fair condition with some cracking observed. Four elevated fuel tanks are located on the east side of the shed.

Feature 35. Ranch House and Buildings. Metal shed. Looking outside through overhead door. Cracks in concrete floor.

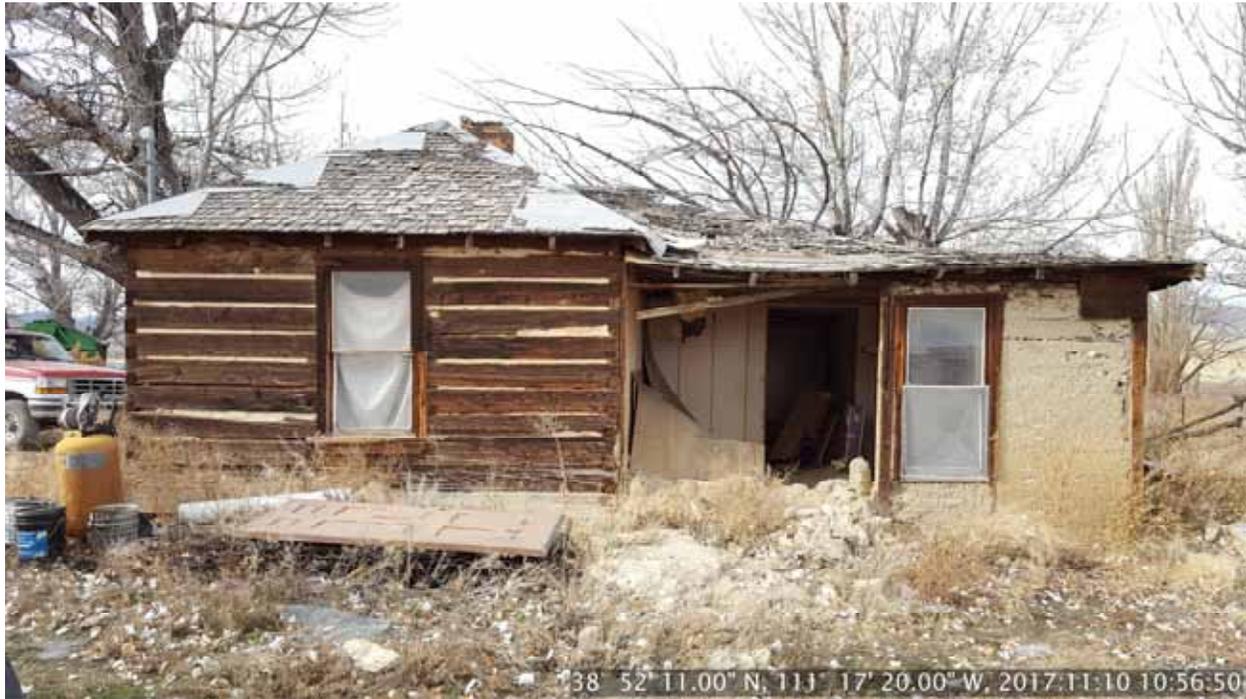
- Wood outhouse constructed of natural rough cut logs. This structure appears to be in fair condition.
- Ranch house constructed of rough sawn logs and adobe brick. The adobe walls have fallen down, exposing the north end of the house to outside elements. It is dilapidated and unlivable. A concrete structure located near the ranch house appears to be an old septic tank.

Feature 35. Ranch House and Buildings. Side view of ranch house. Adobe wall crumbled. Sagging roof.
