**RE: Bronco Utah Operations LLC
Emery Mine
DOGM Permit No. C/015/0015
Emery 2 Second Left Panel Full Extraction Revision**

GEOLOGY AND SUBSIDENCE

The purpose of this report is to present baseline surface conditions prior to full extraction operations from the Emery 2 portal of the Bronco Utah Operations, LLC. (Bronco) Emery Mine, Emery County, Utah. The areas covered in this report include the following:

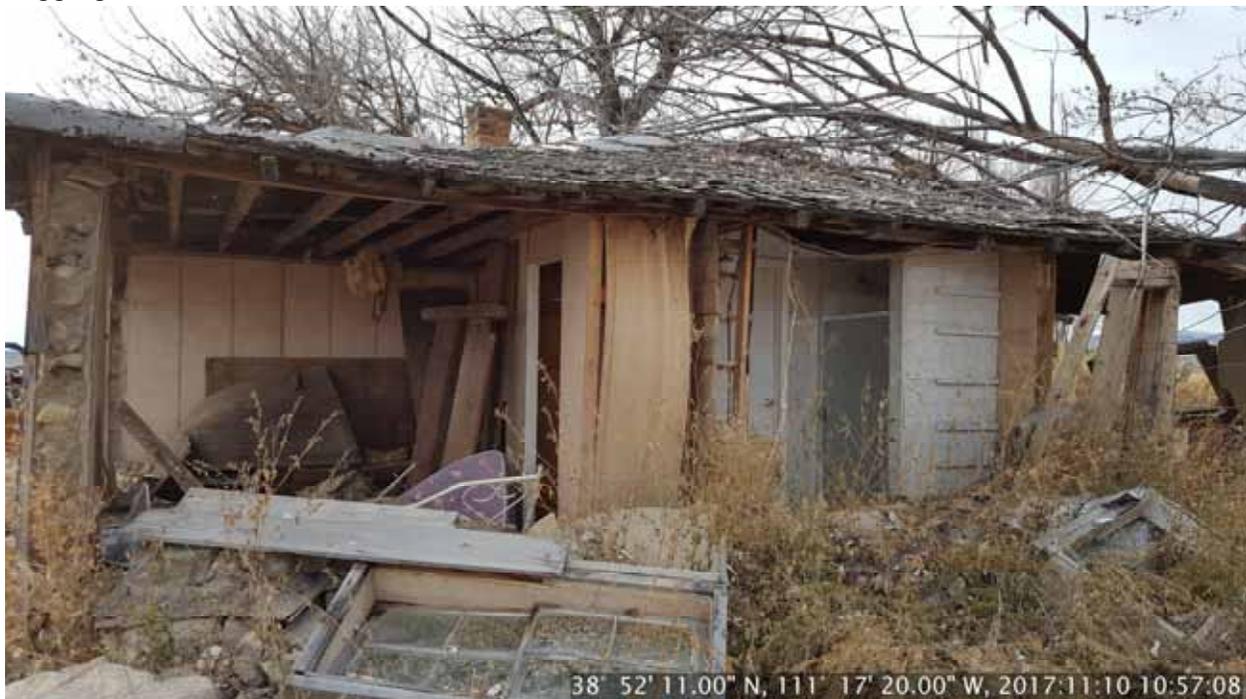
Feature 35. Ranch House and Buildings. Rear view of ranch house. Adobe walls have crumbled.

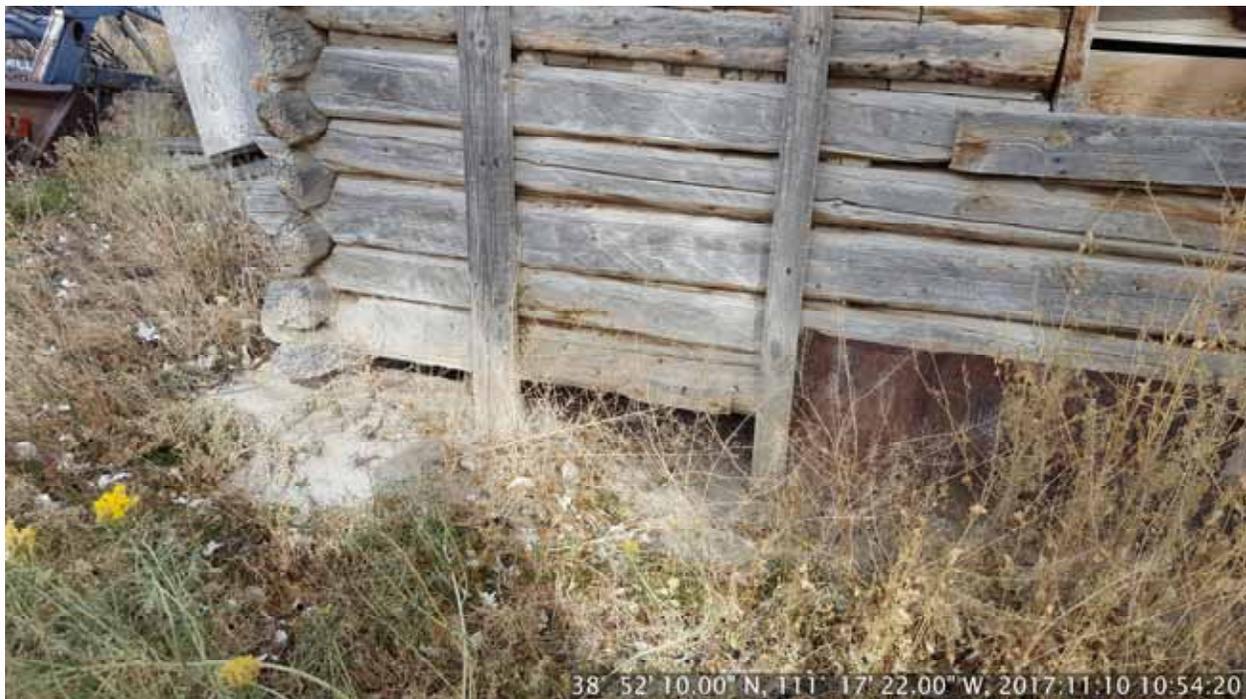
- Wood building constructed of natural rough cut logs. Intermittently placed sandstone rocks serve as a foundation for the structure. The structure is in dilapidated condition.

Feature 35. Ranch House and Buildings. Wood building. View of foundation.

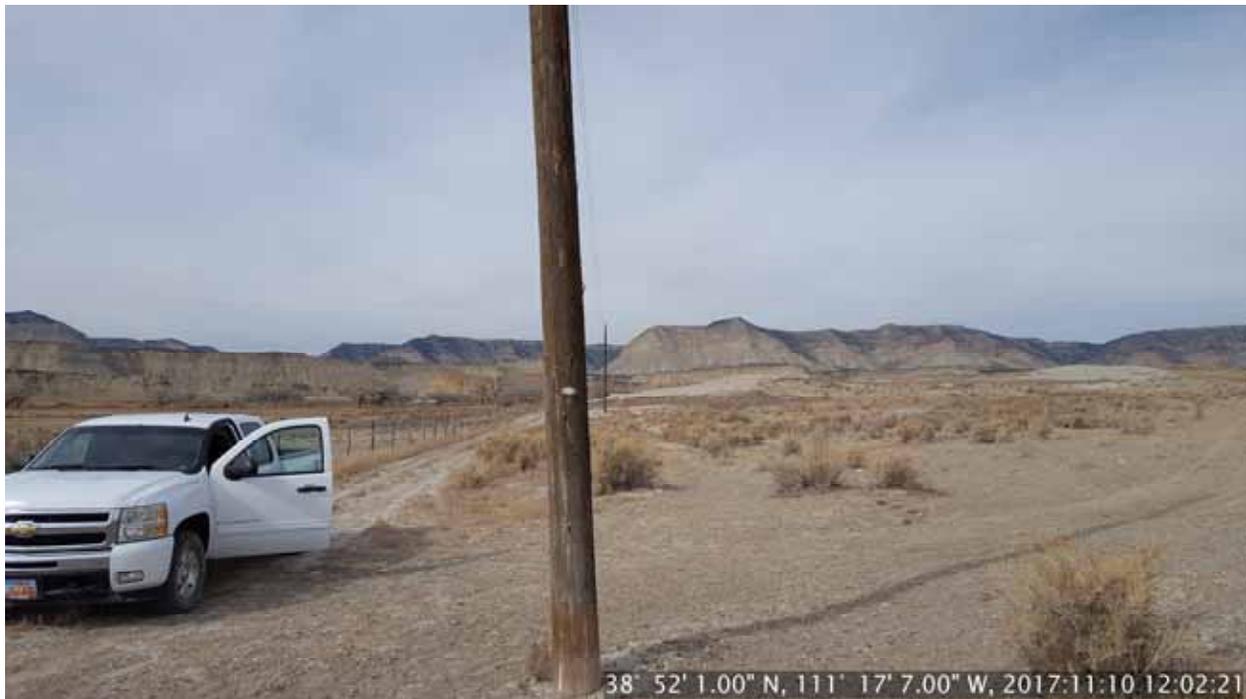
Feature 36. Utility Power Line. The description of this feature has been updated from the Valley Engineering (1980) report. A portion of this feature is located within a buffer zone, depicted on Figure 1 and Plate V-5, where subsidence is not anticipated. The electrical power line is a single line that supplies electricity to the ranch house and buildings (Feature 35). The poles are typical power line poles, approximately 35 feet tall and in good condition. The eastern most pole in this line, which also forms a part of the north/south power line (Feature 5) that this line ties into, leans to the south and west.

Feature 36. Utility Power Line. Looking northwest. Top of pole in foreground leans slightly left.

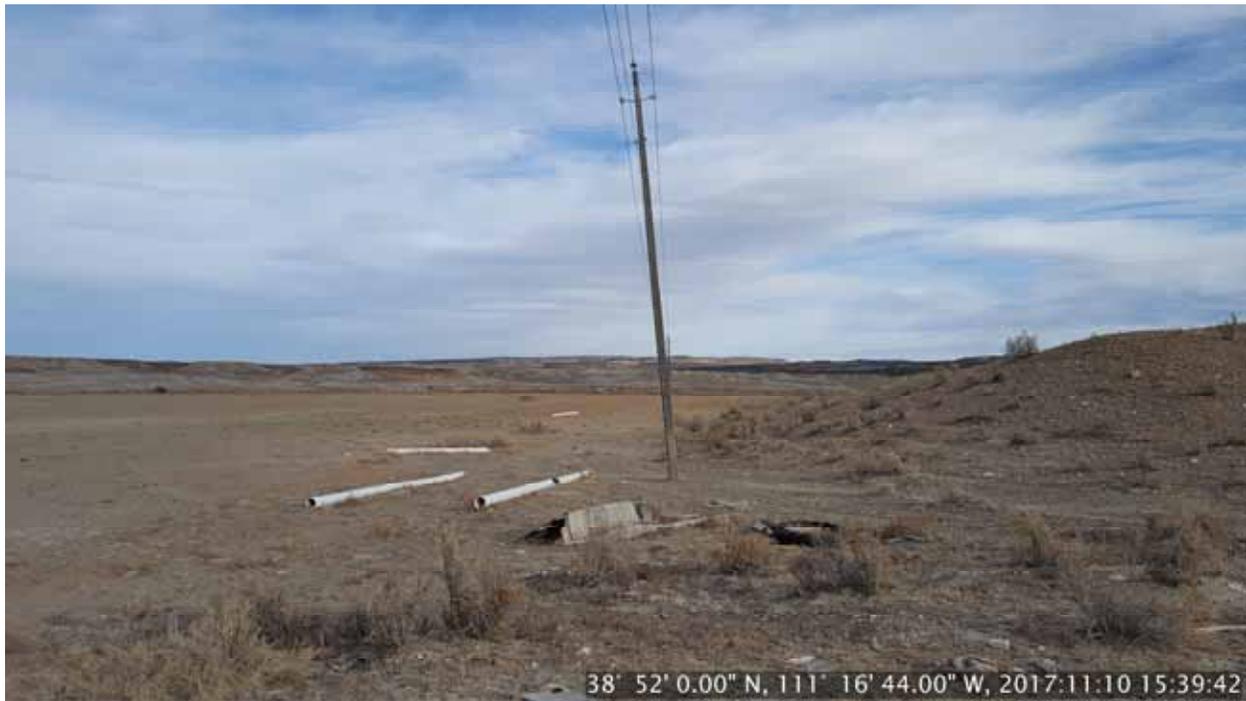
Feature 39. Log Cabins. Looking east along power line. Top of pole in foreground leans to left.

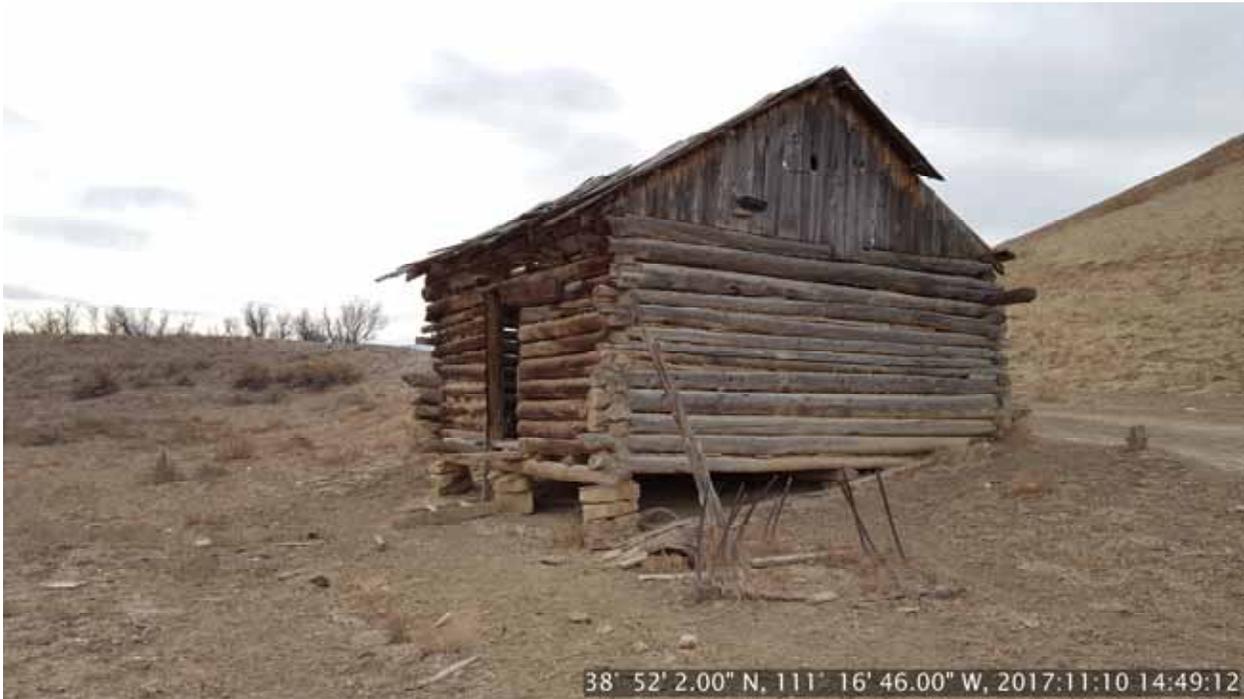
Feature 39. Log Cabins. The title and description of this feature have been updated from the Valley Engineering (1980) report. The corrals mentioned in the 1980 report have been removed. There are two log cabins at this location. The cabins are made of rough cut wood logs and are founded on wood or stacked rocks. Both cabins are in dilapidated condition.

Feature 39. Log Cabins. Cabin 2 founded on rock pieces.
