DATE: January 4, 1990  
TO: Dave Smaldone  
FROM: Val Payne *VP*  
SUBJECT: Rockfall at Des Bee Dove Mine

DES-BEE-DOVE MINES  
ROCKFALL - JAN. 2, 1990

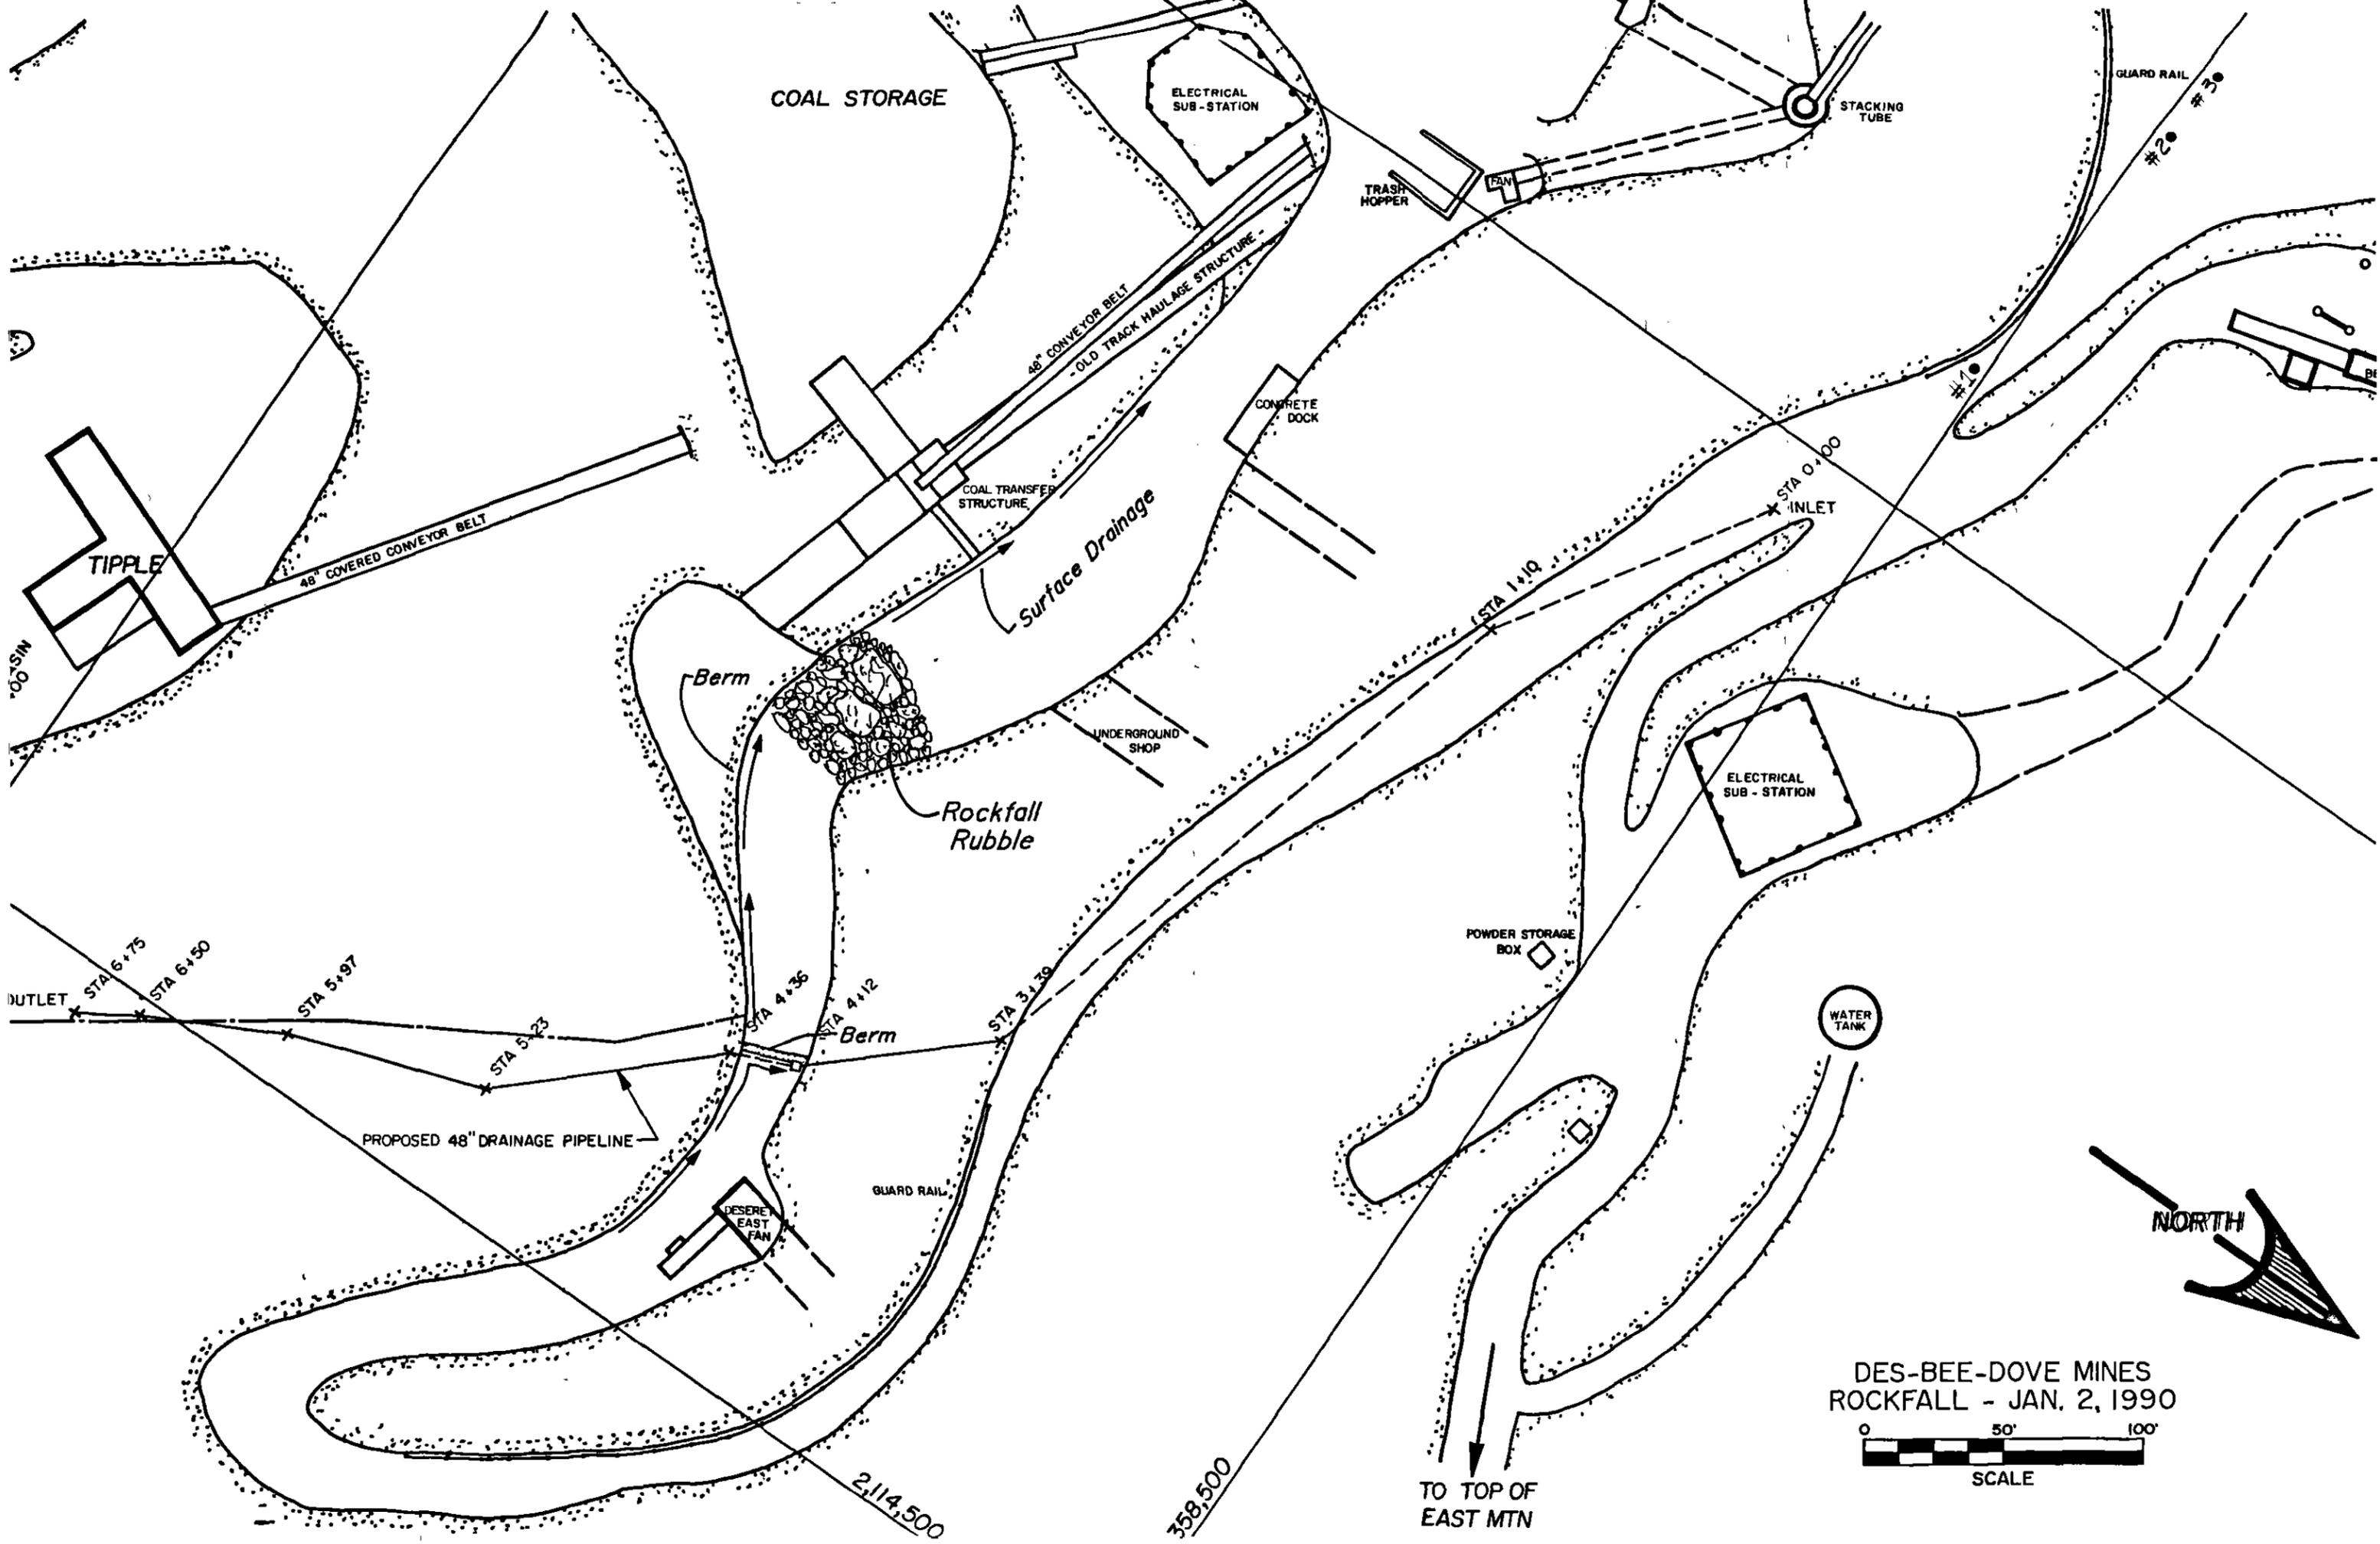
The rockfall occurred on the Deseret Mine level between the Underground Shop and the Deseret East Fan (see map and photos). Approximately 500 tons of rock rubble fell onto the Deseret pad road. The rubble covers an area approximately 30' x 50' and blocks the road. No damage occurred to public health and safety or the environment. No property damage occurred other than blockage of the road.

Examination of the area revealed that unstable conditions may still exist in the material immediately above the rubble. Therefore, cleanup of the rockfall will not be initiated immediately. Access to the area has been restricted and monitoring of the remaining rock overhang has been implemented.

The road serves as part of the mine surface drainage system; therefore, approximately 50' of the system is blocked by the rubble. A total of 150' of the drainage system is affected by the rockfall. Because of the current and forecasted weather conditions and the potential safety concerns, reestablishment of the surface drainage is not considered an immediate priority. However, when the rubble can be safely removed, surface drainage will be reestablished. This is expected to be accomplished prior to spring runoff.
