RE: Technical Field Visit, Phase 2 Reclamation Construction, PacifiCorp, Des-Bee-Dove Mine, C/015/017

**PURPOSE:** Weekly field visit to a site being reclaimed.

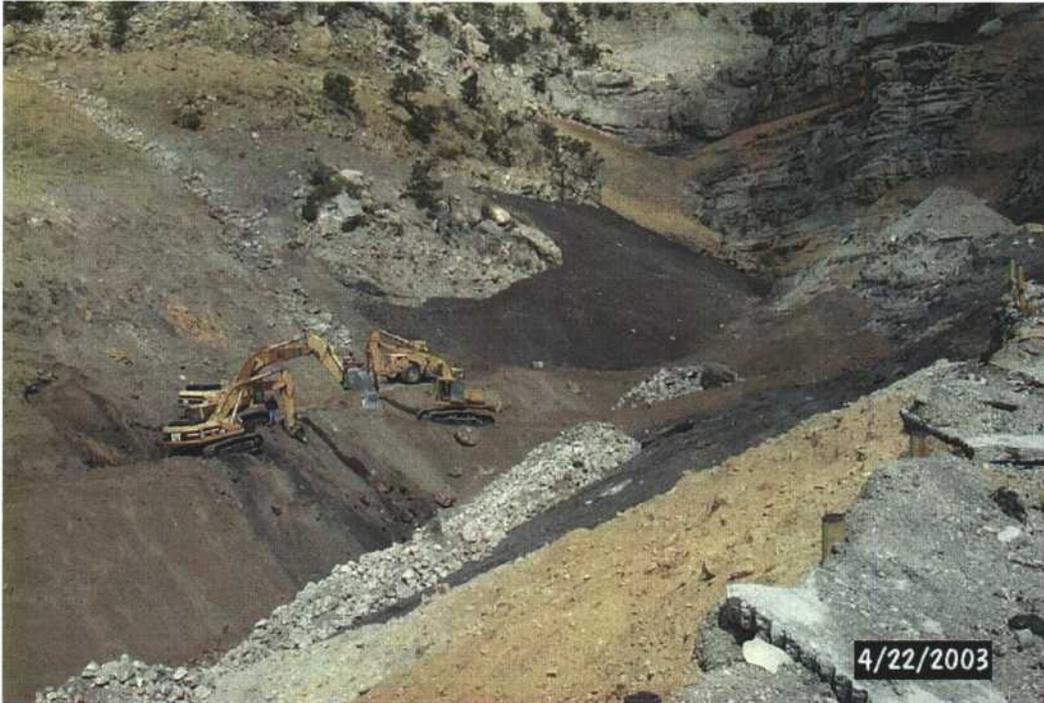
1. The weather is cool, breezy, and cloudy, with intermittent snow and rain.
2. The contractor continues to move material down the bathhouse slope. A pocket of coal waste was uncovered, possibly some that had been uncovered higher on the slope and already moved and buried once (attached photo P0004602).
3. The rocks at the bottom of the bathhouse slope are being moved aside to open passageways to bring bathhouse-slope soil across to the east side.

P0004602 - South bathhouse outslope, tipple to bathhouse road, and material for channel construction.

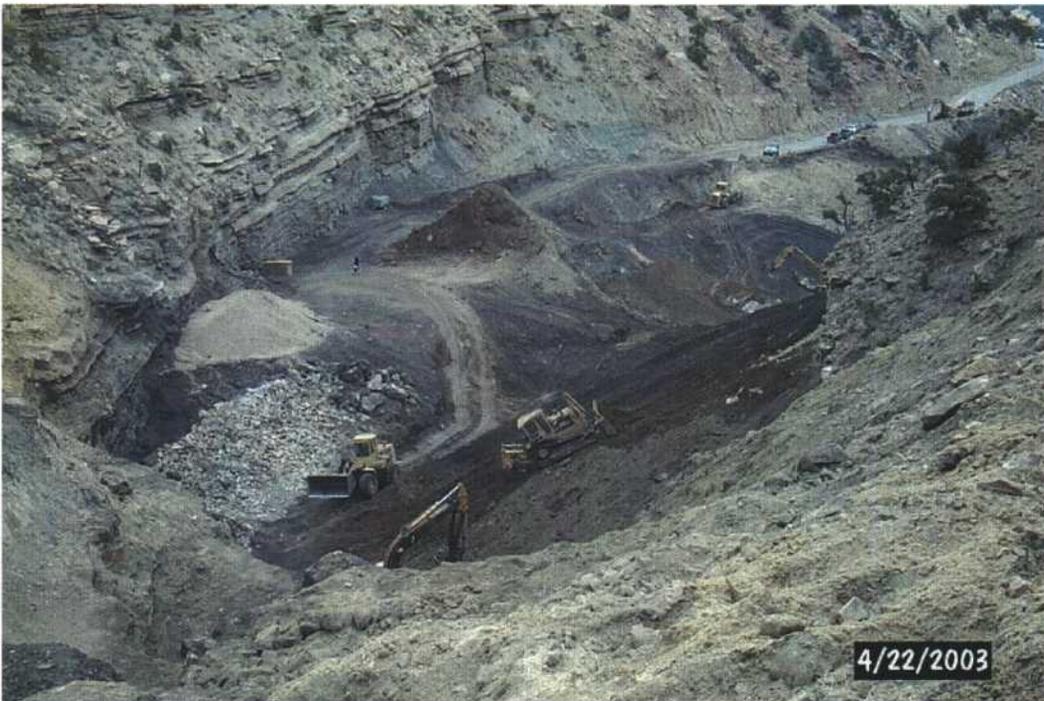
4. Soil is being placed on the west side at the upper part of the constructed main channel. The entire slope will not be covered at this time. If there is enough soil after everything else is done, that remaining soil will be brought up here - otherwise the undisturbed "island" above this slope will be pulled down to cover this area. Soil is from the large pile on the tippel pad (attached photo P0004616).

5. Rock has been temporarily placed in a large pocket east of the upper part of the constructed main channel, at the head of where the channel will be constructed. The rock will be moved and the hole filled with waste material from beneath the soil pile on the tippel pad: the contractor estimates there are several feet of soil beneath that waste. The area under the pile needs to be lowered 15 to 20 feet for construction of the main channel (attached photo P0004616).

P0004616 - Placing soil on fill, upper-east side of the tipple area. Waste beneath the soil pile will replace the rock temporarily stored at left as the surface beneath the soil pile is lowered 15 to 20 feet.
