RE: Technical Field Visit, Phase II Reclamation, Energy West Corp., Des Bee Dove Mine, C/015/017

TECHNICAL FIELD VISIT

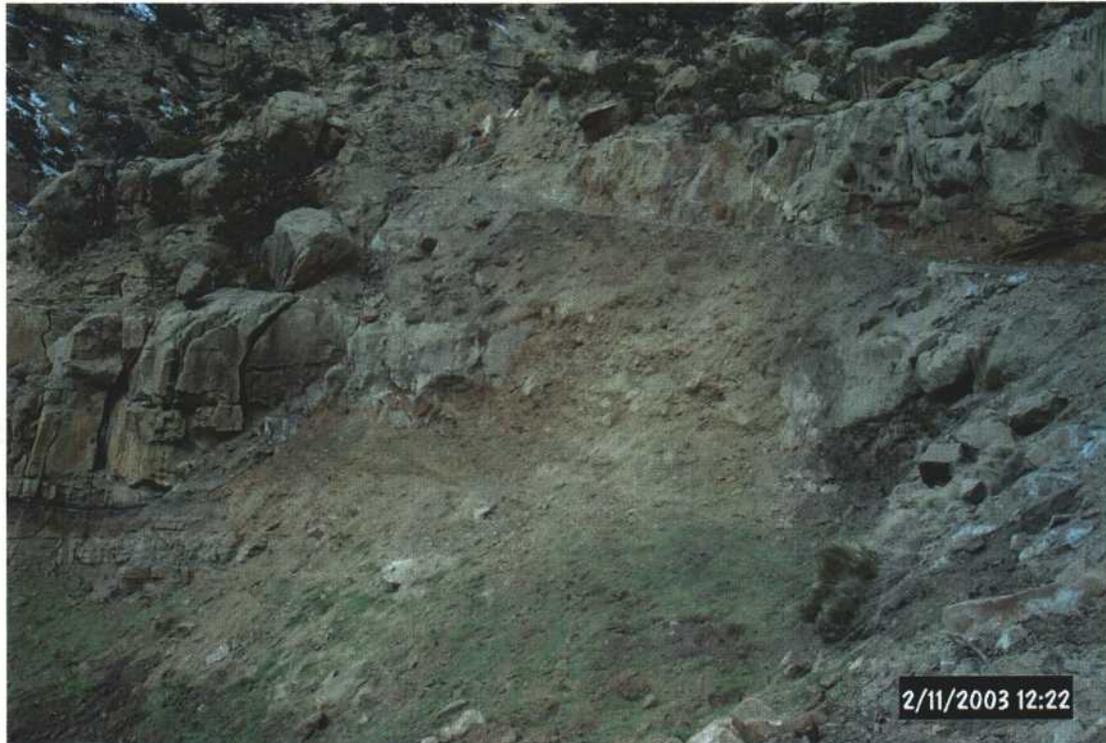
1. Photos are in M:/Files/Coal/015017.dbd/IMAGES/ 02112003
2. The steep surface exposed where the extra soil was removed last week is not bedrock, but it is the same consolidated colluvial material found on the slopes throughout the canyon. This material is not friable, not easily broken by excavating equipment. Pete Hess was asked to participate because of his experience as a mining engineer. After examining the area where the extra soil was removed, Mr. Hess was of the opinion that the area will be stable (attached photo P0000830).

P0000830 - Area where soil was removed from between the cattle trail segments.

The area where the extra soil was removed will be stable and will not compromise the integrity of the cattle trail. Other reclamation work appears to be following the MRP. There are no recommendations at this time, other than continuing inspections on a weekly basis.

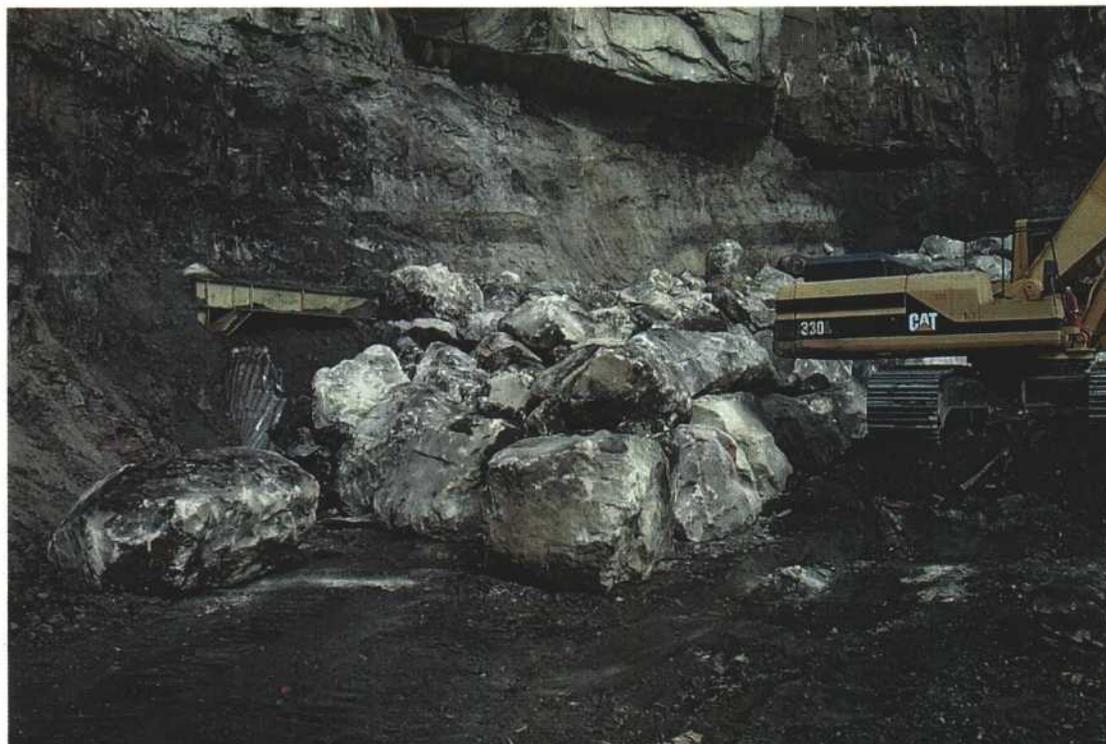
3. Concrete debris – from the thrust blocks that anchored the bypass culvert - is being removed from the cattle trail.
4. Boulders ($D_{50} = 4$ ft) are being placed over the Deseret portals and against the portal and pad faceup. Larger boulders ($D_{50} = 6$ ft) are being placed at the front of the structure to anchor it (attached photo P0003104). There was a discussion as to how D_{50} is determined for such large boulders: there was no definitive answer, the operator and contractor asserting the determination to be a function of rock density and mass rather than strictly of size. A PE is to certify whether the structure meets design and performance specs. (The design calculations in Appendix 15 indicate that $D_{50} = 1$ ft to be adequate and that the larger sized materials used provide a safety factor = 4.0.)

P0003104 - D₅₀ 4-ft material next to wall and D₅₀ 6-ft on outslope side.
