RE: **Informal Assessment Conference on State Notice of Violation N03-49-4-1, N03-49-5-1, N03-49-6-1, PacifiCorp, Deer Creek Mine, C/015/018, Emery County, Utah**

Informal Assessment Conference

Attachment 1

NOV Photos

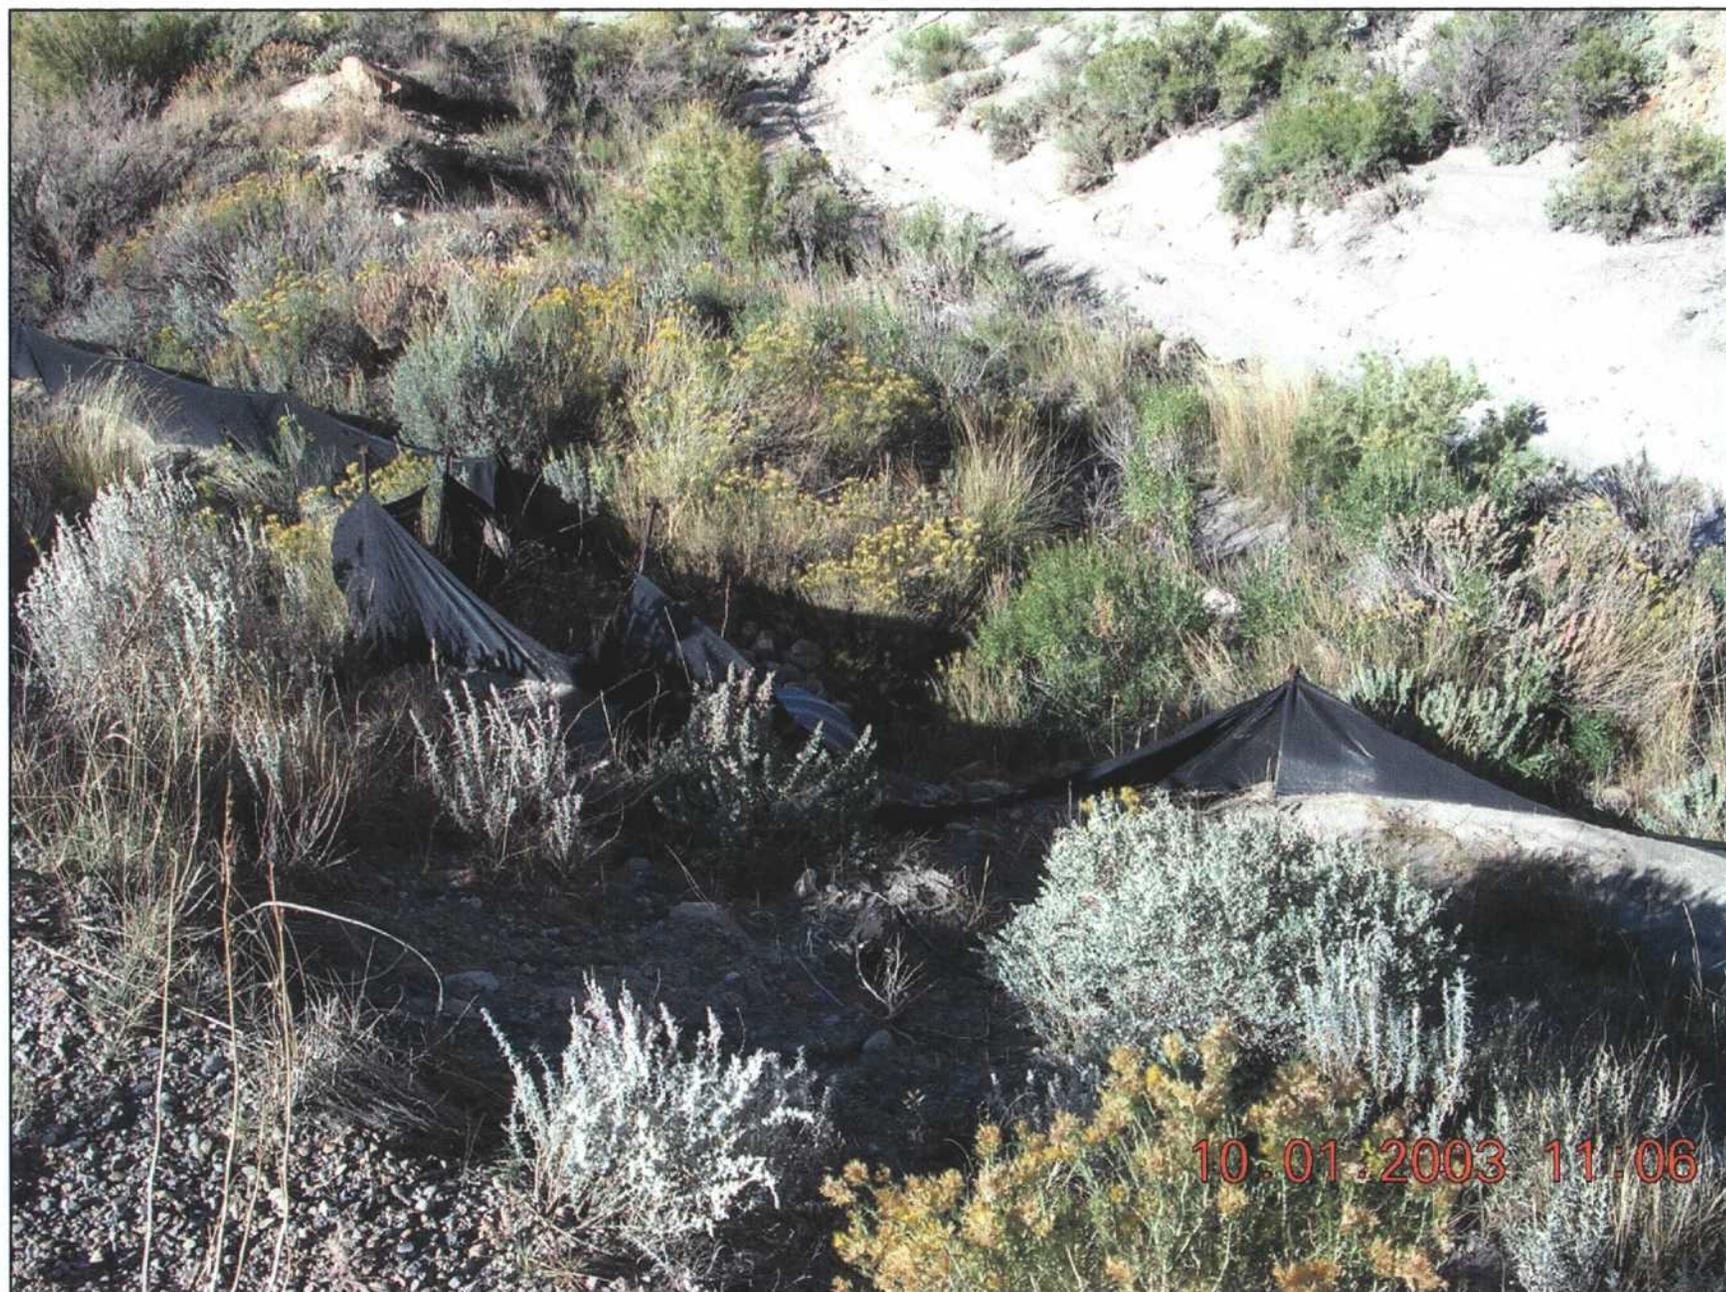
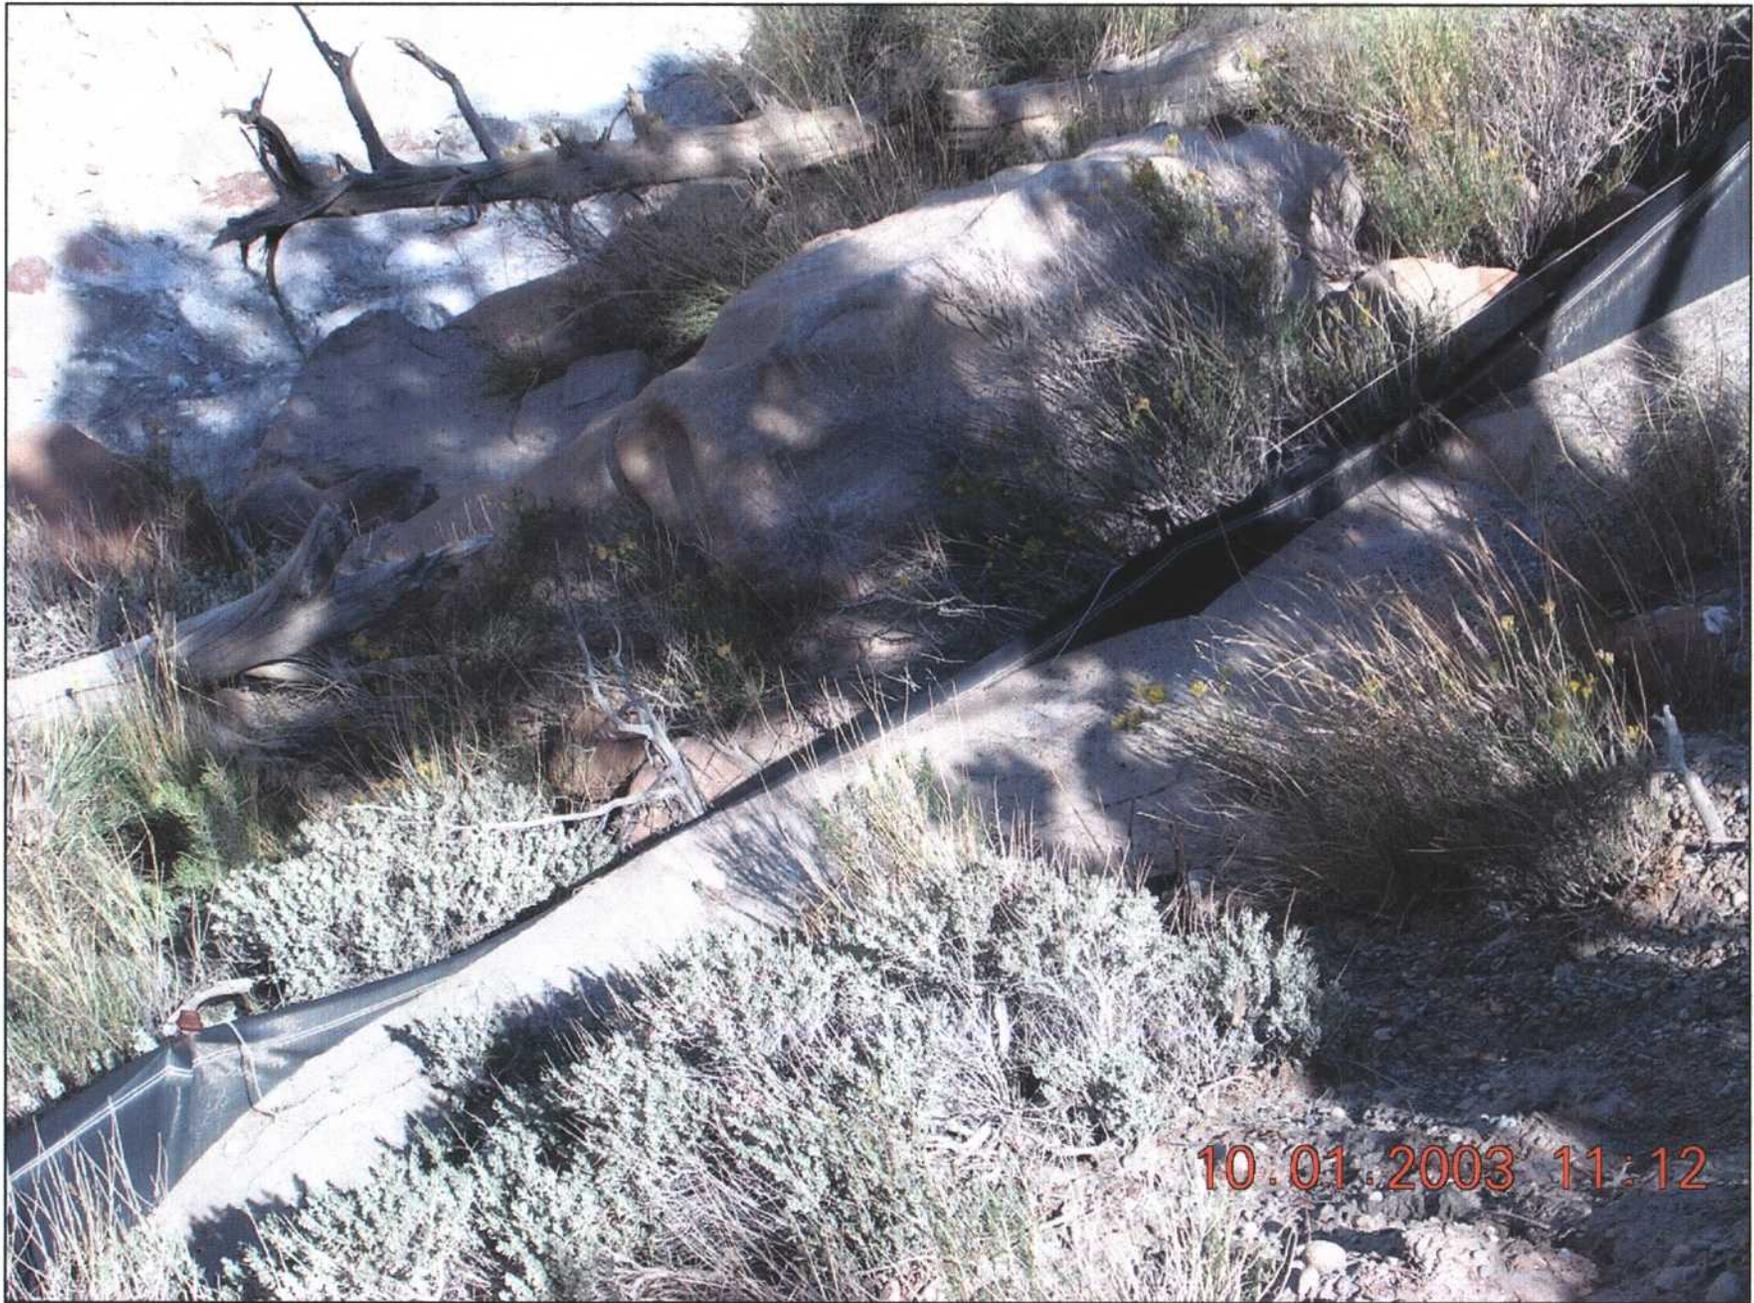
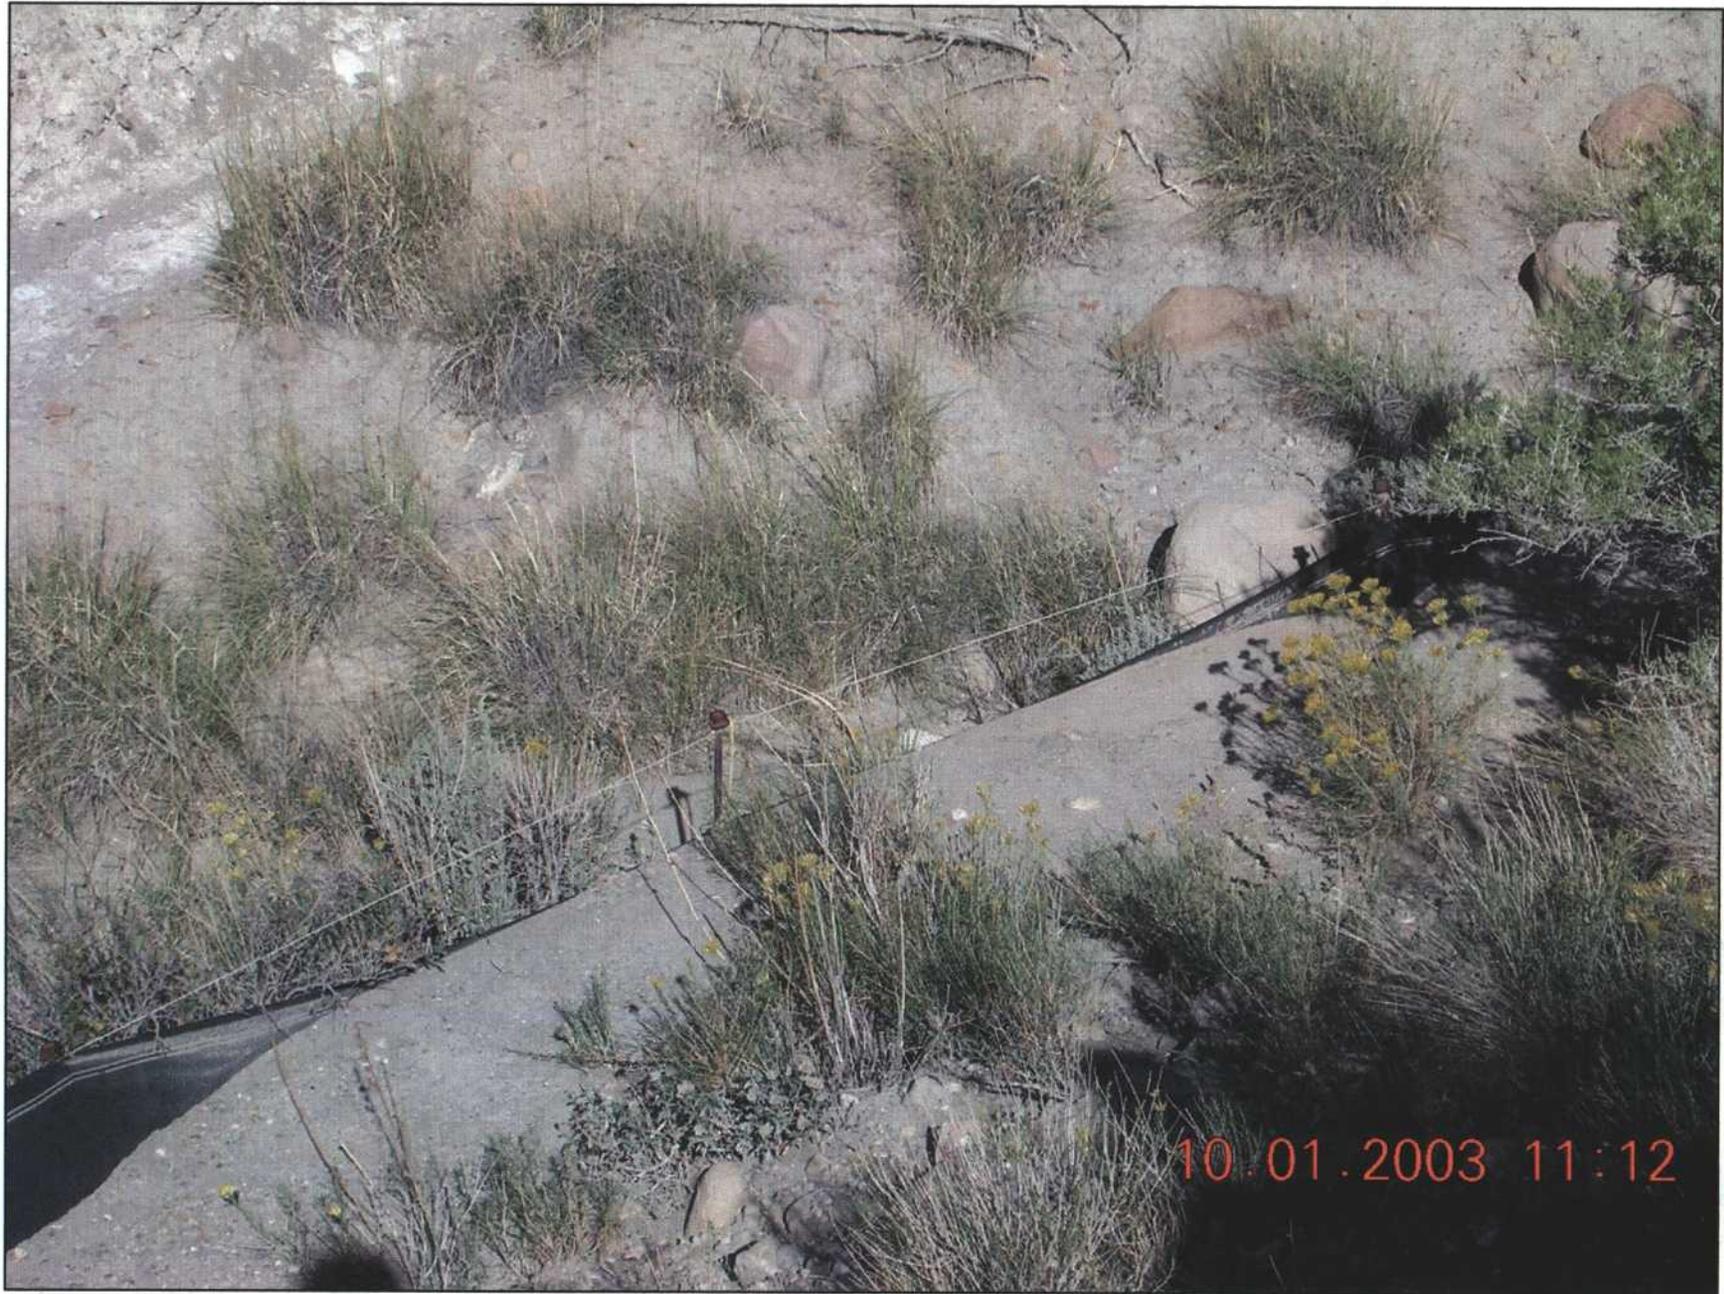
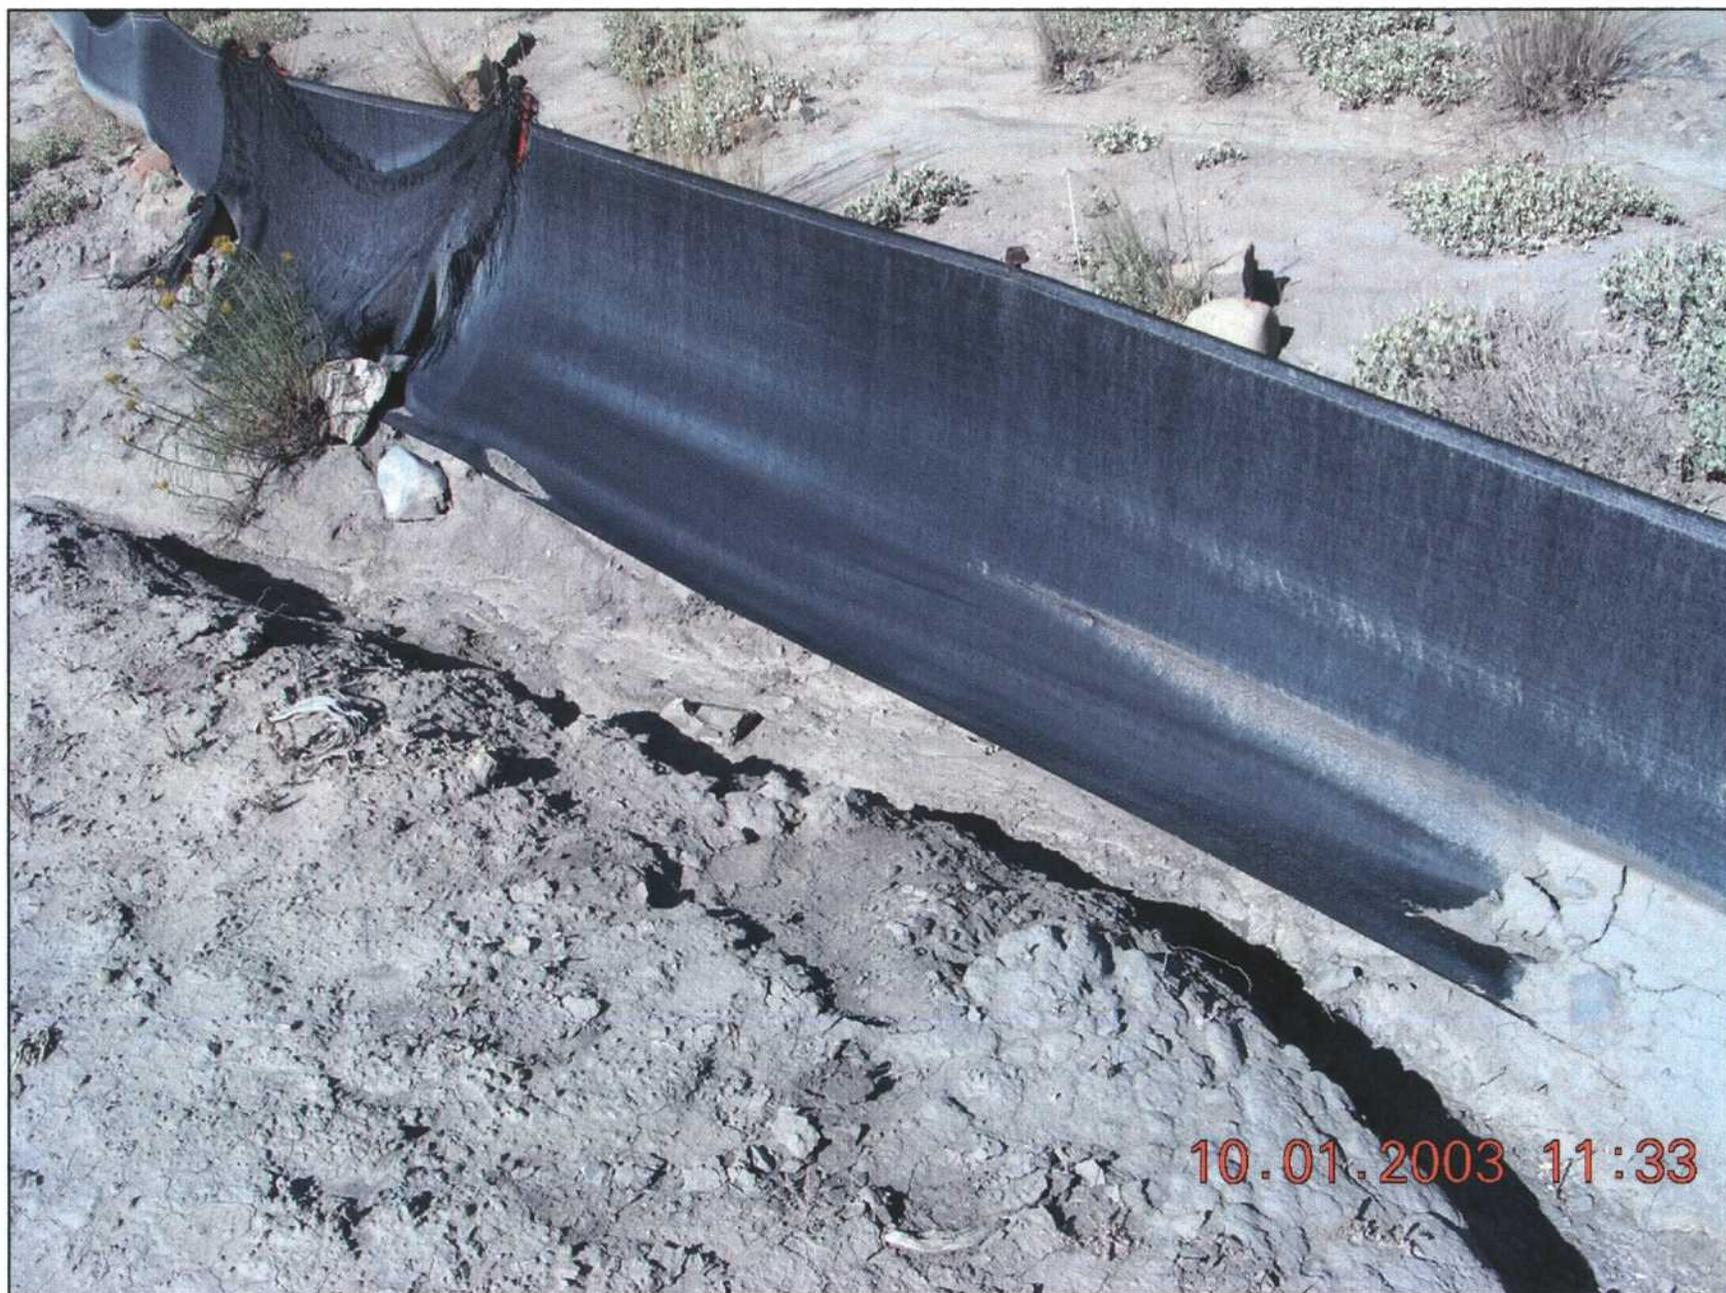
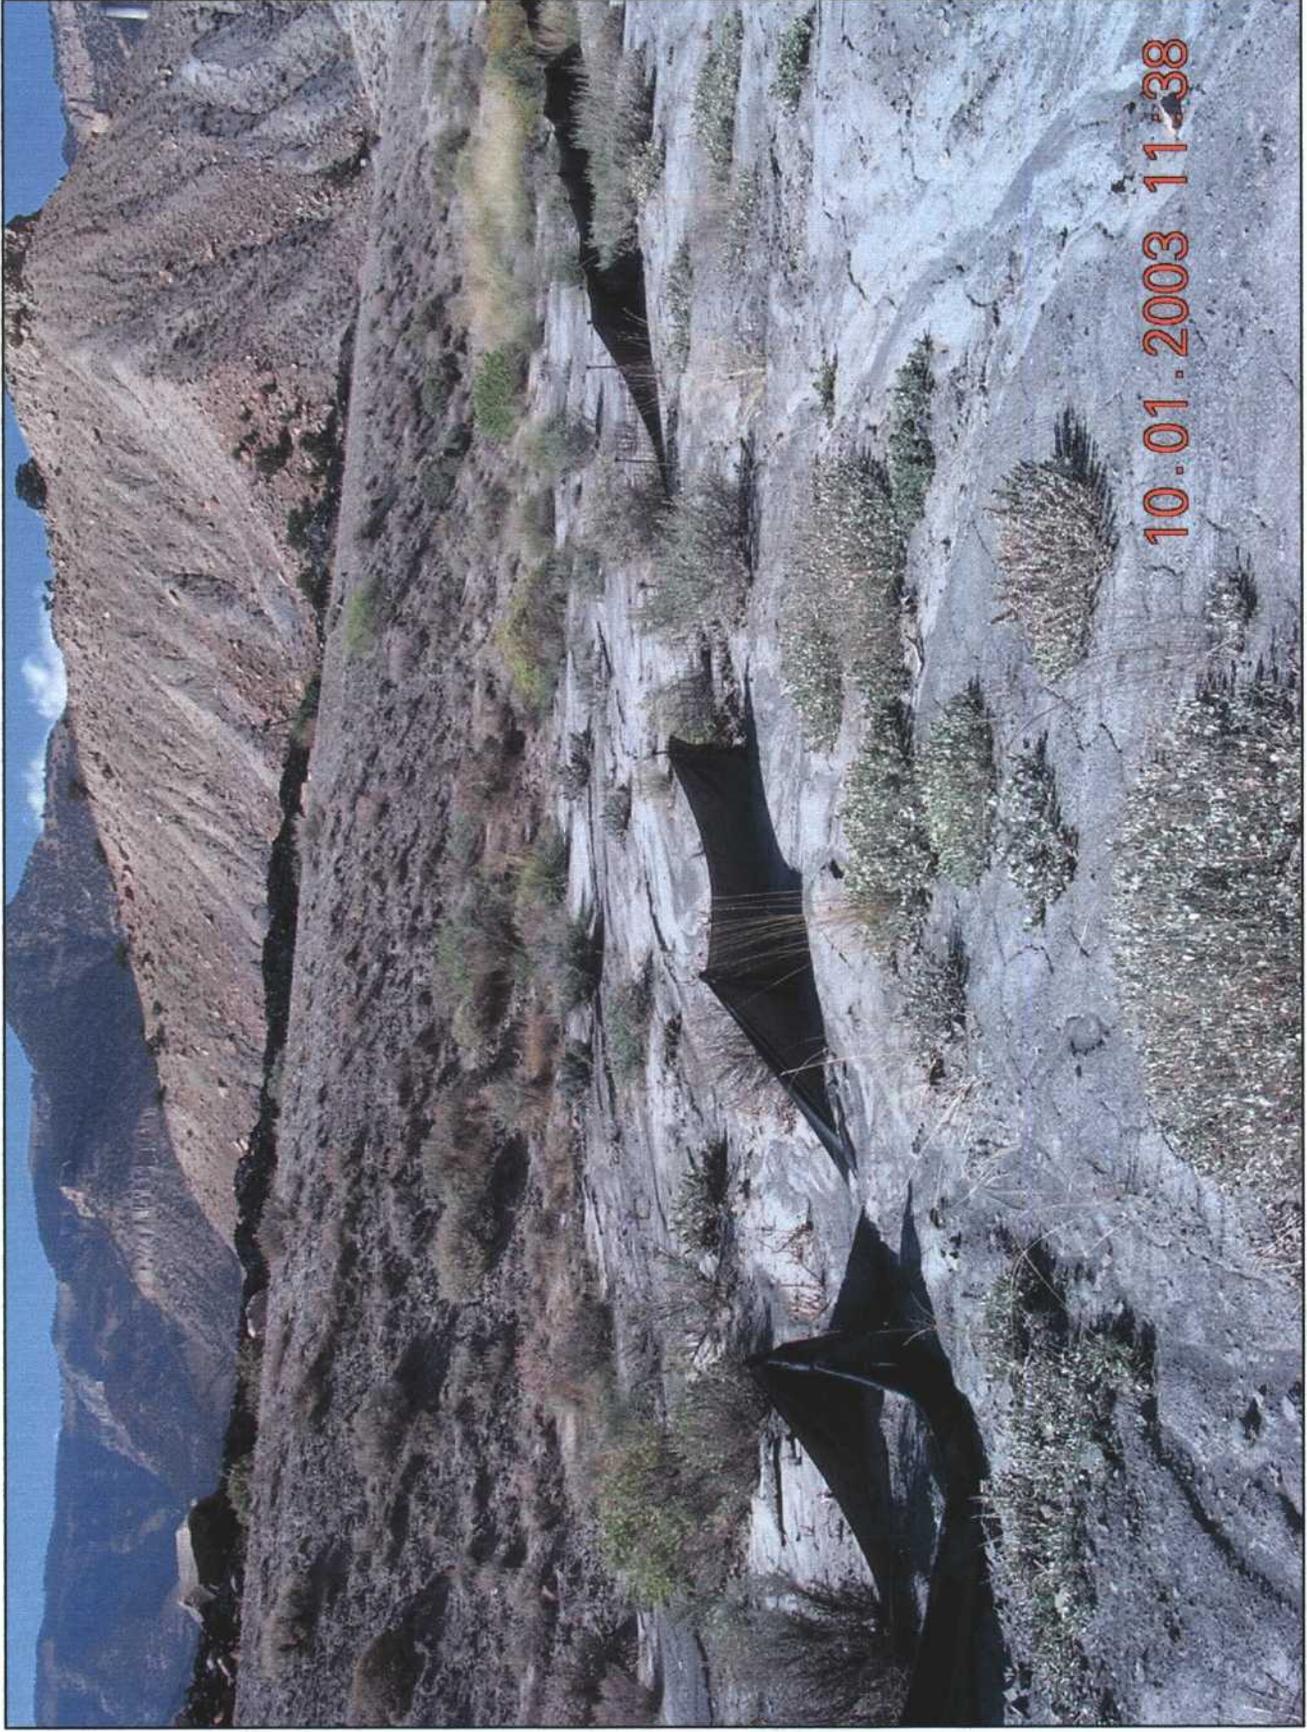
Two areas are involved; 1) Access Road, and 2) North side of Phase 1 area. It is noted that the silt fences #1, #3, and #4 were in poor repair. In a 1997 vegetation report by Mt. Nebo Scientific, it was determined that the vegetation growth along the access road was sufficient to control erosion. However, Division staff determined that there were areas that still needed protection and only allowed the removal of certain portions of the silt fence. The portions of the fence were in place. The #1 fence had a three foot downed section running parallel to the slope. The #3 fence was nearly full. The #4 fence had a small piping hole that was fixed during the inspection.

The fence north end of the waste rock site was inundated with sediment, undercut and in poor repair because of off-site flooding coming onto the disturbed area.

NOV: N03-49-4-1, Failure to maintain siltation structures associated with waste rock site.

An inspection occurred on October 1, 2003 at the mine site and waste rock site. Completed work at the waste rock site consisted of the replacement of approximately 1500 ft of silt fence on the south and east sides. The north and west area was still in need of repair but was completed by the abatement date of November 3, 2003.

The north and west areas of the waste rock site had to be completed by Energy West since the compliance contractor was not available. The work required included the re-establishment of the main bypass ditch, re-establishment of the berm on the northwest corner of the pile, and the replacement of silt fence along the toe of the berm. During this work, the company backhoe broke down and a replacement had to be rented. All work associated with this area was caused by outside permit influences.

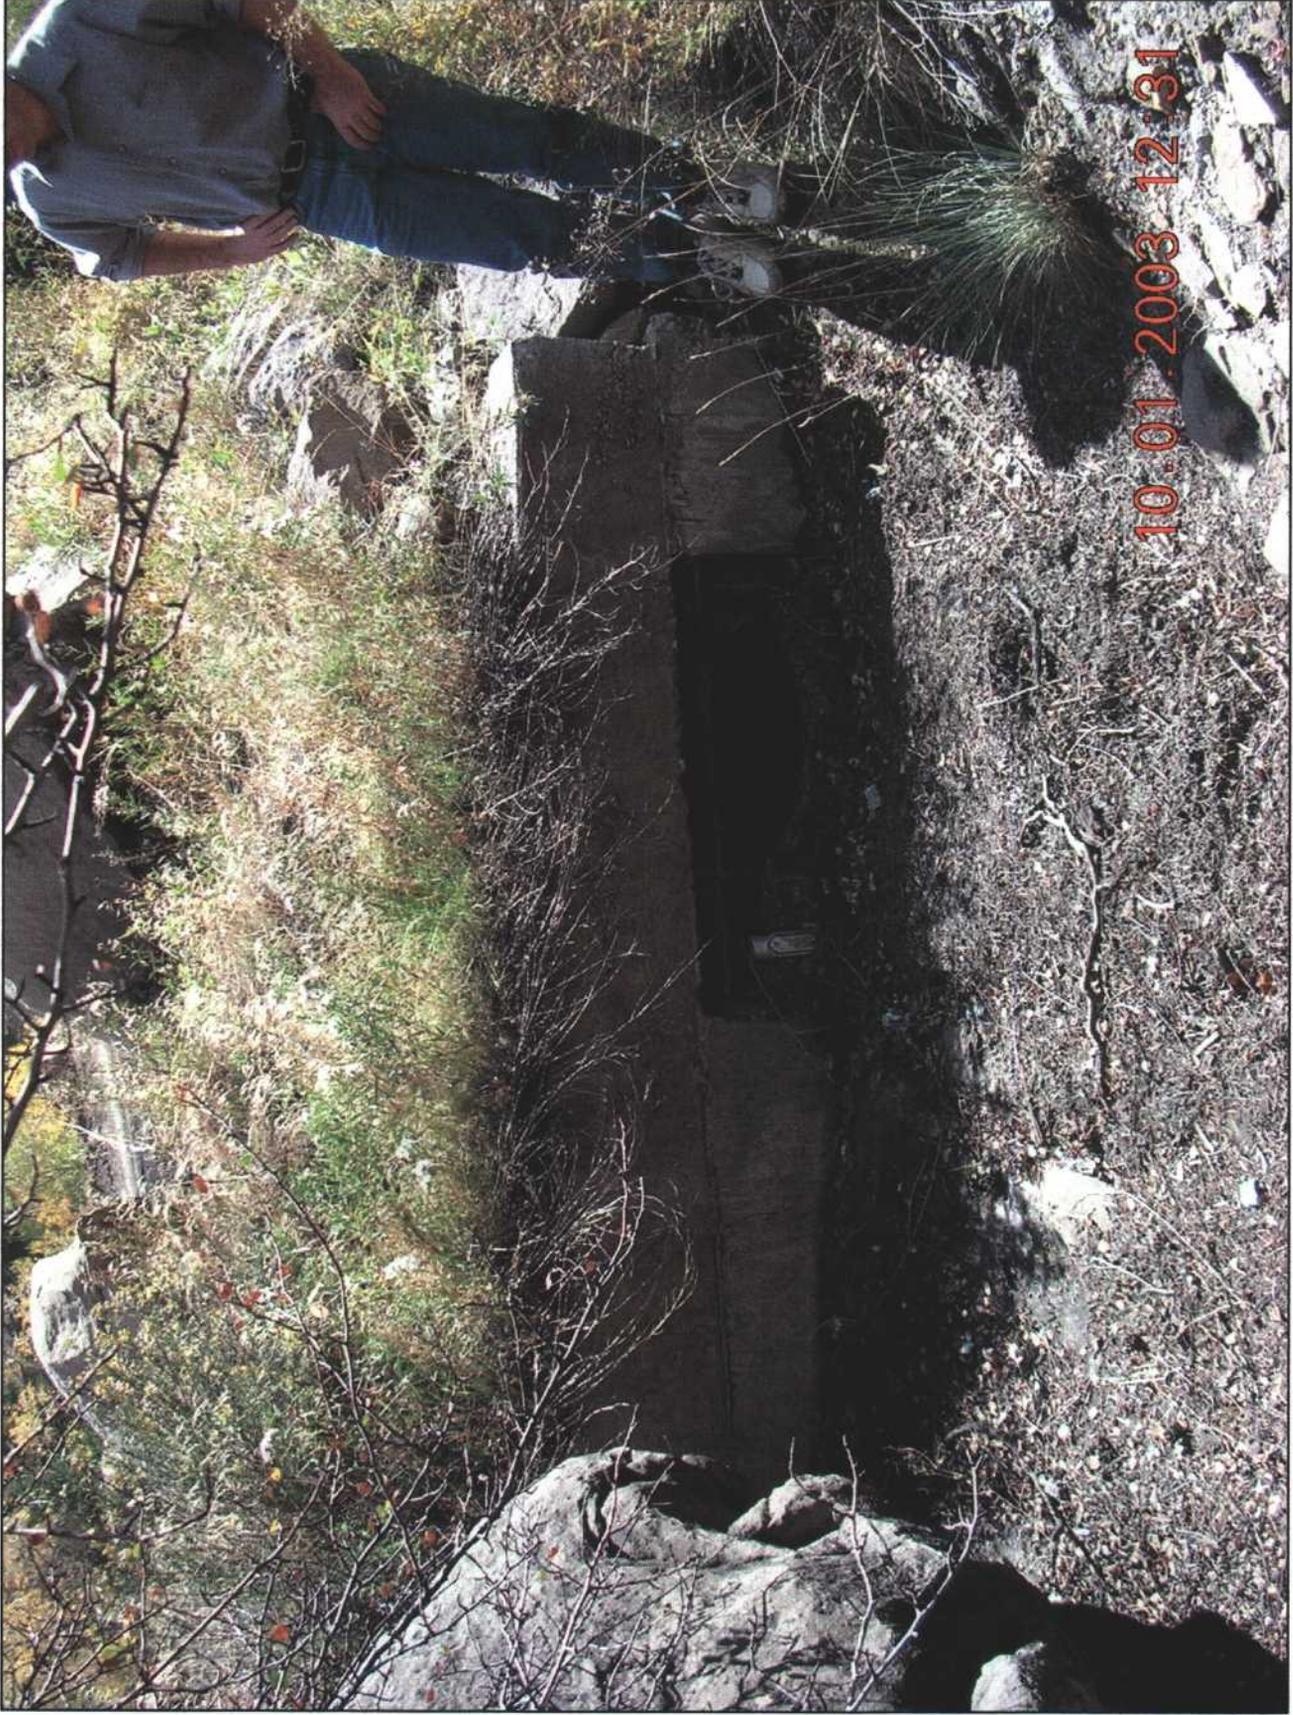
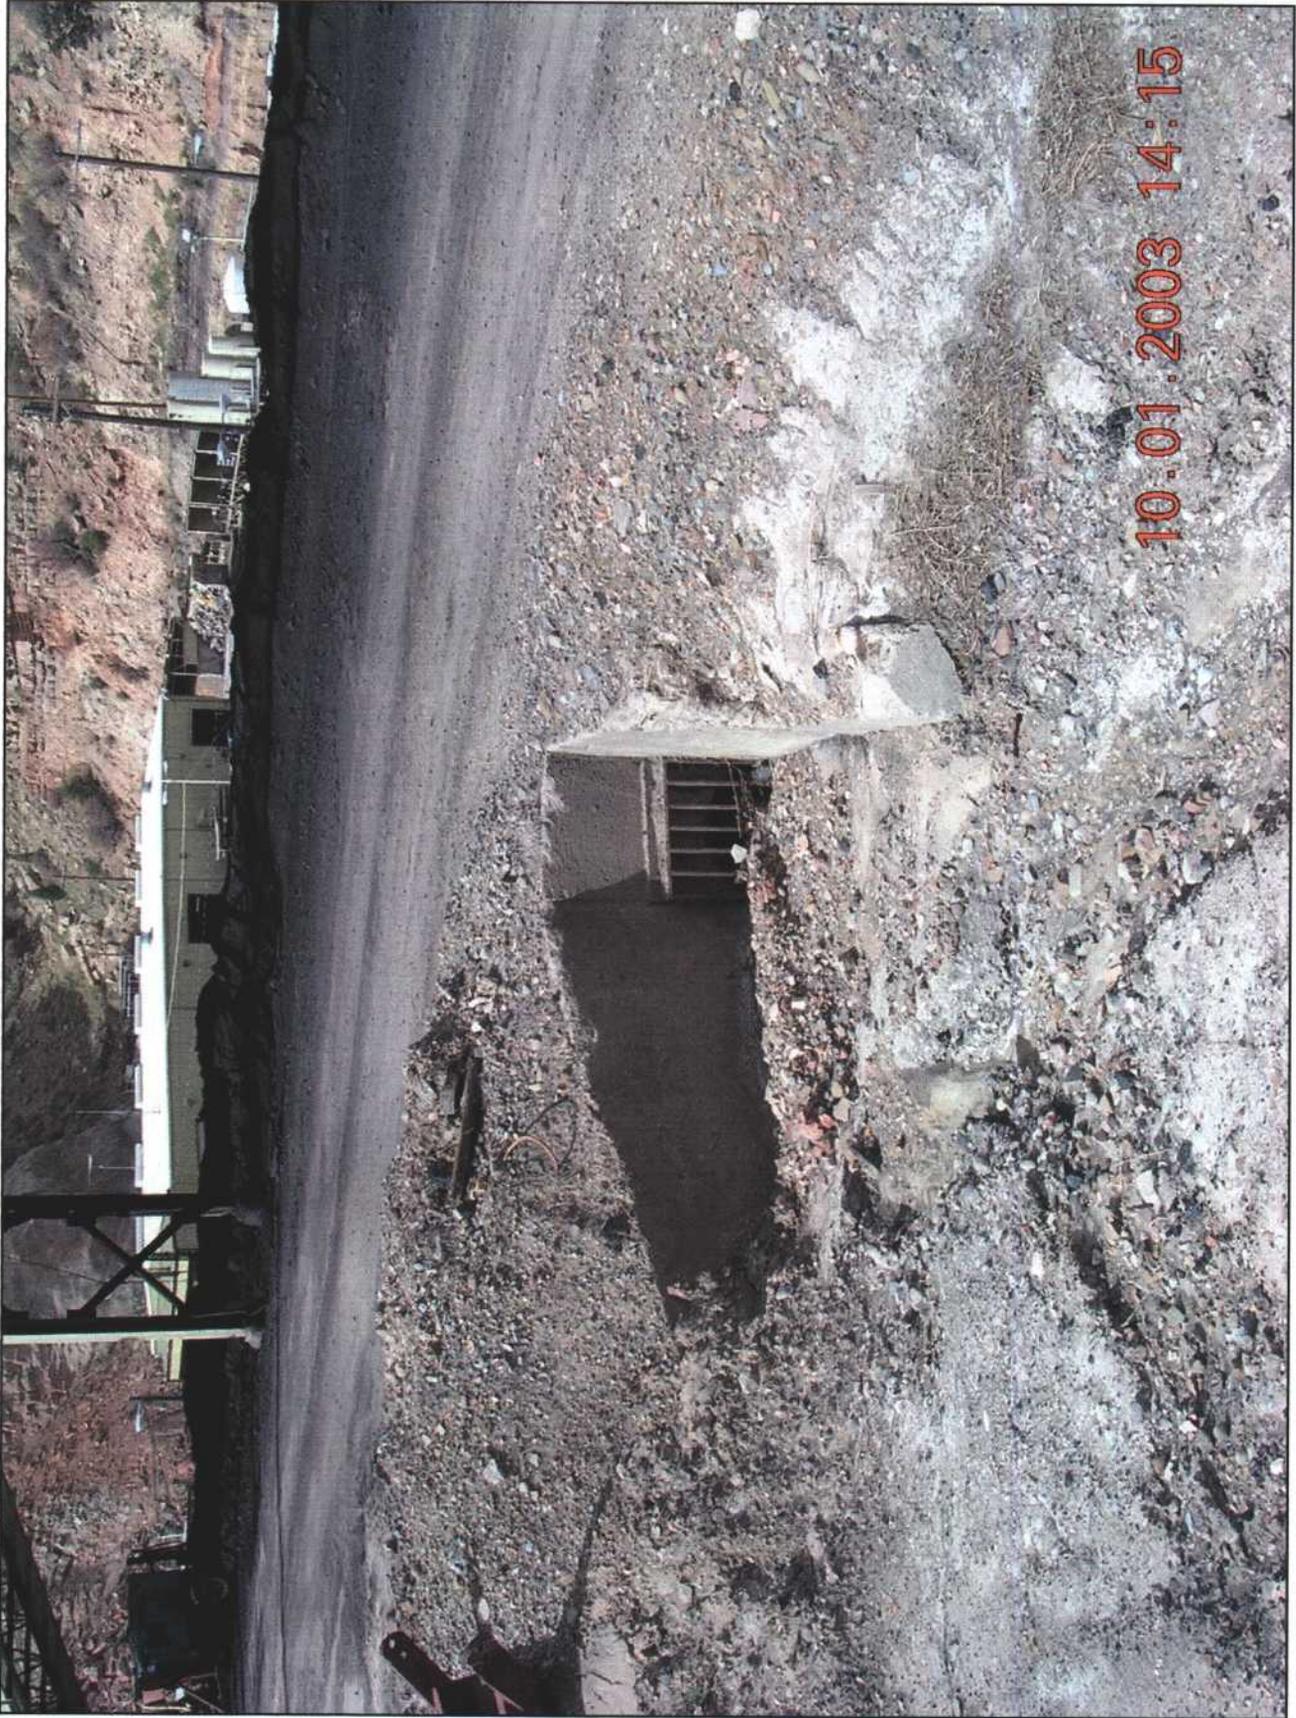
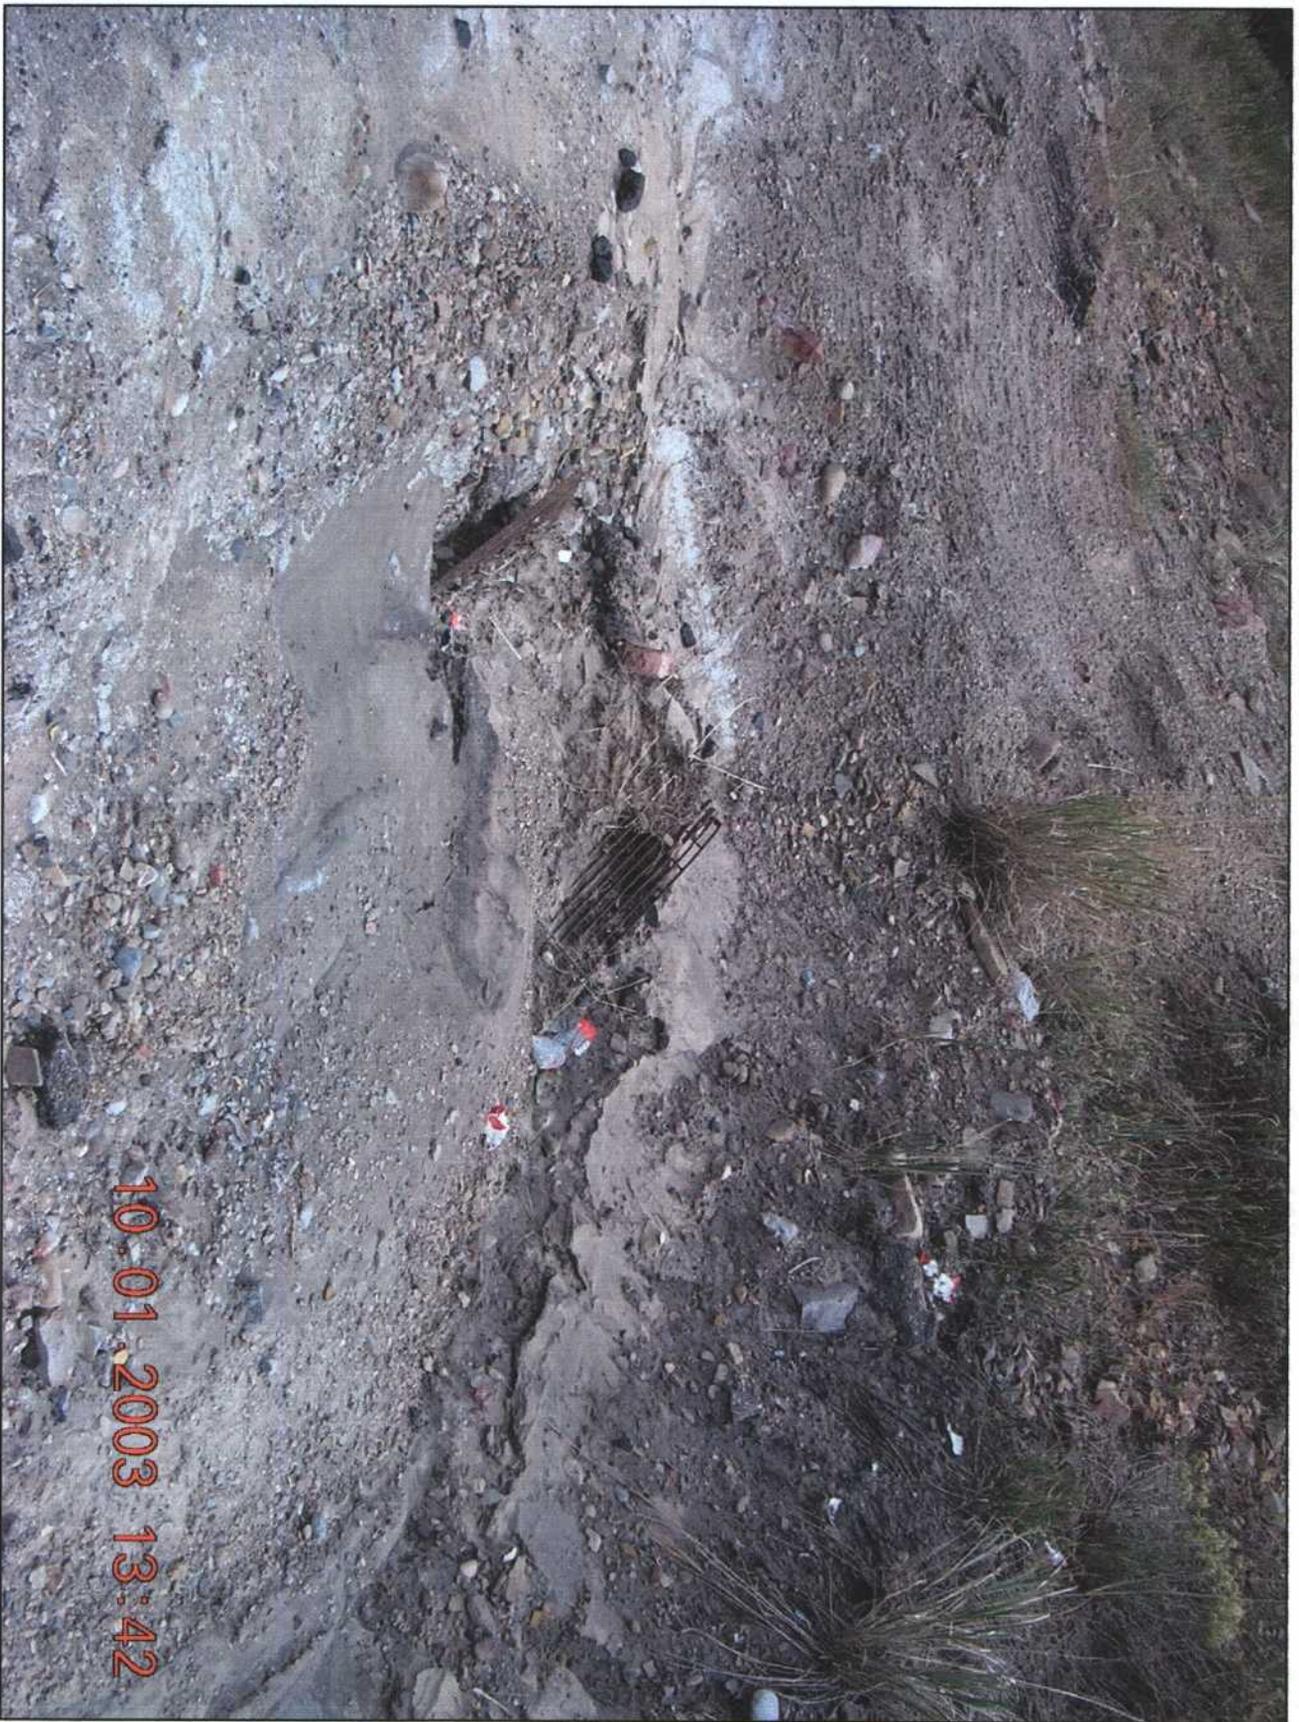
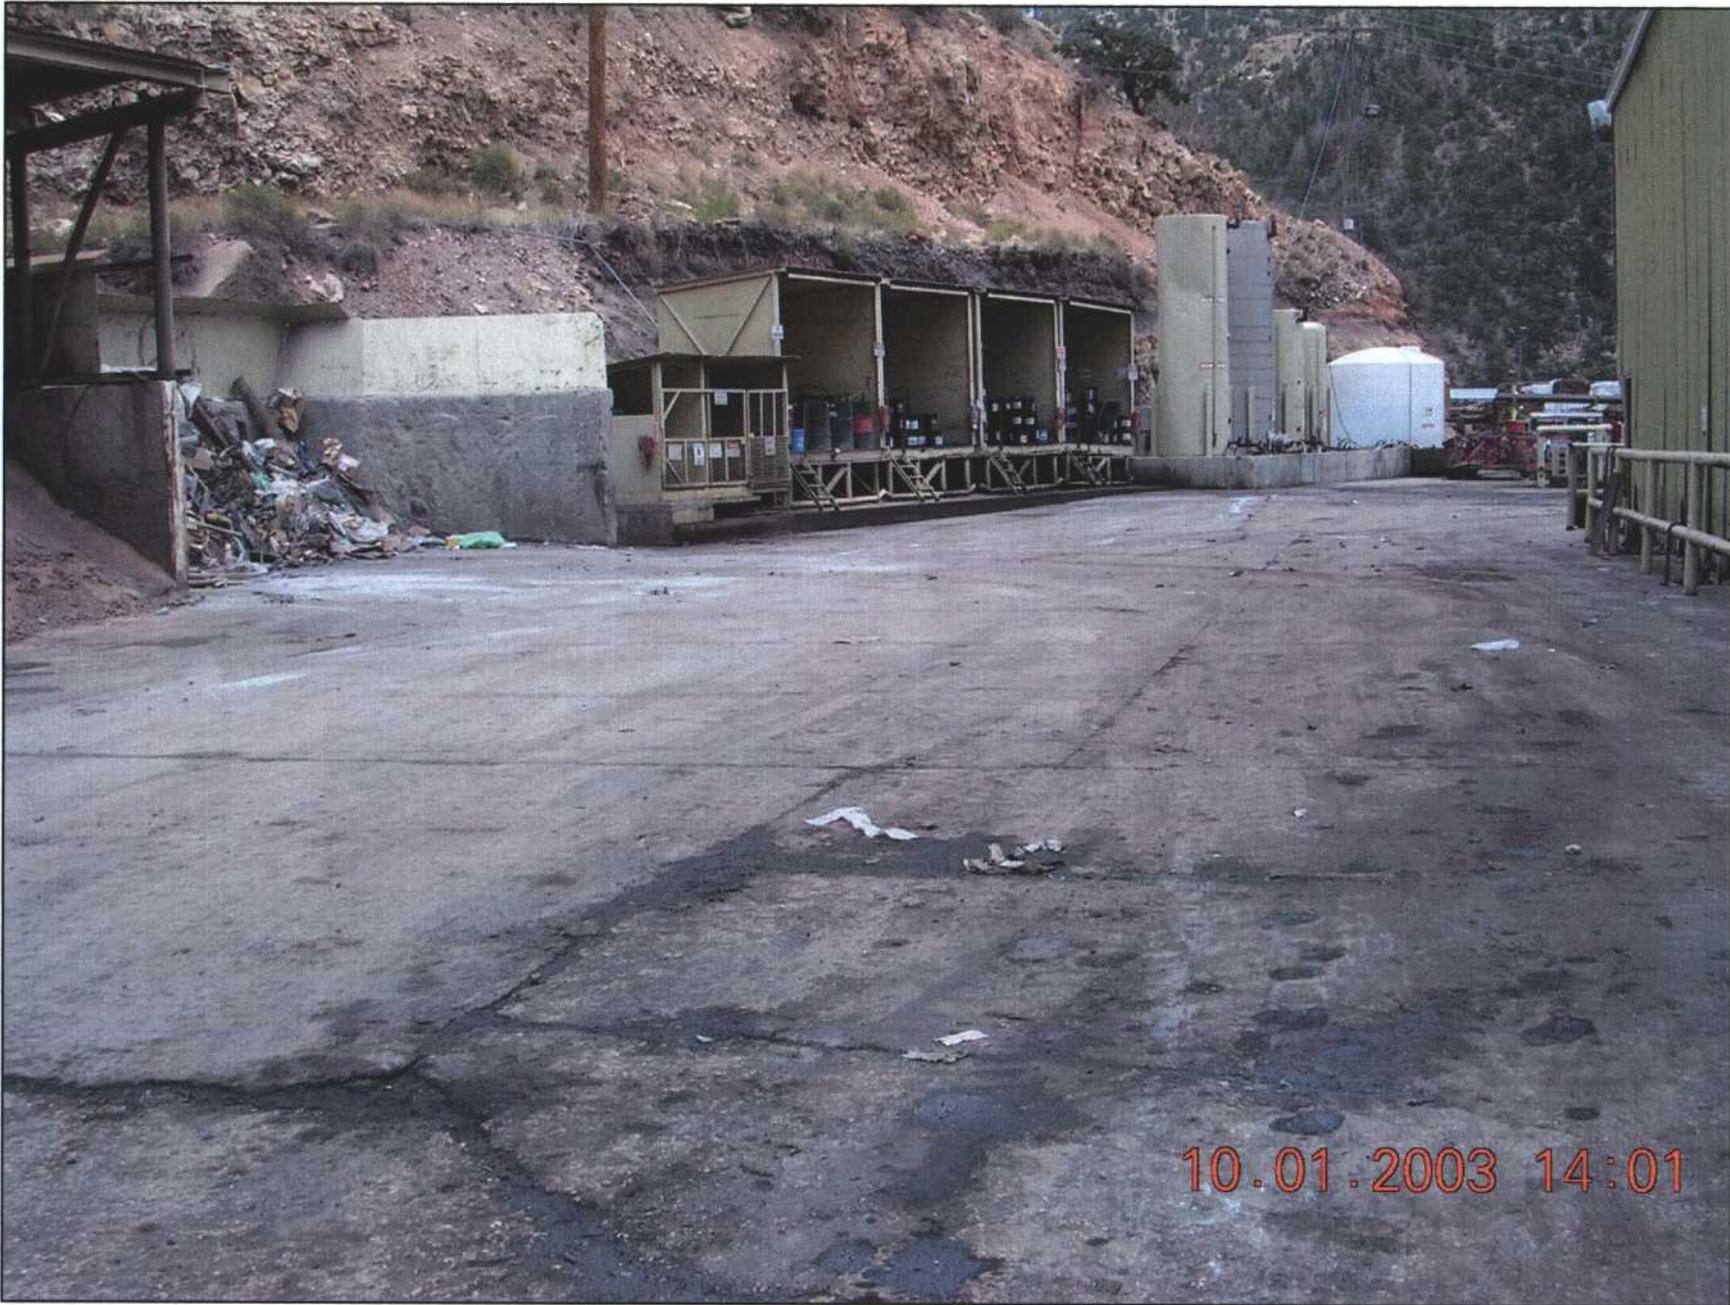
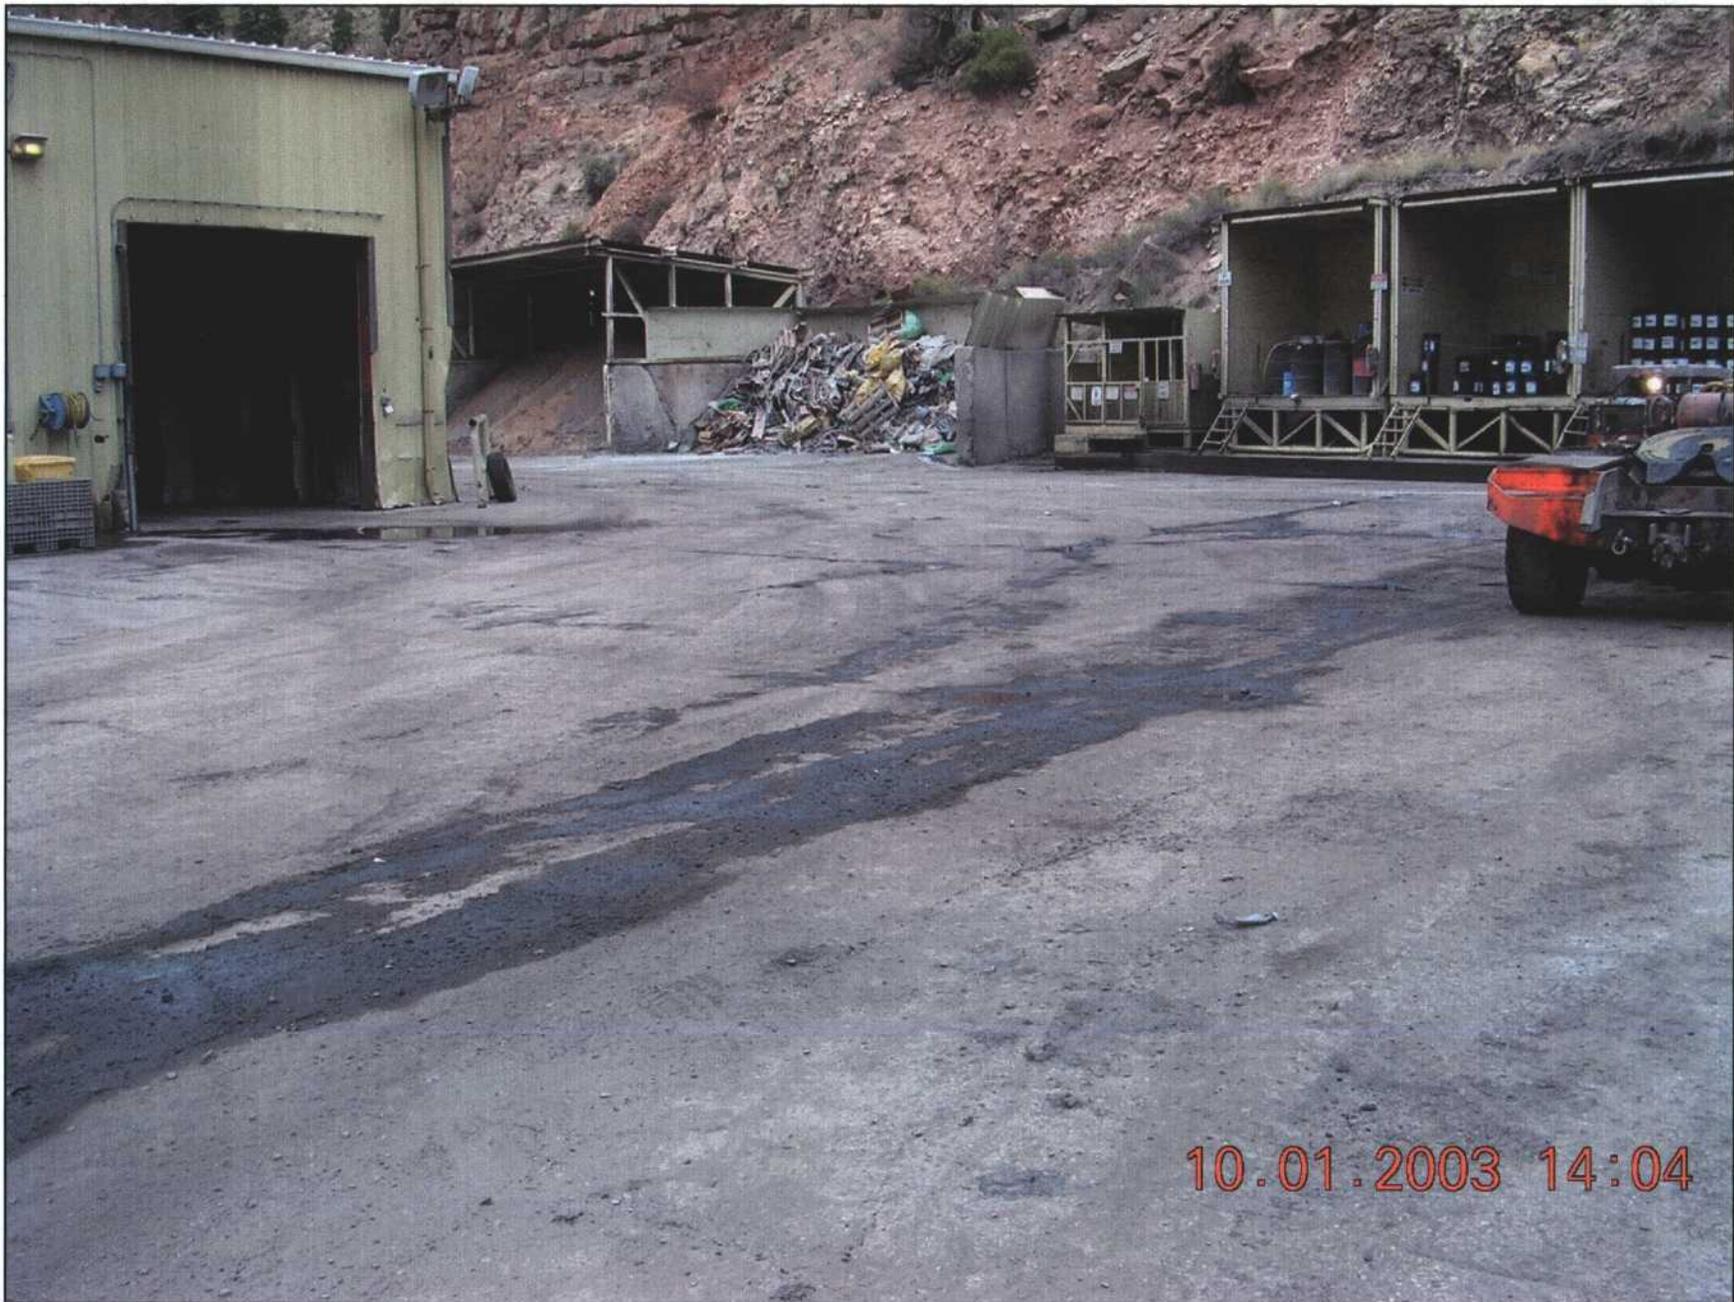
The Officer assigned 15 points for probability of occurrence. The stated event is transfer of sediment from the site with its attendant erosion and water pollution. The actual probability for sediment transferred from the site is none. Culvert inlets may have been restricted, however in each instance, there was a operating treatment structure below. Energy West feels that the assessed points should be zero.

The points assessed by the Officer was 15, which again, borderlines on reckless negligence. These culvert inlets were cleaned after the August storms, but got filled again after the September storms. Energy West feels that the assessed penalty points should be on the lower end of negligence.

NOV: N03-49-5-1, Failure to maintain disturbed and undisturbed diversions associated with mine site.
