RE: **Informal Assessment Conference on State Notice of Violation N03-49-4-1, N03-49-5-1, N03-49-6-1, PacifiCorp, Deer Creek Mine, C/015/018, Emery County, Utah**

Informal Assessment Conference

Attachment 1

NOV Photos

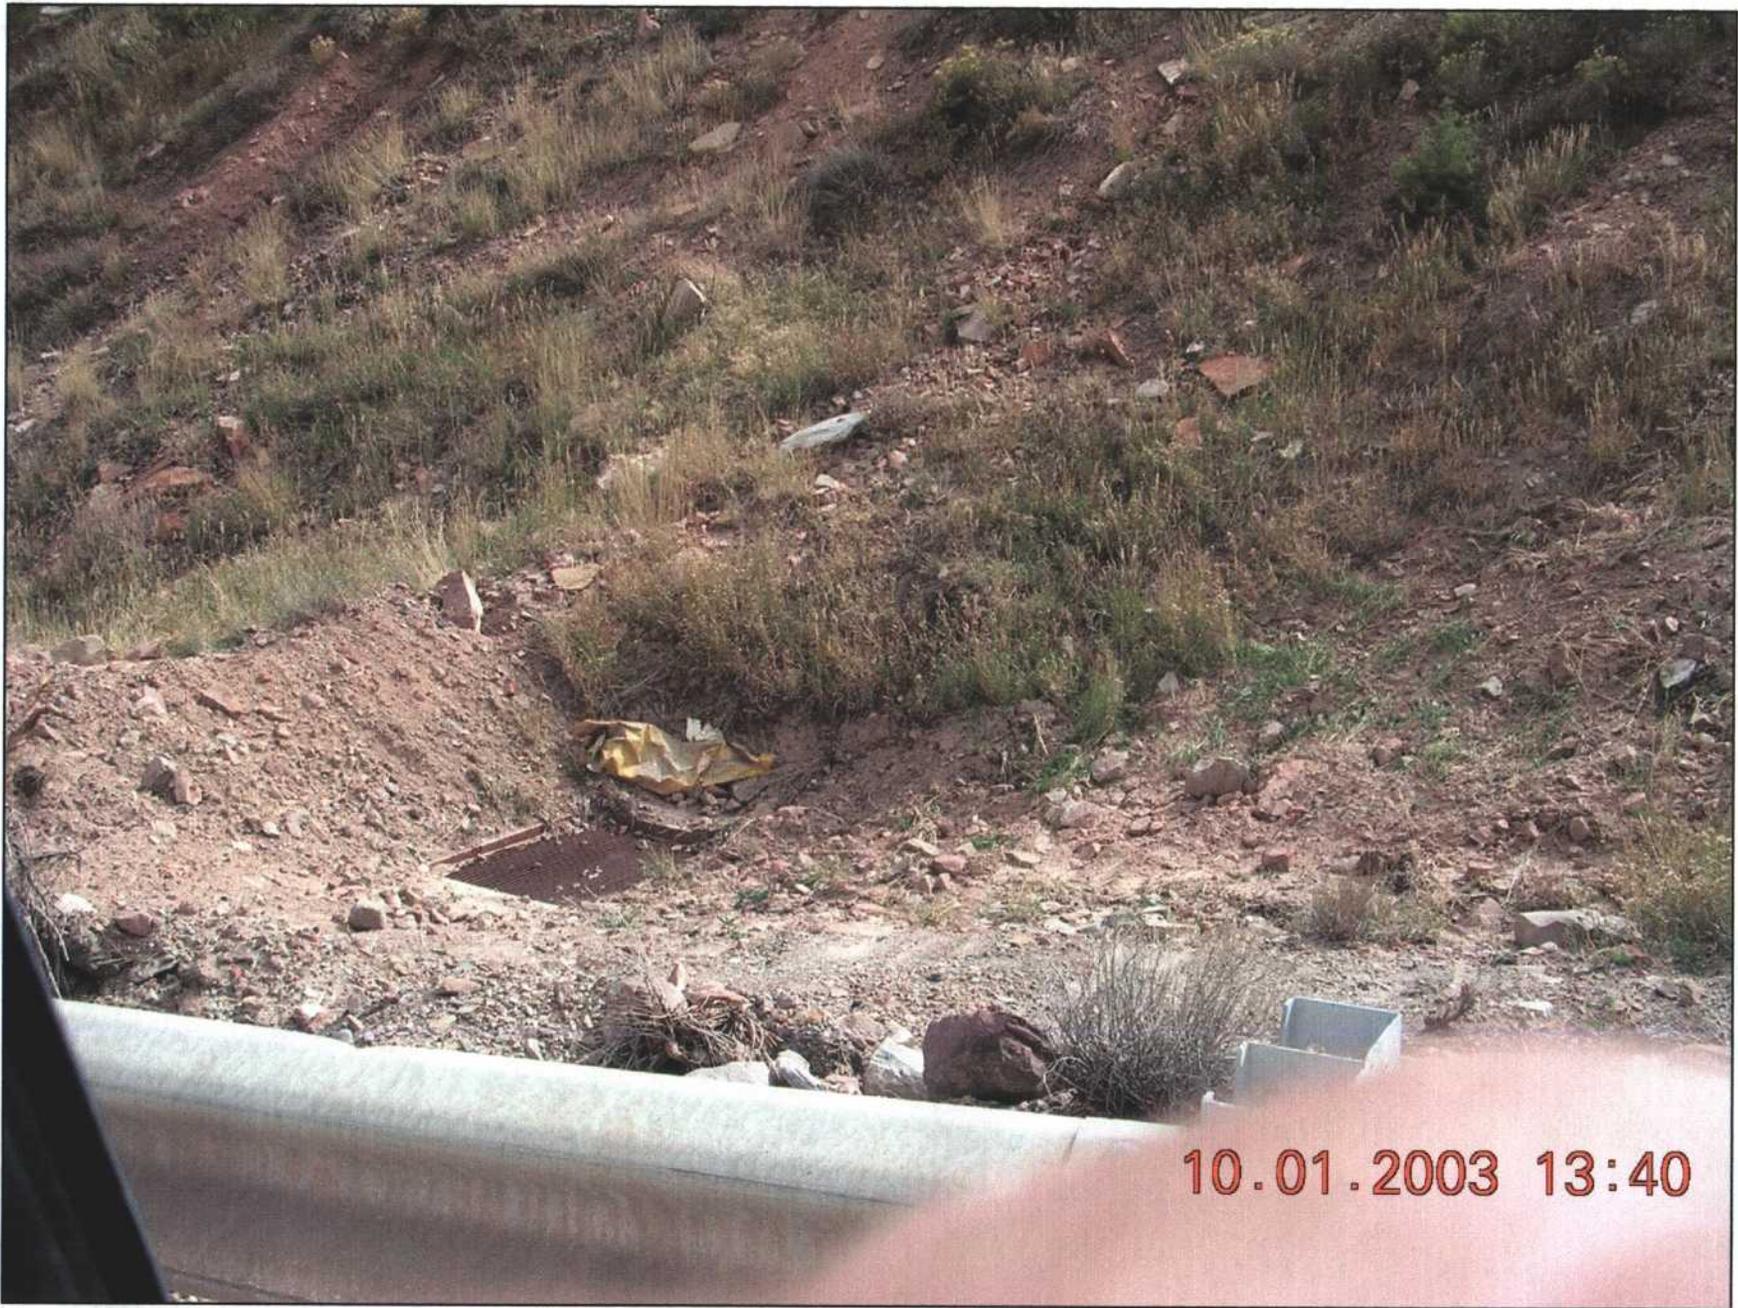
The points assessed by the Officer was 15, which again, borderlines on reckless negligence. Energy West conducts monthly sweeps over the mine site to collect loose trash. It is our goal to keep the

NOV: N03-49-6-1, Failure to control and contain non-coal waste in a controlled manner in the designated control structure.

No good faith points were assessed even though the loose trash had been cleaned up prior to the end of the abatement period. The day that the Division inspector came to the mine site to abate the violation, the mine site had been cleaned and trash was being loaded into an end-dump trailer with a front-end loader. Trash was scattered in this area as a result of this work. The inspector said he could not abate the violation on this day since the trash was observed outside the trash bin. Energy West feels that diligence was used to abate the violation and should be credited accordingly.

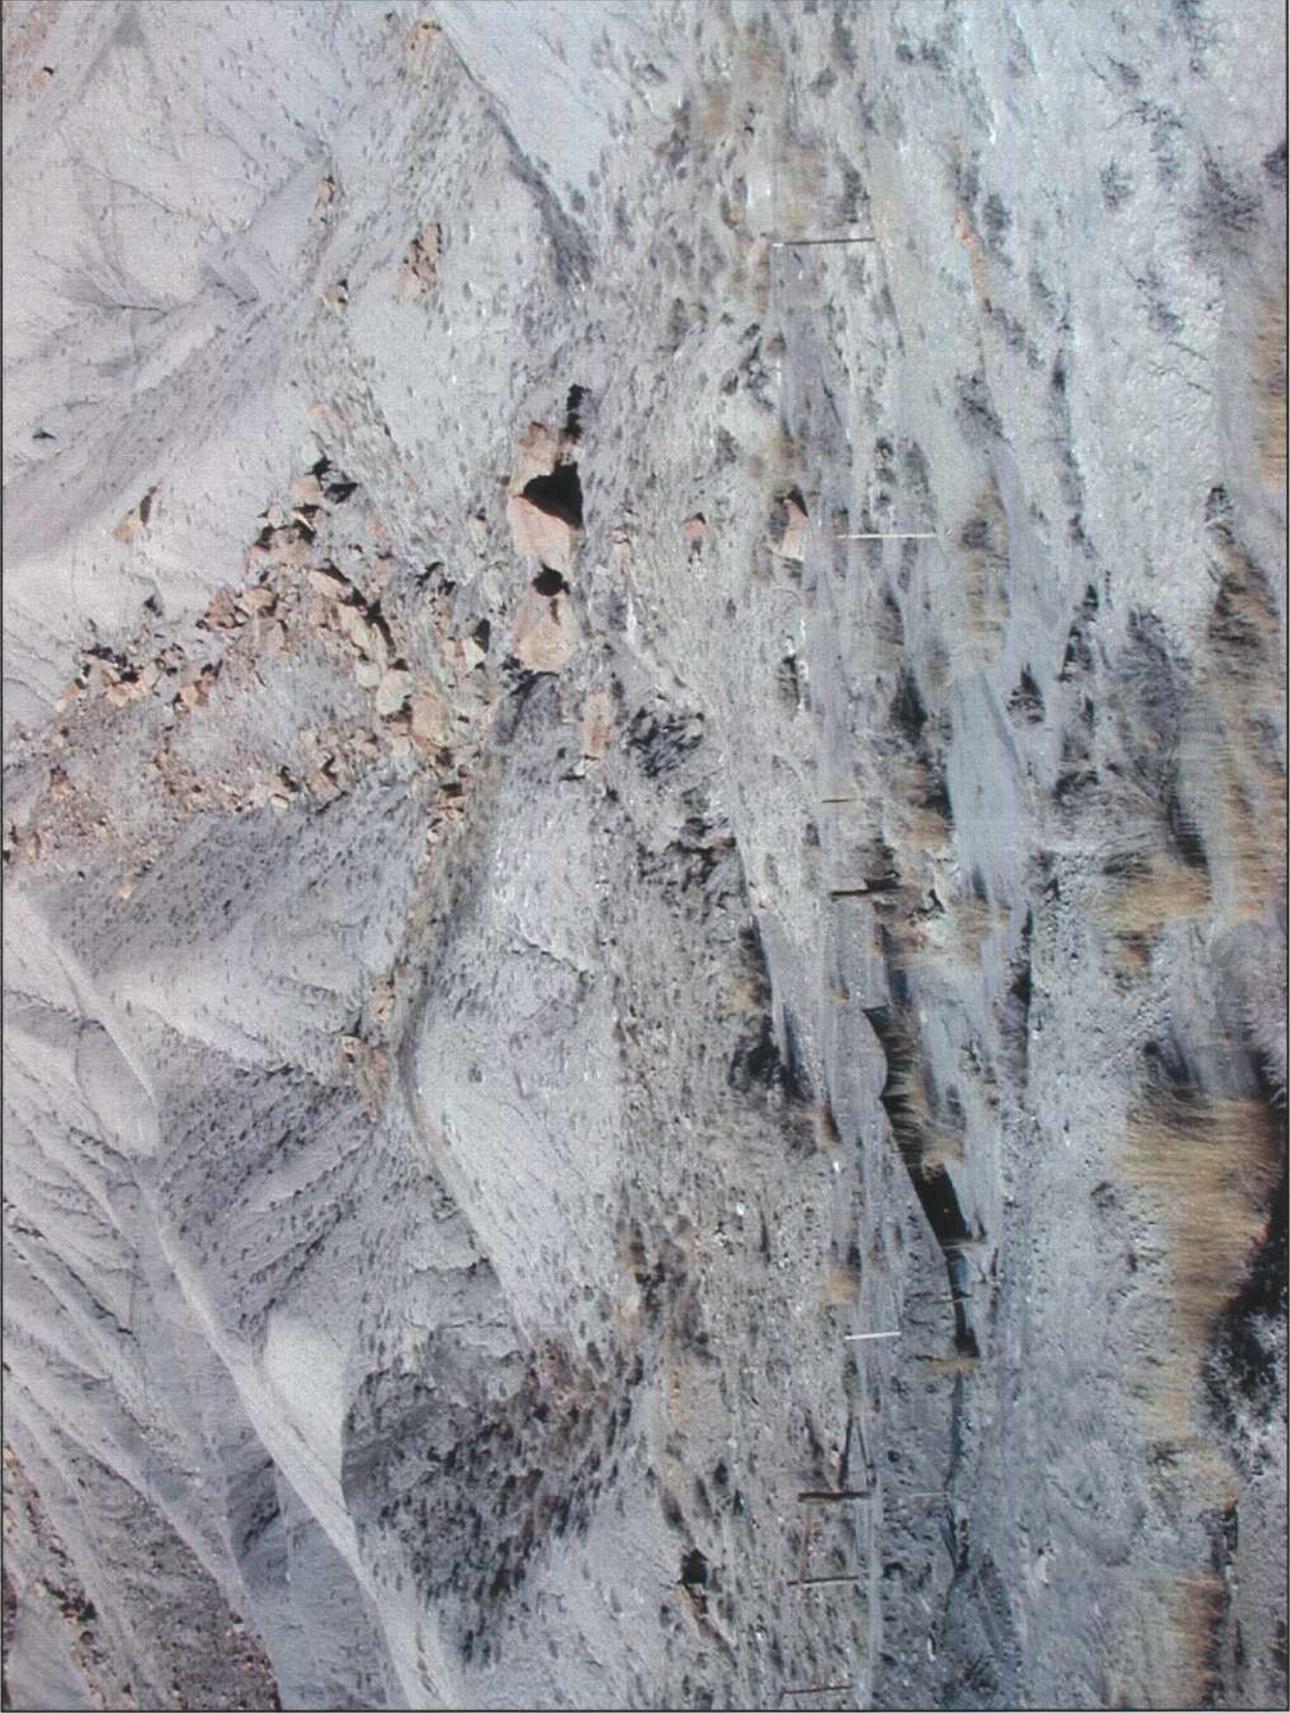
Drainage area Northeast side of waste rock site.

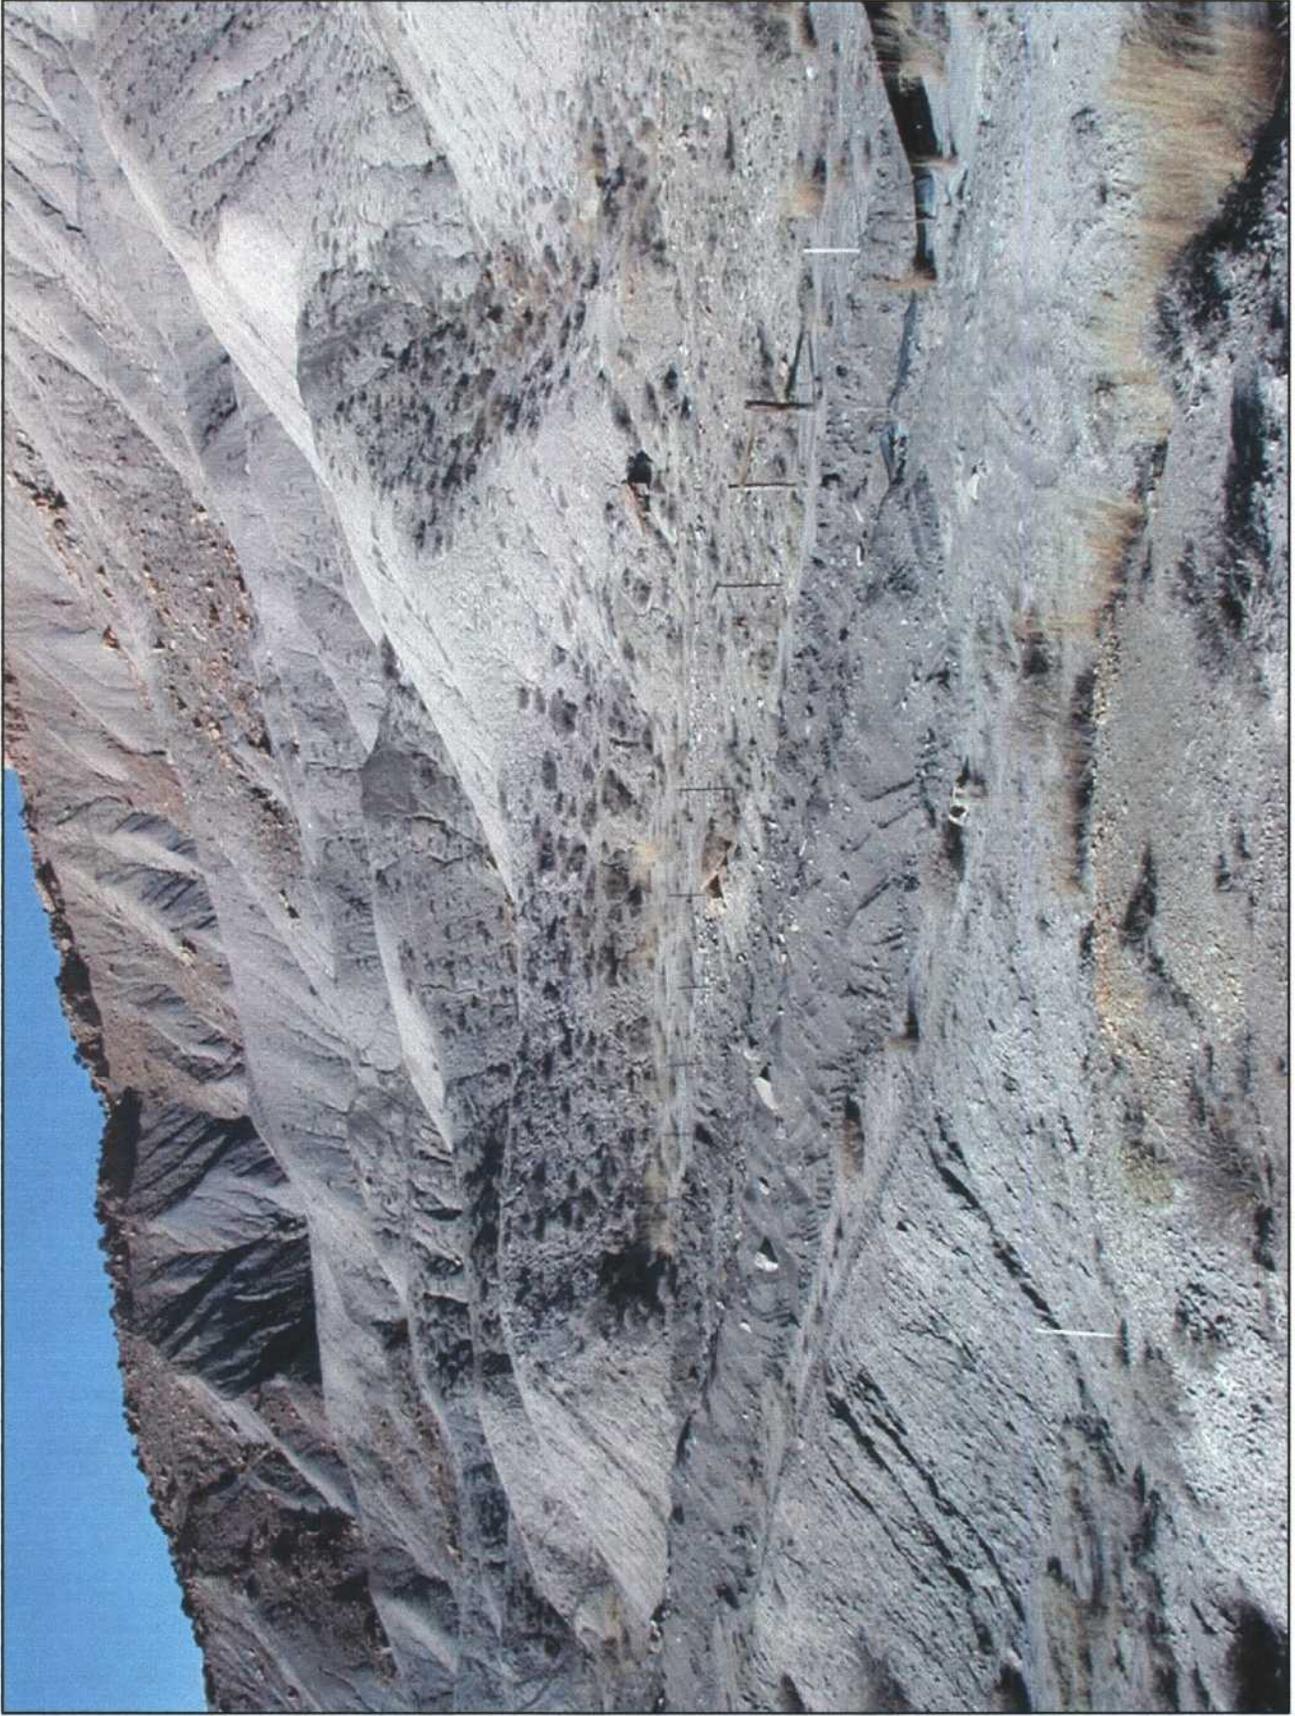
Diversion berm on Northeast side of waste rock site.

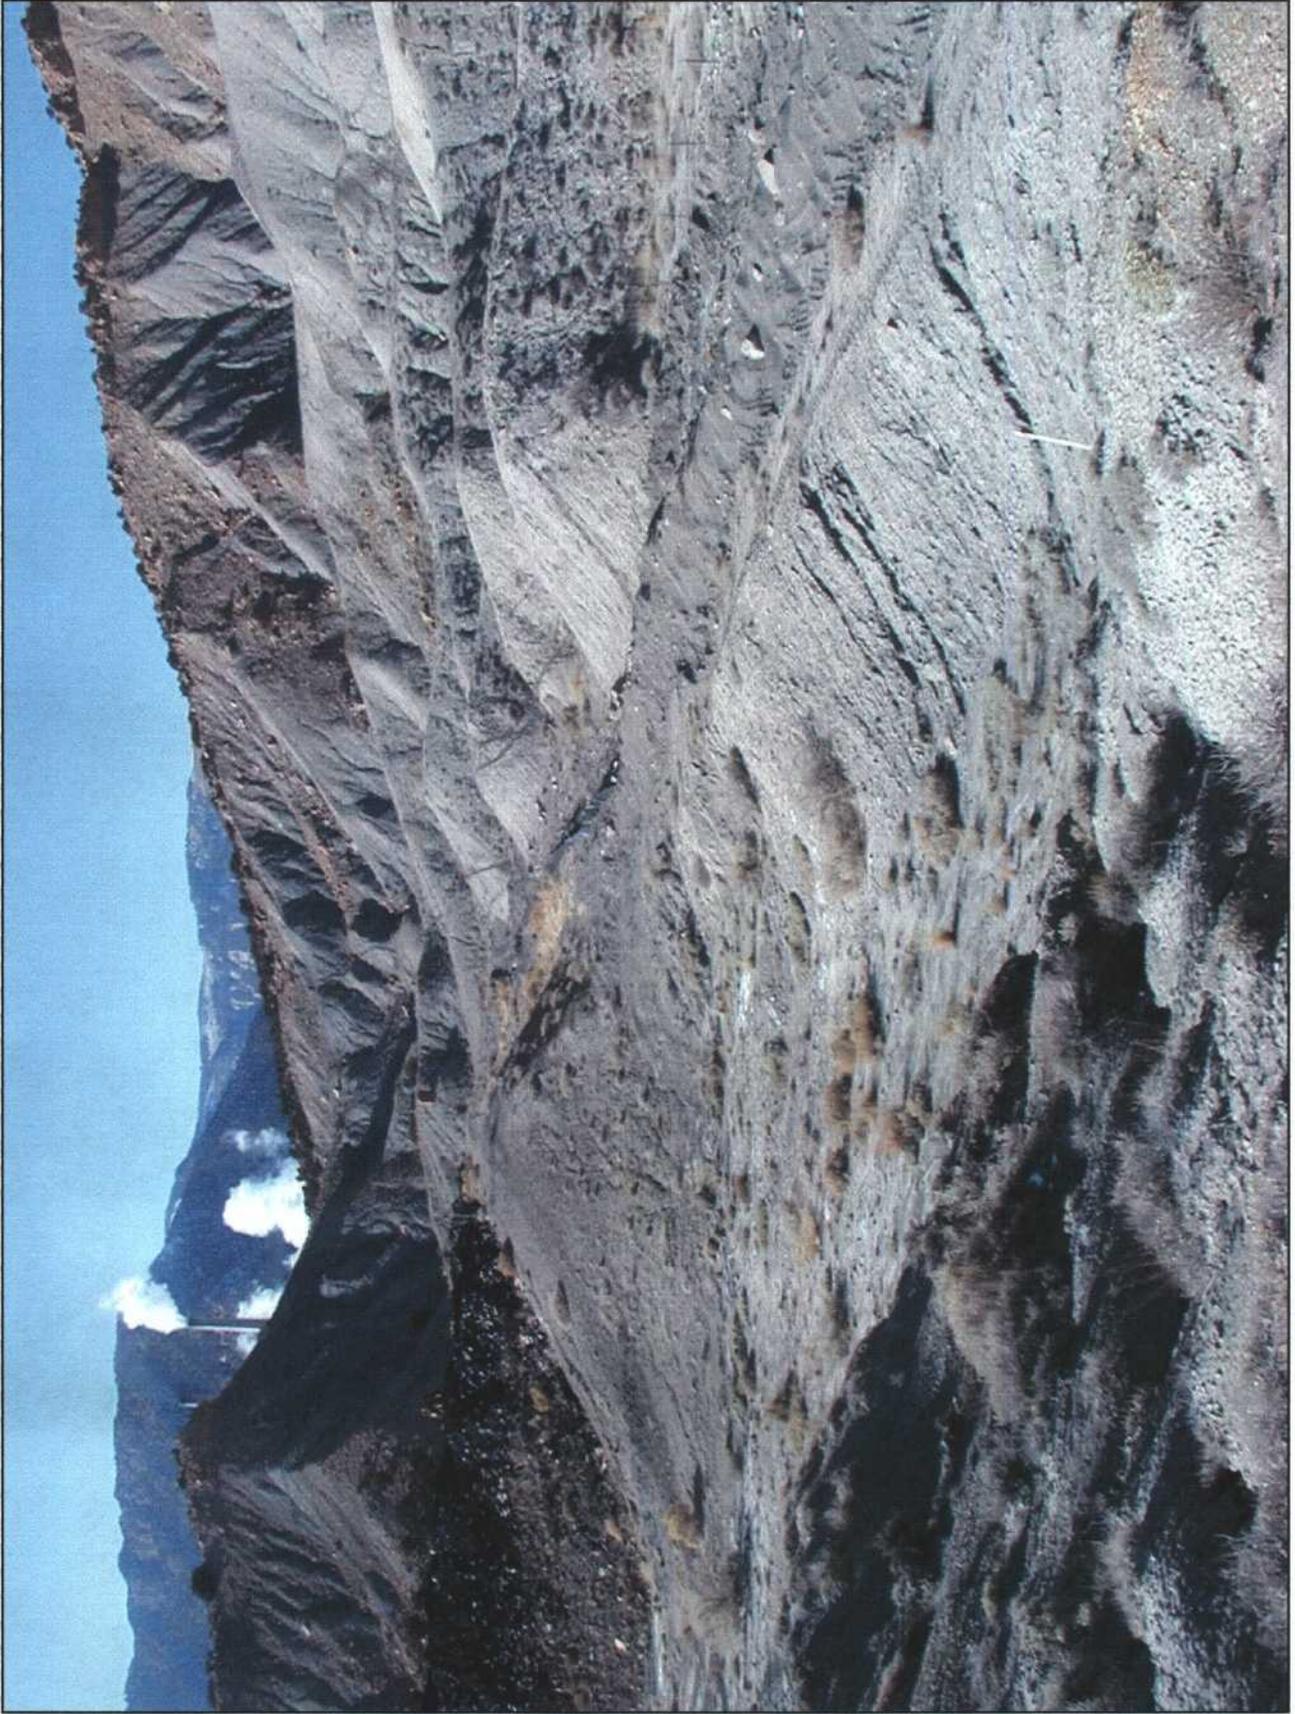
Diversion berm and ditch on North side of waste rock site.

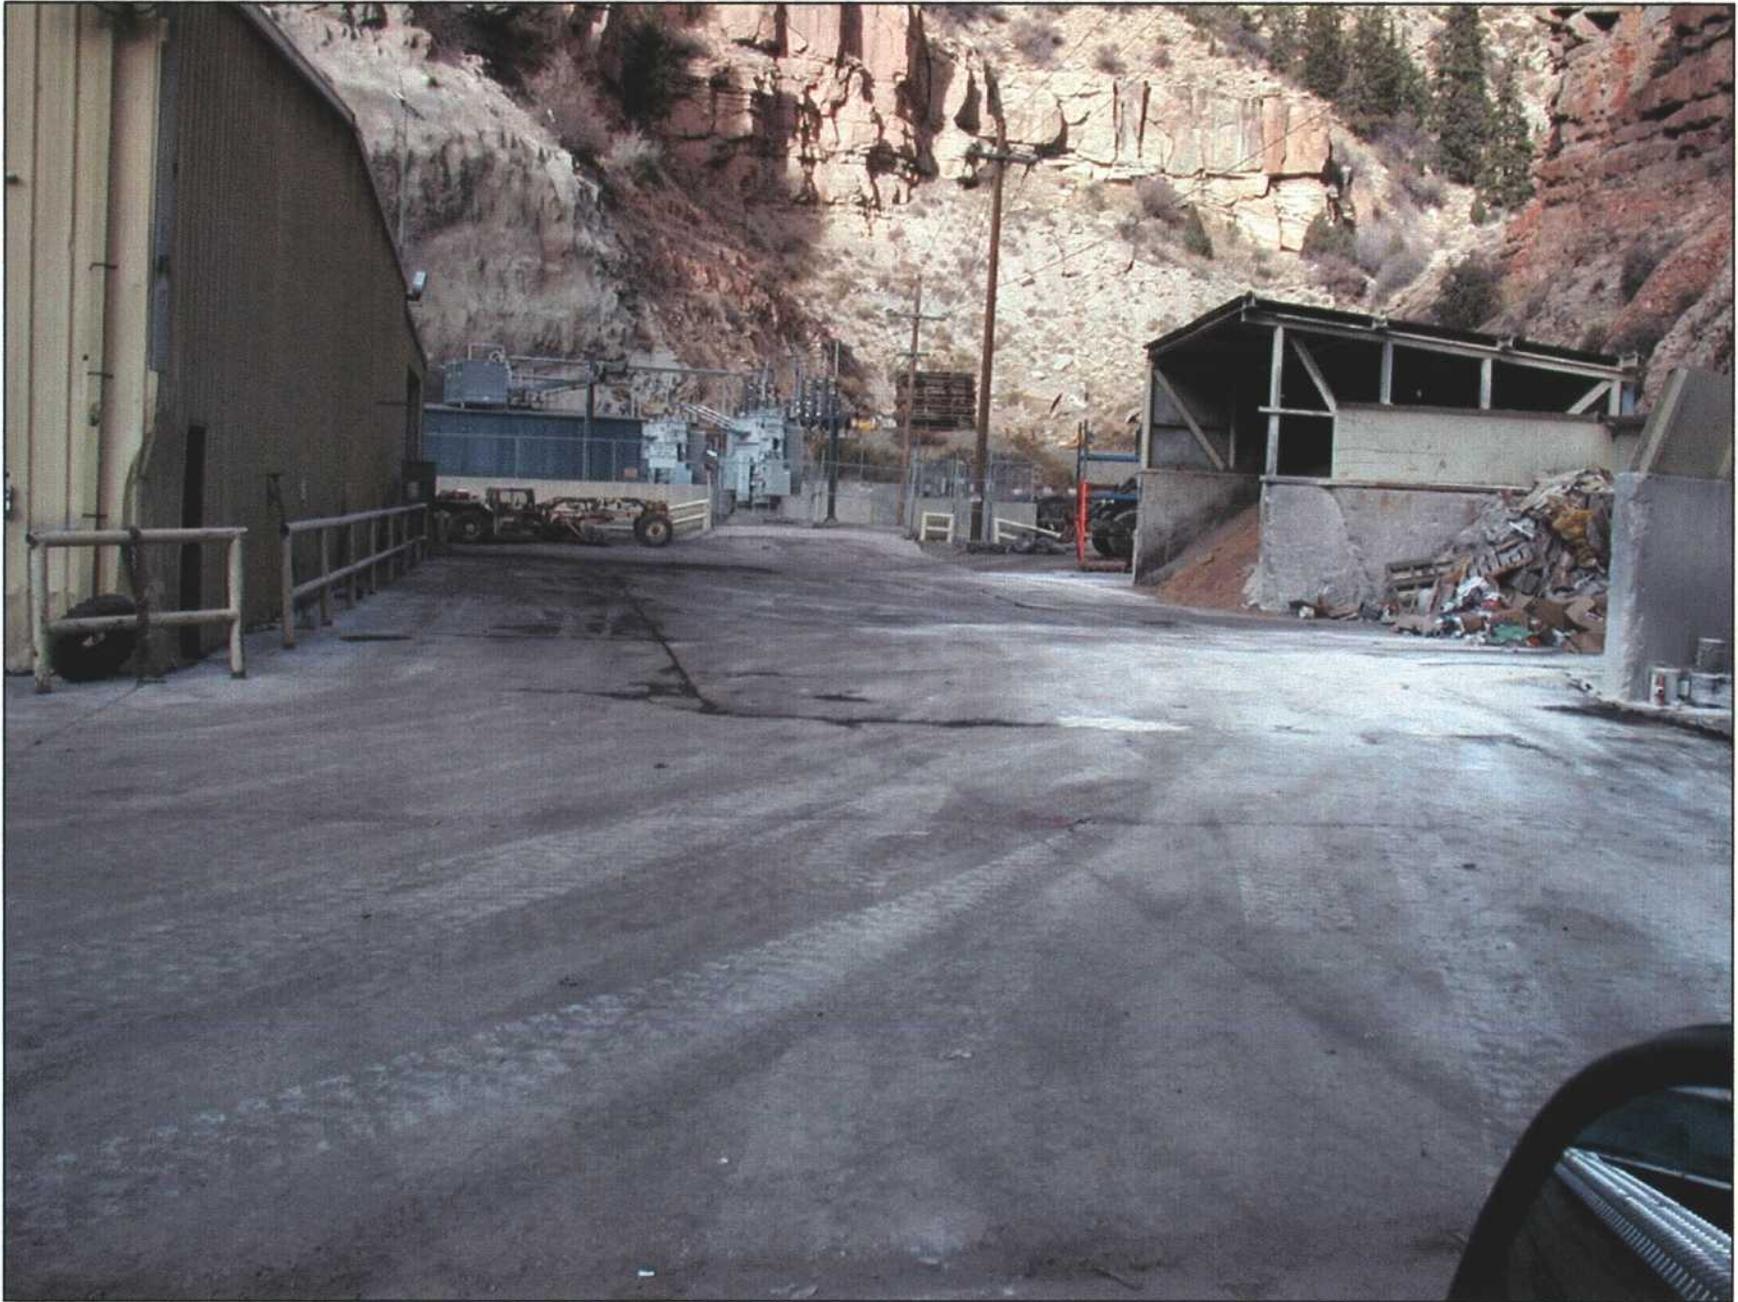
Non-coal waste cleaned. Photo taken October 28, 2003.
