*Annual Subsidence Monitoring Report
East/Trail Mountain Properties
2007*

August 2008

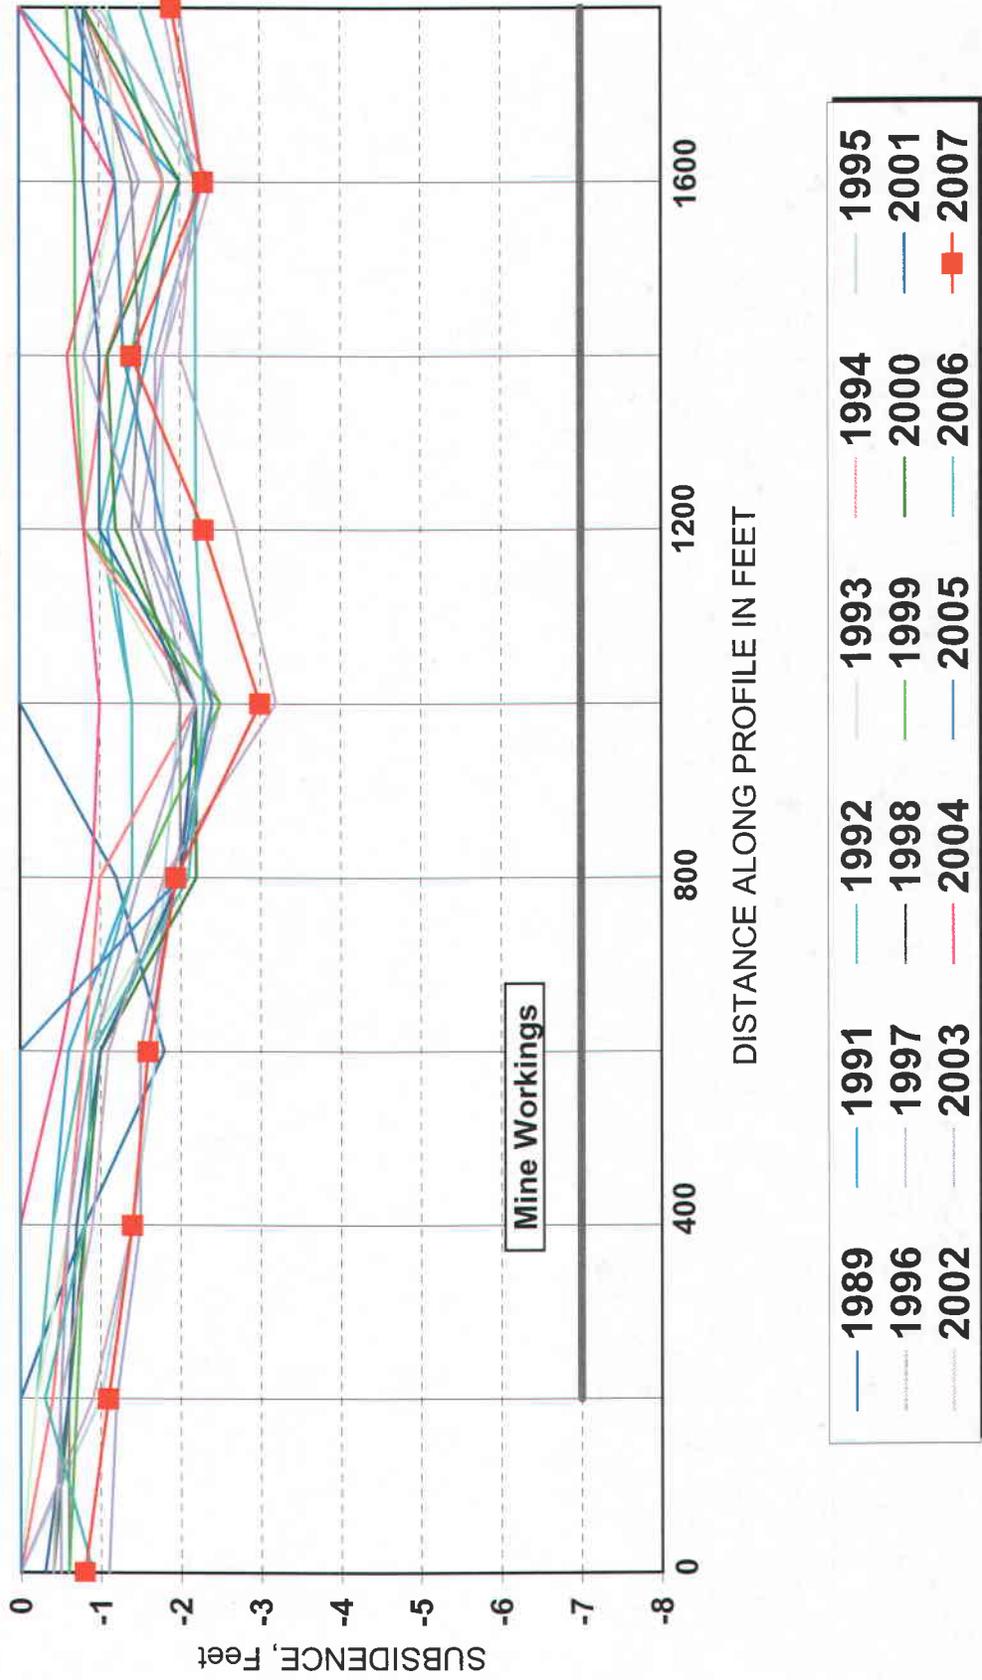
Chart 1

The subsidence above 1st North occurs on a narrow ridge capped by a highly fractured sandstone. The subsidence measured is depicted in Figure 3. The profile chart (Chart 1) for Area 3 is a profile of total subsidence as it occurred above the workings. The subsidence in Area 3 has shown no significant change in the past 9 years.

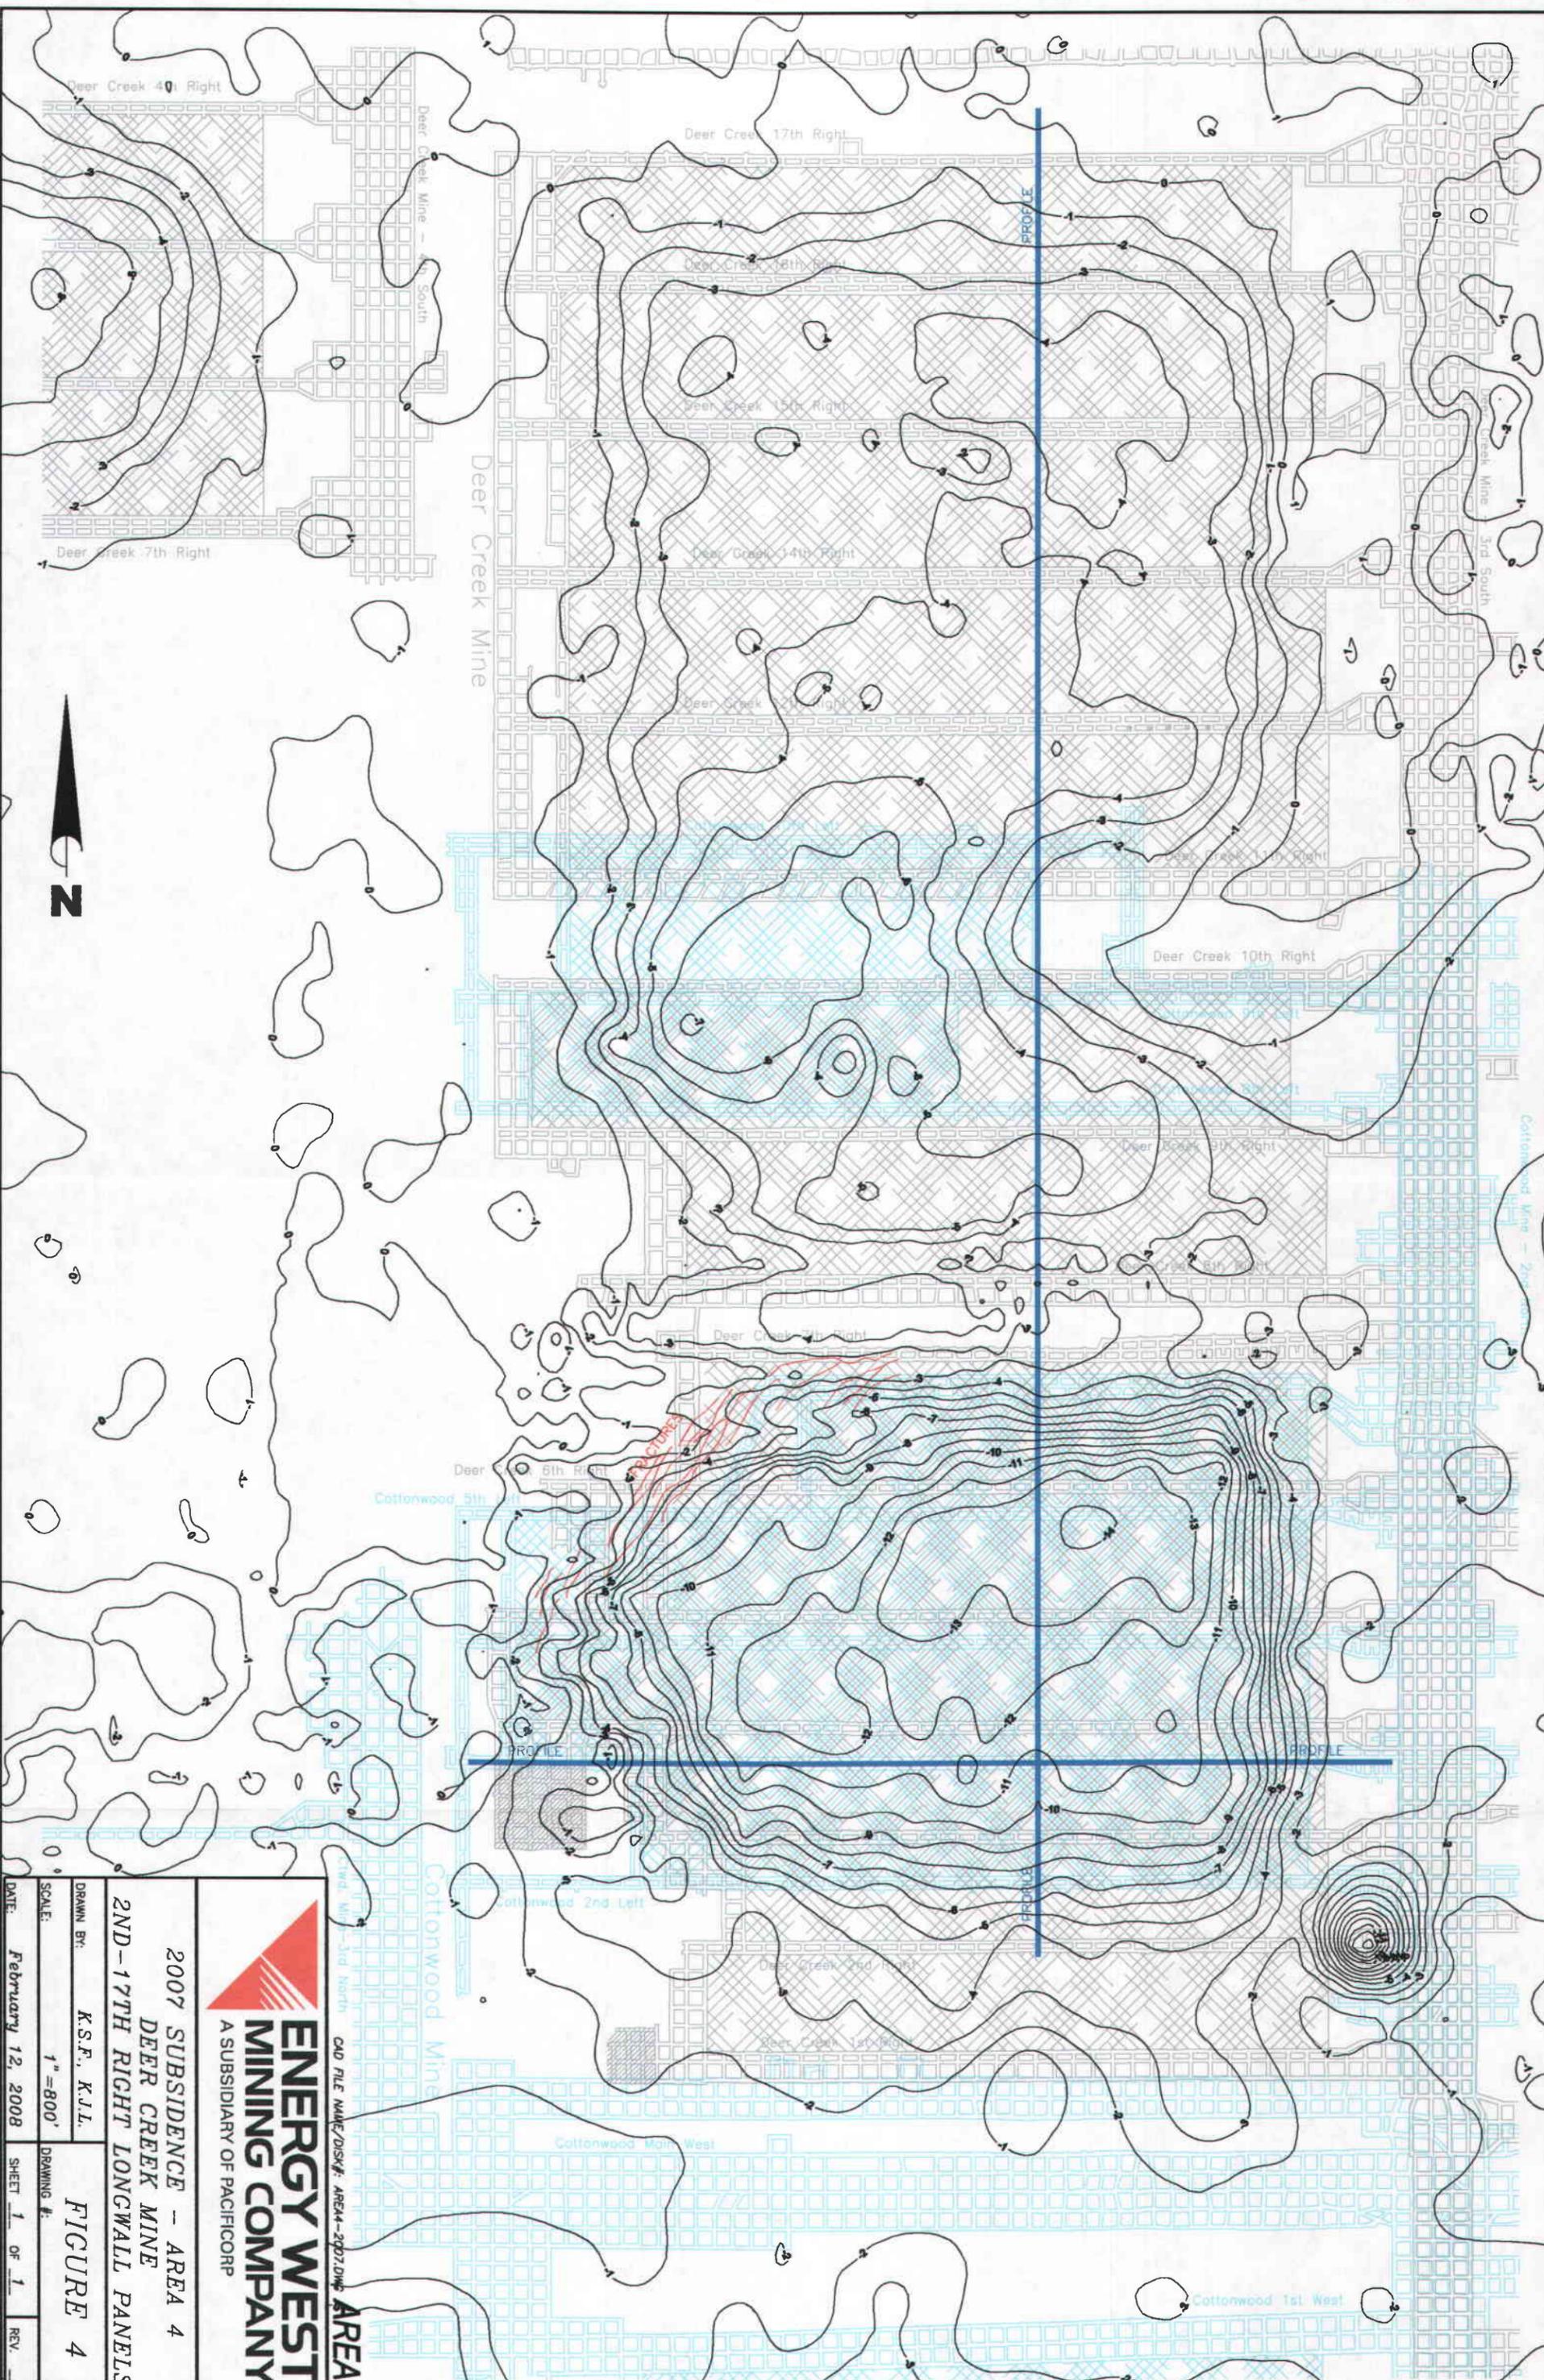
ENERGY WEST MINING COMPANY A SUBSIDIARY OF PACIFICORP	
2007 SUBSIDENCE - AREA 4 DEER CREEK MINE 2ND-17TH RIGHT LONGWALL PANELS	
DRAWN BY: K.S.F., K.J.L.	FIGURE 4
SCALE: 1" = 800'	DRAWING #:
DATE: February 12, 2008	SHEET 1 OF 1
	REV.

Maximum subsidence increased dramatically between 1994 and 1995, from eight feet caused by mining in Deer Creek to over thirteen feet (Figure 4) due to the additional mining in the Hiawatha seam in Cottonwood Mine. The subsidence has been virtually unchanged between 1995 and 2007 as shown in the subsidence profile charts (Charts 2 & 3).

Surface fractures were identified in the field in late May of 1995. These fractures were located on fee (privately owned) surface. Energy West filled in the fractures with a motor grader and reseeded the area. The location of the fractures is shown on Figure 4. The revegetation in these areas is now established and no further fracturing has been

The calculated angle-of-draw of the subsidence ranges from less than zero to 22 degrees. Several springs are located on East Mountain above these longwall panels and the 2nd through 5th Left panels located directly to the east (see Area 5). Fluctuations in spring flow occur from year to year but are to be related to variations in precipitation rather than mining. Flows are generally low in dry years and higher in wetter years (see Hydrologic Monitoring Report, 2007).

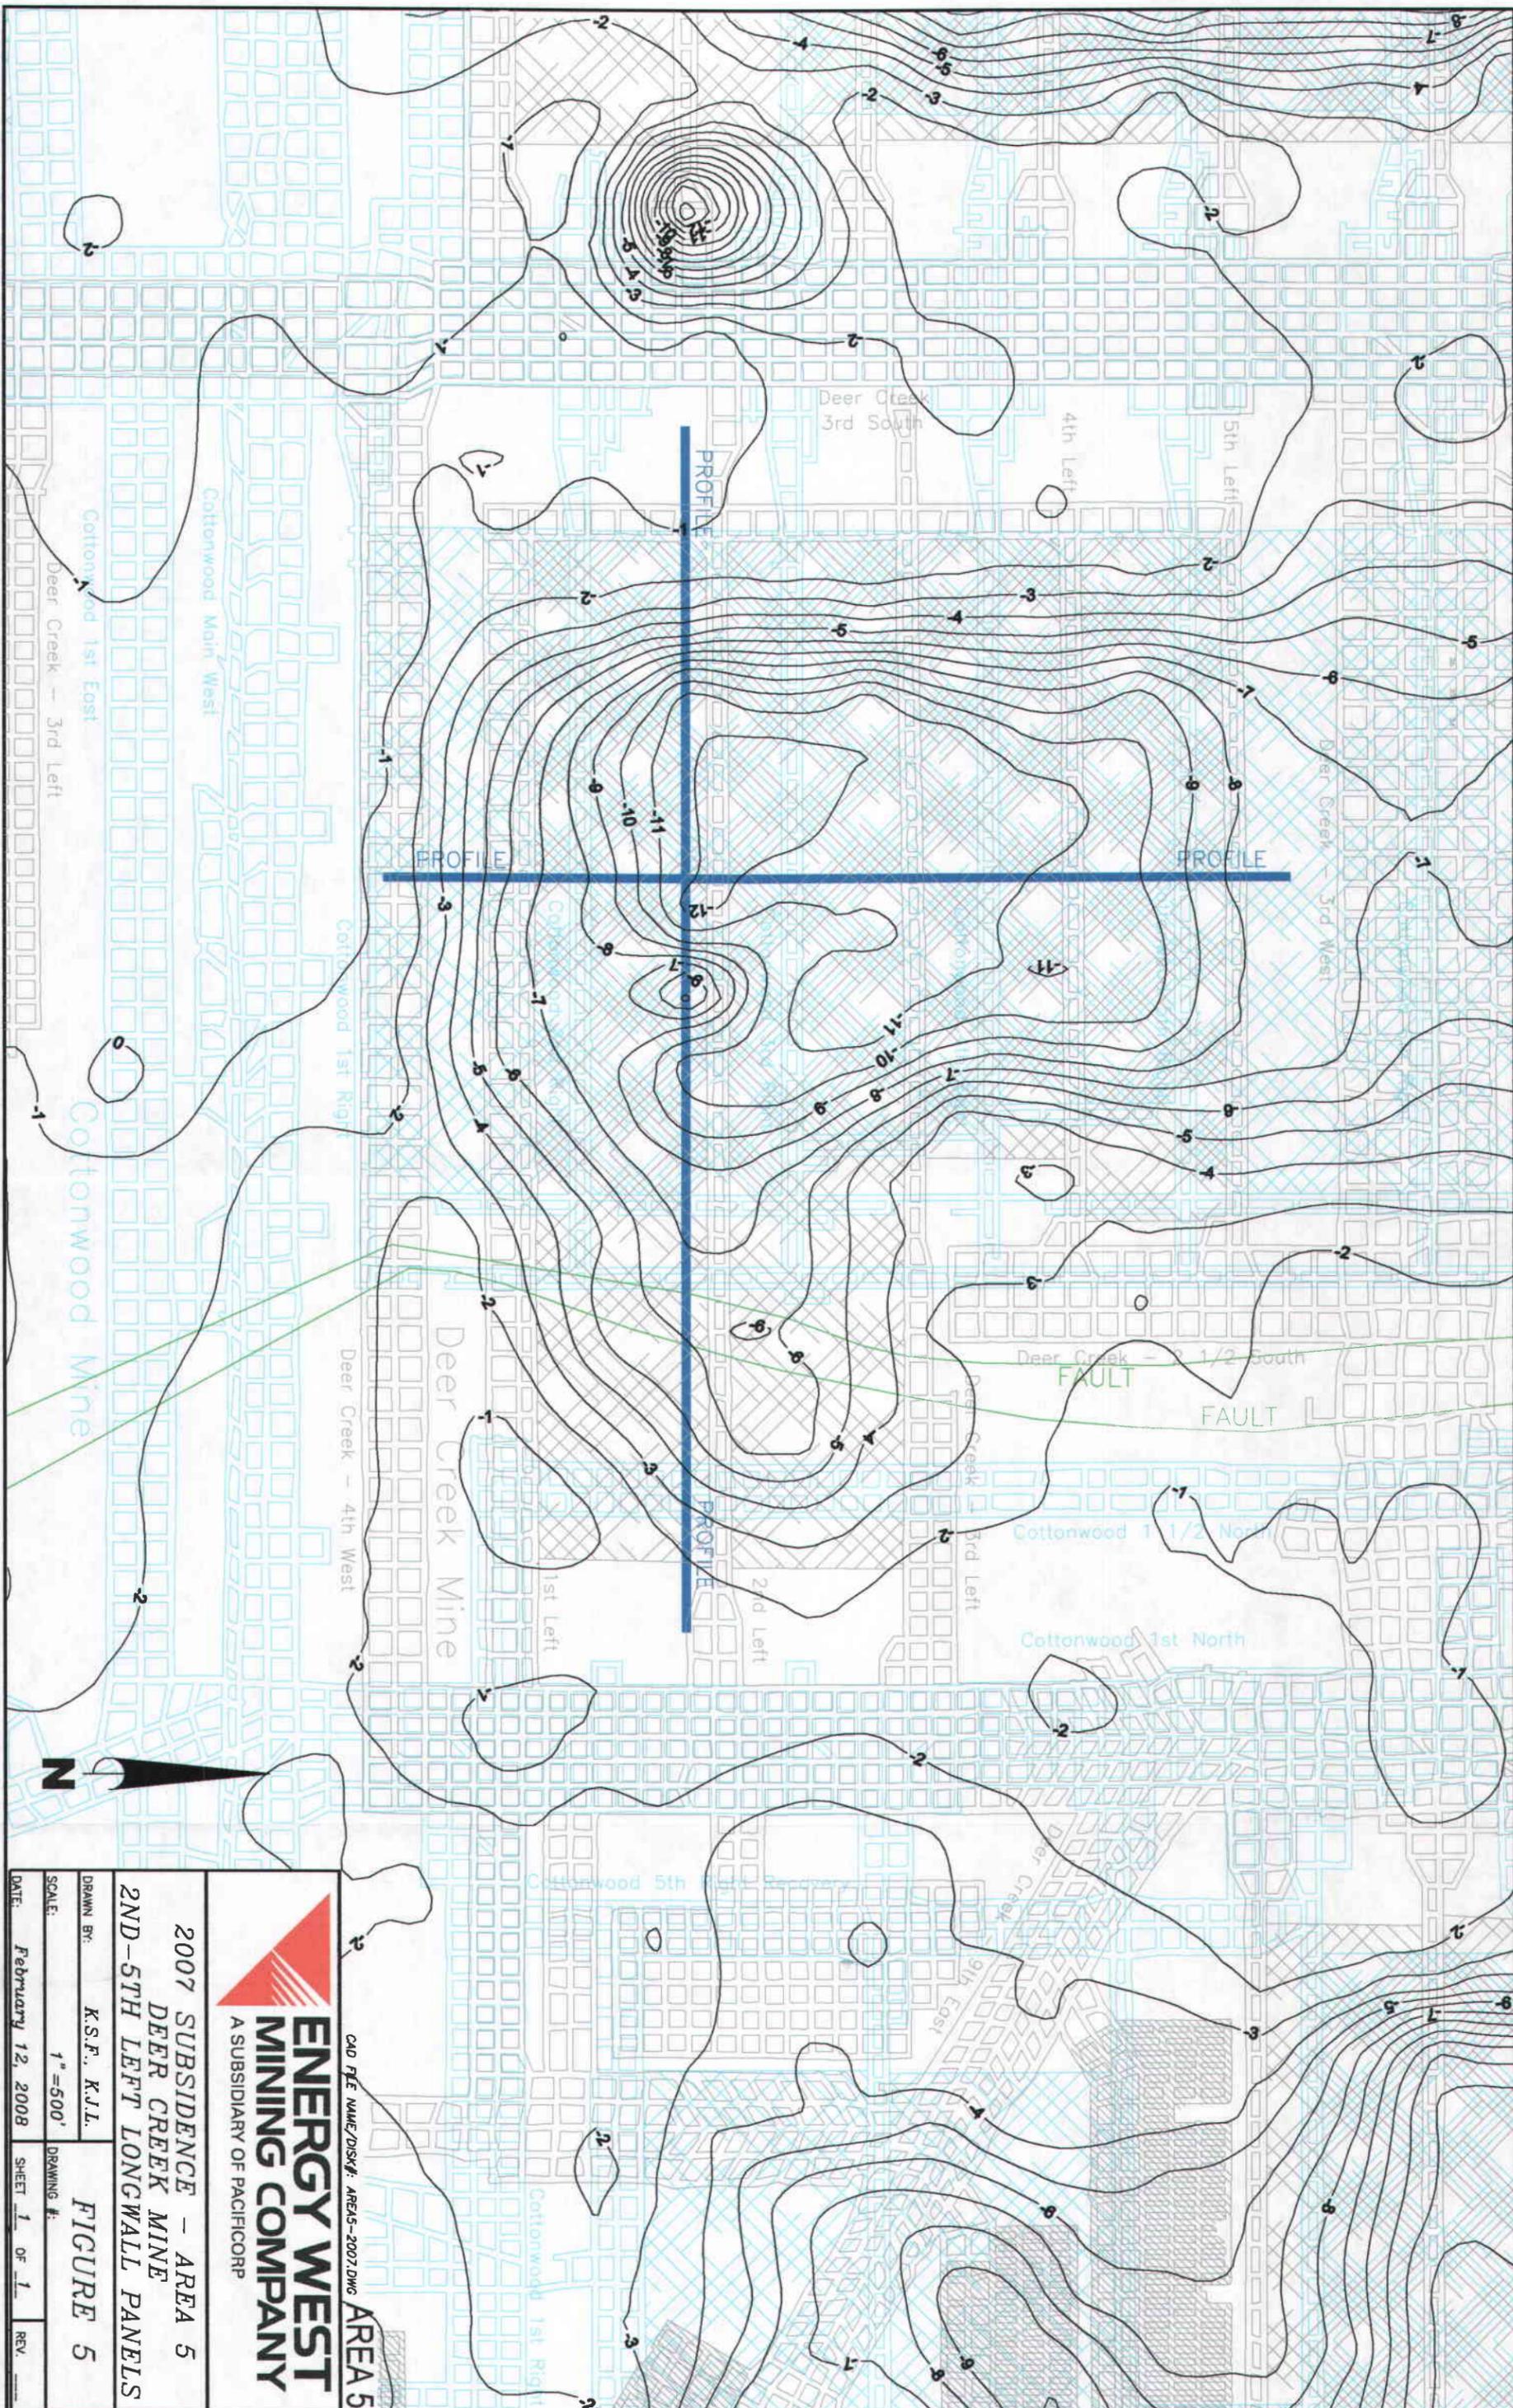
2007 SUBSIDENCE - AREA 5
 DEER CREEK MINE
 2ND-5TH LEFT LONGWALL PANELS

Maximum subsidence over the panels is slightly greater than thirteen (13) feet where both seams have been mined (Figure 5). The maximum subsidence showed a substantial increase between 1993 and 1994 but showed slight change between 1994 and 1998. The 2007 monitoring showed virtually no change as compared with the 2006 data (see the Profile Charts 4 & 5 for Area 5). No surface disturbance has been identified over the panels.

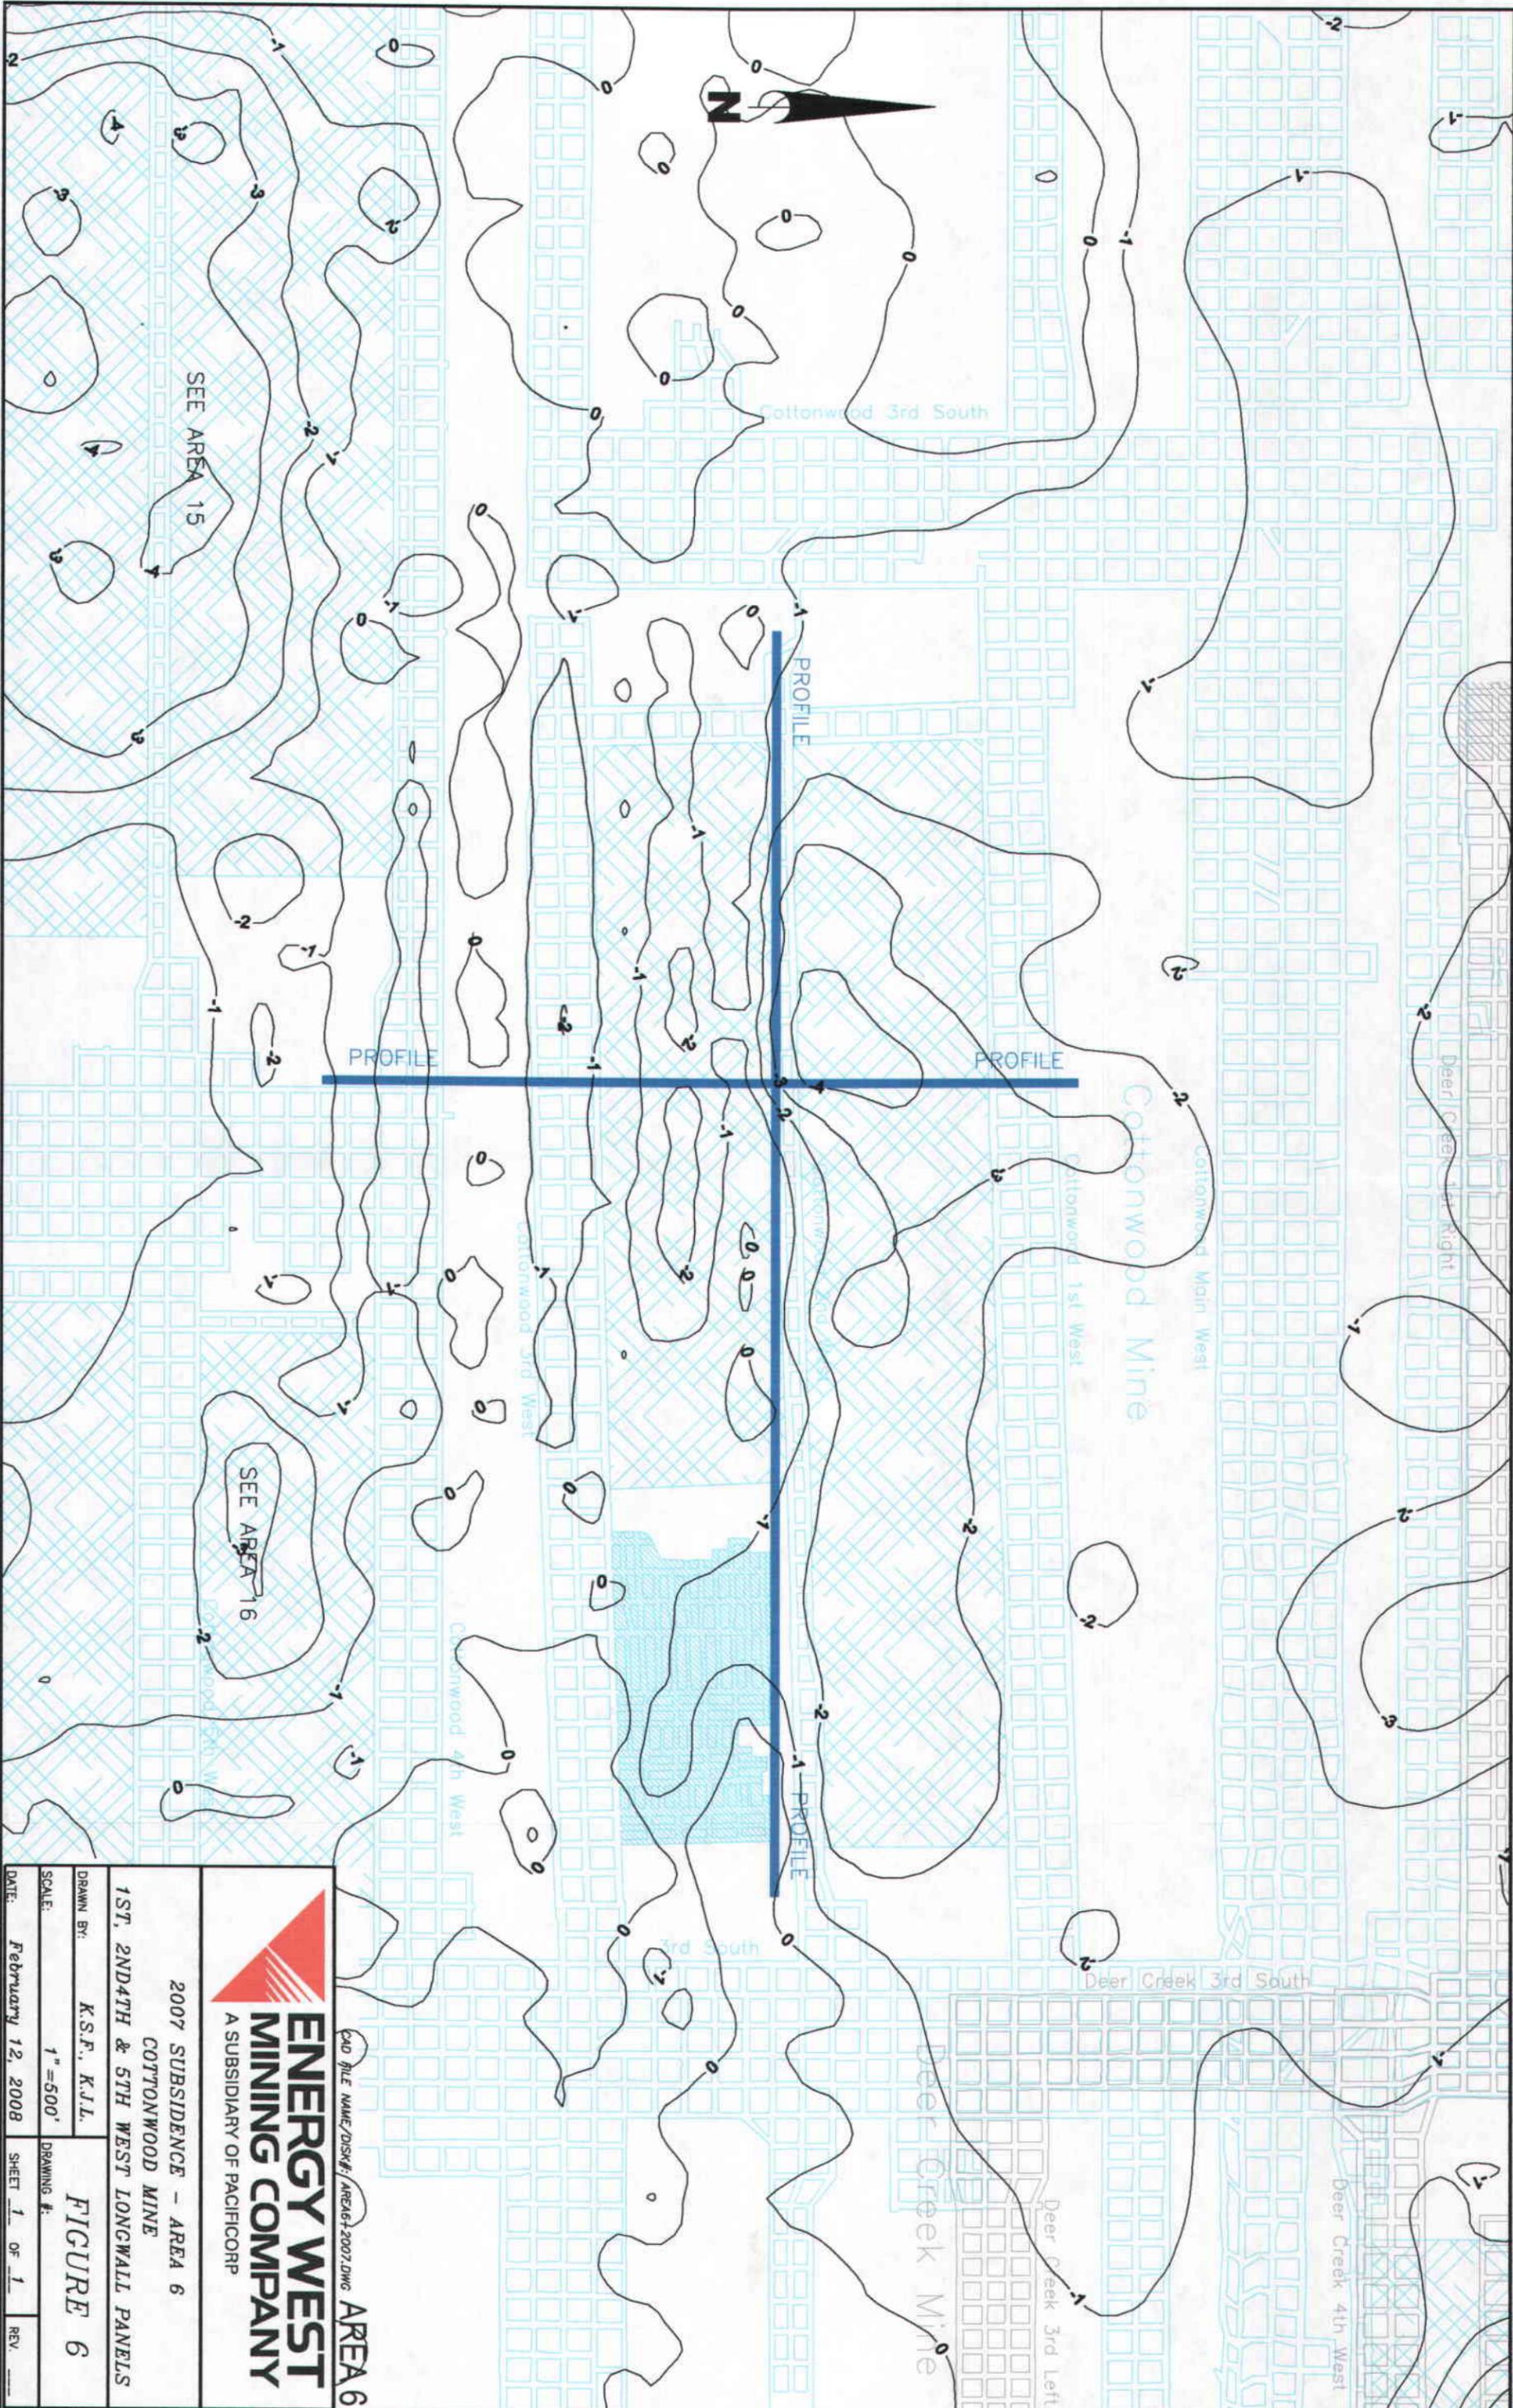
2007 SUBSIDIENCE - AREA 6
 COTTONWOOD MINE
 1ST, 2ND, 4TH & 5TH WEST LONGWALL PANELS

Mining in the Wilberg 1st and 2nd West longwall panels was completed in June 1983 (Figure 6). This area of subsidence reached a maximum of between four and five feet over the Second West Longwall Panel (Figure 6). The subsidence profile charts (Charts 6 & 7) for Area 6 show the change in subsidence since 1983.

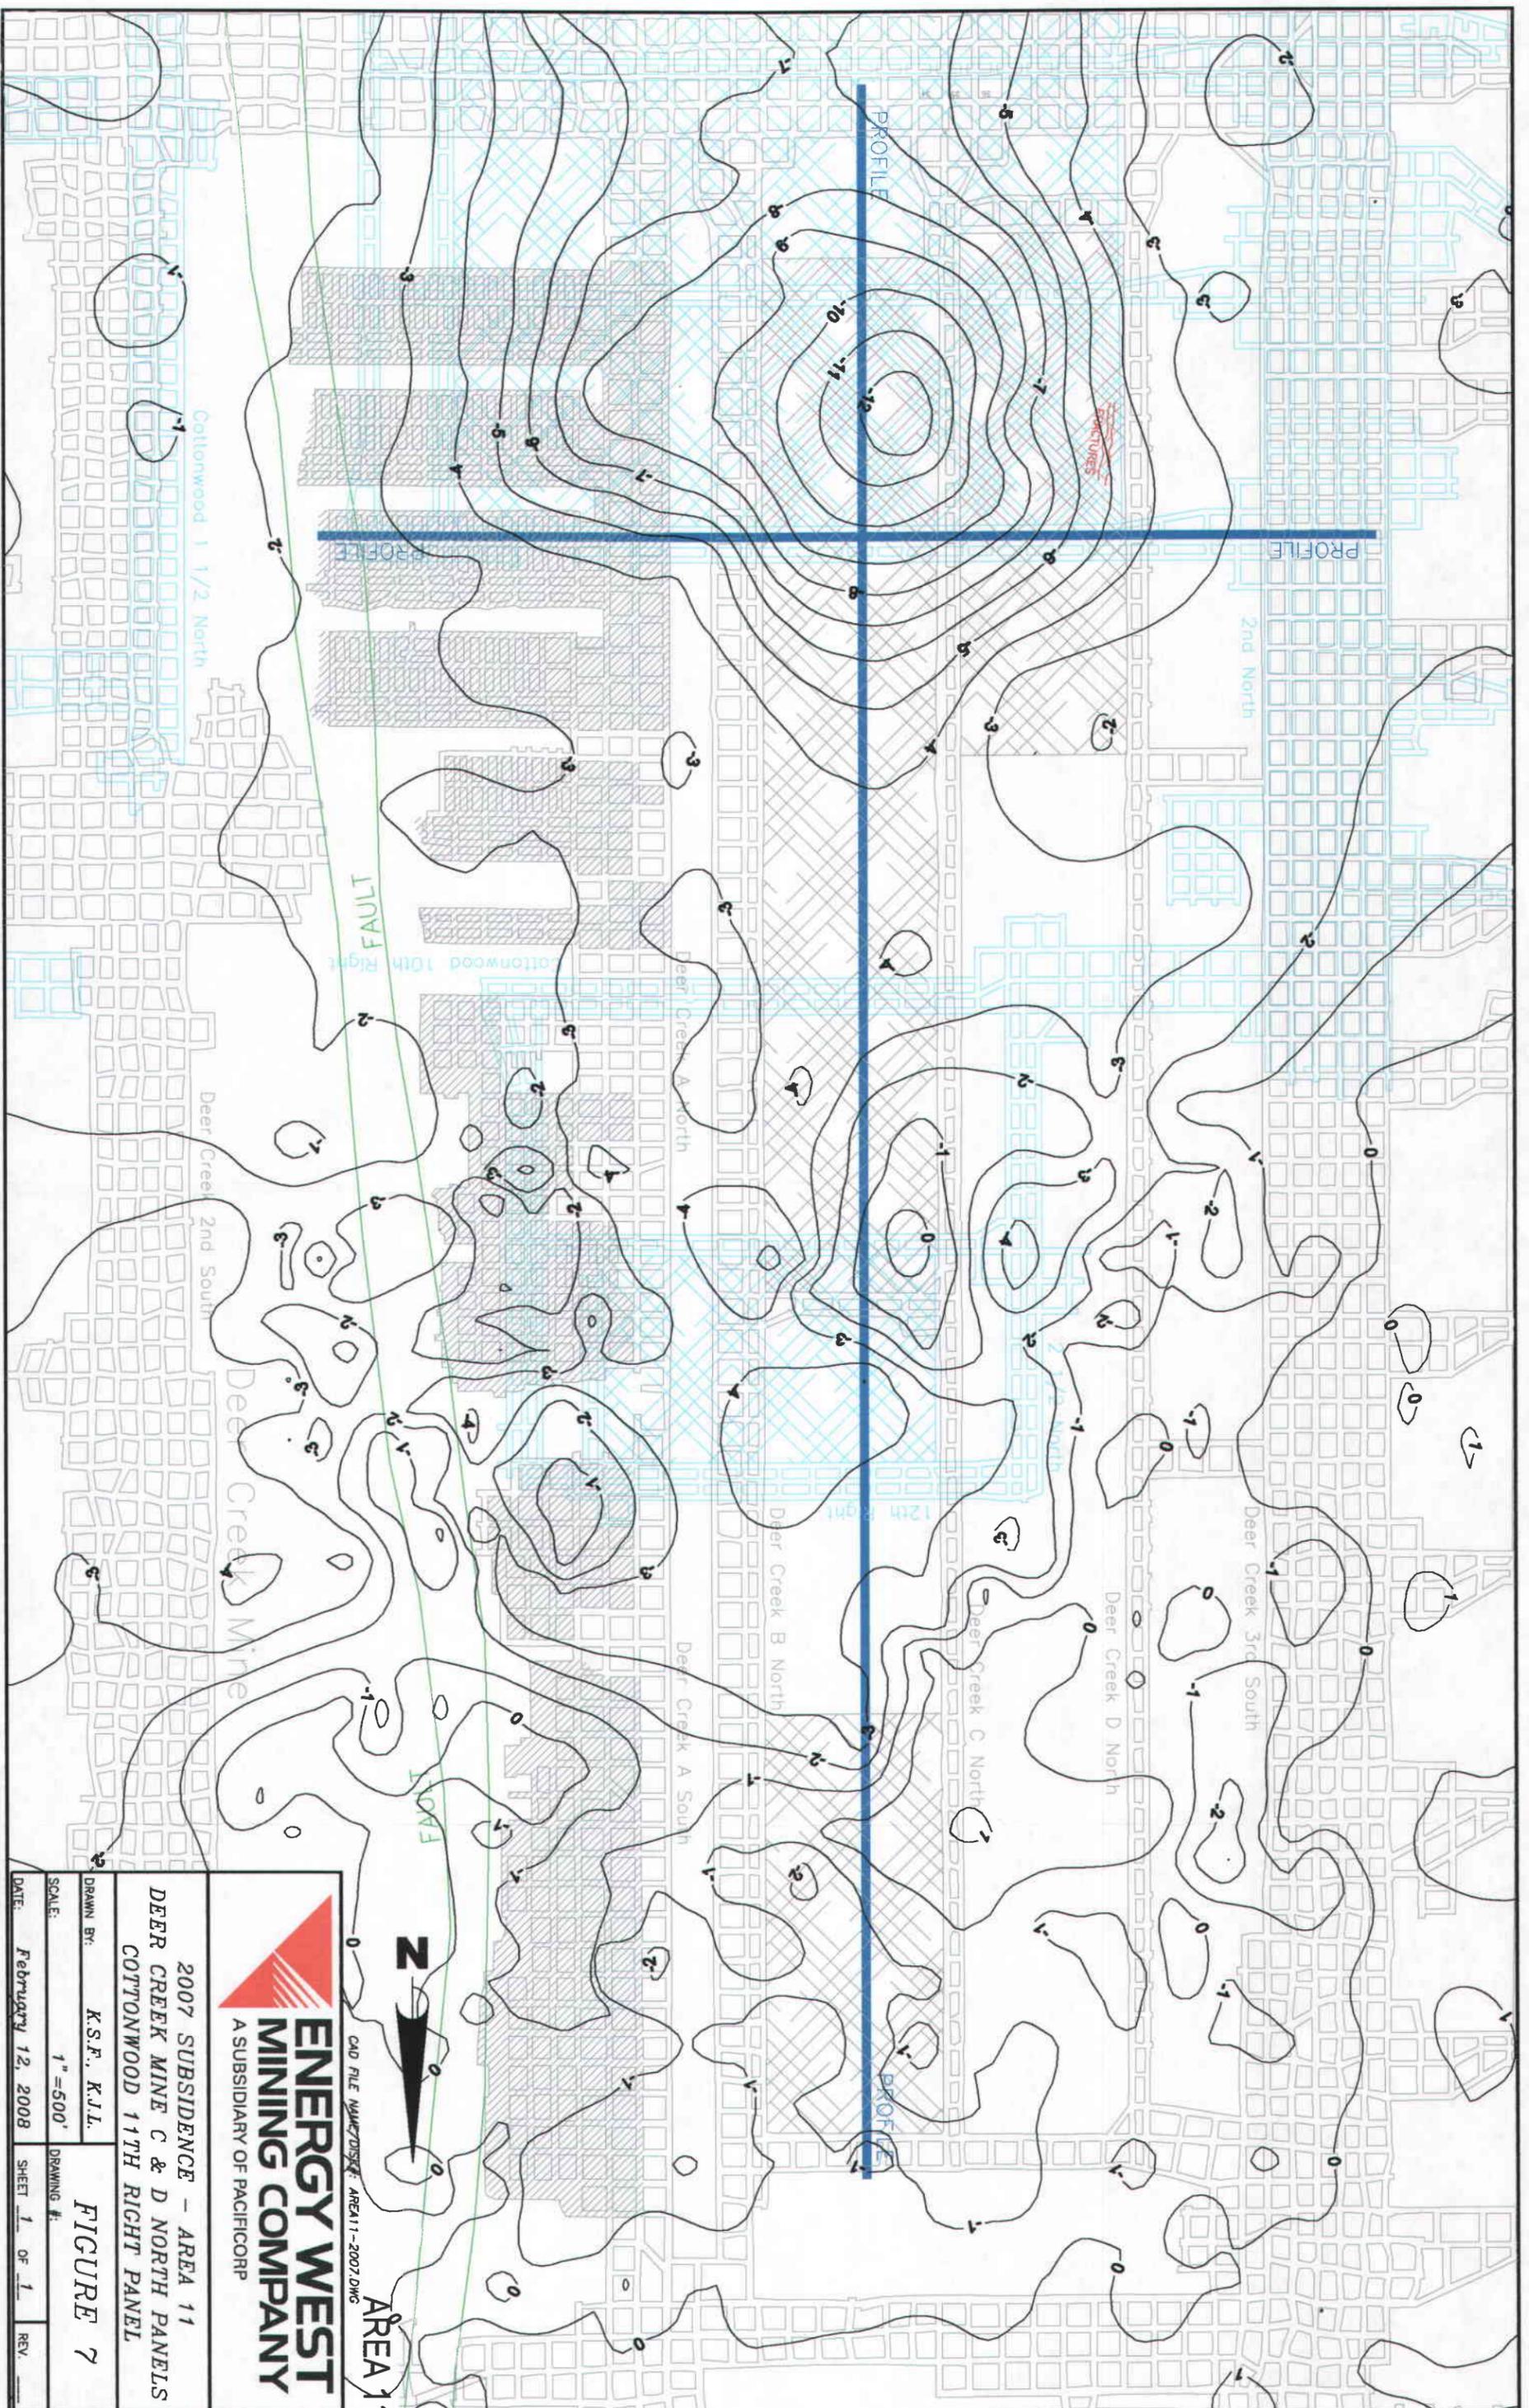
Measurable subsidence to date has exceeded twelve (12) feet in the area of dual seam mining above the 6th and 7th Right Longwall Panels in the Cottonwood mine (Figure 7). The maximum subsidence showed an increase between 1993 and 1994 but has been stable since 1994 (see Profile Charts 8 & 9 for Area 11).

Fractures were discovered at the western end of coal extraction above the 7th Right Longwall Panel on June 17, 1993. Mining of the longwall panel was completed on May 12, 1993. An aerial reconnaissance of the area on May 18, 1993 revealed no surface fractures at that time. This places the occurrence of the fractures between May 18, 1993 and June 17, 1993. PacifiCorp reclaimed the fractures in fall of 1995. Burnt Tree Spring is located approximately 800 feet to the southeast of the fractures. Measurements of the spring discharge throughout the summer of 1993 through 2007 indicated that the fracturing had no effect on the spring. The angle-of-draw measured ranges from less than zero to 28 degrees.

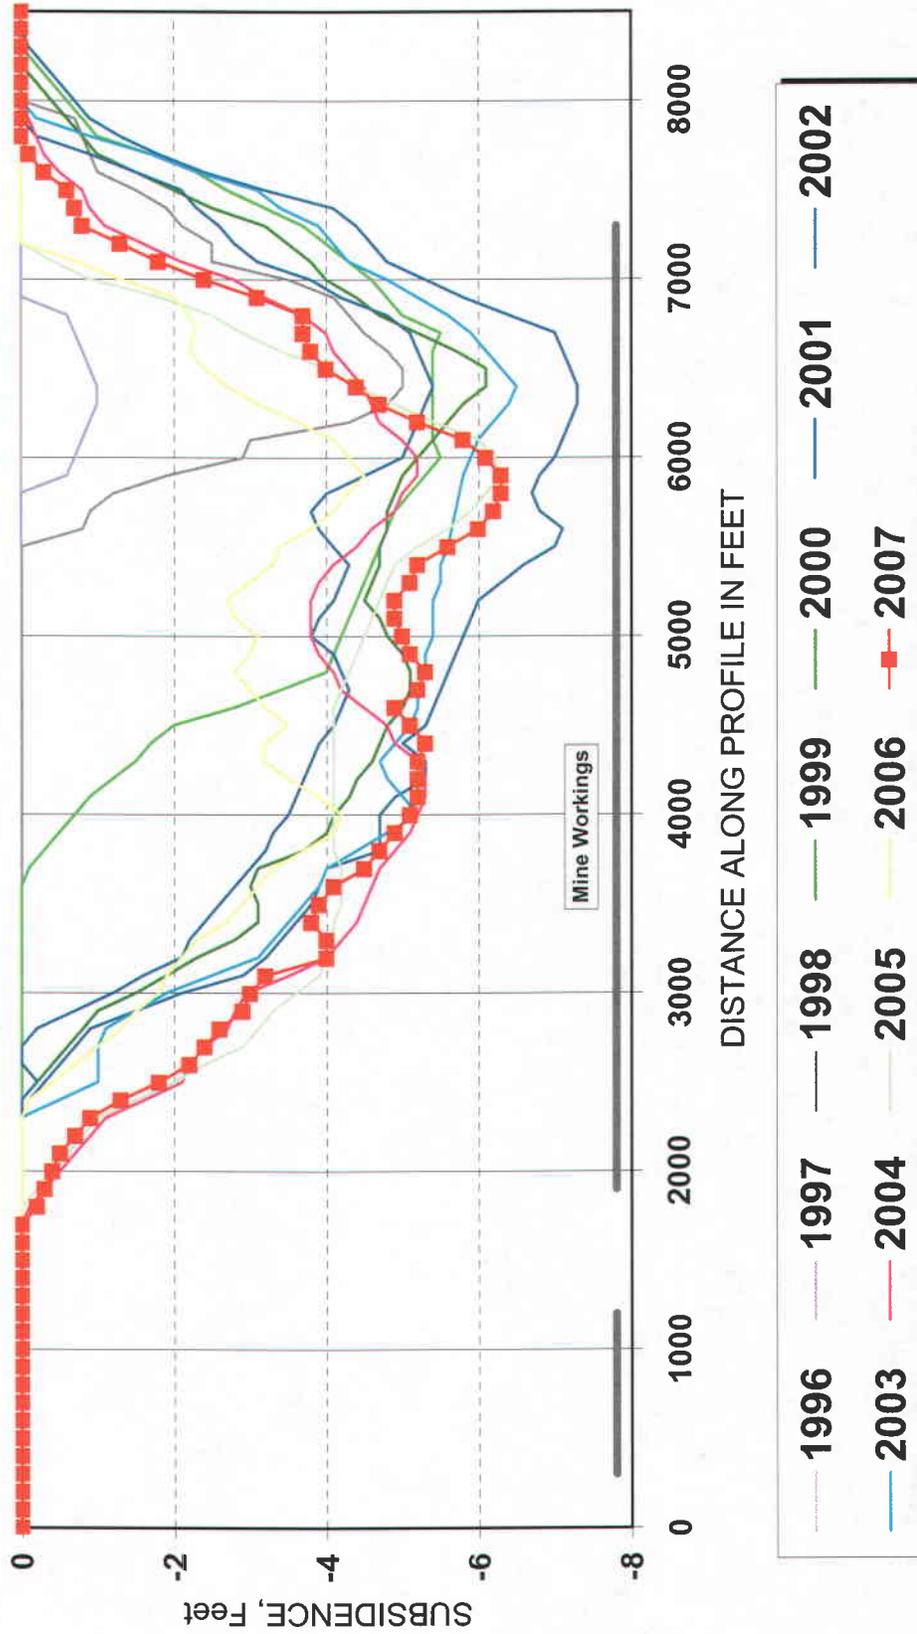
Chart 22

The subsidence monitoring showed a steady increase in subsidence from 1997 through 2001 (Profile charts 22, 23). A small group of fractures appeared on the surface above 4th Right panel in October 2000. These were already partially “healed” or filled in when noticed. Aerial reconnaissance in June, 2008 and a surface inspection in August, 2008 was unable to locate these fractures. The subsidence profiles for 2007 are very similar to previous years, indicating that subsidence in this area is essentially complete. No subsidence was detected over the single panel 1st Right. The majority of detectable subsidence at the surface has occurred within the outline of the longwall panel area, indicating an angle-of-draw nearly vertical. The subsidence that has occurred has not had any effect on the current land use or on the hydrology of the area (see 2007 Annual Hydrologic Monitoring Report).
