*Annual Subsidence Monitoring Report
East/Trail Mountain Properties
2007*

August 2008

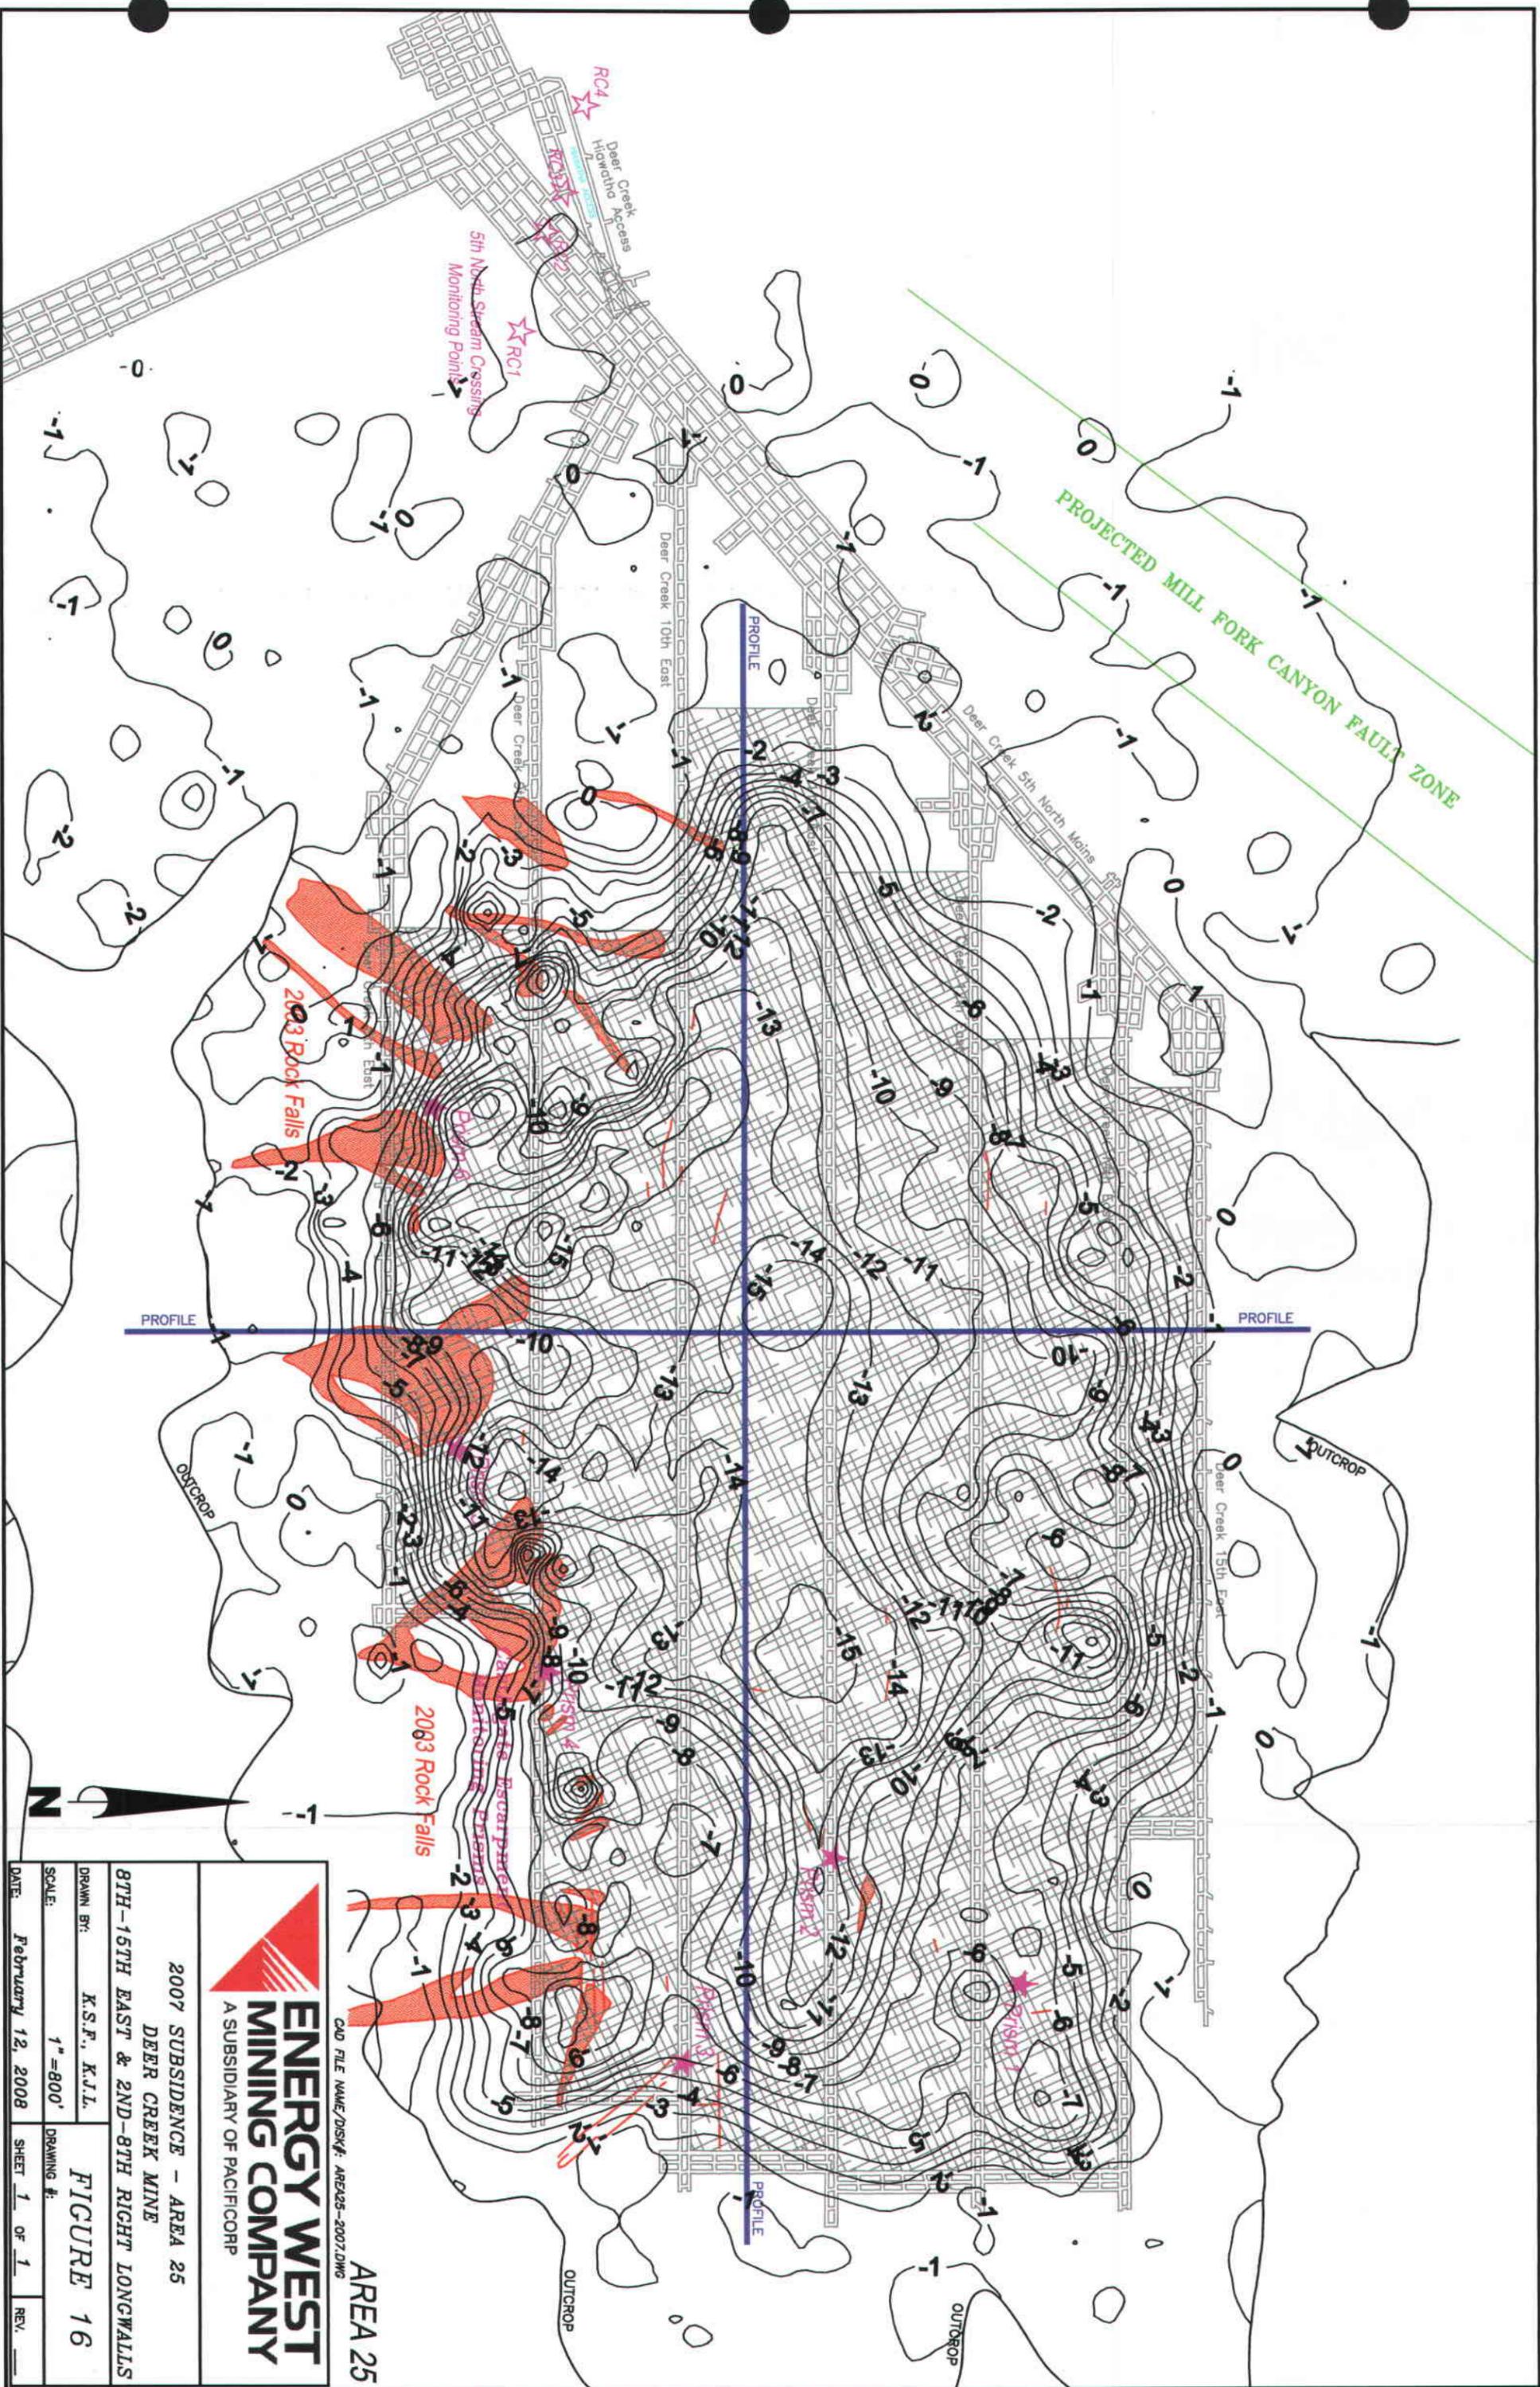
Several Castlegate escarpment failures and rock falls occurred as 9th and 8th East panels were mined in the Blind Canyon seam during the spring, summer, and fall of 2002. These are shown on Figure 24. Significant additional rock falls have occurred along the escarpment have occurred as the 4th, 3rd, and 2nd Right panels were mined during December 2002 – September 2003, extending double seam mining under the escarpment area.

Fractures have appeared on the surface of North Rilda Ridge in several places. The first of these was an area where several east-west cracks appeared above and to the south of the dual-seam extraction of 11th and 12th East in the Blind Canyon seam and 5th Right panel in the Hiawatha seam. These cracks are gradually filling in, and are less evident now than they were in 2002.
