Annual Subsidence Monitoring Report East/Trail Mountain Properties 2009

March 2010

Energy West Mining Company
Annual Subsidence Monitoring Report
East and Trail Mountain Properties – 2009

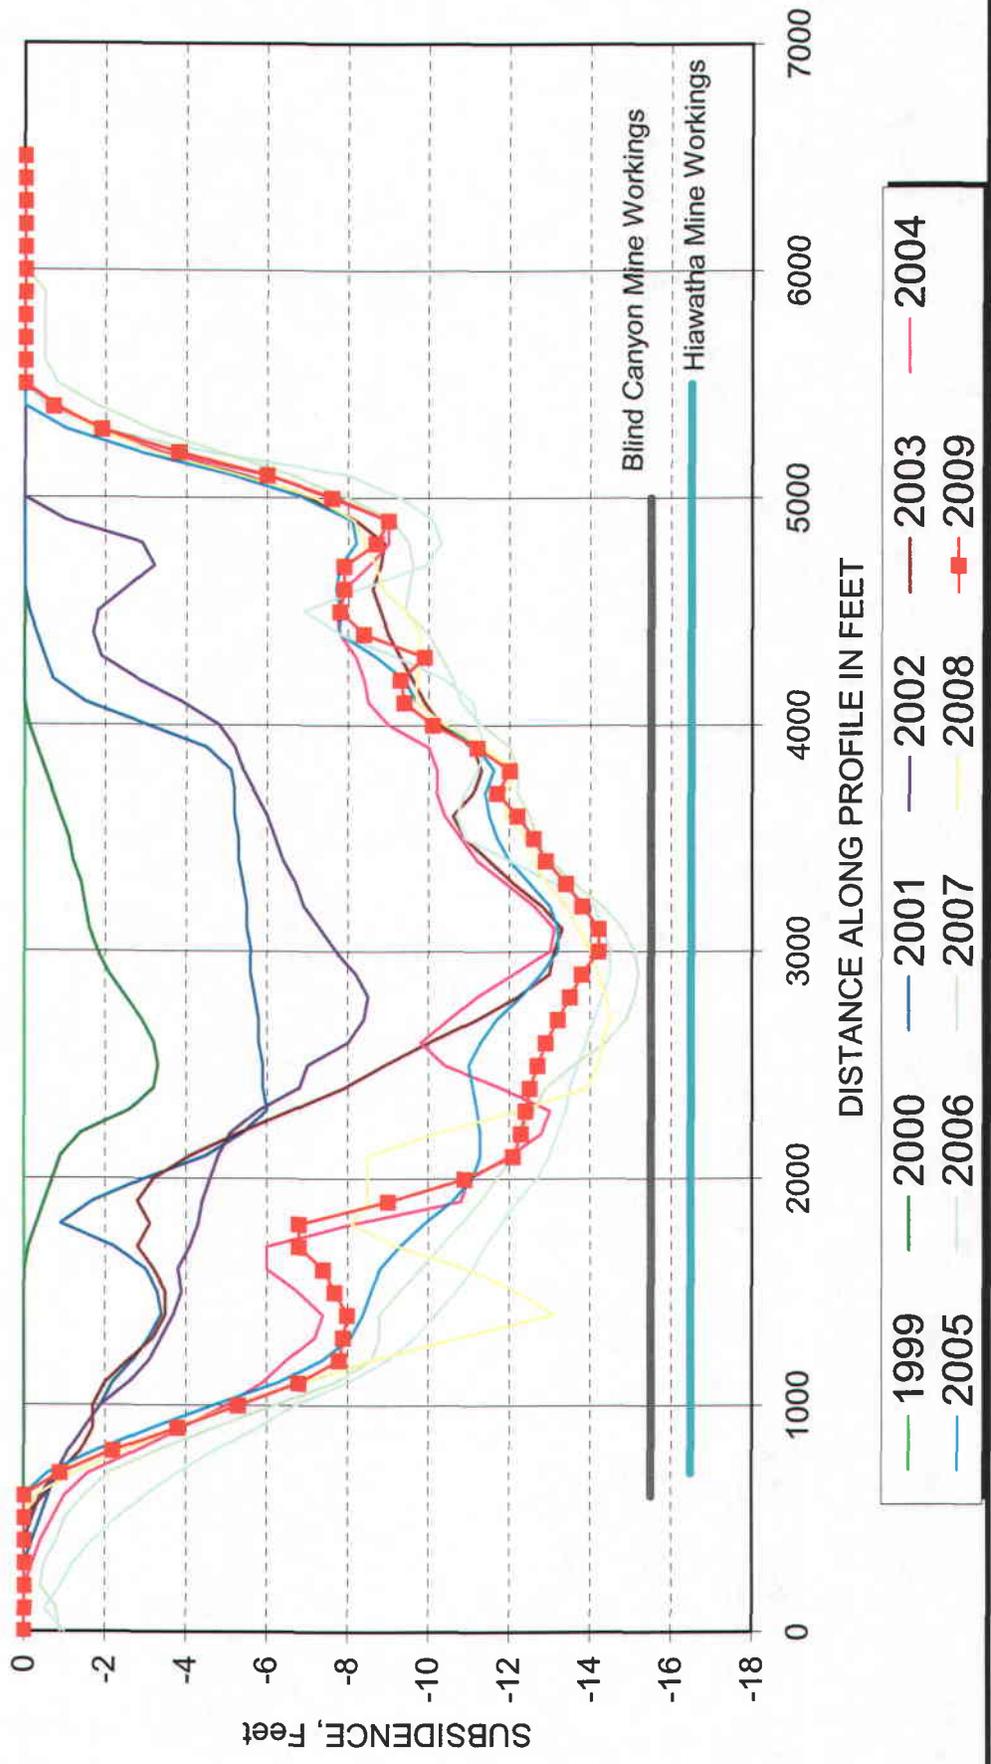
Chart 1

Subsidence monitoring in this area shows that subsidence has occurred under all of the area mined out in the Blind Canyon seam. The maximum amount of subsidence observed for Blind Canyon mining areas is just over 8 feet in the eastern end of 14th East panel. As the underlying 5th, 4th, 3rd, and 2nd Right Hiawatha seam panels were mined in 2002 and 2003, the amount of subsidence over the 2-seam extraction area increased to over 15 feet in the 2-seam mining area. As of 2009, total subsidence has increased gradually to just over 16 feet in several areas of the dual seam overlap. Numerous subsidence “bullseyes” are present in the area of the prominent cliffs on the south-facing side of Rilda Canyon. Two prominent bullseyes that were present in 2005 above 9th East panel were gone in 2006. These are evidently related to cliff movement, boulder movement, and possibly ground cracking and healing in the vicinity of the cliffs.

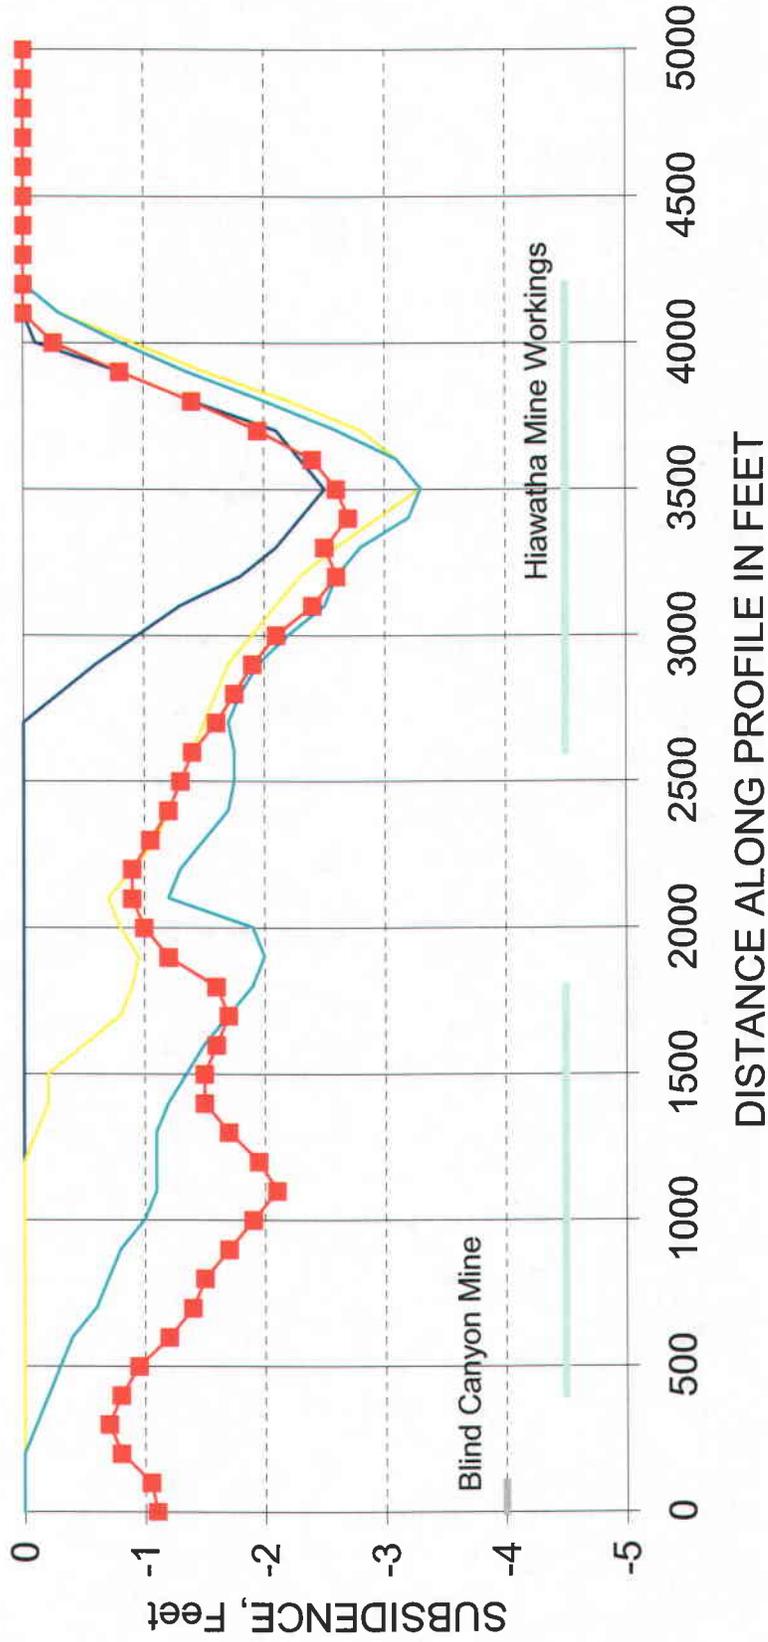
Chart 3

Noticeable subsidence has occurred above the combined areas of 12th through 17th West panels (District 1) as of the date of this report; just over 4 feet total so far (Figure 4, Profile Charts 3 and 4). A sizeable part of the western end of the West-East profile (Chart 4) shows a decrease in subsidence from 2008 to 2009. Subsidence shown in 2009 resembles that of 2007. The reason for 2008 being lower in this area is unknown.

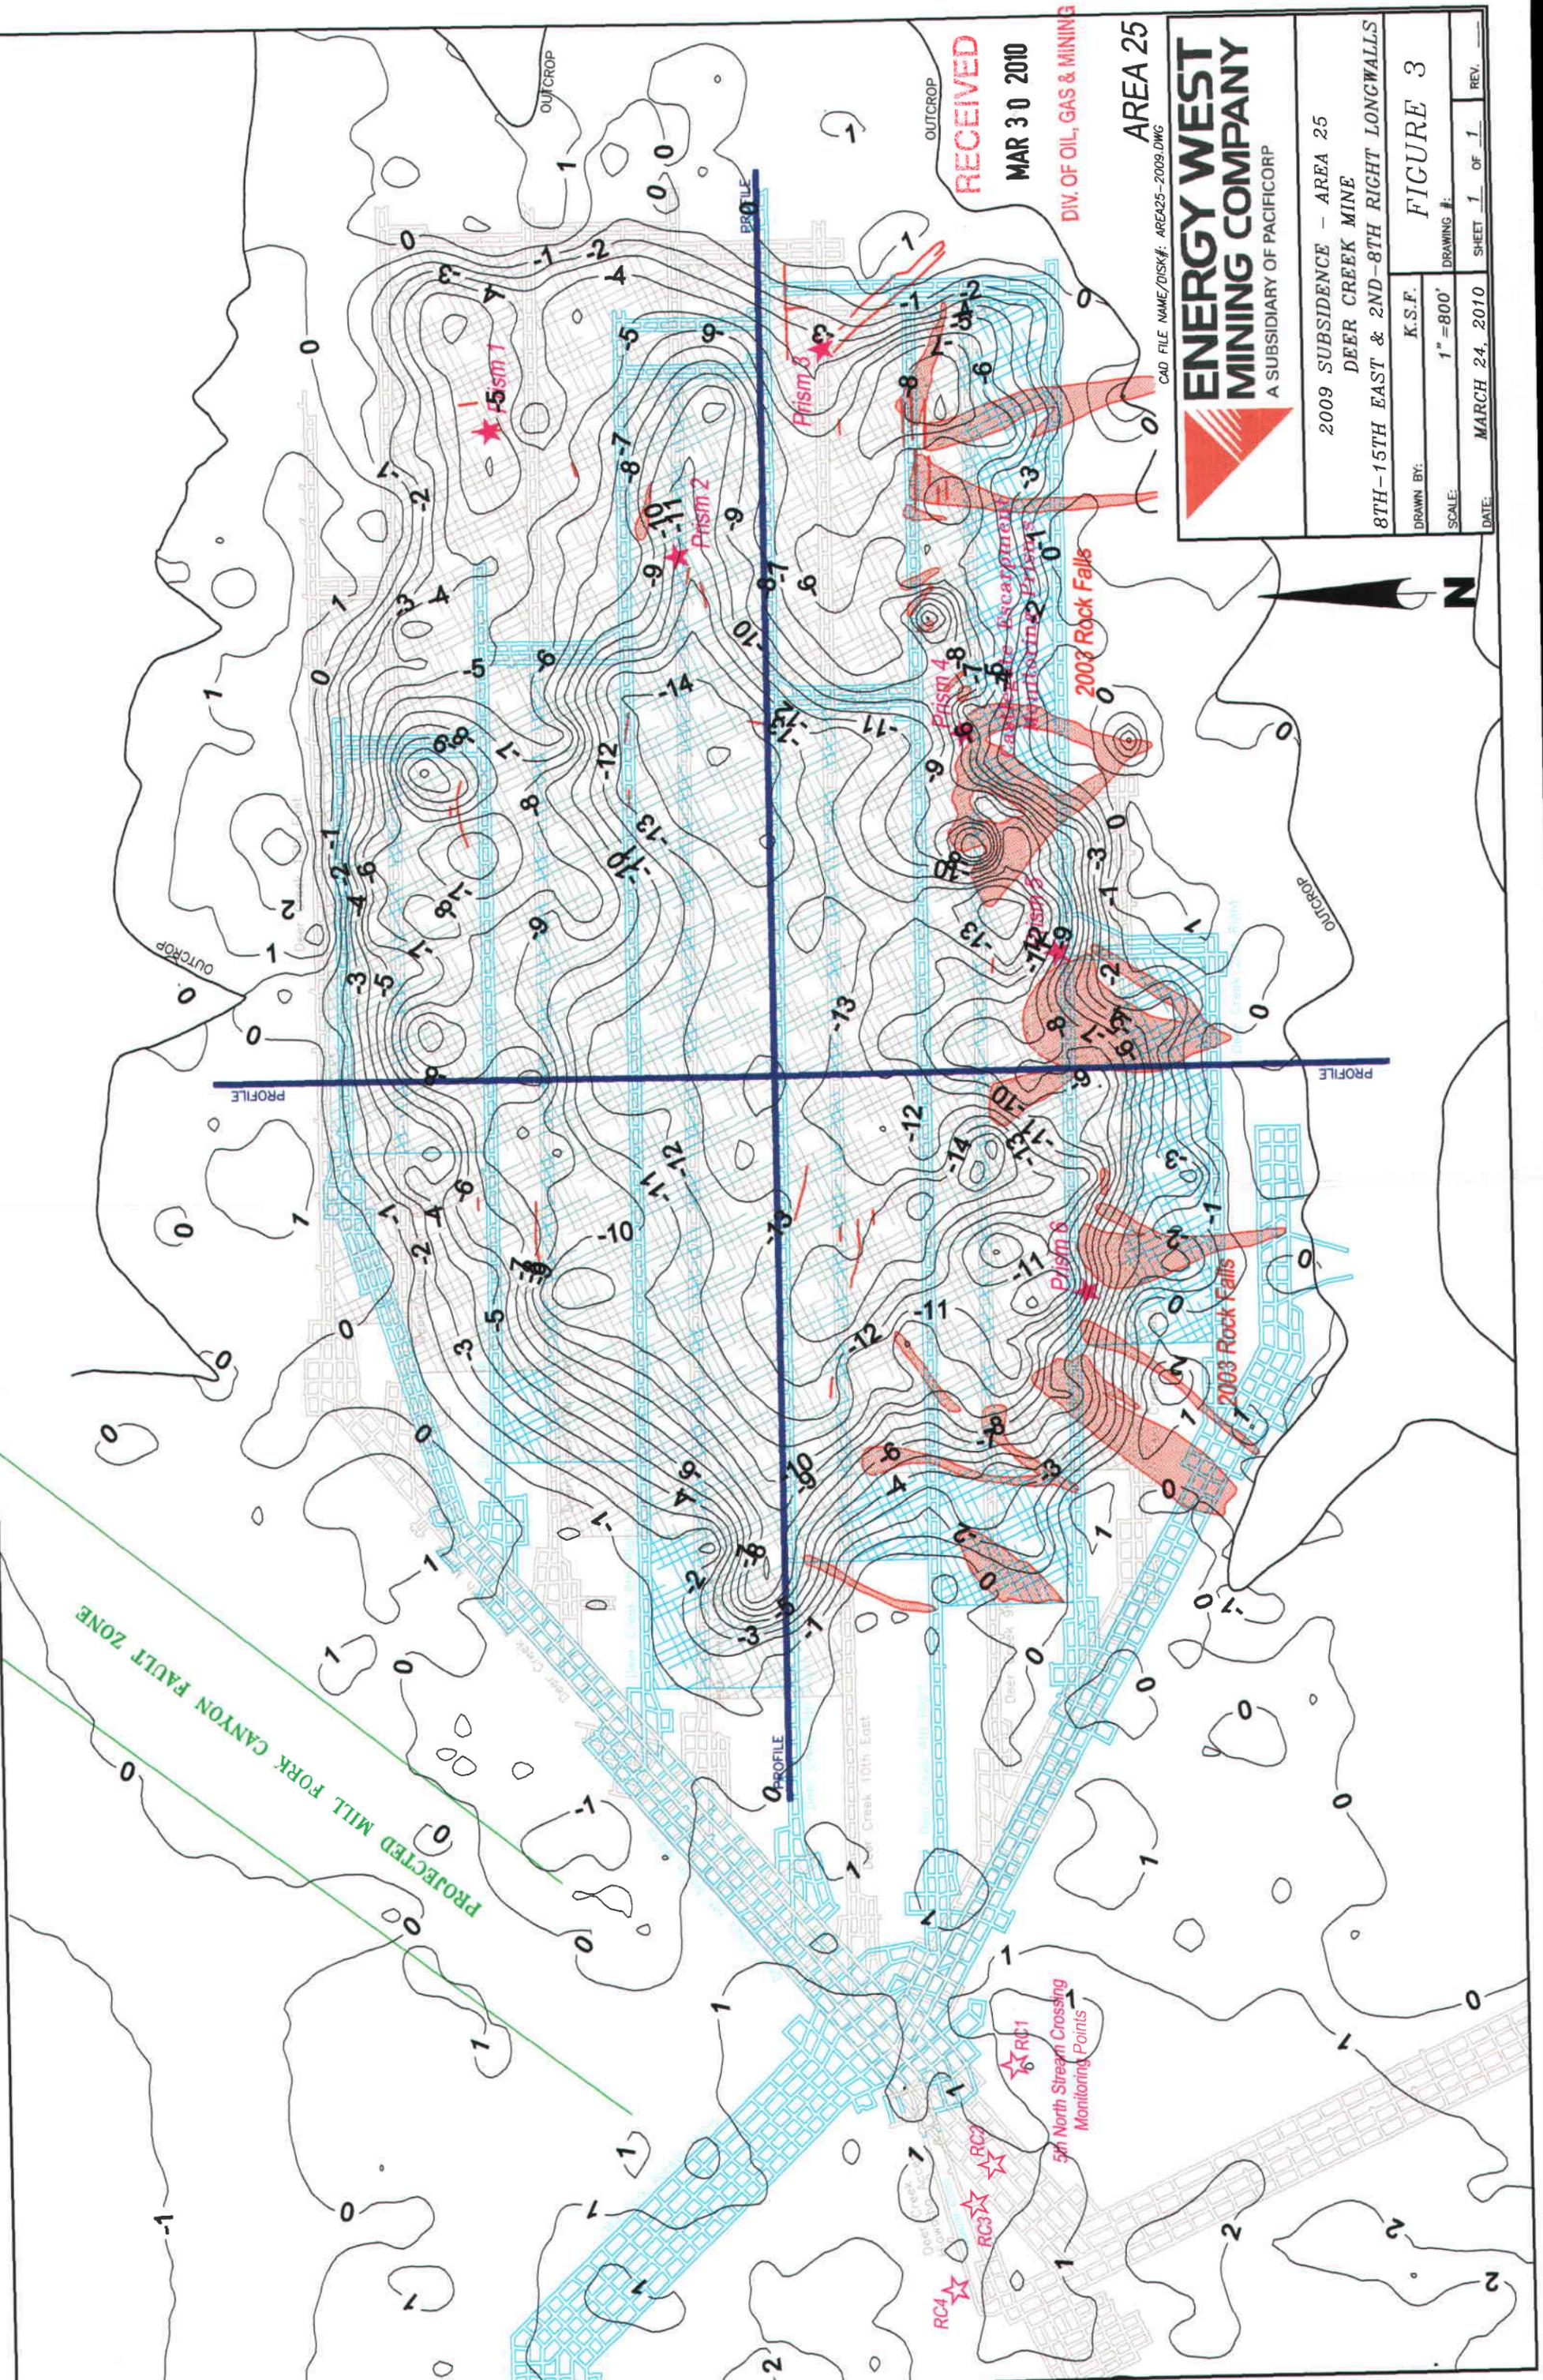
FIGURE 3

Area 25 contains all of the North Rilda Ridge reserves in the Blind Canyon and Hiawatha seams (Figure 3, Profile Charts 1 & 2). This is an area of dual-seam mining. As of September 2004, the Blind Canyon reserves (9th, 10th, 11th, 12th, 14th, and 15th East panels) were completely mined out, and mining of the Hiawatha reserves 80 feet below was complete, with the complete extraction of 2nd Right through 8th Right panels.

Fractures have appeared on the surface of North Rilda Ridge in several places. The first of these was an area where several east-west cracks appeared above and to the south of the dual-seam extraction of 11th and 12th East in the Blind Canyon seam and 5th Right panel in the Hiawatha seam. These cracks are gradually filling in, and are less evident now than they were in 2002.

In the area around the rocky Castlegate point containing Prism #1, above 14th East panel (Blind Canyon, single seam mining area), large north-south cracks opened.

Significant east-west cracking has occurred on and just below the prominent Castlegate point at the east end of the mining area. The 9th East Blind Canyon panel, completely extracted in 9/01, has been undermined by the 3rd Right Hiawatha panel, completely extracted in 1/03.

A large east-west crack crosses a ridge on the north side, above the center of the 14th East Blind Canyon panel and the south edge of the 8th Right Hiawatha panel. Warning signs were placed above and below this crack prior to hunting season on 10/14/03. The most severe portion of this crack was filled in using helicopter supported operations during July, 2004.
