U. S. DEPT. OF THE INTERIOR OFFICE OF SURFACE MINING Mine Site Evaluation State Program

Deer Creek Partial Independent Oversight Inspection
Utah Division of Oil, Gas, and Mining (DOGM) Permit ID # UT-015-018
Wednesday, April 27, 2011, 11:00 a.m. -2:00 p.m.

Operator: Energy West Mining Company

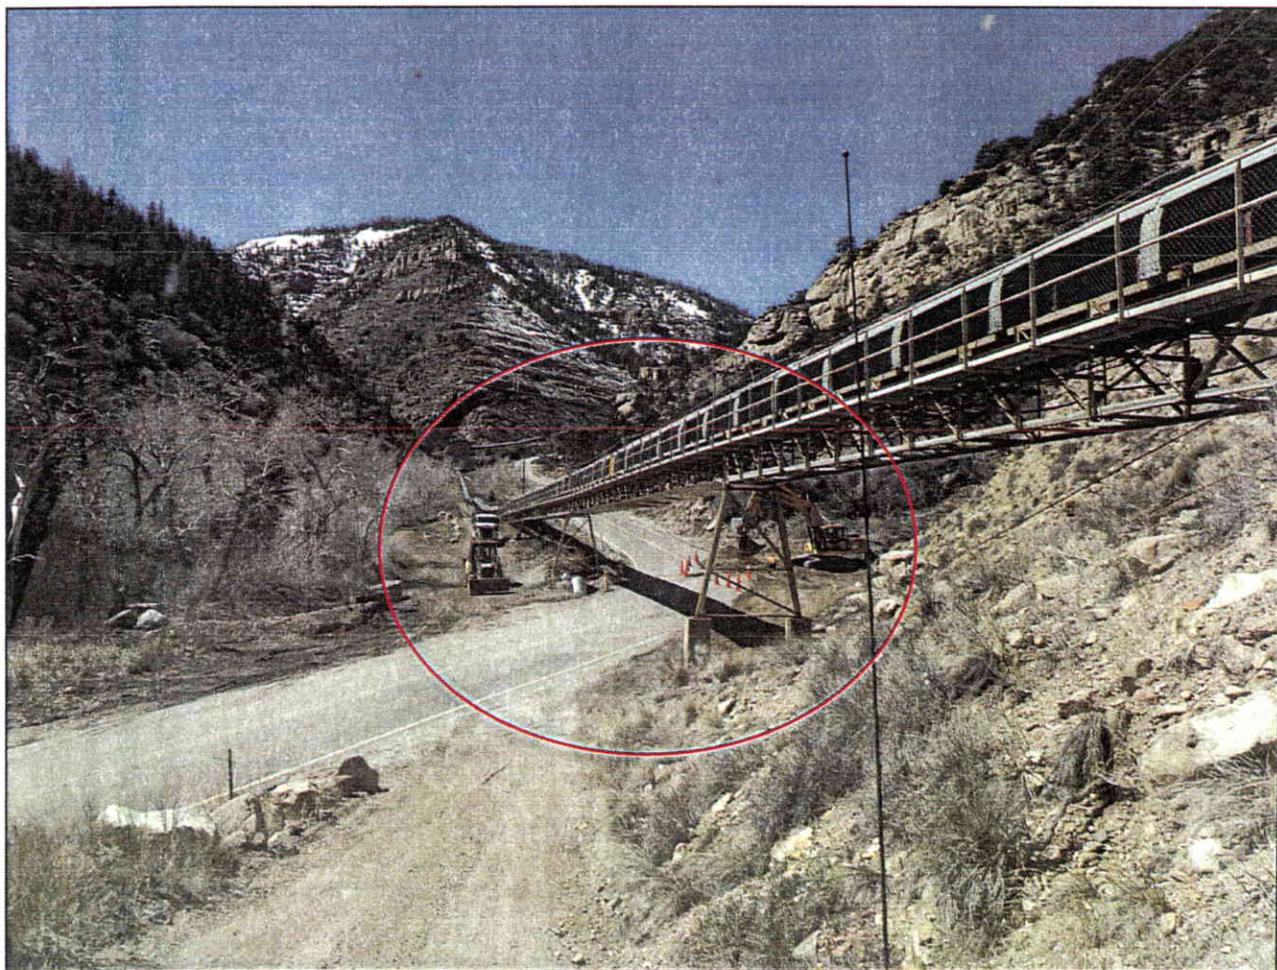
The mine ID signs were intact and contained all of the necessary information at the main facilities, waste rock site, and Rilda Canyon facilities. All roads associated with the mine were well maintained. Recently, a rotted-out culvert pipe that ran underneath the mine access road caused a sinkhole in the road. At the time of inspection, a crew was repairing the road and installing a new culvert. The mining company and the county are sharing the cost of this repair (see Photo 1).

Photo 1 – Road construction associated with culvert replacement

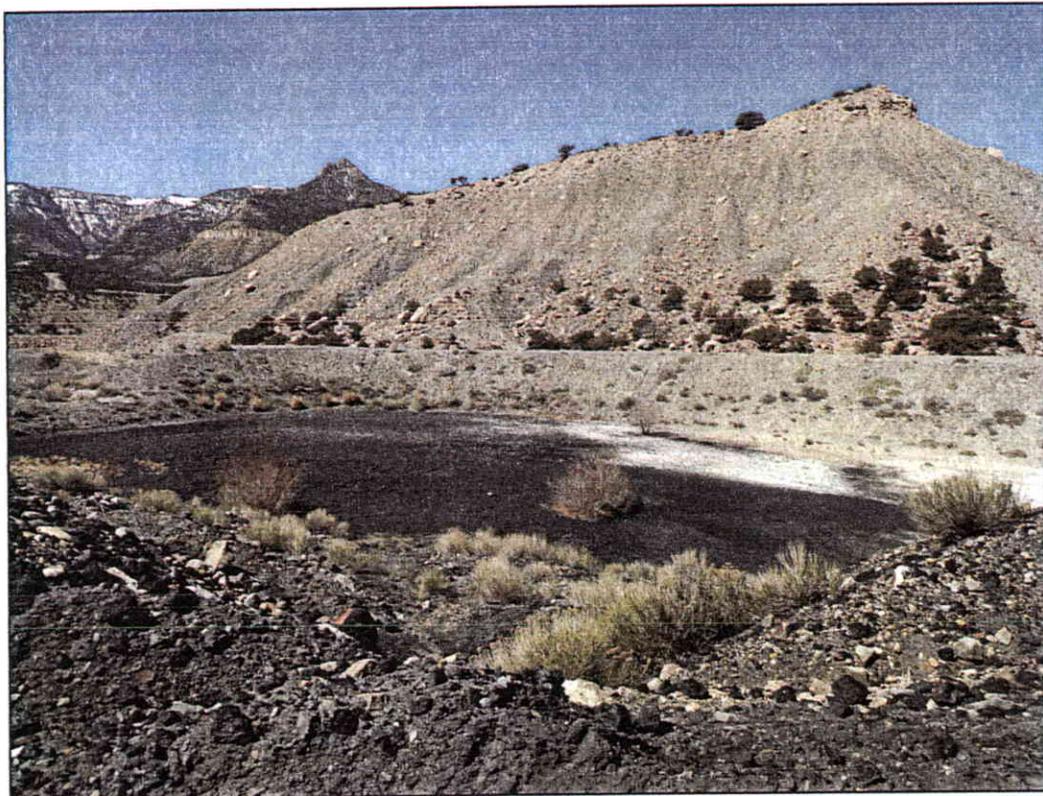
We began our inspection by visiting the waste rock site/refuse pile area. The topsoil along the outslope of the embankment is well established and the silt fences have been removed. Topsoil identification markers are in place. We approached the north and south piles (or cells) which both appeared stable. The north pile appeared to have recently received new material and is approaching its approved maximum capacity (approximately 3 ft available) and should be surveyed soon so that the operator does not exceed the designed limit. There is an area at the top of the north pile that now serves as a pad area for parking (see Photo 2). This pad will be filled in and reclaimed. The runoff from the north pile will continue to drain into the sediment pond below (see Photo 3). At the time of inspection this sedimentation pond was dry and the embankment appeared stable.

Photo 3 – Sedimentation associated with waste rock site, north and south cells

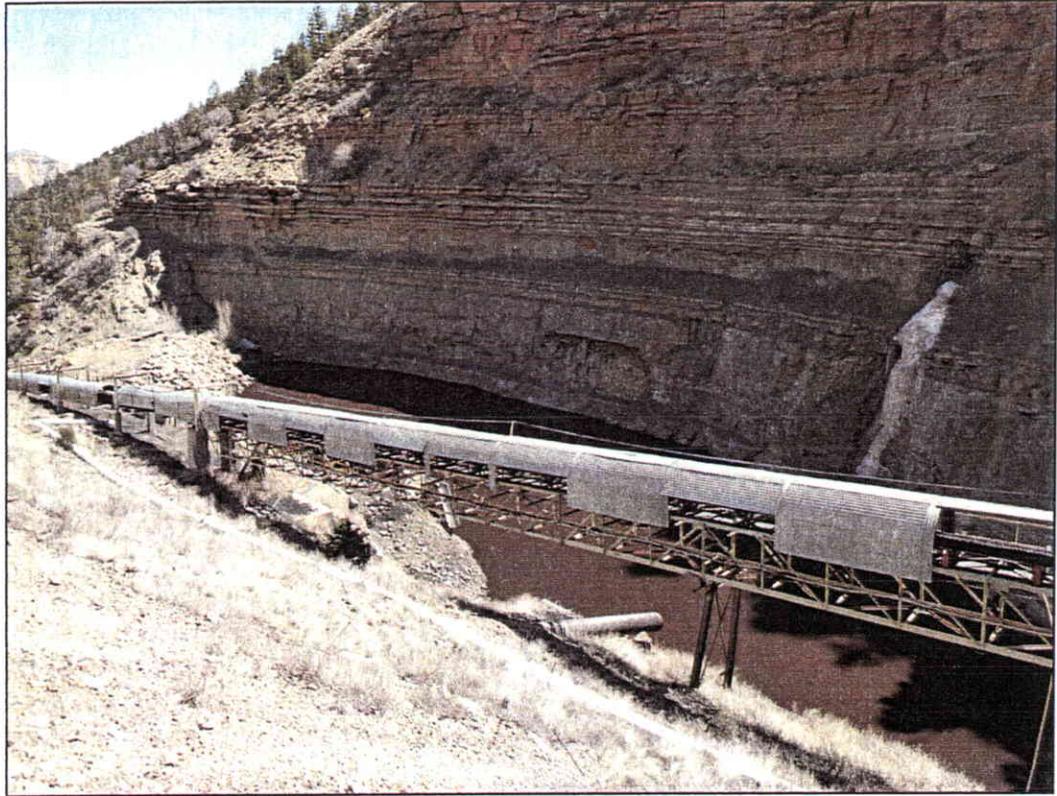
As we approached the tippie, the Run of Mine belt was actively transporting coal through the tippie and into the coal stockpile. Coal fines that go into the main facility sedimentation pond below the tippie are continually washed through the tippie process. This pond contained water and appeared stable (see Photo 4).

Photo 4 – Sedimentation pond, main facilities area with C1 beltline in foreground

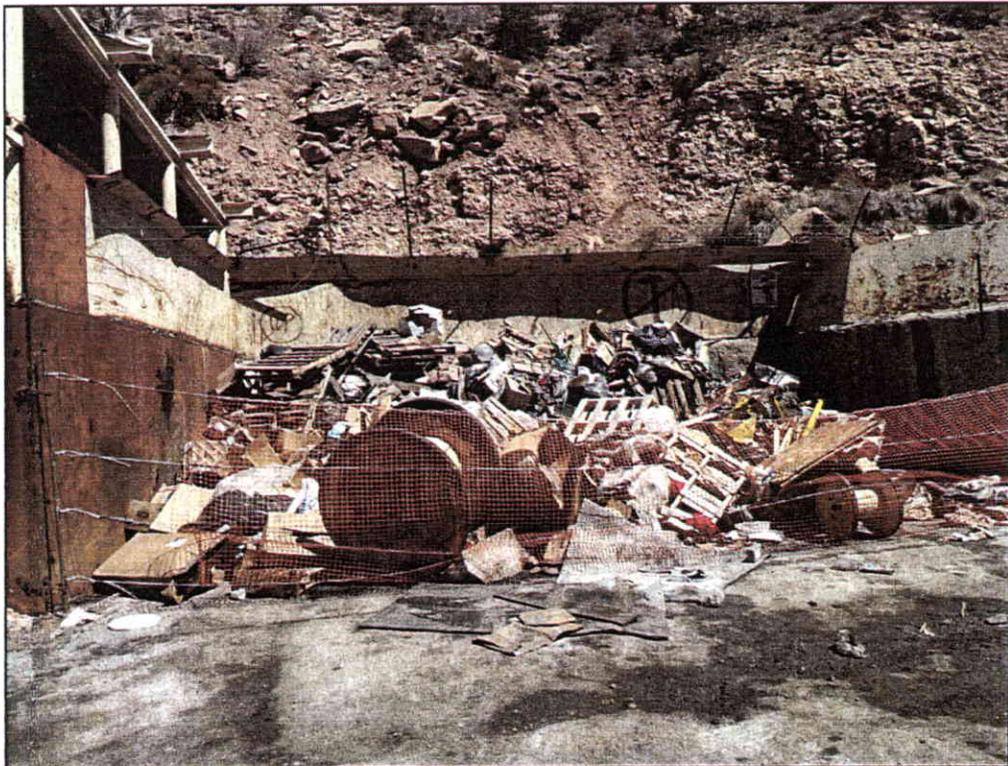
We observed noncoal waste at many locations near the main facility including the parking area, access road, intake portal, and storage areas. Mr. Houskeeper communicated to me that this is an ongoing issue at the mine. We observed the noncoal waste storage area, which was overflowing with trash. There was an orange plastic mesh construction-type fence that was intended to contain the noncoal waste, but was not functioning in this capacity (see Photo 5). The trash needs to be gathered, contained, and disposed of in a way that will not enable it to overflow and spread/blow to other parts of the facilities area. Because this has been an ongoing issue at the mine, and Energy West has received many warnings about this noncoal waste issue, I recommend that DOGM take enforcement action if the problem continues.

Photo 5 – Noncoal waste containment, main facilities area

- Repair damaged portion of corrugated metal belt cover near Inverted U No. 52
- Create and implement new containment strategy for noncoal waste

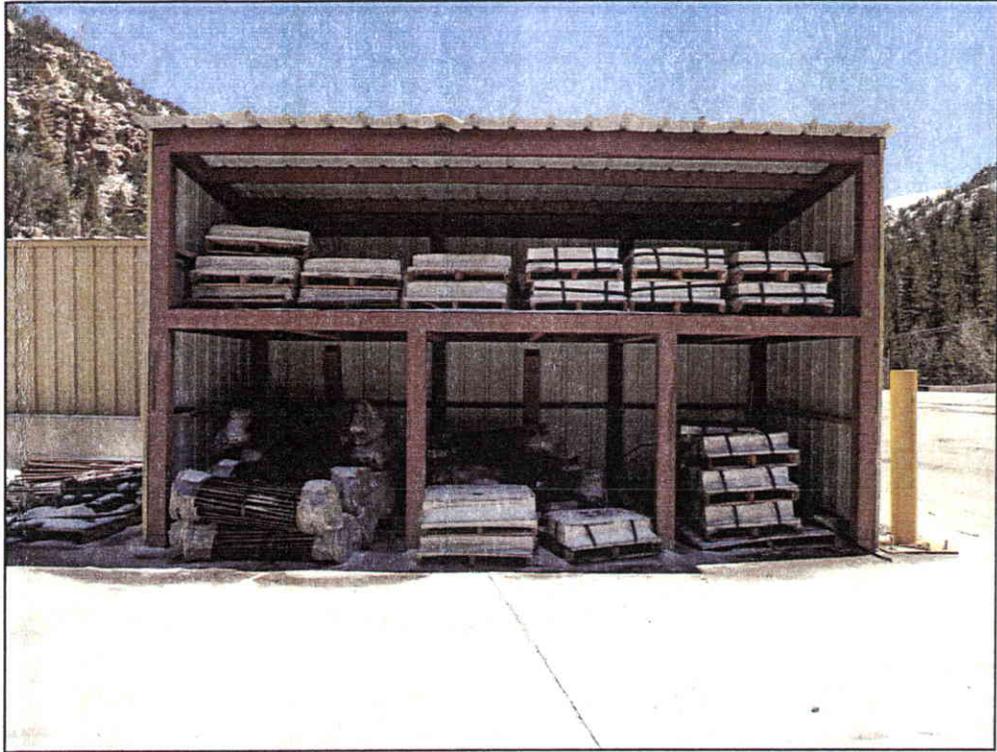
Next, we drove to the Rilda Canyon facilities area. The storage facilities at this newly developed site are well maintained and organized (see Photo 6).

Photo 6 - Well maintained storage area, Rilda Facilities
