Manti-La Sal
National Forest

Date: July 12, 2011

RE: Partial Phase II and III Bond Release, Deer Creek Mine, Permit No. UT-015-018 DOGM
Proposed Decision and Findings Compliance, June 2, 2011

Field Inspection of Deer Creek Mine Reclamation for Phase II and III Bond Release Review

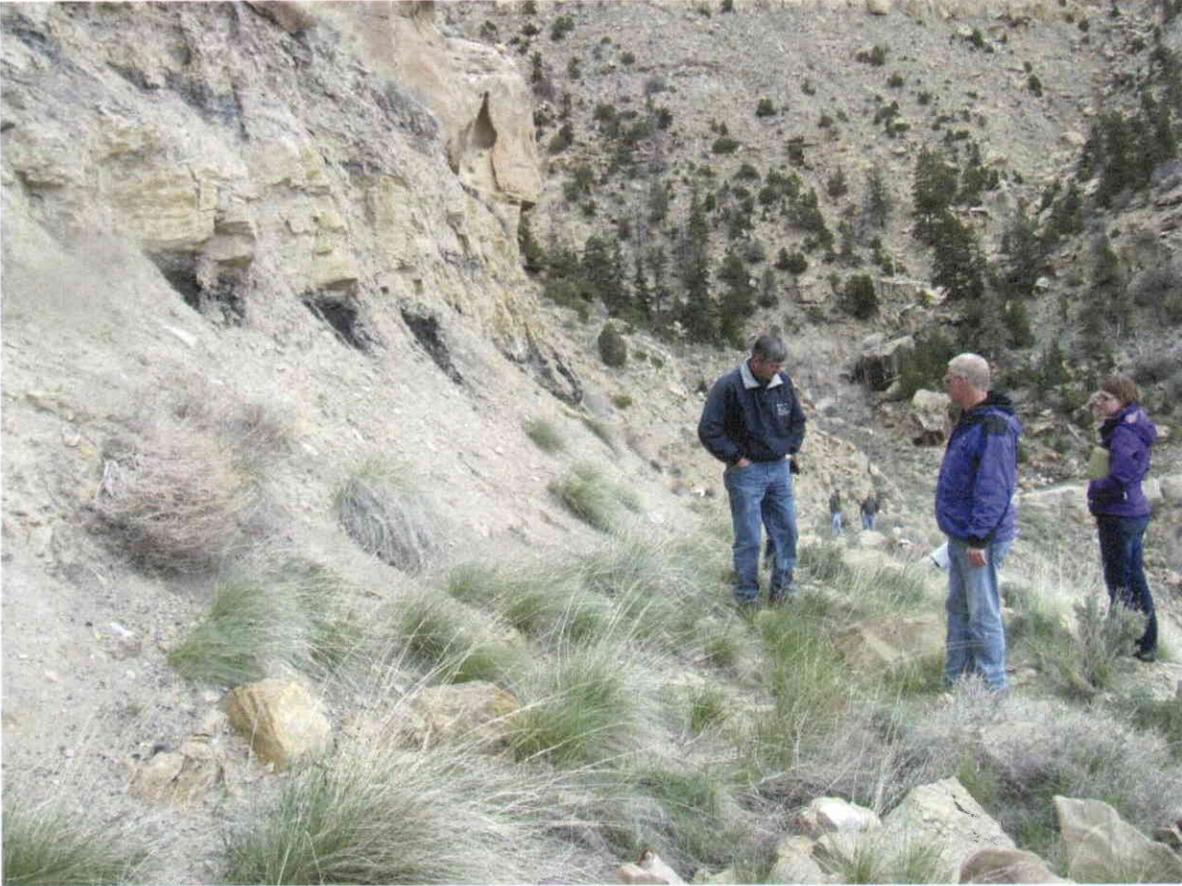
Regraded and re-vegetated area above Vent 3.

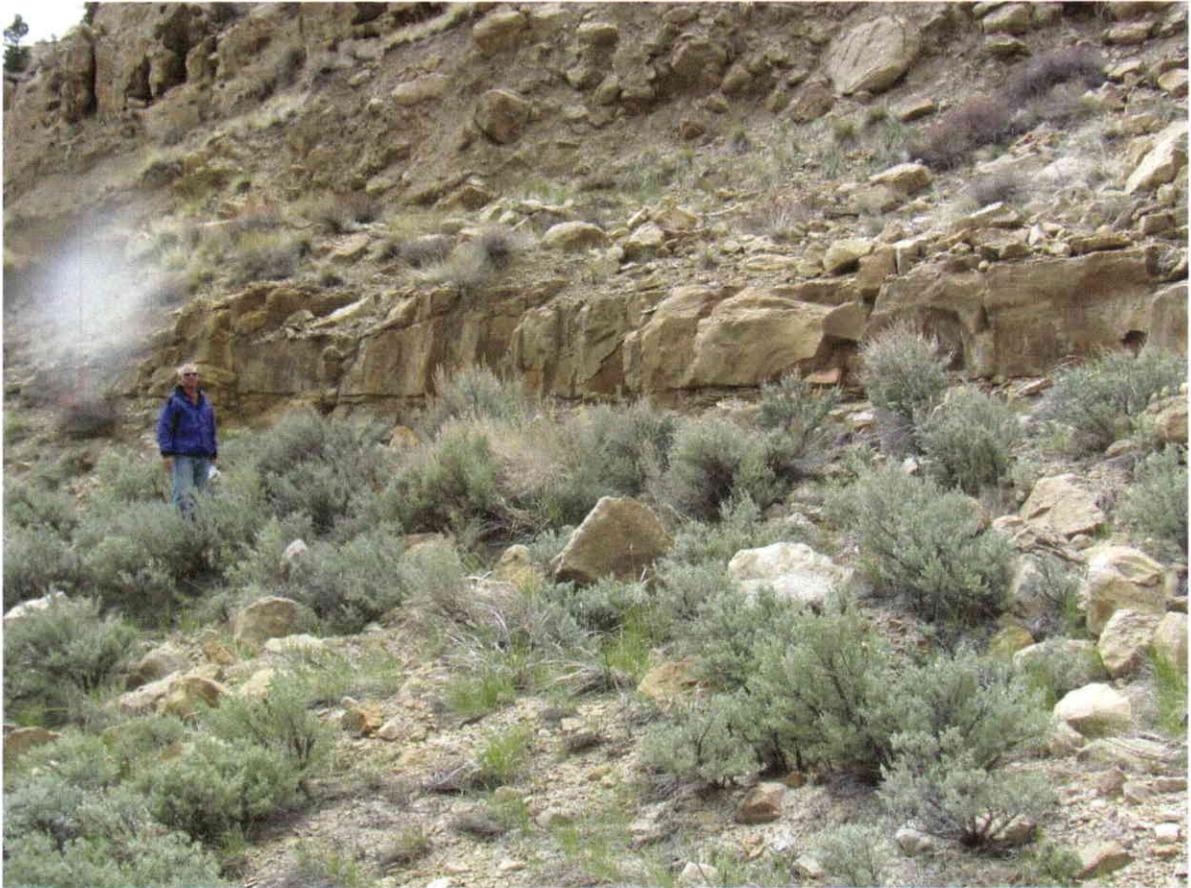
Vent 3 area re-vegetated and regraded.

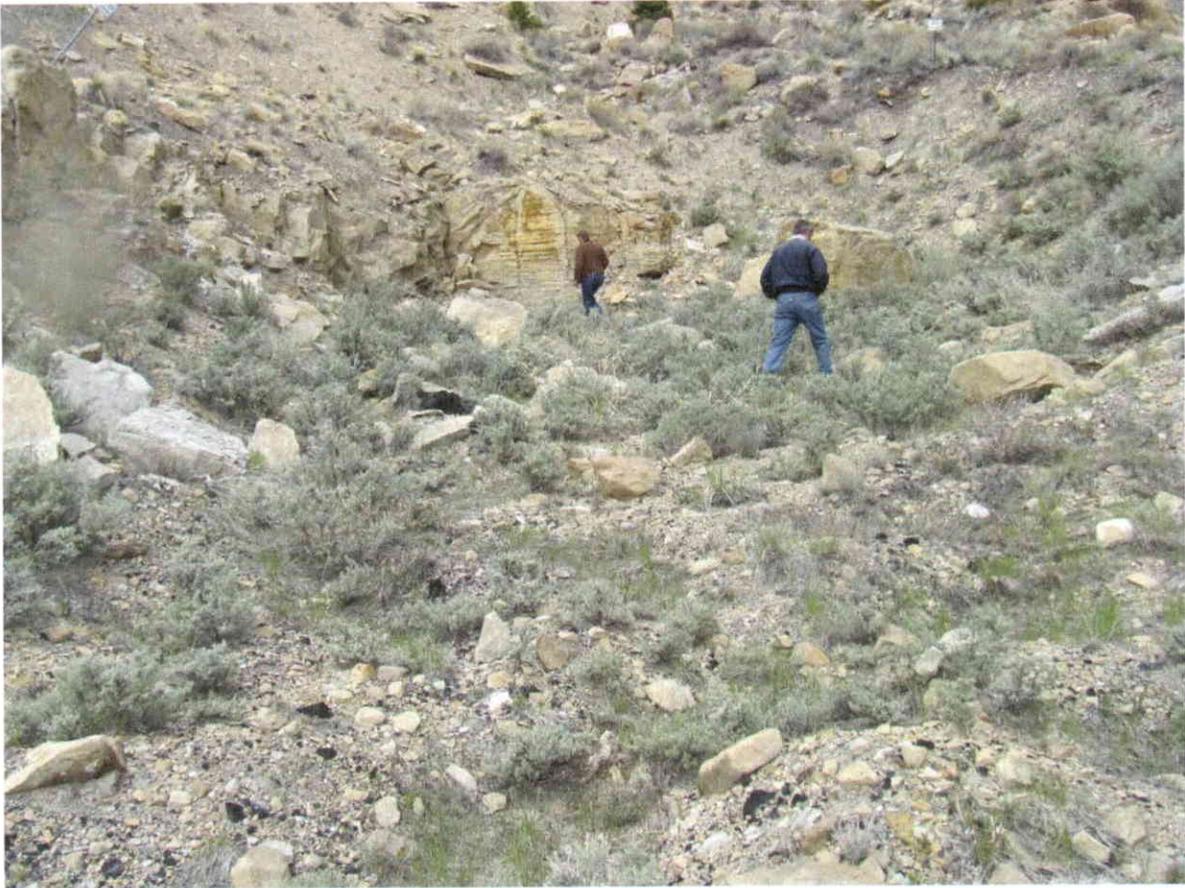
A full view showing the Vent 2 area and access road regraded and re-vegetated.

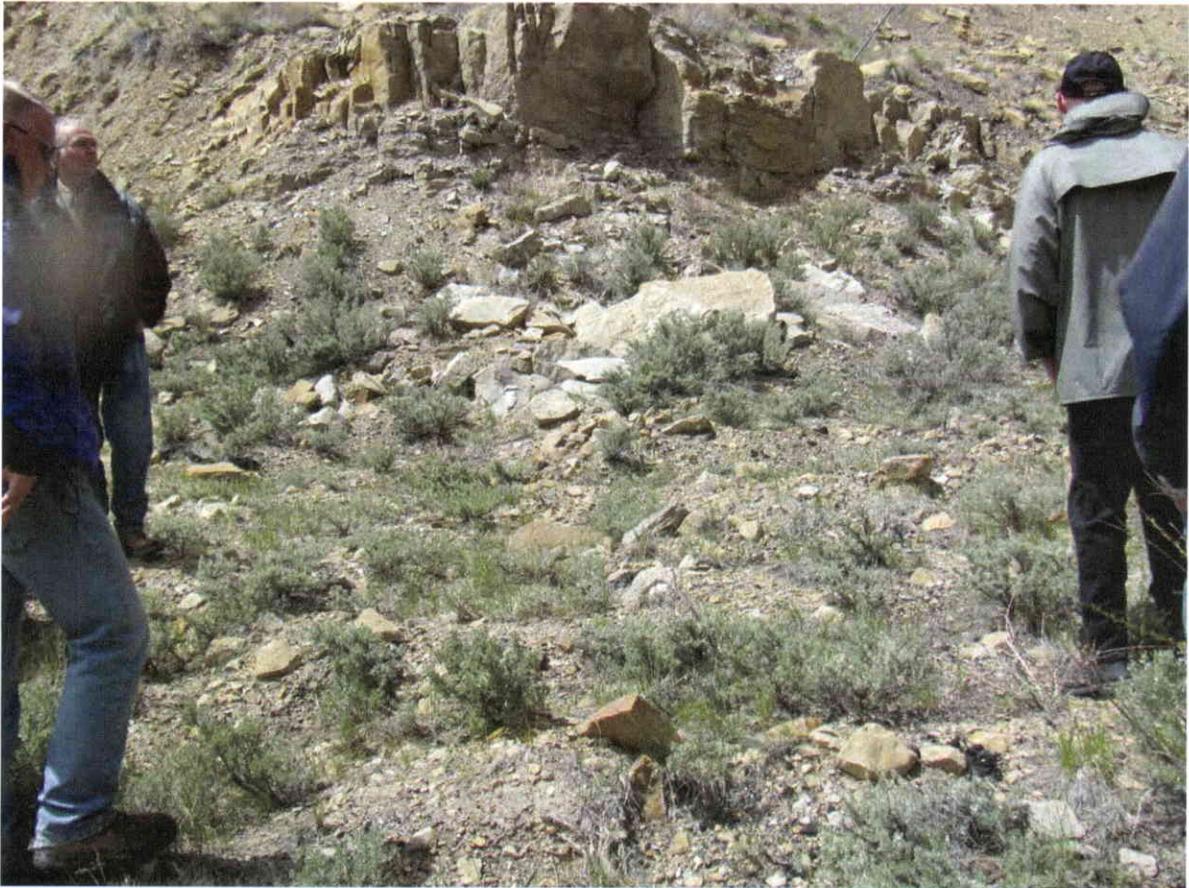
Another view of the Vent 2 area showing regrading and re-vegetation.

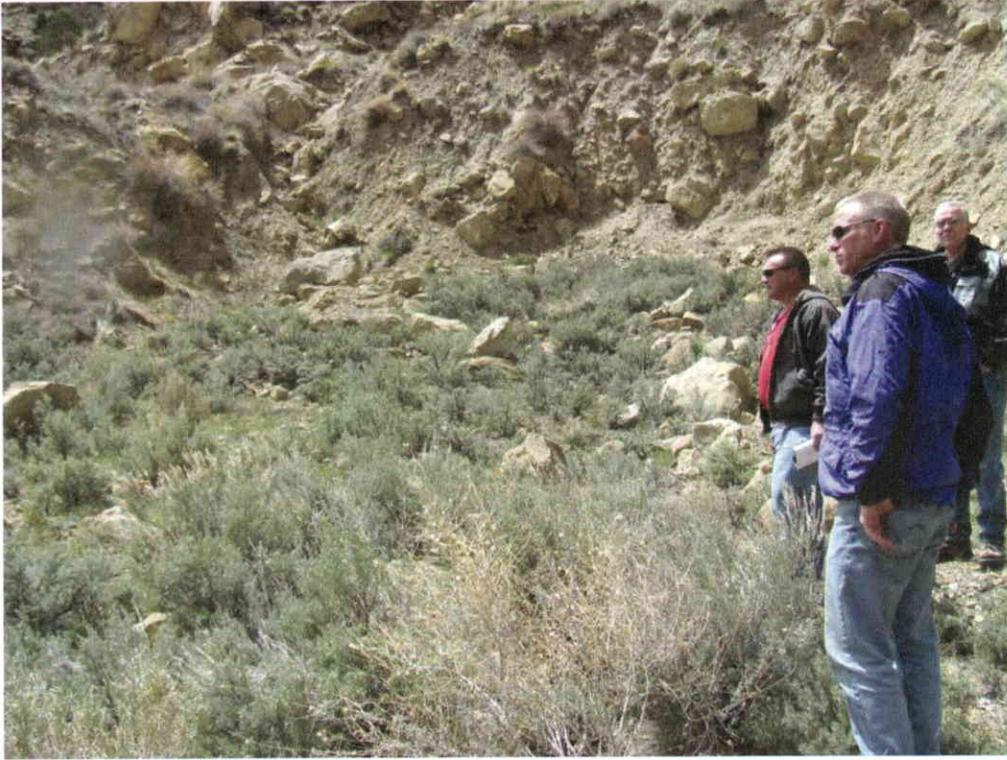
Vent 2 area showing the regraded vent area and the re-vegetation progress.

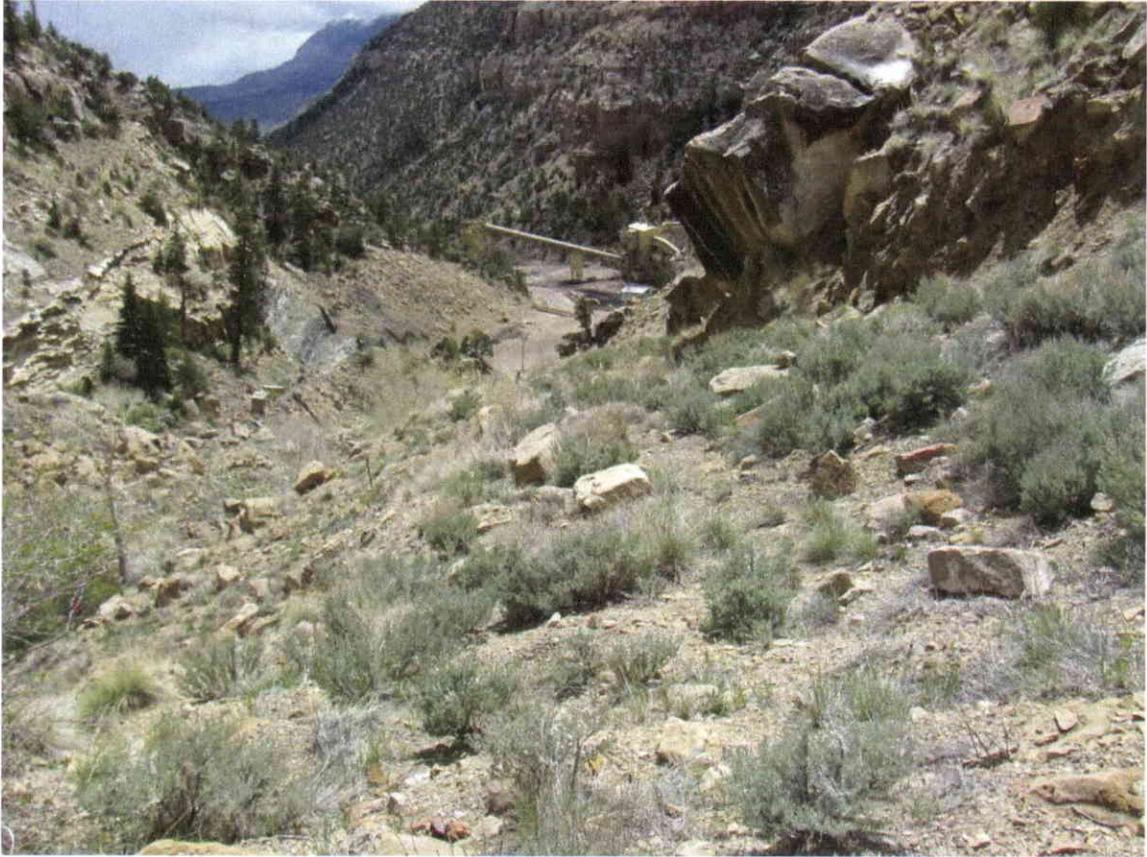
View back down the access road illustrating the recovery and re-vegetation work.

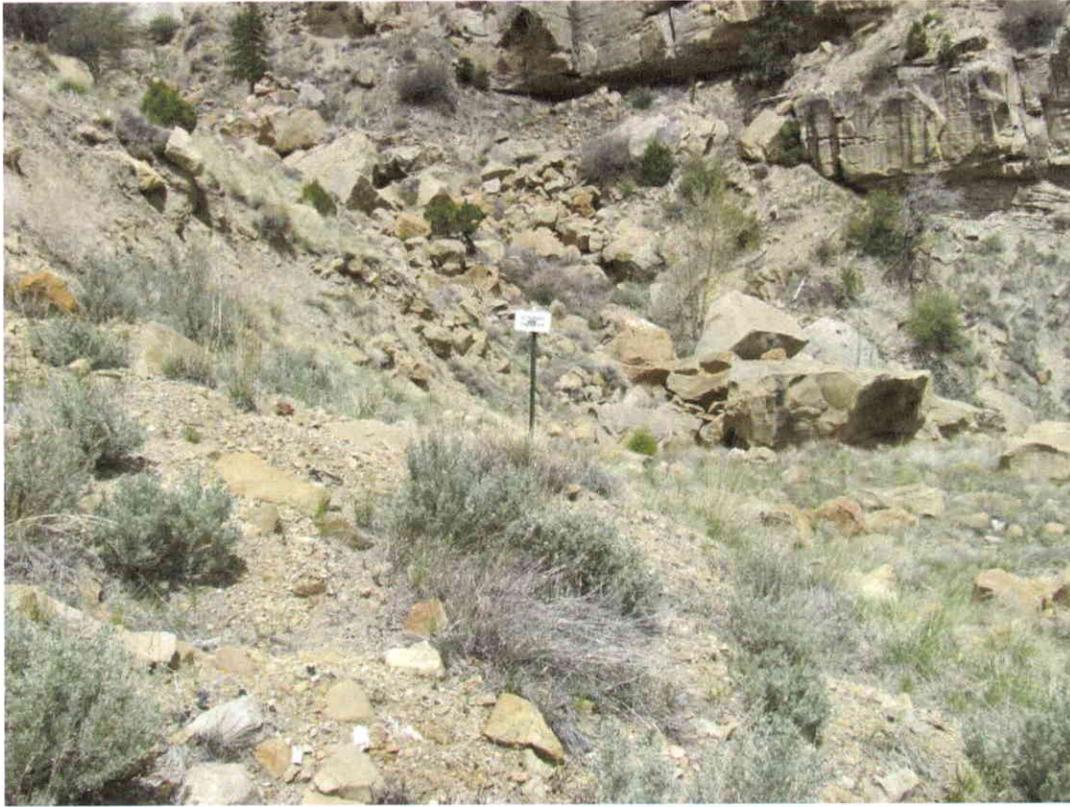
Signs delineating the disturbed area will be removed once the bond release is accomplished.

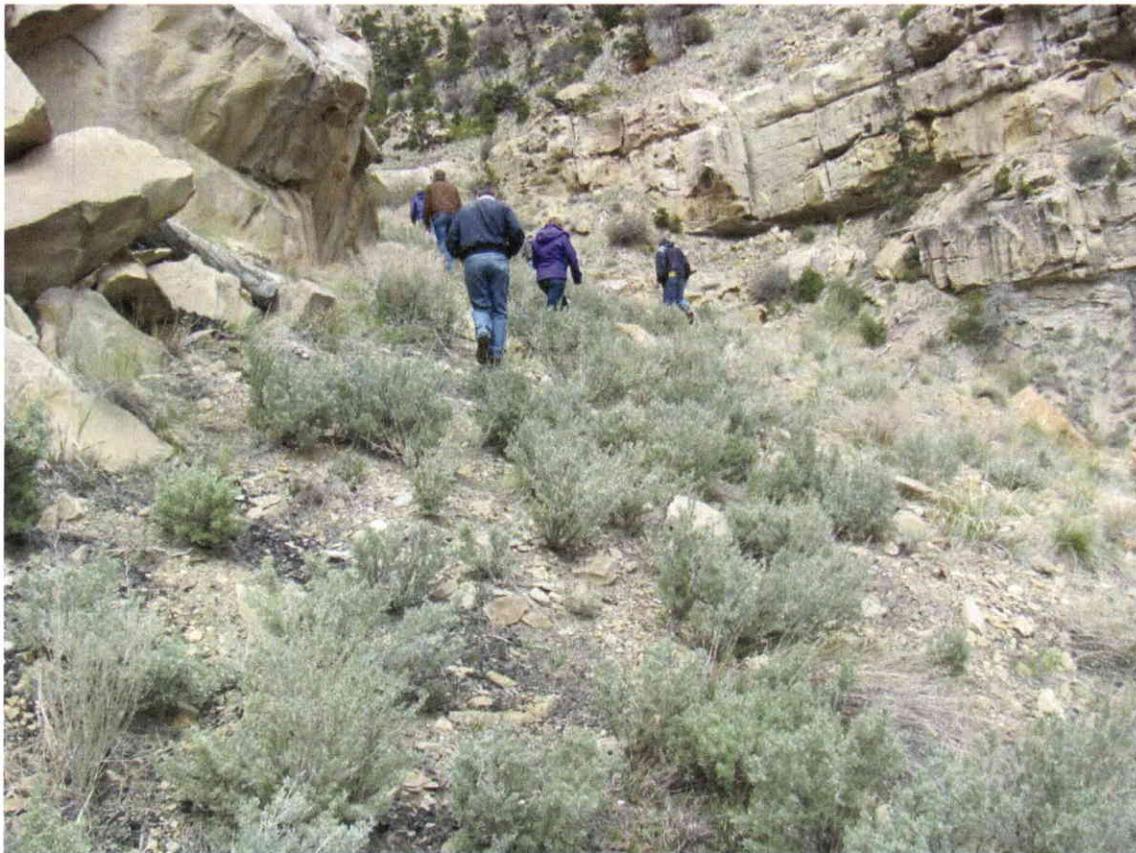
Reclaimed area along the recovered access road above Vent 1.

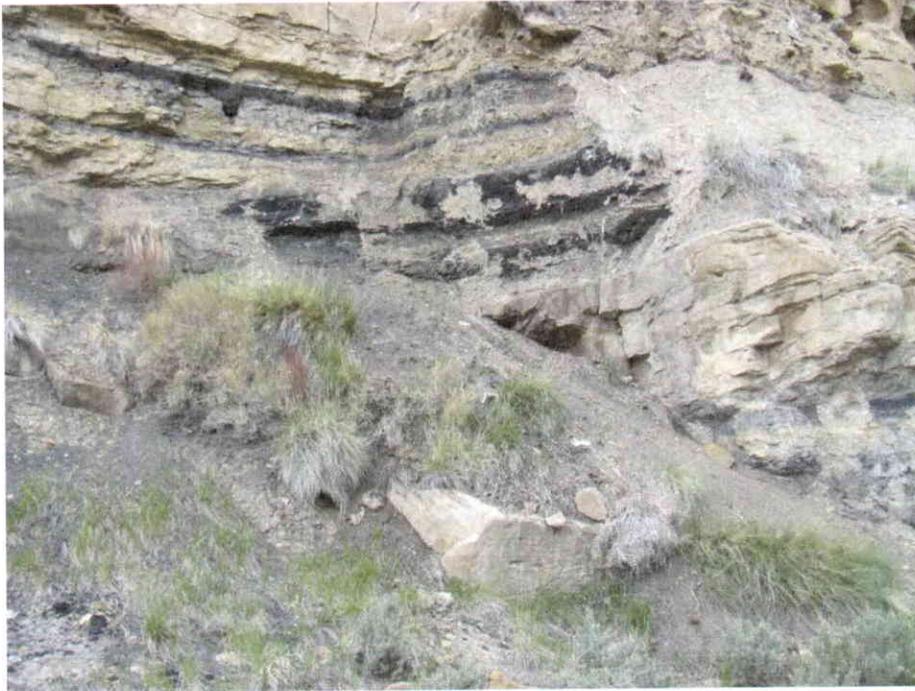
Vent 1 Recovery Area: Regraded and re-vegetated
