Inspection Report

Permit Number:	C0150018
Inspection Type:	PARTIAL
Inspection Date:	Wednesday, August 15, 2012
Start Date/Time:	8/15/2012 8:15:00 AM
End Date/Time:	8/15/2012 2:00:00 PM
Last Inspection:	Wednesday, July 11, 2012

Permitee: **PACIFICORP**
 Operator: **ENERGY WEST MINING CO**
 Site: **DEER CREEK MINE**
 Address: **PO BOX 310, HUNTINGTON UT 84528**
 County: **EMERY**
 Permit Type: **PERMANENT COAL PROGRAM**
 Permit Status: **ACTIVE**

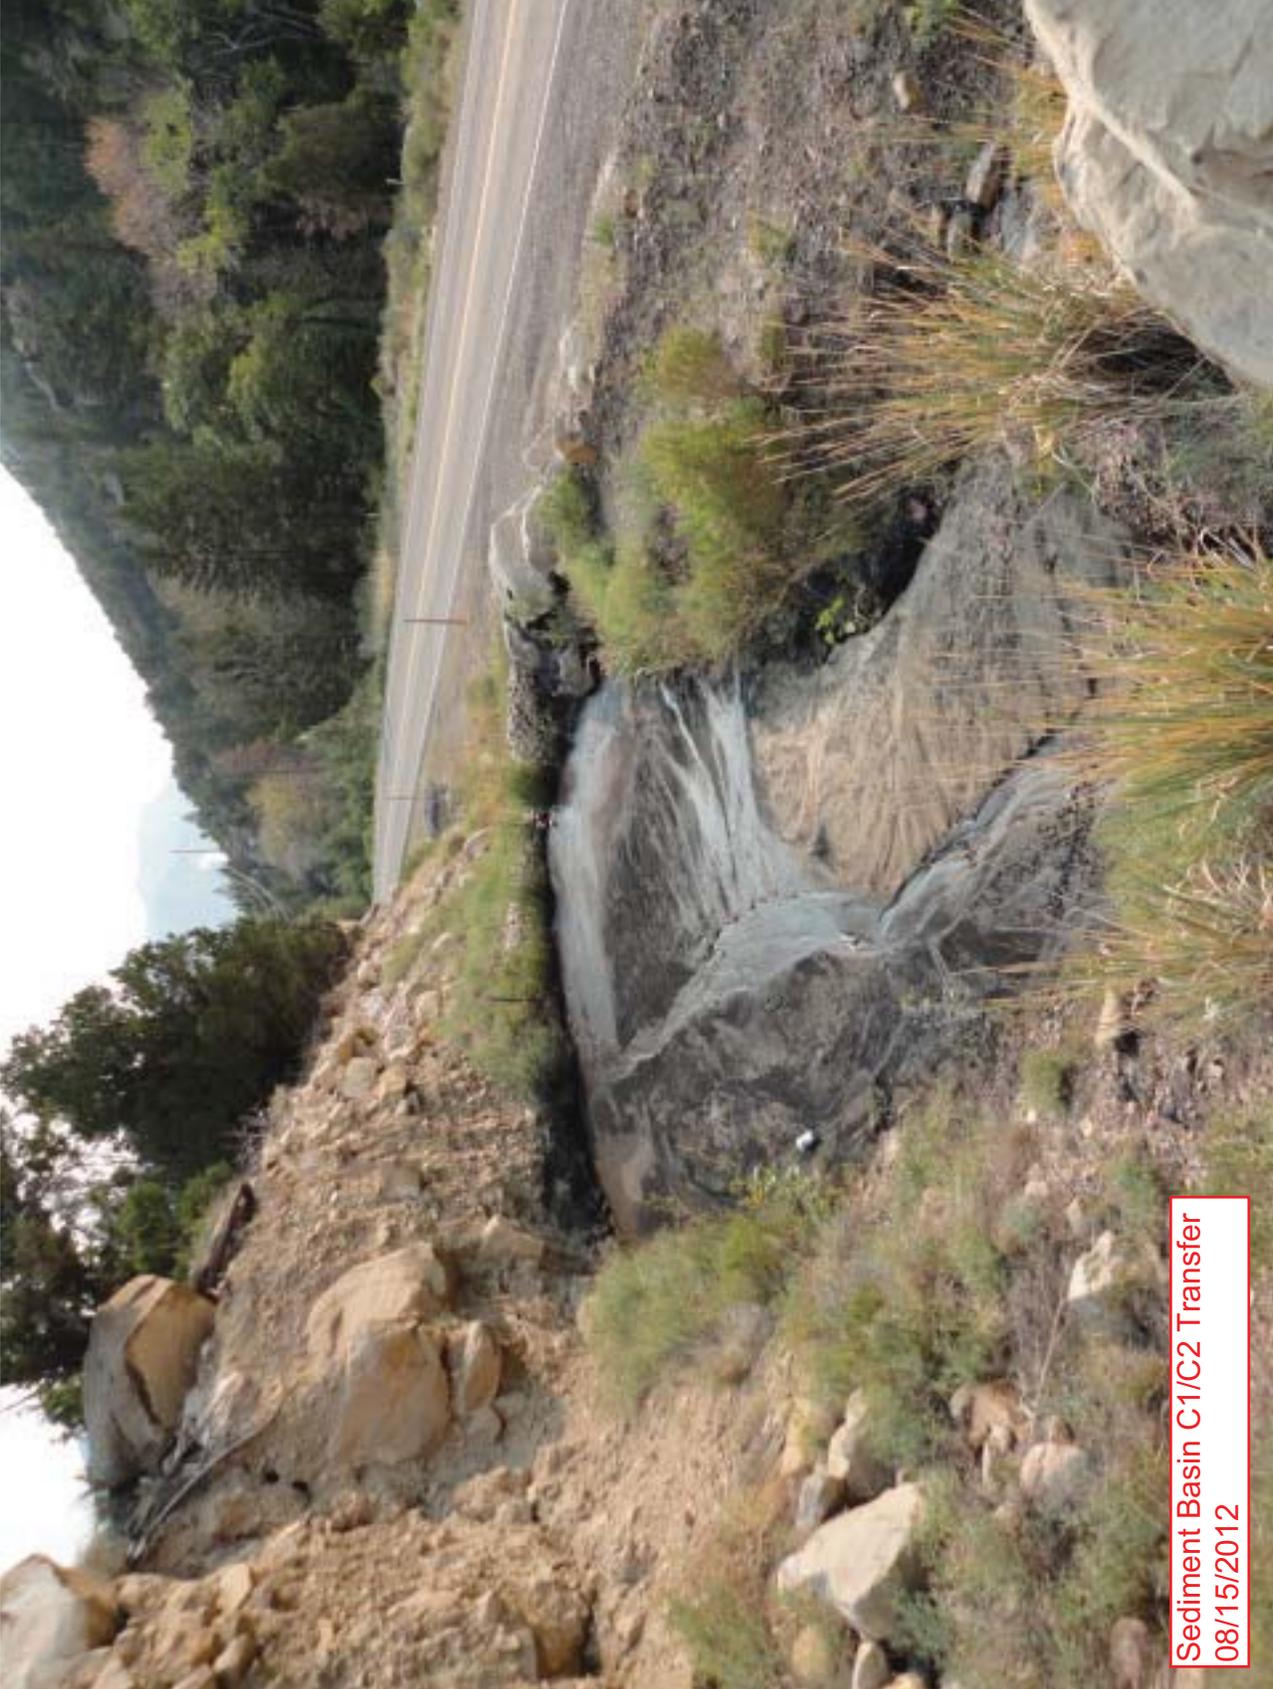
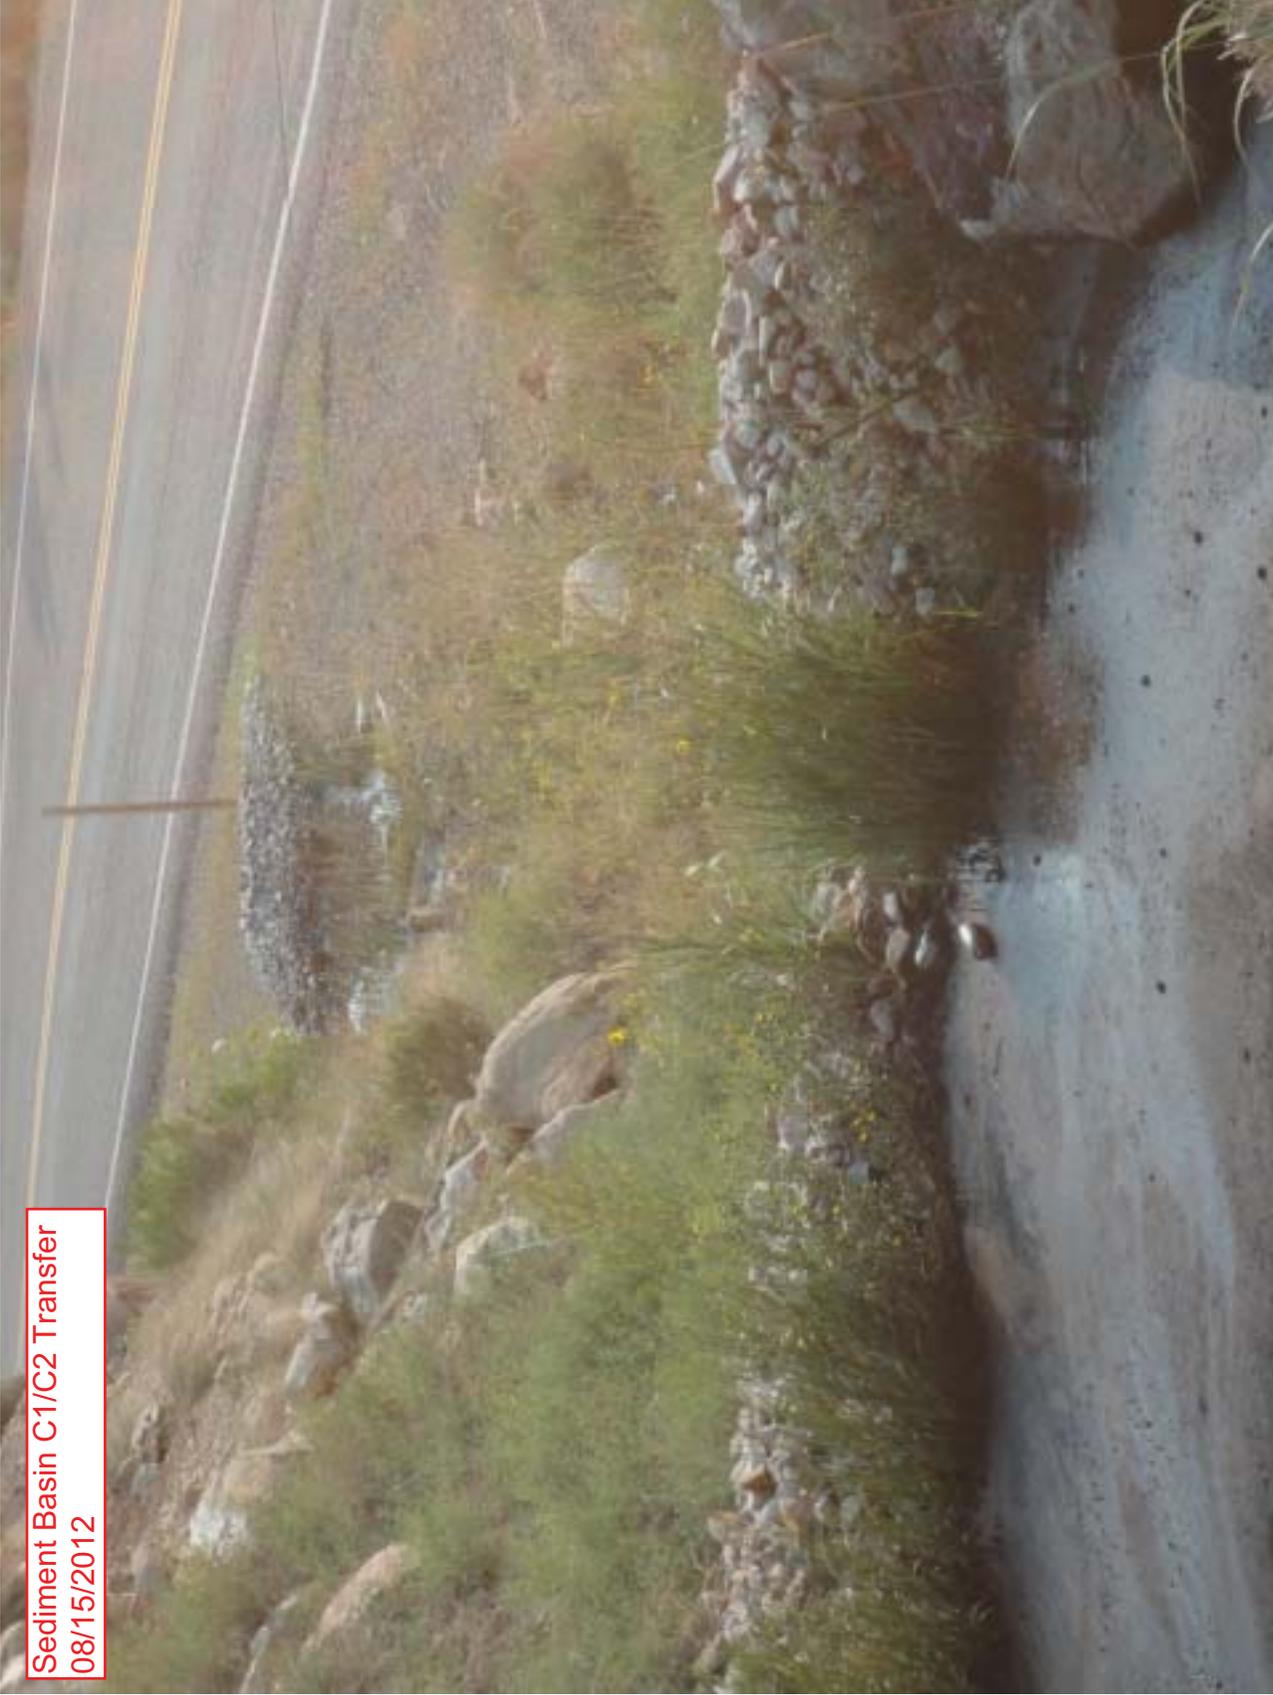
The sediment basin located along side of the access road to the C1/C2 Transfer is complete full. The sediment trap below the sediment basin is now receiving the flow and sedimentation as all flow and sedimentation is overtopping the sediment basin during any storm event. The sediment basin needs to be cleaned out so that it can function as designed to retain the sediment in the basin.

Sediment Basin C1/C2 Transfer
08/15/2012

Cleaning of the sediment basin at the C1/C2 transfer (see item 4c), 100% plugged culvert inlet below the old truck load out, and Rilda diversion were scheduled with a contractor on the afternoon of 08/15/2012 with equipment to be mobilized and work to begin on the morning of 08/16/2012. The belting by the old truck load out was being removed during the 08/16/2012 inspection.

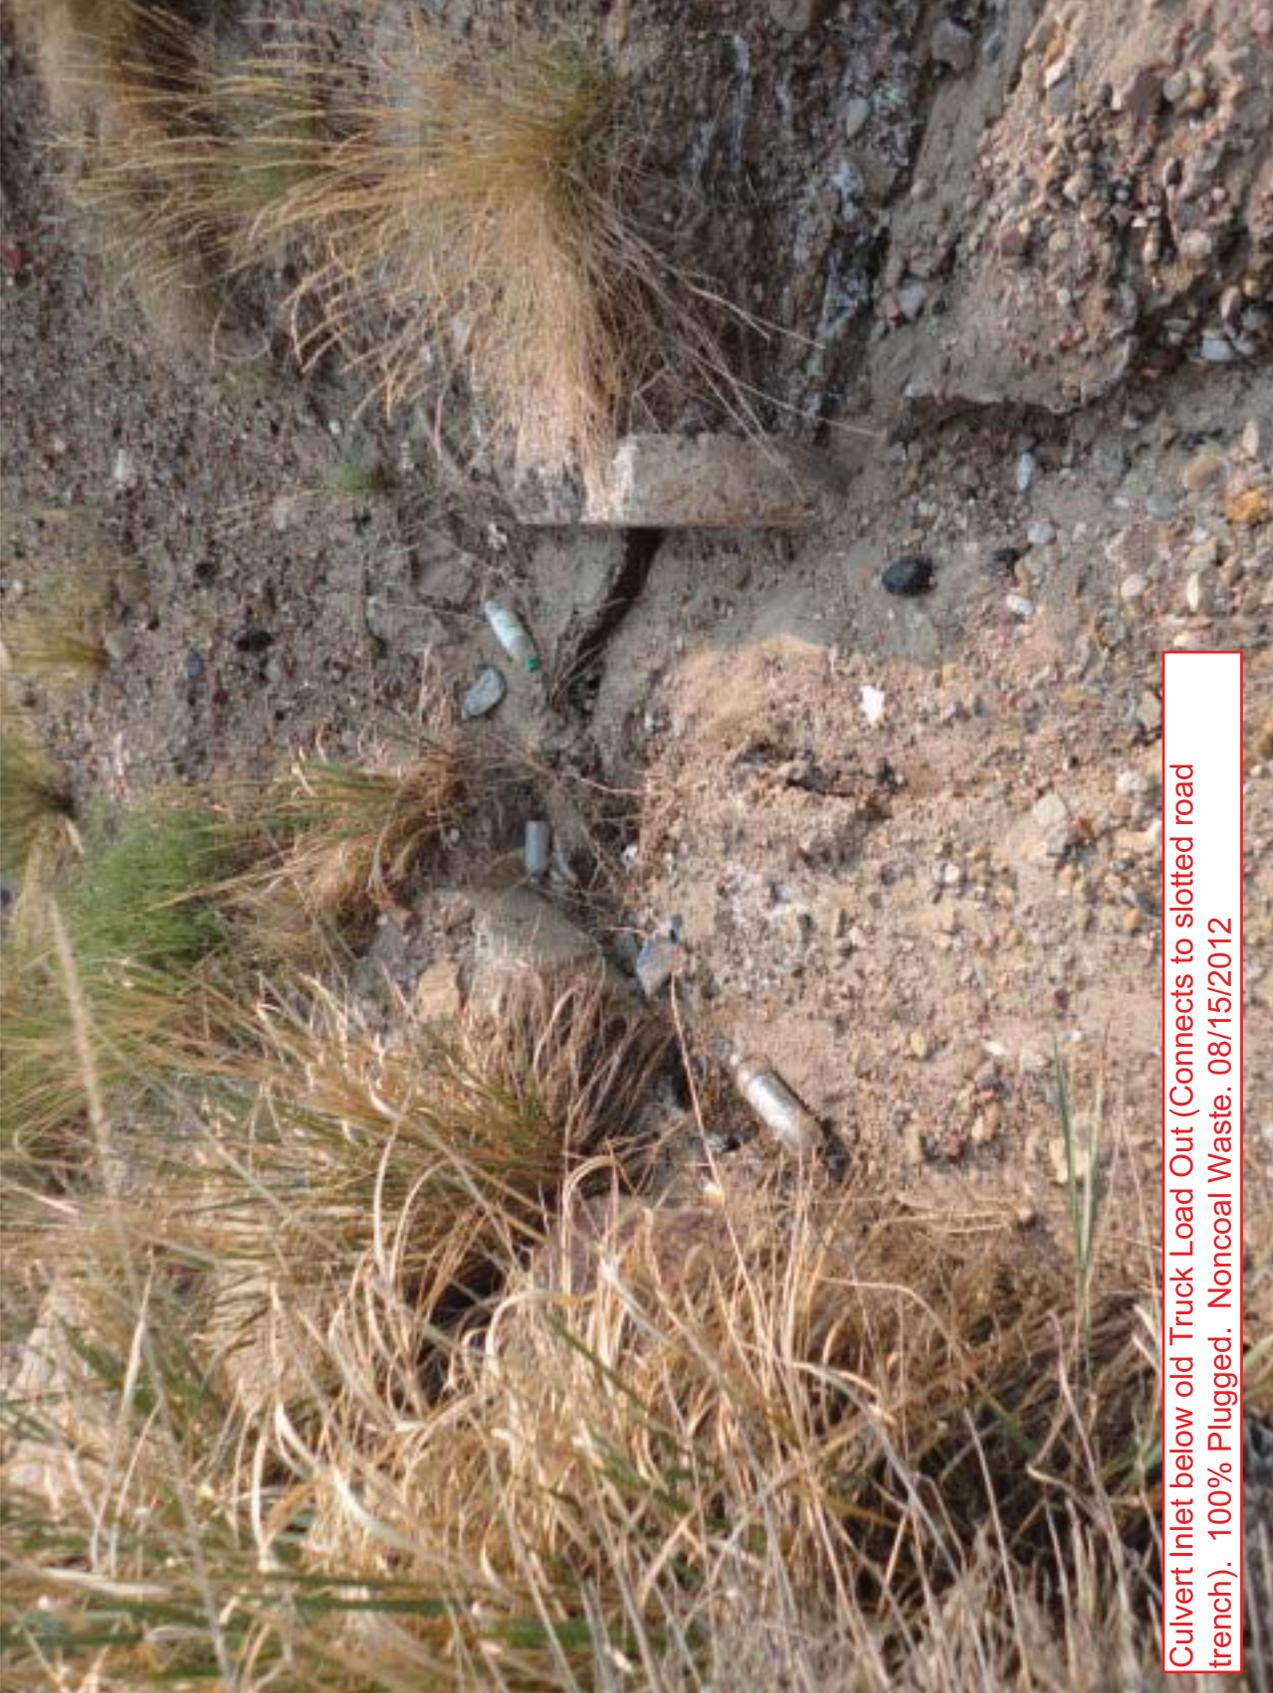
The culvert inlet located below the old truck load-out that leads into the slotted trench that crosses the main access road is complete Plugged (100%). This culvert inlet needs to be cleaned immediately.

Culvert Inlet below old Truck Load Out (Connects to slotted road trench). 100% Plugged. Noncoal Waste. 08/15/2012

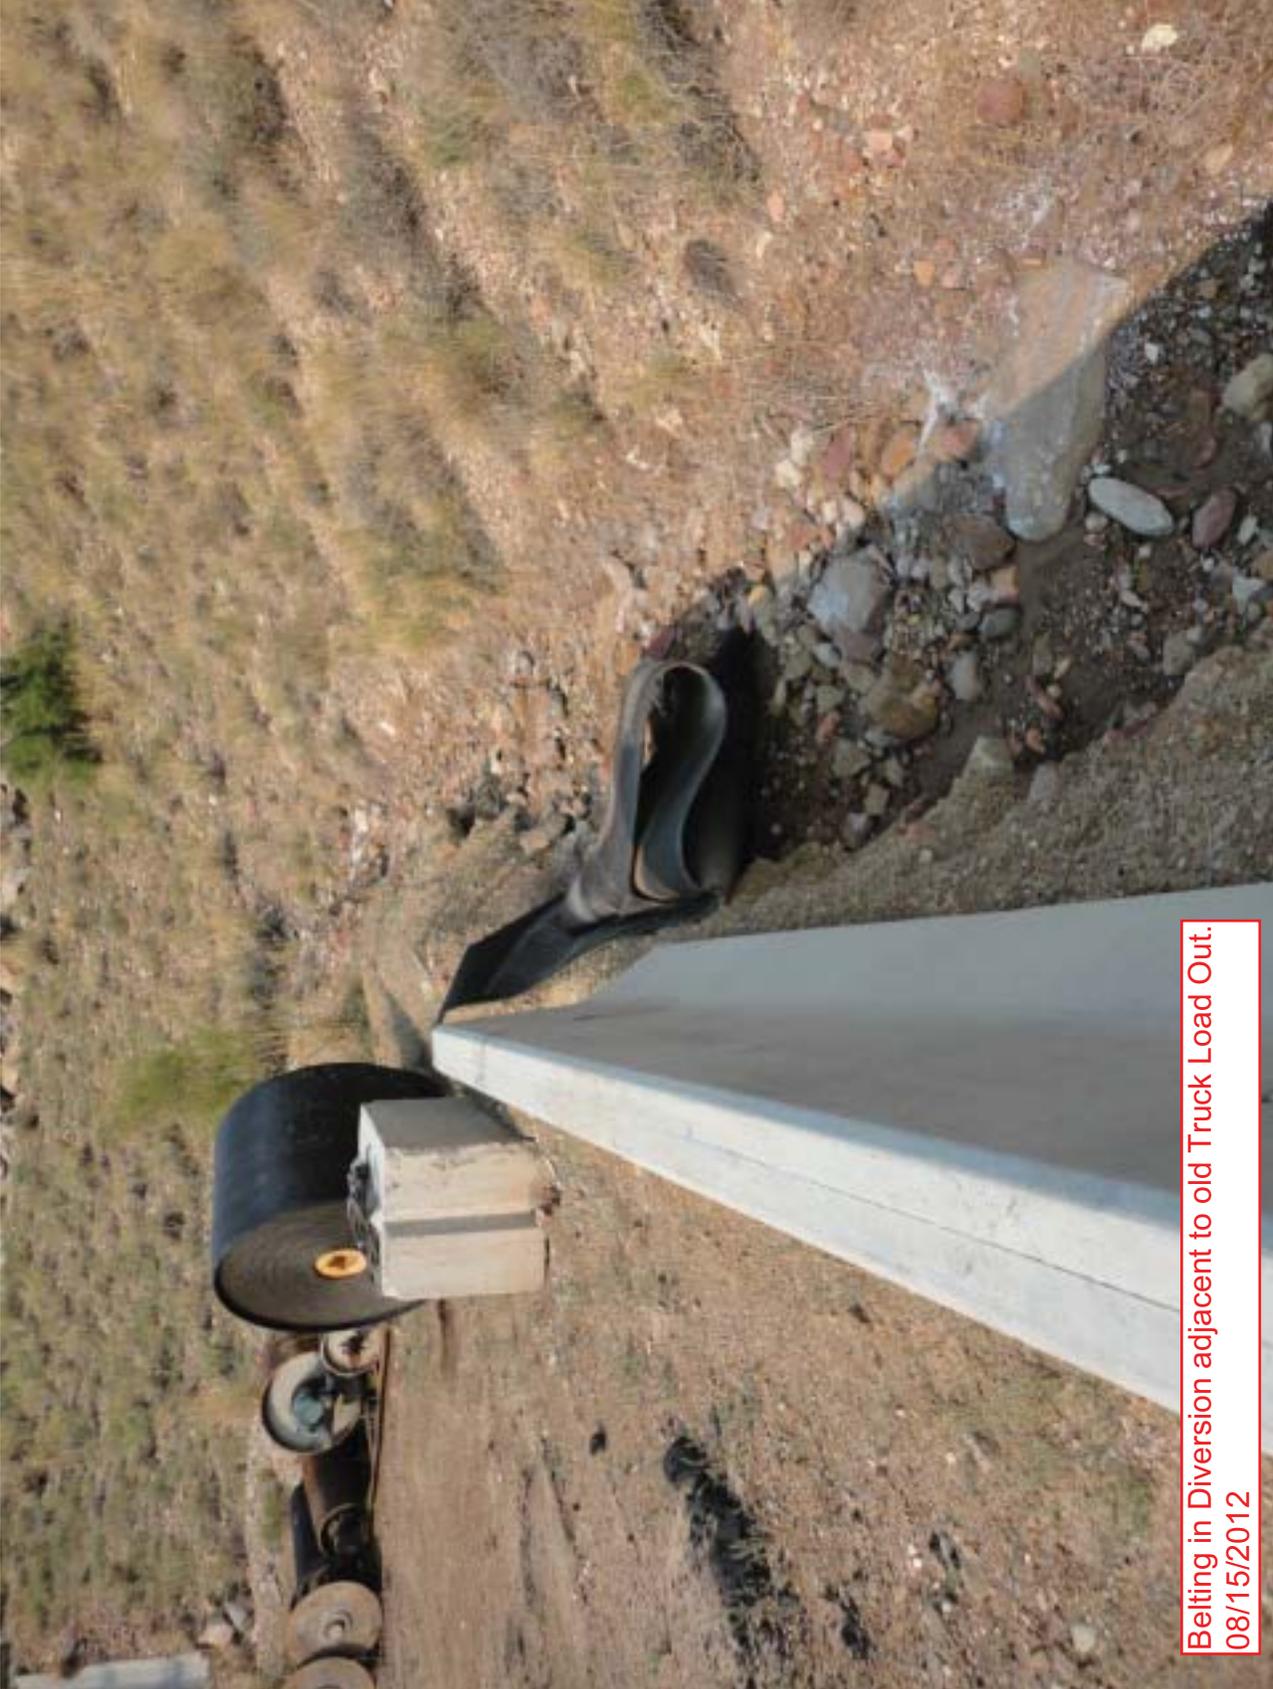
Belting is with the reaches of the diversion that wraps around the old truck load-out. The belting needs to be removed from the interior of the diversion and placed back on the storage pad.

Belting in Diversion adjacent to old Truck Load Out.
08/15/2012

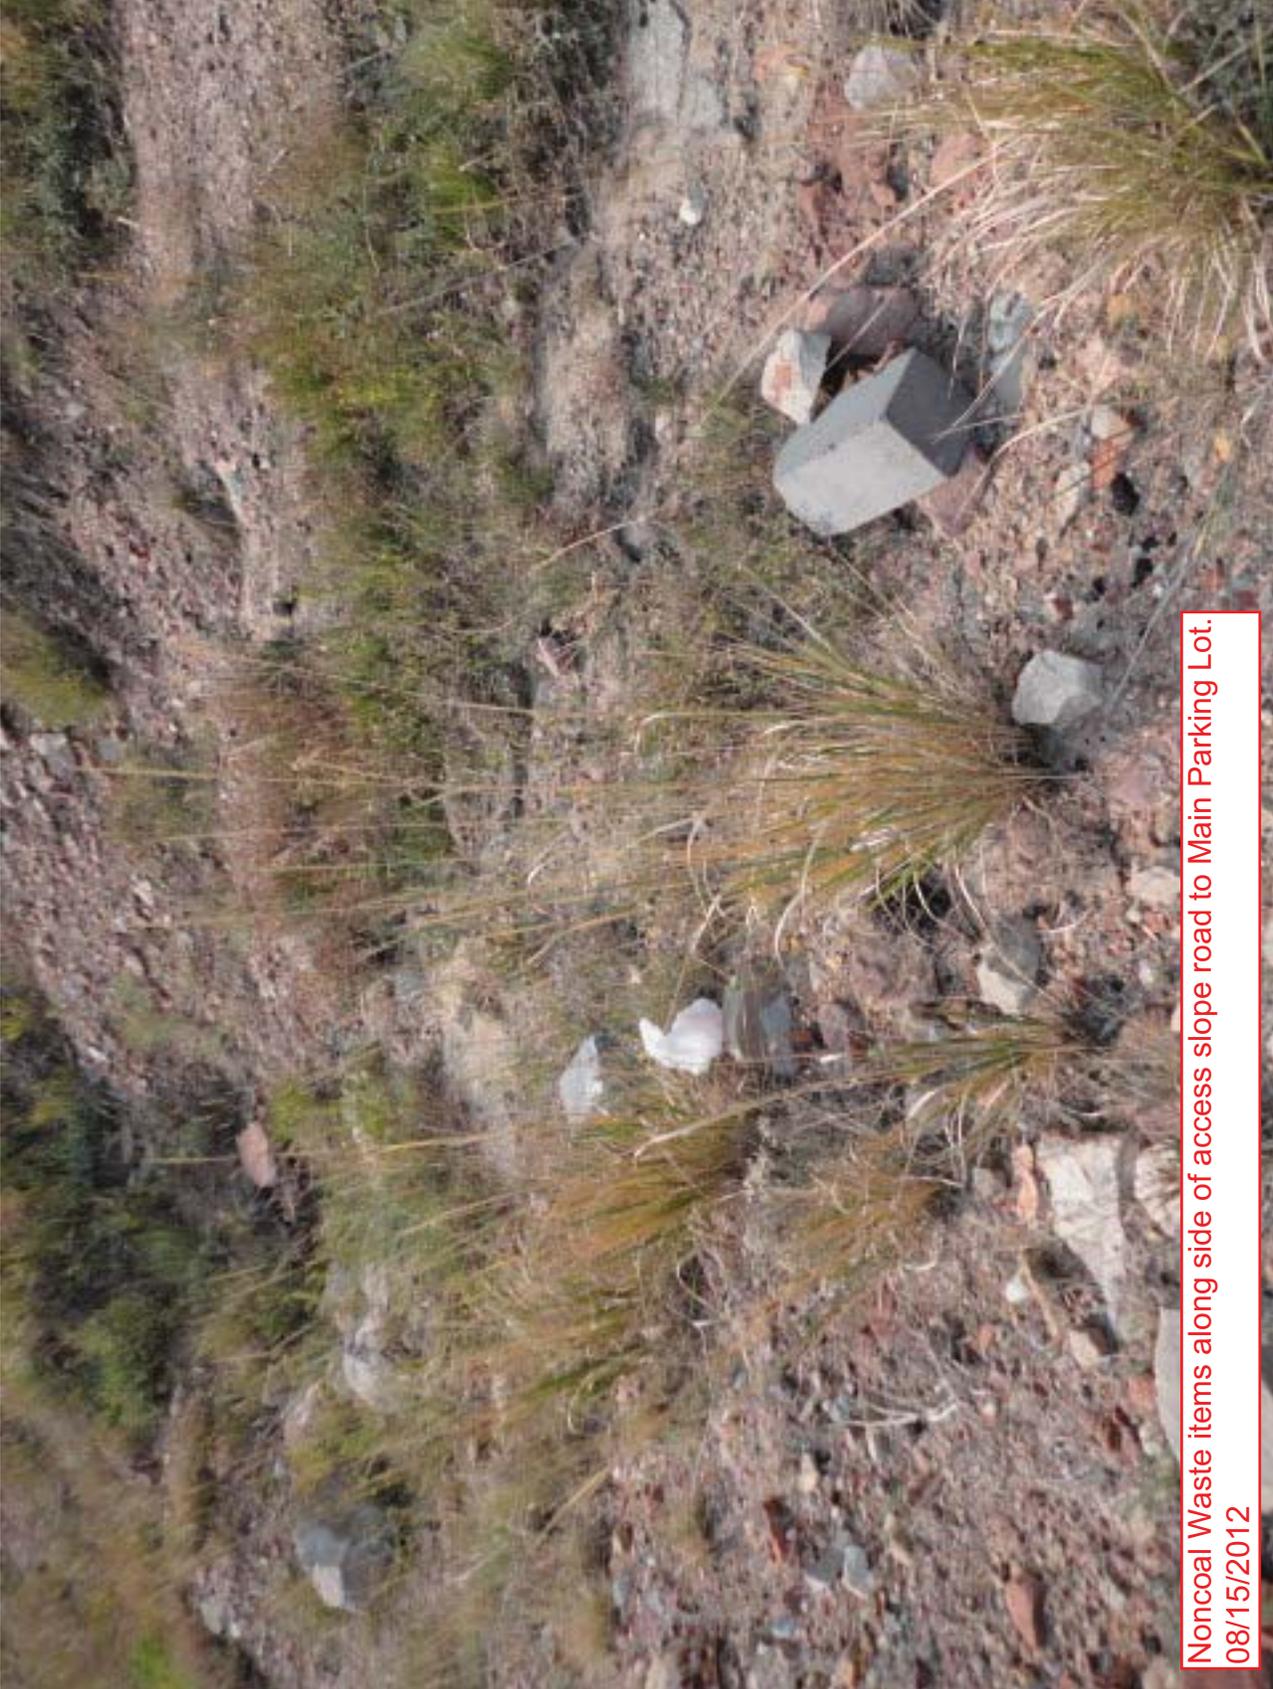
The roadways, pad areas, parking areas, facilities areas are covered with noncoal waste items. This has been a continual problem at this site. It was believed that the problem existed from the noncoal waste items being air borne. Several violations have been issued on this issue. Numerous warnings have been given. OSM expressed concerns of this problem during their complete oversight. The mine indicated that it would build a new noncoal waste storage facility. The new noncoal waste storage facility has been constructed and in use for approximately 2-3 months. This same problem was identified on the July 2012 inspection. At that time the company representative Ken Fleck picked up two full garbage bags of trash. It is evident that this problem does not stem from air borne dispersion of noncoal waste items, but from employees lack of care or concern. The noncoal waste items need to be picked up immediately and a way to educate employee's and change their behavioral patterns developed. Continued disregard will lead to violations and cessation orders.

Noncoal Waste items along side of access slope road to Main Parking Lot.
08/15/2012

Noncoal waste items were gathered and disposed of on the afternoon of 08/15/2012.

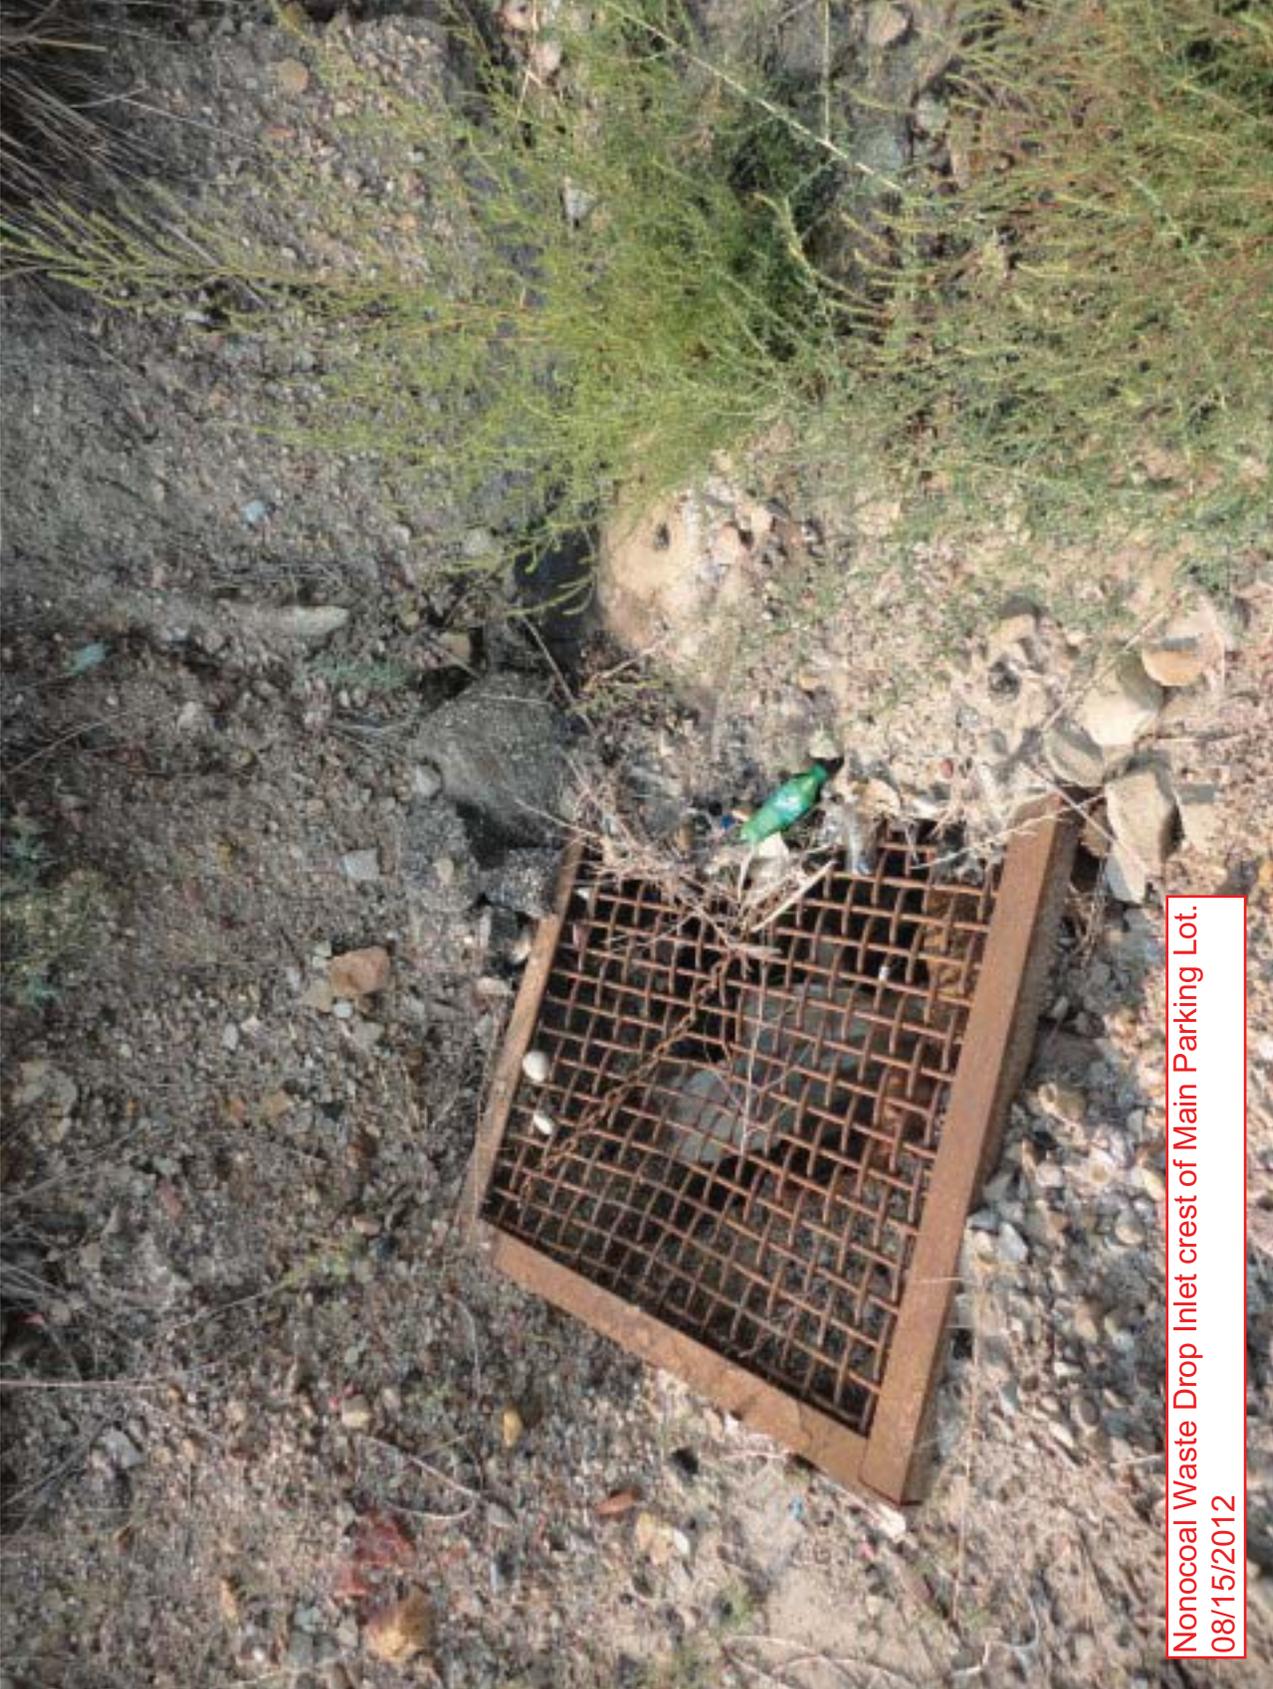
Noncoal Waste Drop Inlet crest of Main Parking Lot.
08/15/2012

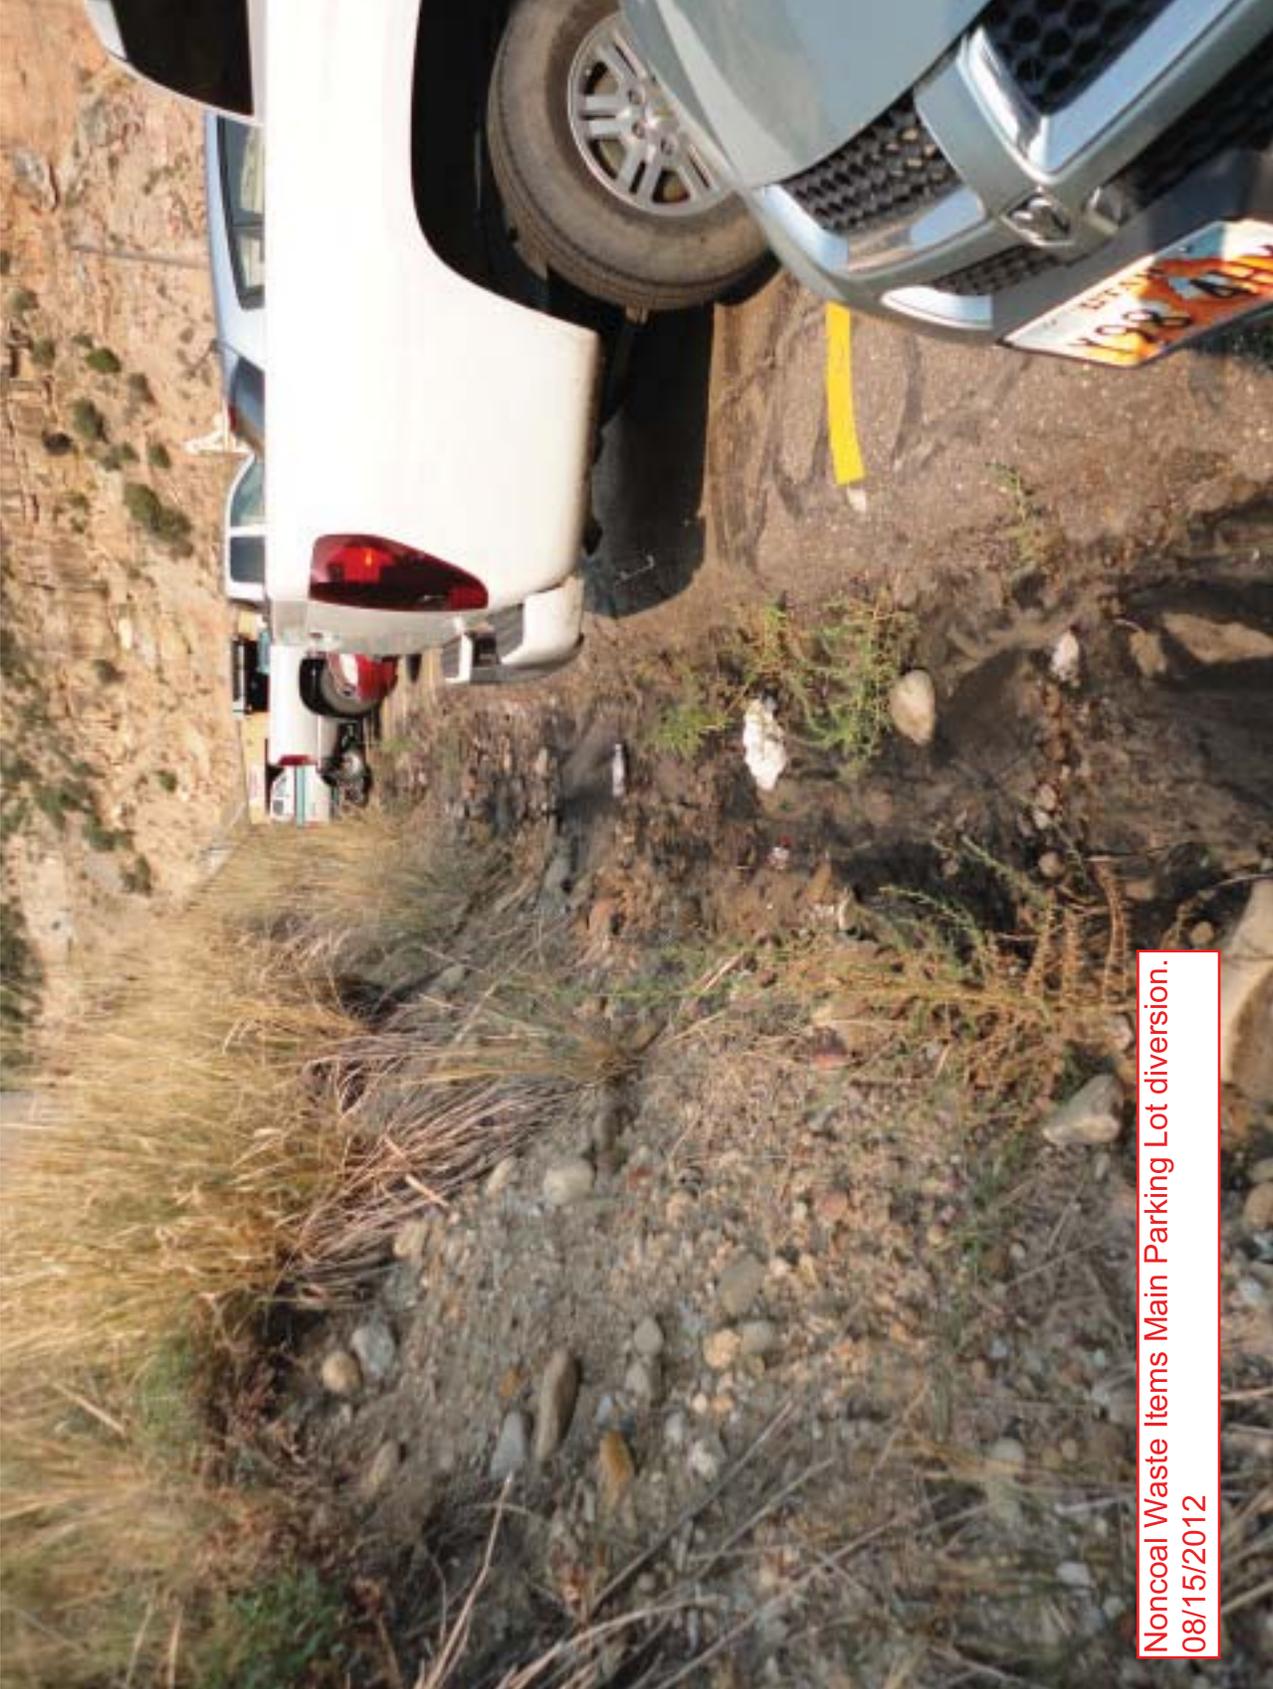
Noncoal Waste Items Main Parking Lot diversion.
08/15/2012

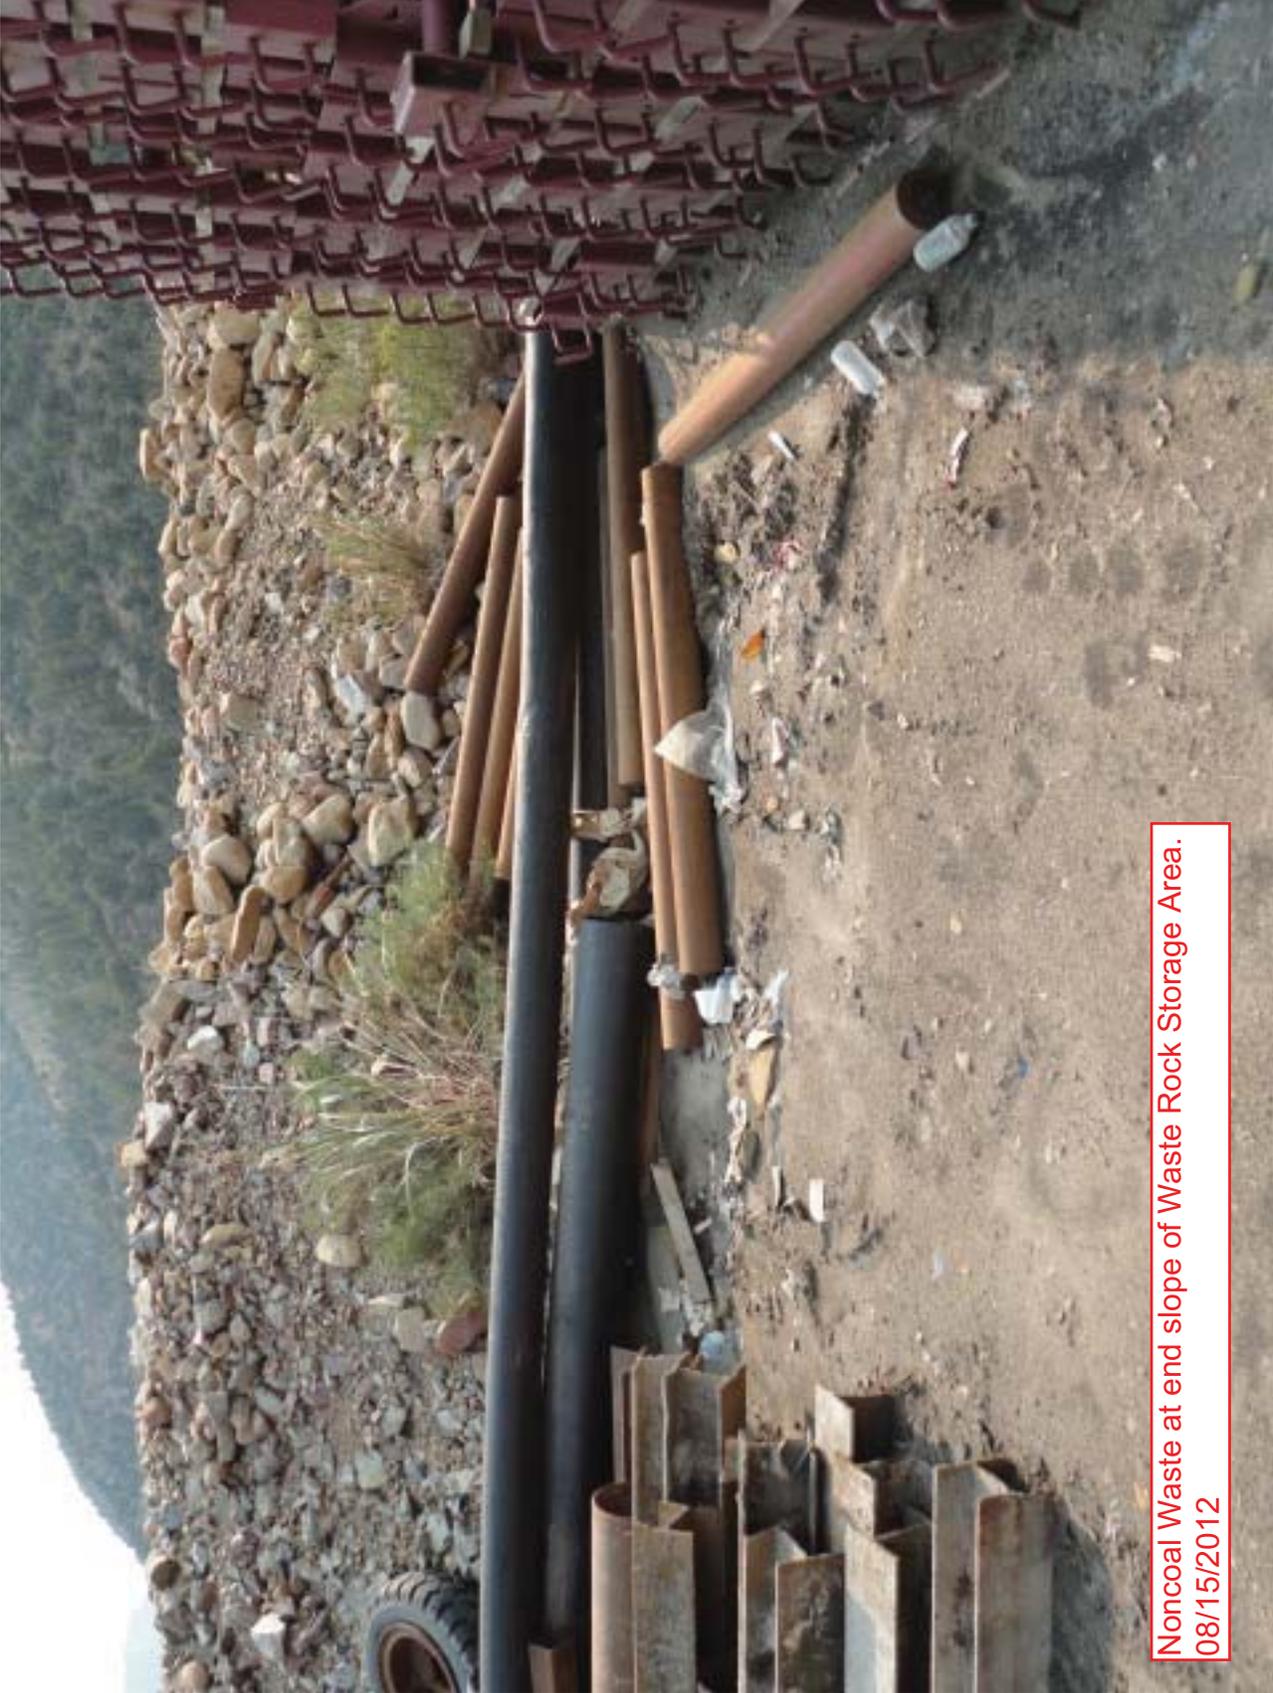
Noncoal Waste at end slope of Waste Rock Storage Area.
08/15/2012

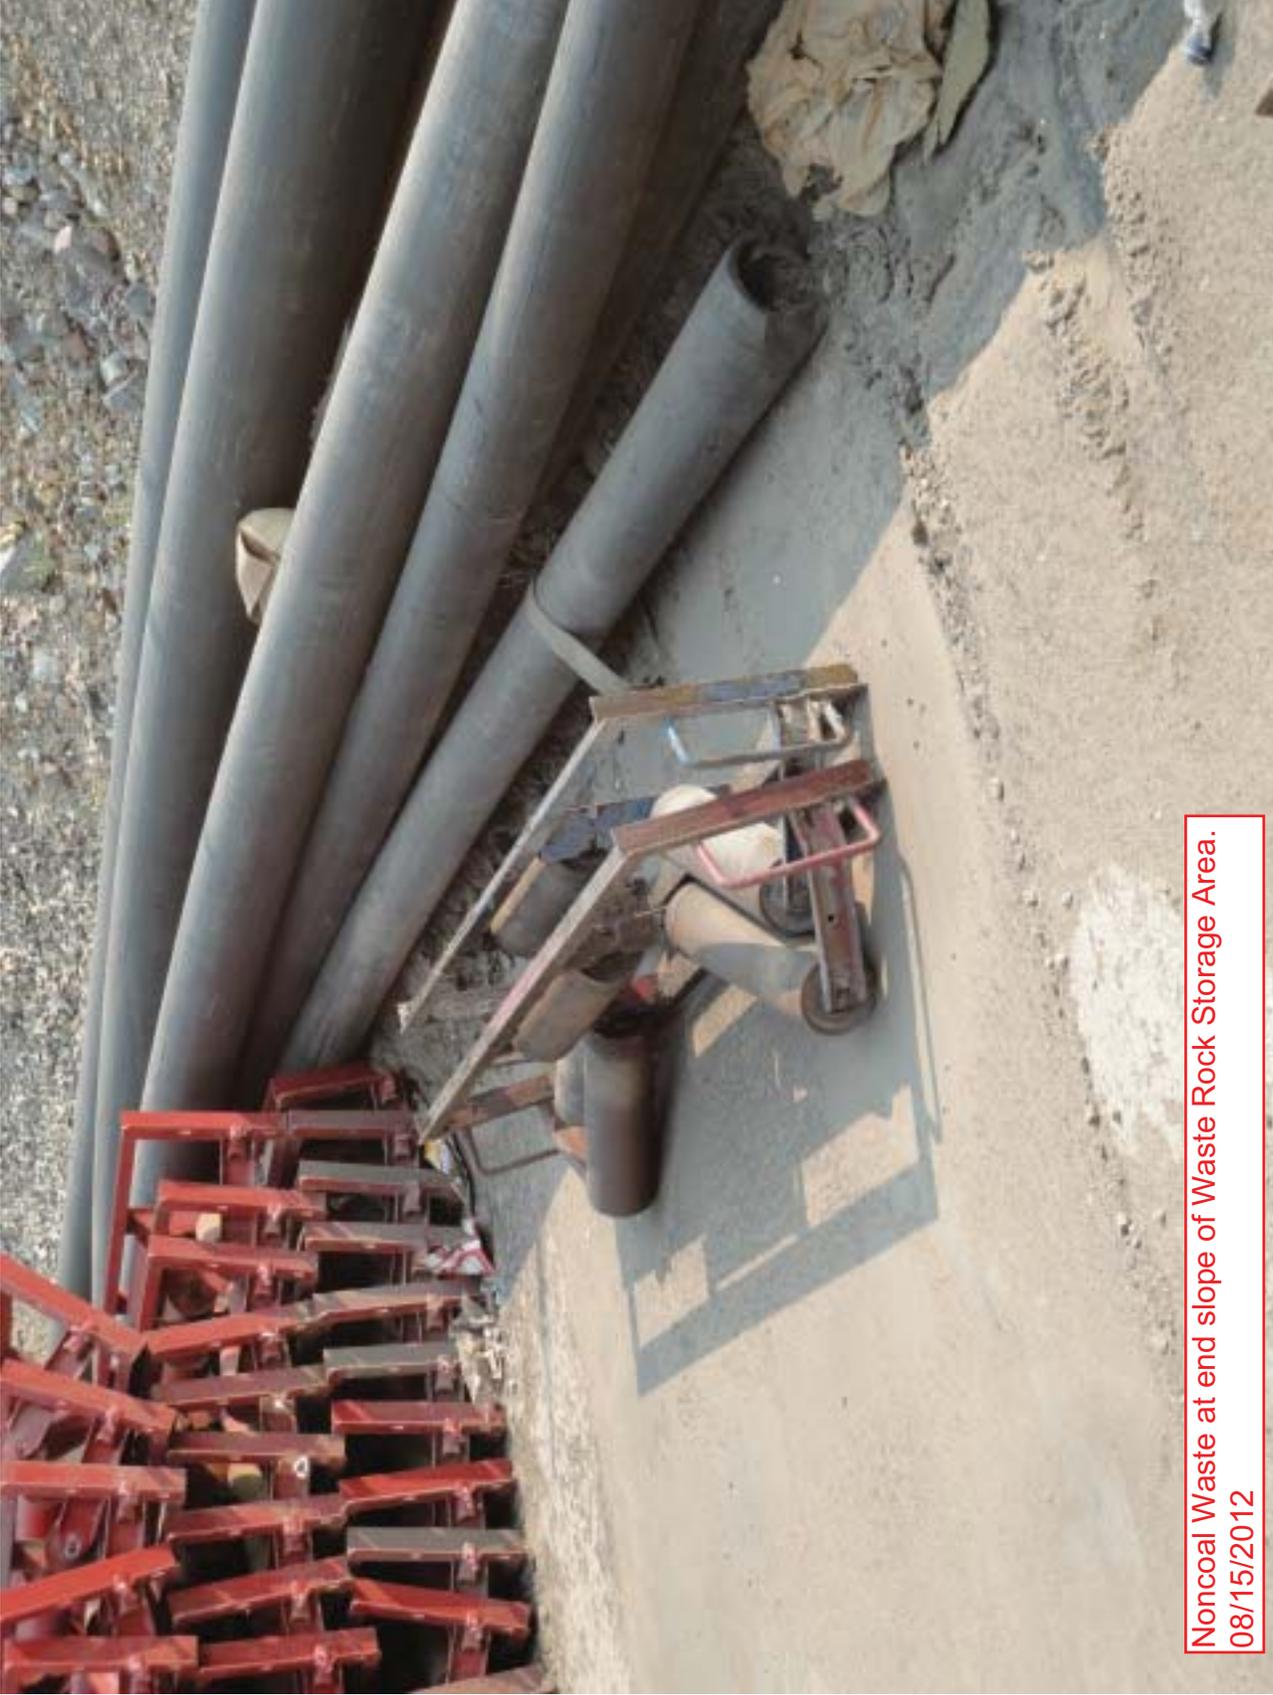
Noncoal Waste at end slope of Waste Rock Storage Area.
08/15/2012

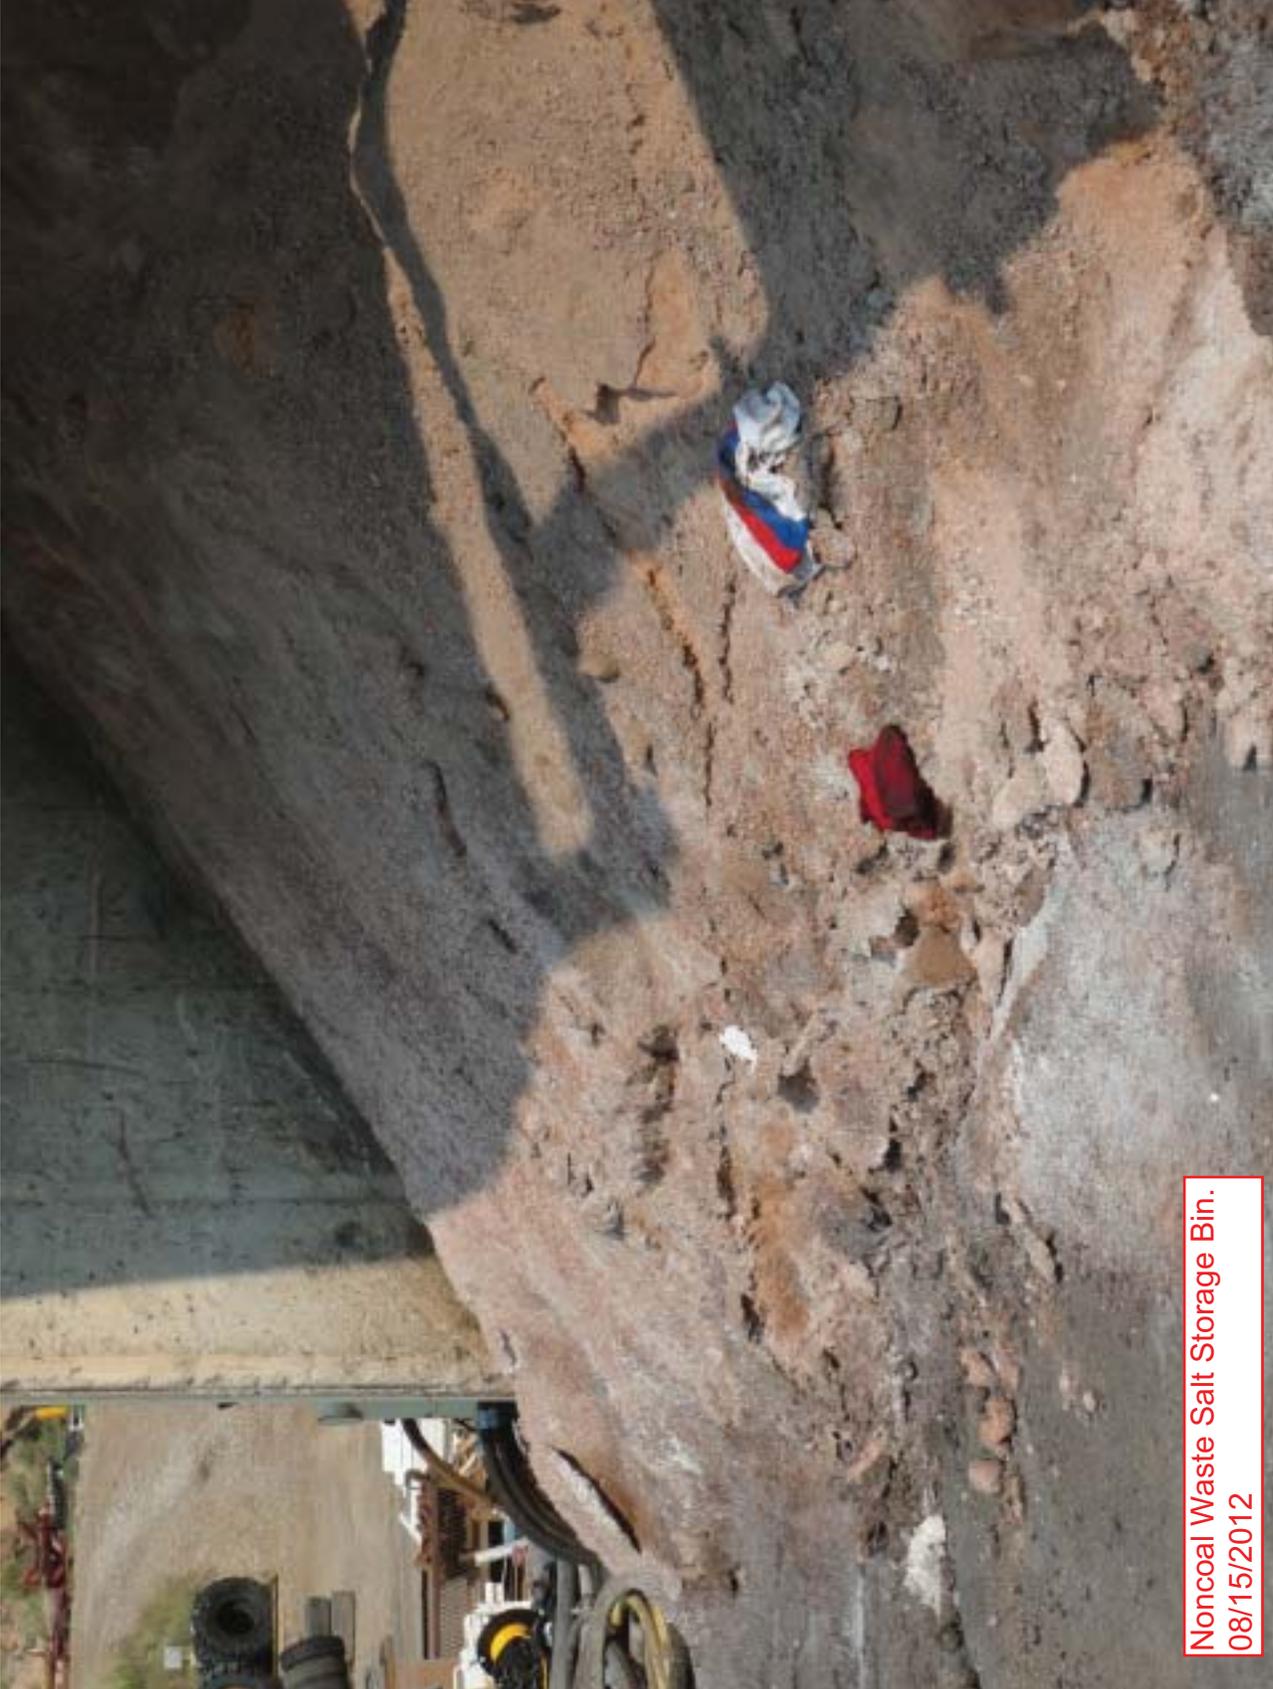
Noncoal Waste Salt Storage Bin.
08/15/2012
